**Flood Control Project Maintenance
Levee Inspections**

Maintenance Issue Types Only, Levee Inspection Report By Mile - Spring 2015

Merced Streams Group

Waterway	Bank	Unit Miles	Inspection Start/End	Inspector
Unit No. 01 Black Rascal Diversion	Right	1.61	05/04/2015 05/04/2015	Herman Phillips

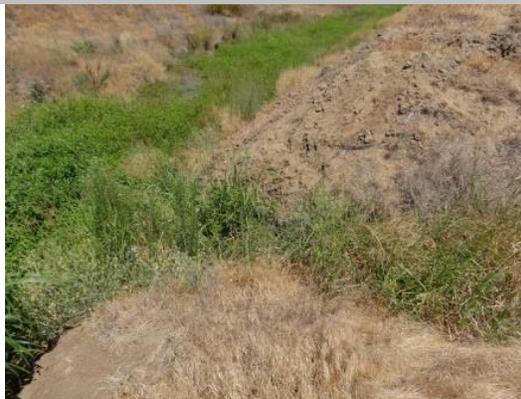
Photo 1 of 1 : SP_2015_NA0013_332_26_20150312_00006.jpg

LM Start	1.29	Rating **	M	Issue No.	26
LM End	1.29	Issue Type +	Ma	Location *	WS
Category	Supplemental			GPS Latitude/Longitude	
				Start	End
Item	DWR Erosion Survey			37.322615 °	37.322615 °
				-120.395948 °	-120.395948 °
DWR ID	DWR_NA0013_02_s_2015_26				
Action/Comments					
Inspector Comments: 7/31/2014: Soil has been added near the site. More vegetation is visible. 7/16/2013: The site was reported in the 2013 Spring Levee Inspection Reports. The erosion was caused by the water from the discharge line crossing the levee. Above the erosion a concrete discharge structure is present at the levee toe. The site is covered with dense vegetation. [2014 Site ID:NA0013U02RM1.31]

Looking down at the site.

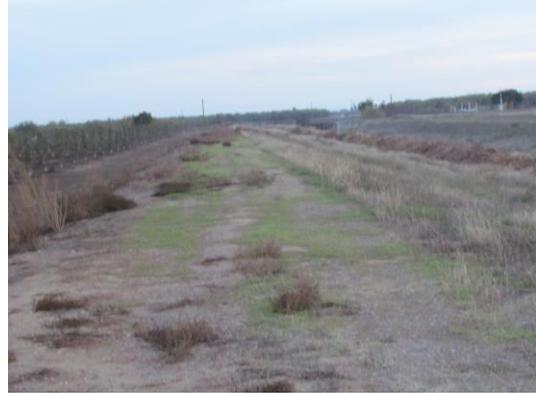
Photo 1 of 1 : SP_2015_NA0013_332_28_20150312_00007.jpg

LM Start	1.64	Rating **	M	Issue No.	28
LM End	1.85	Issue Type +	Ma	Location *	CR
Category	Earthen Levee		GPS Latitude/Longitude		
			Start	End	
Item	Vegetation		37.317588 °	37.314669 °	
			-120.395738 °	-120.395810 °	
DWR ID	DWR_NA0013_02_f_2014_28				
Action/Comments					
Keep the crown roadway free of vegetation. Inspector Comments: The crown roadway is overgrown with unwanted wild weeds.

Looking downstream at the crown.

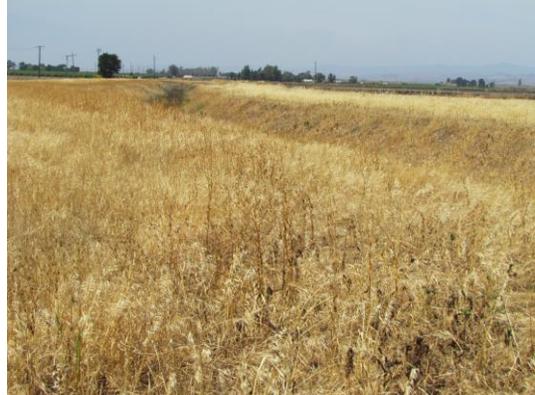
Photo 1 of 1 : SP_2015_NA0013_333_97_20150508_00102.jpg

LM Start	0.00	Rating **	U	Issue No.	97
LM End	1.41	Issue Type +	Ma	Location *	WS
Category	Earthen Levee		GPS Latitude/Longitude		
			Start	End	
Item	Vegetation		37.257731 °	37.273315 °	
			-120.288550 °	-120.277750 °	
DWR ID	DWR_NA0013_03_s_2015_97				
Action/Comments					
Control annual grass and weeds on the levee slopes and easements. Inspector Comments: Remove the tall weeds from the waterside levee slope.

Unsatisfactory wild tall weeds on the landside levee slope.

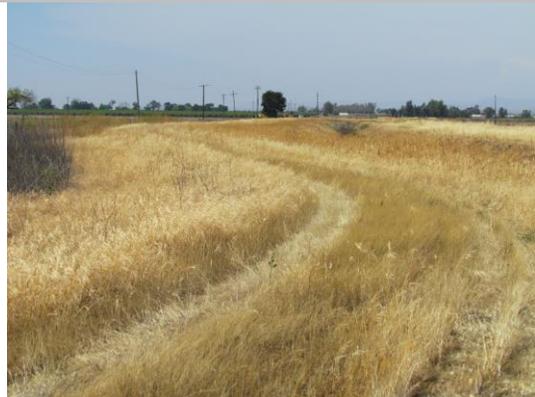
Photo 1 of 1 : SP_2015_NA0013_333_21_20150508_00100.jpg

LM Start	0.00	Rating **	U	Issue No.	21
LM End	0.65	Issue Type +	Ma	Location *	CR
Category	Earthen Levee		GPS Latitude/Longitude		
			Start	End	
Item	Vegetation		37.257731 °	37.266833 °	
			-120.288546 °	-120.287558 °	
DWR ID	DWR_NA0013_03_s_2014_21				
Action/Comments					
Keep the crown roadway free of vegetation. Inspector Comments: Crown roadway shall be free of vegetation.

Looking downstream from levee mile 0.00 the crown road way is overgrown with weeds asis both slopes.

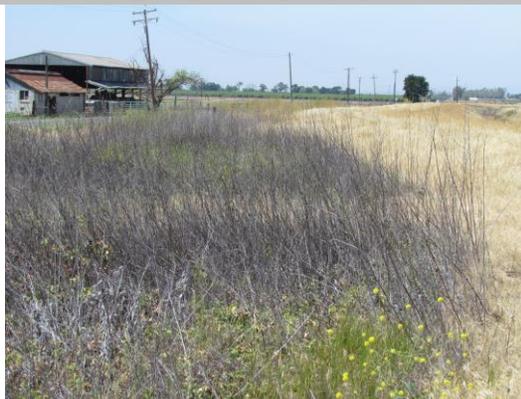
Photo 1 of 1 : SP_2015_NA0013_333_27_20150508_00101.jpg

LM Start	0.48	Rating **	U	Issue No.	27
LM End	0.75	Issue Type +	Ma	Location *	LS
Category	Earthen Levee		GPS Latitude/Longitude		
			Start	End	
Item	Vegetation		37.264472 °	37.267925 °	
			-120.288464 °	-120.286572 °	
DWR ID	DWR_NA0013_03_f_2014_27				
Action/Comments					
Control annual grass and weeds on the levee slopes and easements. Inspector Comments: Remove the tall dead weeds from the levee section landside.

Looking upstream landside unsatisfactory tall weeds on slope and berm.

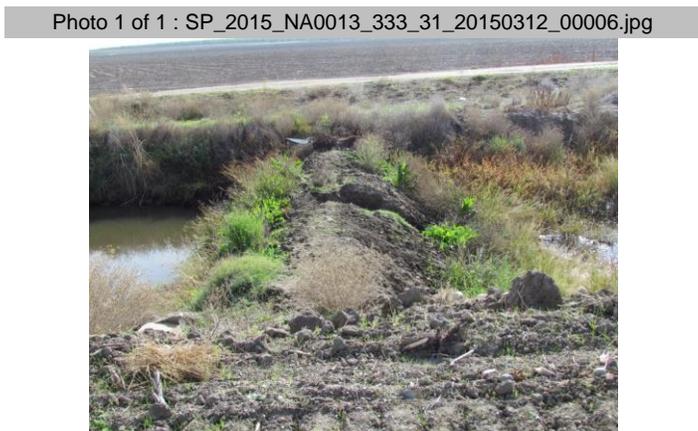
LM Start	0.97	Rating **	U	Issue No.	31
LM End	0.97	Issue Type +	Ma	Location *	WS
Category	Rivers, Channels & Designated Floodways			GPS Latitude/Longitude	
				Start	End
Item	Encroachments			37.270665 °	37.270665 °
				-120.284330 °	-120.284330 °
DWR ID	DWR_NA0013_03_f_2014_31				
Action/Comments					
Inspector Comments: Remove the earthen dam placed across the channel. May 2015: THIS EARTHEN DAM WAS NOT REMOVED.

Earthen dam placed across the channel. No new photo taken 2015.

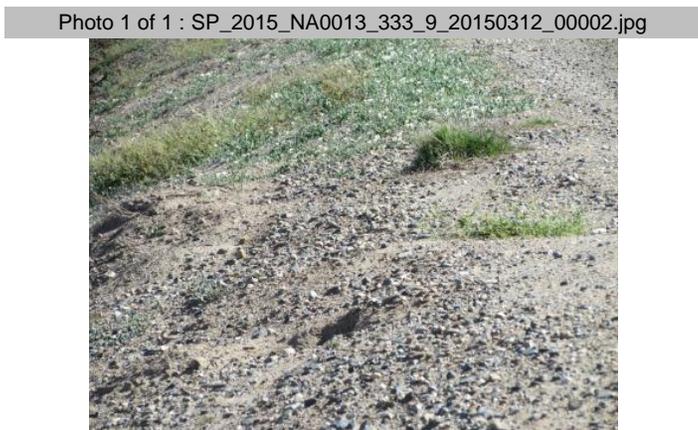
LM Start	1.09	Rating **	U	Issue No.	9
LM End	1.22	Issue Type +	Ma	Location *	LS
Category	Earthen Levee			GPS Latitude/Longitude	
				Start	End
Item	Animal Control			37.271737 °	37.272498 °
				-120.282642 °	-120.280511 °
DWR ID	DWR_NA0013_03_f_2012_9				
Action/Comments					
Exterminate rodents and backfill and compact or grout burrows. Inspector Comments: This levee section has a history of rodent problems that has been known for many years. There should be bait stations in place in these infested areas.

Levee slope taken over by rodents Photo taken 4-23-2014. No new photo 2015.

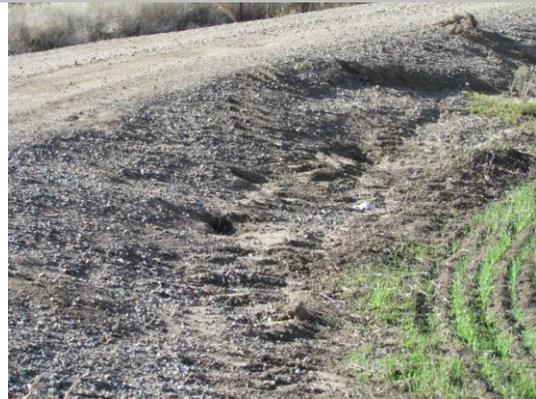
Photo 1 of 1 : SP_2015_NA0013_333_7_20150312_00001.jpg

LM Start	1.24	Rating **	M	Issue No.	7
LM End	1.29	Issue Type +	Ma	Location *	LS
Category	Earthen Levee			GPS Latitude/Longitude	
				Start	End
Item	Animal Control			37.272707 °	37.273379 °
				-120.280334 °	-120.279976 °
DWR ID	DWR_NA0013_03_s_2012_7				
Action/Comments					
Exterminate rodents and backfill and compact or grout burrows. Inspector Comments: The District needs to be more aggressive in their efforts of controlling the ground rodents. There should be some bait stations placed in infected areas.

Looking at the rodent holes at the levee slope. Levee mile 1.25-1.30.
No new picture.

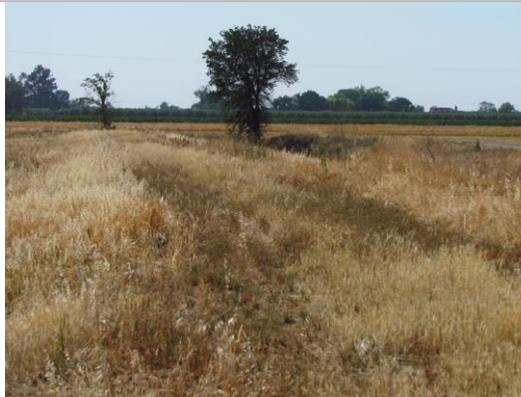
Photo 1 of 1 : SP_2015_NA0013_334_84_20150508_00088.jpg

LM Start	0.00	Rating **	U	Issue No.	84
LM End	0.15	Issue Type +	Ma	Location *	CR
Category	Earthen Levee		GPS Latitude/Longitude		
			Start	End	
Item	Vegetation		37.273315 °	37.272862 °	
			-120.277750 °	-120.280005 °	
DWR ID	DWR_NA0013_04_s_2015_84				
Action/Comments					
Keep the crown roadway free of vegetation. Inspector Comments: Remove the wild growth from levee section.

Unsatisfactory growth on crown roadway and both slopes.

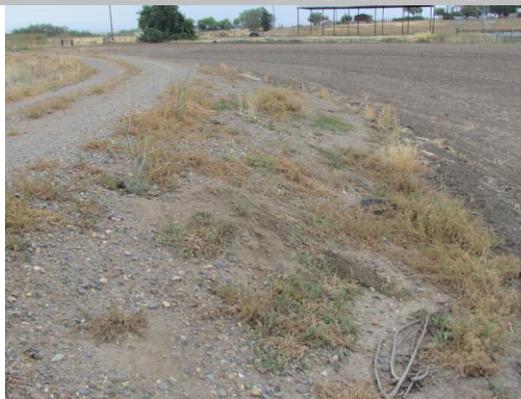
Photo 1 of 1 : SP_2015_NA0013_334_87_20150508_00089.jpg

LM Start	0.17	Rating **	U	Issue No.	87
LM End	0.20	Issue Type +	Ma	Location *	LS
Category	Earthen Levee		GPS Latitude/Longitude		
			Start	End	
Item	Animal Control		37.272507 °	37.272335 °	
			-120.280172 °	-120.280617 °	
DWR ID	DWR_NA0013_04_s_2015_87				
Action/Comments					
Exterminate rodents and backfill and compact or grout burrows.

Active rodents on landside slope.

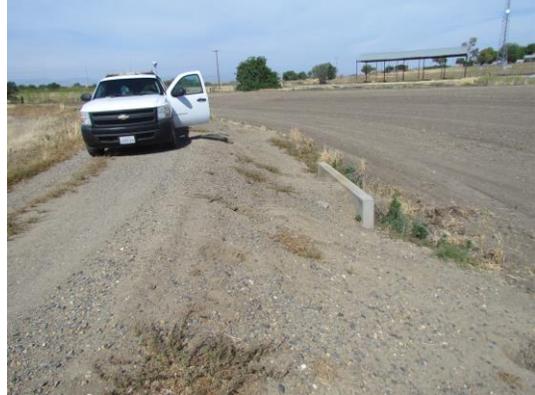
Photo 1 of 1 : SP_2015_NA0013_334_8_20150508_00087.jpg

LM Start	0.18	Rating **	U	Issue No.	8
LM End	0.19	Issue Type +	Ma	Location *	LS
Category	Earthen Levee		GPS Latitude/Longitude		
			Start	End	
Item	Animal Control		37.272429 °	37.272380 °	
			-120.280250 °	-120.280360 °	
DWR ID	DWR_NA0013_04_f_2012_8				
Action/Comments					
Exterminate rodents and backfill and compact or grout burrows. Inspector Comments: There should be bait stations placed along the infested areas.

Unsatisfactory rodent activity continues to be present and active.

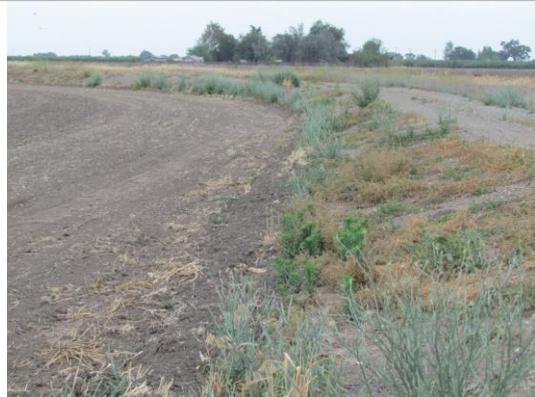
Photo 1 of 1 : SP_2015_NA0013_334_89_20150508_00098.jpg

LM Start	0.20	Rating **	U	Issue No.	89
LM End	0.59	Issue Type +	Ma	Location *	LS
Category	Earthen Levee		GPS Latitude/Longitude		
			Start	End	
Item	Vegetation		37.272342 °	37.268648 °	
			-120.280480 °	-120.285563 °	
DWR ID	DWR_NA0013_04_s_2015_89				
Action/Comments					
Remove the wild growth other than native grasses from the levee slopes.

Tall weeds present on the landside levee slope and toe.

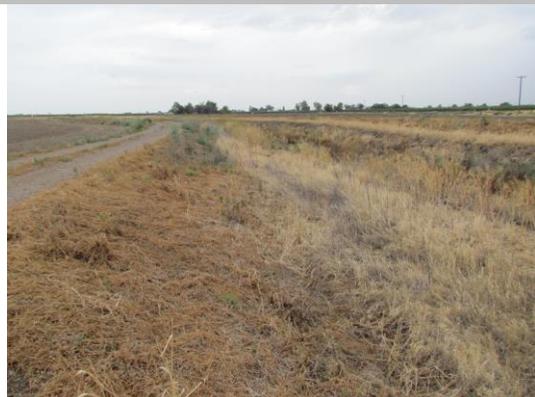
Photo 1 of 1 : SP_2015_NA0013_334_88_20150508_00099.jpg

LM Start	0.20	Rating **	U	Issue No.	88
LM End	1.03	Issue Type +	Ma	Location *	WS
Category	Earthen Levee		GPS Latitude/Longitude		
			Start	End	
Item	Vegetation		37.272342 °	37.262847 °	
			-120.280480 °	-120.287878 °	
DWR ID	DWR_NA0013_04_s_2015_88				
Action/Comments					
Remove the wild growth other than native grasses from the levee slopes.

Tall weeds present on the waterside levee slope and toe from levee mile 0.20-1.03.

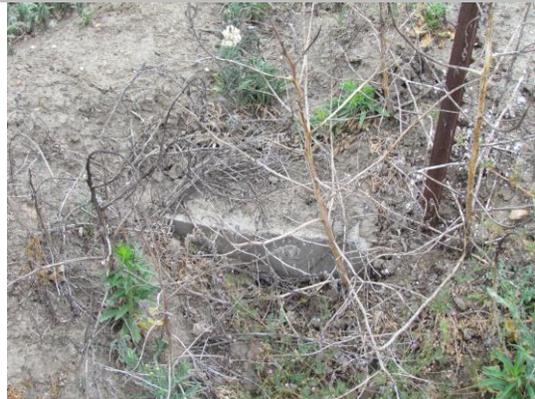
Photo 1 of 2 : SP_2015_NA0013_334_1_20150508_00090.jpg

LM Start	0.45	Rating **	U	Issue No.	1
LM End	0.45	Issue Type +	Ma	Location *	LS
Category	Earthen Levee		GPS Latitude/Longitude		
			Start	End	
Item	Encroachments		37.270328 °	37.270328 °	
			-120.284227 °	-120.284227 °	
DWR ID					
Action/Comments					
Pipe Inspector Comments: The inlet should not be blocked off.

Culvert inlet completely covered up on the landside.

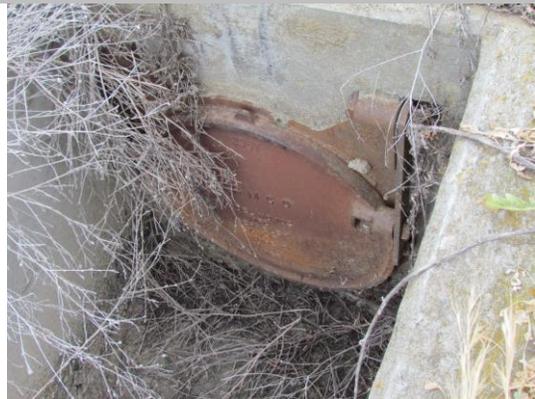
Photo 2 of 2 : SP_2015_NA0013_334_1_20150508_00091.jpg

LM Start	0.45	Rating **	U	Issue No.	1 (cont)
LM End	0.45	Issue Type +	Ma	Location *	LS

View of the outlet.

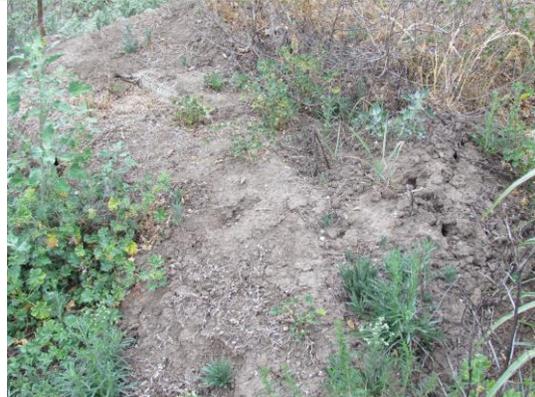
Photo 1 of 1 : SP_2015_NA0013_334_2_20150508_00092.jpg

LM Start	0.58	Rating **	U	Issue No.	2
LM End	0.58	Issue Type +	Ma	Location *	CR
Category	Interior Drainage & Piping Systems			GPS Latitude/Longitude	
				Start	End
Item	Culverts: Inlets / Outlets			37.268675 °	37.268675 °
				-120.285513 °	-120.285513 °
DWR ID	DWR_NA0013_04_s_2015_2				
Action/Comments					
Inspector Comments: Inlet covered with dirt.

Culvert has been blocked off with dirt on the inlet side.

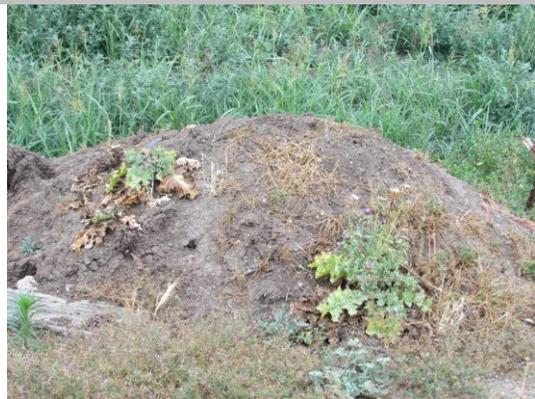
Photo 1 of 2 : SP_2015_NA0013_334_27_20150508_00093.jpg

LM Start	0.81	Rating **	U	Issue No.	27
LM End	0.81	Issue Type +	Ma	Location *	CR
Category	Interior Drainage & Piping Systems			GPS Latitude/Longitude	
				Start	End
Item	Culverts: Inlets / Outlets			37.265923 °	37.265923 °
				-120.287797 °	-120.287797 °
DWR ID	DWR_NA0013_04_s_2015_27				
Action/Comments					
Inspector Comments: Remove the material from the inlet of this culvert.

The inlet of the culvert has been blocked.

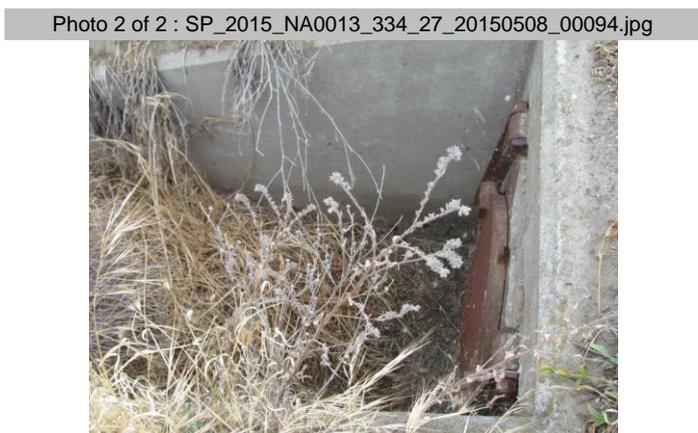
LM Start	0.81	Rating **	U	Issue No.	27 (cont)
LM End	0.81	Issue Type +	Ma	Location *	CR
Category	Interior Drainage & Piping Systems			GPS Latitude/Longitude	
				Start	End
Item	Culverts: Inlets / Outlets			37.265923 °	37.265923 °
				-120.287797 °	-120.287797 °
DWR ID	DWR_NA0013_04_s_2015_27				
Action/Comments					
Inspector Comments: Remove the material from the inlet of this culvert.

View on the outlet.

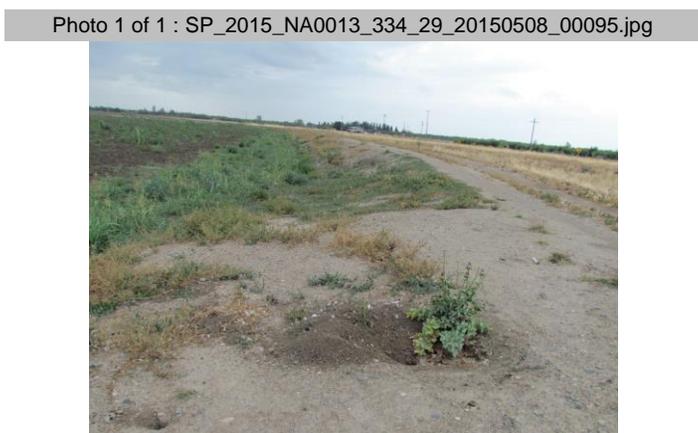
LM Start	0.87	Rating **	U	Issue No.	29
LM End	0.95	Issue Type +	Ma	Location *	LS
Category	Earthen Levee			GPS Latitude/Longitude	
				Start	End
Item	Animal Control			37.265188 °	37.263963 °
				-120.288058 °	-120.288050 °
DWR ID	DWR_NA0013_04_f_2014_29				
Action/Comments					
Exterminate rodents and backfill and compact or grout burrows. Inspector Comments: District needs to place bait stations along infested areas of the levee section where activity is high.

Looking downstream from levee mile 0.87 active rodent holes on landside slope.

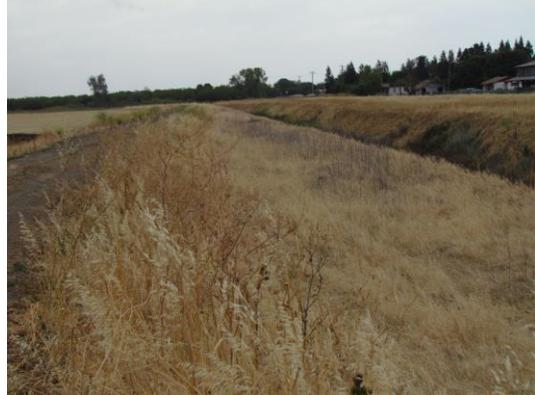
Photo 1 of 1 : SP_2015_NA0013_334_6_20150508_00096.jpg

LM Start	1.08	Rating **	U	Issue No.	6
LM End	1.42	Issue Type +	Ma	Location *	WS
Category	Earthen Levee		GPS Latitude/Longitude		
			Start	End	
Item	Vegetation		37.262188 °	37.257387 °	
			-120.288142 °	-120.288287 °	
DWR ID	DWR_NA0013_04_s_2015_6				
Action/Comments					
Remove the wild growth other than native grasses from the levee slopes. Inspector Comments: Remove the wild growth of weeds from the waterside levee slope.

Unsatisfactory wild growth of weeds on the waterside levee slope.

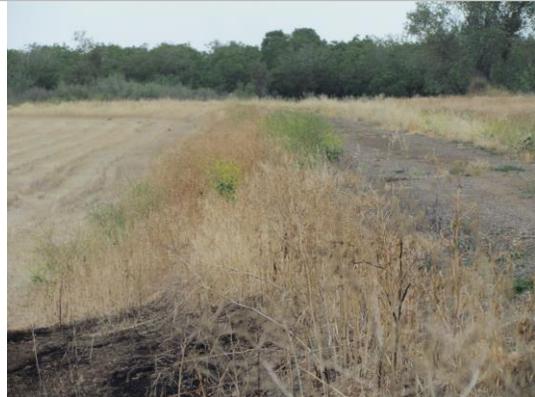
Photo 1 of 1 : SP_2015_NA0013_334_10_20150508_00097.jpg

LM Start	1.12	Rating **	U	Issue No.	10
LM End	1.42	Issue Type +	Ma	Location *	LS
Category	Earthen Levee		GPS Latitude/Longitude		
			Start	End	
Item	Vegetation		37.261633 °	37.257387 °	
			-120.288105 °	-120.288287 °	
DWR ID	DWR_NA0013_04_s_2015_10				
Action/Comments					
Remove the wild growth other than native grasses from the levee slopes. Inspector Comments: Remove the wild weeds from the levee section.

Unsatisfactory growth of weeds on the landside levee slope.
