**Flood Control Project Maintenance
Levee Inspections**

Maintenance Issue Types Only, Levee Inspection Report By Mile - Spring 2016

Merced Streams Group

Waterway	Bank	Unit Miles	Inspection Start/End	Inspector
Unit No. 01 Black Rascal Diversion	Right	1.61	04/12/2016 04/12/2016	Herman Phillips

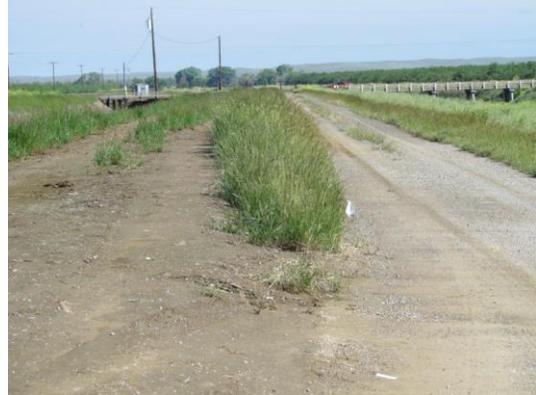
Photo 1 of 1 : SP_2016_NA0013_331_2_20160506_00005.jpg

LM Start	0.01	Rating **	U	Issue No.	2
LM End	0.19	Issue Type +	Ma	Location *	LS
Category	Earthen Levee		GPS Latitude/Longitude		
			Start	End	
Item	Vegetation		37.314812 °	37.317443 °	
			-120.396380 °	-120.396317 °	
DWR ID	DWR_NA0013_01_s_2016_2				
Comment Code					
V1 : Control annual grass and weeds on the levee slopes and easements.					
Inspector Comment					
Control the wild weeds on the landside shoulder and slope.

Looking upstream from levee mile 0.01 Unit 1 Black Rascal Creek, tall weeds 24-inches and greater on the landside slope.

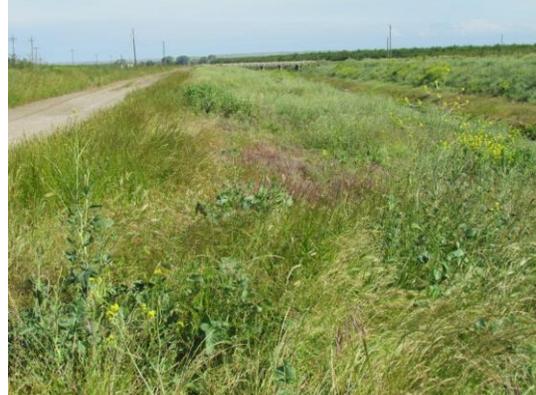
Photo 1 of 1 : SP_2016_NA0013_331_6_20160506_00006.jpg

LM Start	0.01	Rating **	U	Issue No.	6
LM End	1.25	Issue Type +	Ma	Location *	WS
Category	Earthen Levee		GPS Latitude/Longitude		
			Start	End	
Item	Vegetation		37.314812 °	37.332237 °	
			-120.396380 °	-120.394693 °	
DWR ID	DWR_NA0013_01_s_2016_6				
Comment Code					
V1 : Control annual grass and weeds on the levee slopes and easements.					
Inspector Comment					
Control the tall weeds on the waterside shoulder and slope.

looking upstream levee mile 0.01 -1.25 unwanted tall weeds are present on the waterside shoulder and slope.

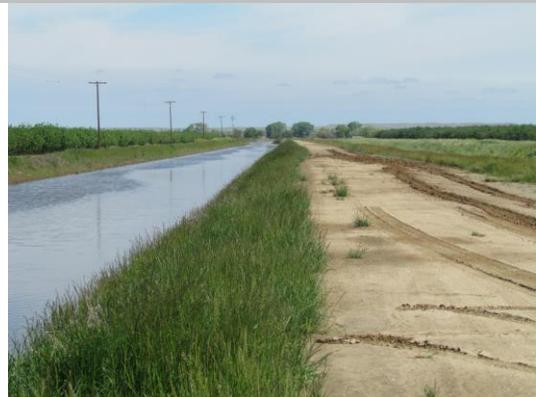
Photo 1 of 1 : SP_2016_NA0013_331_11_20160506_00007.jpg

LM Start	0.24	Rating **	U	Issue No.	11
LM End	1.25	Issue Type +	Ma	Location *	LS
Category	Earthen Levee		GPS Latitude/Longitude		
			Start	End	
Item	Vegetation		37.318130°	37.332237°	
			-120.396382°	-120.394693°	
DWR ID	DWR_NA0013_01_s_2016_11				
Comment Code					
V1 : Control annual grass and weeds on the levee slopes and easements.					
Inspector Comment					
Control the tall weeds on the landside slope.

Looking upstream from the landside of levee mile 0.24-1.25 weeds taller than 24" on the slope.

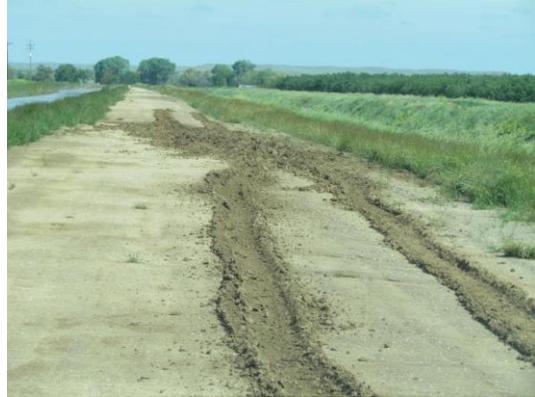
Photo 1 of 1 : SP_2016_NA0013_331_12_20160506_00008.jpg

LM Start	0.27	Rating **	M	Issue No.	12
LM End	0.37	Issue Type +	Ma	Location *	CR
Category	Earthen Levee			GPS Latitude/Longitude	
				Start	End
Item	Crown Surface / Depressions / Rutting			37.318523 °	37.319920 °
				-120.396642 °	-120.396582 °
DWR ID	DWR_NA0013_01_s_2016_12				
Comment Code					
C2 : Repair depressions or ruts in the crown or slope.					
Inspector Comment					
Repair the crown damaged by vehicle.

Looking upstream from levee mile 0.27- 0.37 crown roadway damage by vehicle.

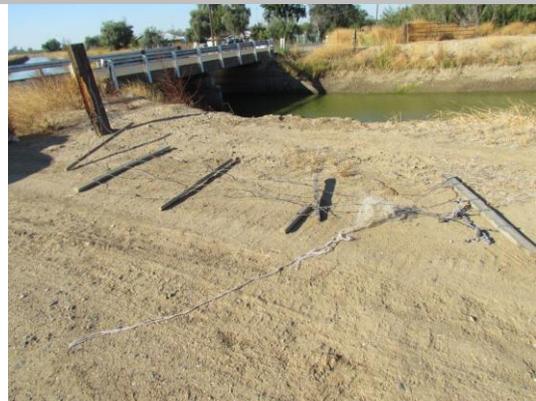
Photo 1 of 1 : SP_2016_NA0013_331_4_20160223_00001.jpg

LM Start	1.24	Rating **	M	Issue No.	4
LM End	1.24	Issue Type +	Ma	Location *	CR
Category	Earthen Levee		GPS Latitude/Longitude		
			Start	End	
Item	Repair Gates		37.332165 °	37.332165 °	
			-120.394698 °	-120.394698 °	
DWR ID	DWR_NA0013_01_f_2014_4				
Comment Code					
Inspector Comment					
This wire gate across the crown roadway needs to be replaced.

This wire gate needs replacing, it poses a safety hazard.

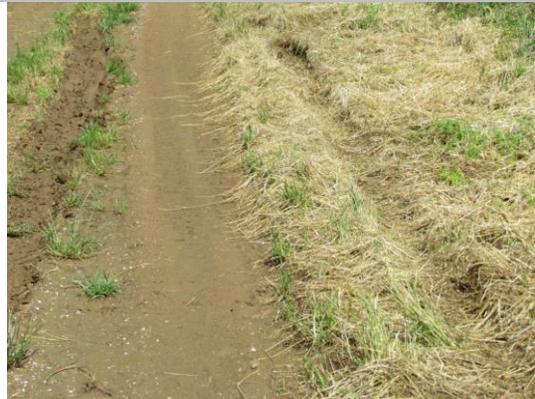
Photo 1 of 1 : SP_2016_NA0013_331_18_20160506_00009.jpg

LM Start	1.41	Rating **	U	Issue No.	18
LM End	1.61	Issue Type +	Ma	Location *	CR
Category	Earthen Levee		GPS Latitude/Longitude		
			Start	End	
Item	Crown Surface / Depressions / Rutting		37.334533 °	37.337097 °	
			-120.395398 °	-120.396520 °	
DWR ID	DWR_NA0013_01_s_2016_18				
Comment Code					
C1 : Add appropriate material and re-grade the levee to bring the crown above the design elevation.					
Inspector Comment					
This vehicle damage would be prevented if the crown road way had appropriate road base placed and graded.

Looking upstream from the levee miles 1.41 to 1.61 soft crown roadway. Not enough appropriate gravel and or road base.

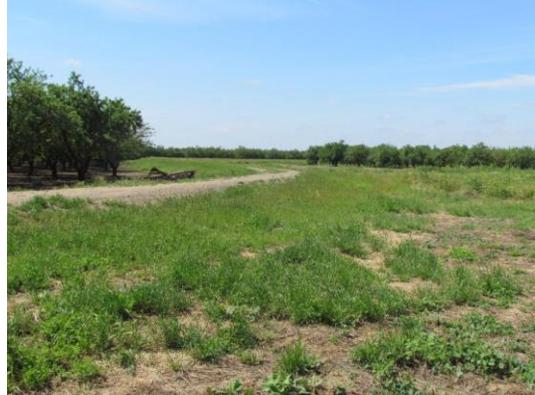
Photo 1 of 1 : SP_2016_NA0013_332_10_20160506_00021.jpg

LM Start	0.01	Rating **	M	Issue No.	10
LM End	0.61	Issue Type +	Ma	Location *	WS
Category	Earthen Levee		GPS Latitude/Longitude		
			Start	End	
Item	Vegetation		37.337008 °	37.332155 °	
			-120.387457 °	-120.394130 °	
DWR ID	DWR_NA0013_02_s_2016_10				
Comment Code					
V1 : Control annual grass and weeds on the levee slopes and easements.					
Inspector Comment

Looking downstream from levee miles 0.01-0.61 waterside slope.

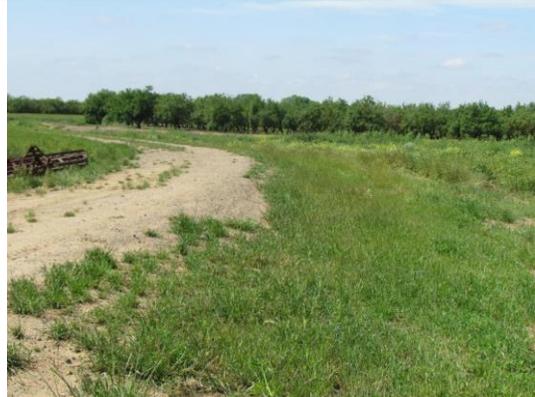
Photo 1 of 1 : SP_2016_NA0013_332_8_20160506_00020.jpg

LM Start	0.01	Rating **	M	Issue No.	8
LM End	0.61	Issue Type +	Ma	Location *	CR
Category	Earthen Levee		GPS Latitude/Longitude		
			Start	End	
Item	Vegetation		37.337008 °	37.332155 °	
			-120.387457 °	-120.394130 °	
DWR ID	DWR_NA0013_02_s_2016_8				
Comment Code					
V9 : Keep the crown roadway free of vegetation.					
Inspector Comment					
Crown roadway should be free of vegetation.

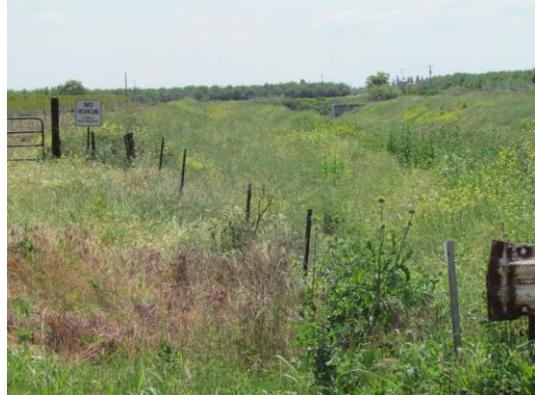
Photo 1 of 1 : SP_2016_NA0013_332_12_20160506_00025.jpg

LM Start	0.61	Rating **	U	Issue No.	12
LM End	1.82	Issue Type +	Ma	Location *	WS
Category	Earthen Levee		GPS Latitude/Longitude		
			Start	End	
Item	Vegetation		37.332155 °	37.314999 °	
			-120.394130 °	-120.395745 °	
DWR ID	DWR_NA0013_02_s_2016_12				
Comment Code					
V2 : Remove the wild growth other than native grasses from the levee slopes.					
Inspector Comment					
Remove the wild growth from the waterside levee slope.

Looking downstream from levee mile 0.61-1.85 weeds taller than 2.0 foot on the waterside slope.

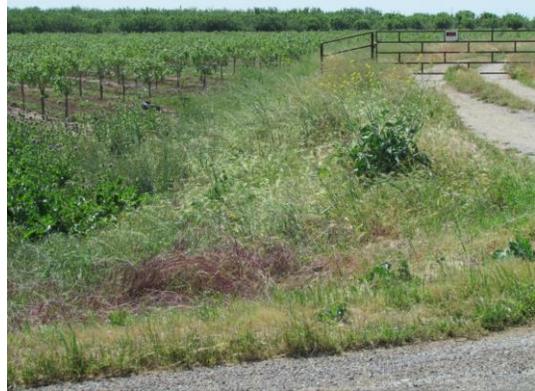
Photo 1 of 1 : SP_2016_NA0013_332_13_20160506_00026.jpg

LM Start	0.62	Rating **	U	Issue No.	13
LM End	0.86	Issue Type +	Ma	Location *	LS
Category	Earthen Levee		GPS Latitude/Longitude		
			Start	End	
Item	Vegetation		37.332042 °	37.328865 °	
			-120.394105 °	-120.396062 °	
DWR ID	DWR_NA0013_02_s_2016_13				
Comment Code					
V1 : Control annual grass and weeds on the levee slopes and easements.					
Inspector Comment					
Remove the tall weeds from the landside levee section.

Looking downstream from the landward shoulder unwanted tall weeds present on the slope.

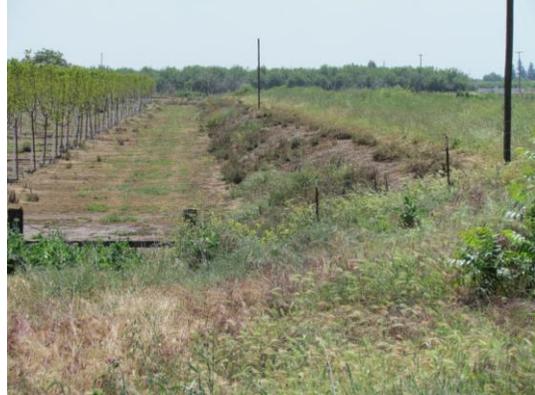
Photo 1 of 1 : SP_2016_NA0013_332_21_20160506_00027.jpg

LM Start	1.63	Rating **	U	Issue No.	21
LM End	1.85	Issue Type +	Ma	Location *	LS
Category	Earthen Levee		GPS Latitude/Longitude		
			Start	End	
Item	Vegetation		37.317798 °	37.314609 °	
			-120.395720 °	-120.395807 °	
DWR ID	DWR_NA0013_02_s_2016_21				
Comment Code					
V1 : Control annual grass and weeds on the levee slopes and easements.					
Inspector Comment					
Control the wild growth from the landside slope levee miles 1.63 -1.85.

Looking downstream from levee miles 1.63-1.85 landside slope covered with tall weeds.

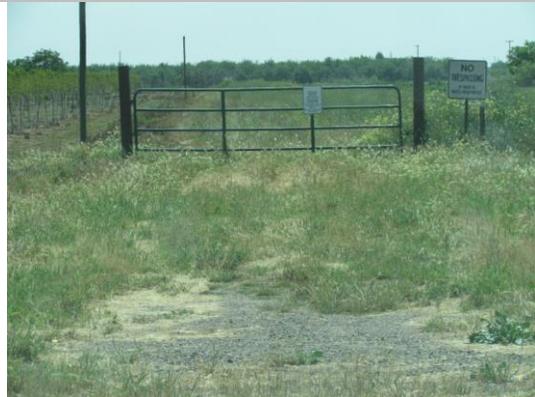
Photo 1 of 1 : SP_2016_NA0013_332_22_20160506_00028.jpg

LM Start	1.63	Rating **	U	Issue No.	22
LM End	1.85	Issue Type +	Ma	Location *	CR
Category	Earthen Levee		GPS Latitude/Longitude		
			Start	End	
Item	Vegetation		37.317798 °	37.314609 °	
			-120.395720 °	-120.395807 °	
DWR ID	DWR_NA0013_02_s_2016_22				
Comment Code					
V9 : Keep the crown roadway free of vegetation.					
Inspector Comment					
Keep the crown roadway free of all vegetation.

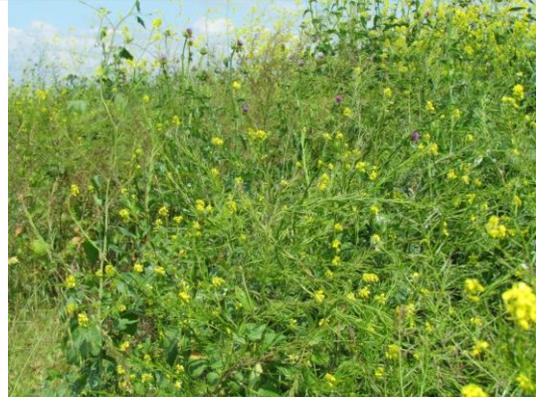
Photo 1 of 1 : SP_2016_NA0013_333_8_20160506_00024.jpg

LM Start	0.00	Rating **	U	Issue No.	8
LM End	0.35	Issue Type +	Ma	Location *	LS
Category	Earthen Levee		GPS Latitude/Longitude		
			Start	End	
Item	Vegetation		37.257738 °	37.262640 °	
			-120.288518 °	-120.288618 °	
DWR ID	DWR_NA0013_03_s_2016_8				
Comment Code					
V2 : Remove the wild growth other than native grasses from the levee slopes.					
Inspector Comment					
Remove the unwanted tall weeds from the landward slope and toe.

Looking upstream from levee mile 0.00 - 0.35 landside slope over grown with tall weed growth.

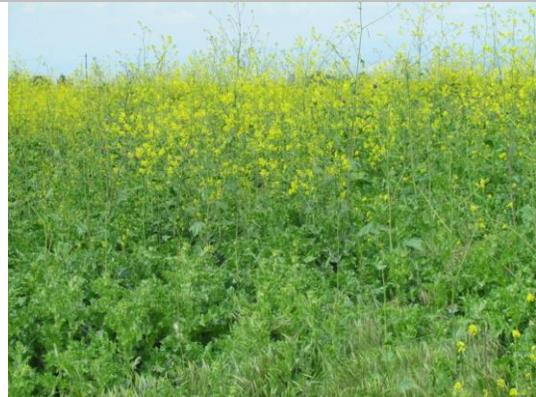
Photo 1 of 1 : SP_2016_NA0013_333_9_20160506_00023.jpg

LM Start	0.00	Rating **	U	Issue No.	9
LM End	0.35	Issue Type +	Ma	Location *	WS
Category	Earthen Levee		GPS Latitude/Longitude		
			Start	End	
Item	Vegetation		37.257738 °	37.262640 °	
			-120.288518 °	-120.288618 °	
DWR ID	DWR_NA0013_03_s_2016_9				
Comment Code					
V1 : Control annual grass and weeds on the levee slopes and easements.					
Inspector Comment					
Unable to see the slope weeds taller than 5.0 foot blocking view levee section.

Looking upstream levee mile 0.00 -0.35 weeds taller than 5.0-foot present on the slope and shoulder.

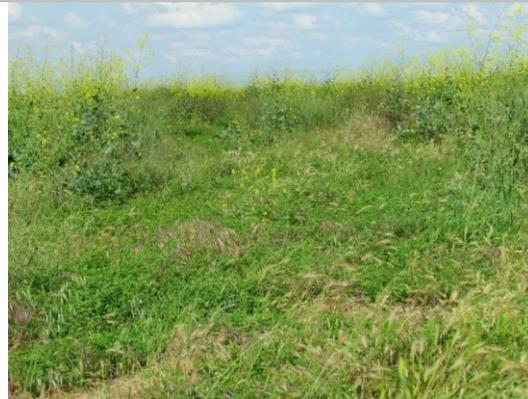
Photo 1 of 1 : SP_2016_NA0013_333_10_20160506_00025.jpg

LM Start	0.00	Rating **	U	Issue No.	10
LM End	0.35	Issue Type +	Ma	Location *	CR
Category	Earthen Levee		GPS Latitude/Longitude		
			Start	End	
Item	Vegetation		37.257738 °	37.262640 °	
			-120.288518 °	-120.288618 °	
DWR ID	DWR_NA0013_03_s_2016_10				
Comment Code					
V9 : Keep the crown roadway free of vegetation.					
Inspector Comment					
Keep the crown roadway free of vegetation.

Looking upstream from levee mile 0.00 - 0.35 vegetation covering crown roadway.

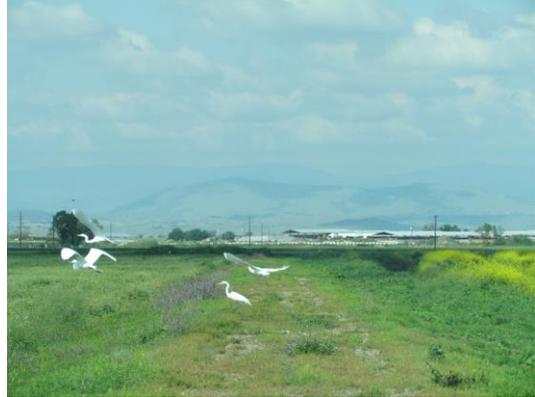
Photo 1 of 1 : SP_2016_NA0013_333_12_20160506_00026.jpg

LM Start	0.42	Rating **	U	Issue No.	12
LM End	1.25	Issue Type +	Ma	Location *	CR
Category	Earthen Levee		GPS Latitude/Longitude		
			Start	End	
Item	Vegetation		37.263628 °	37.272905 °	
			-120.288635 °	-120.280283 °	
DWR ID	DWR_NA0013_03_s_2016_12				
Comment Code					
V9 : Keep the crown roadway free of vegetation.					
Inspector Comment					
Keep the crown roadway free of vegetation.

looking upstream from levee mile 0.42 Crown road covered with vegetation.

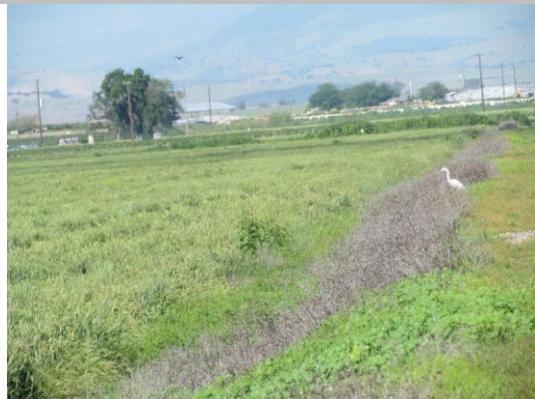
Photo 1 of 1 : SP_2016_NA0013_333_16_20160506_00027.jpg

LM Start	0.60	Rating **	U	Issue No.	16
LM End	1.25	Issue Type +	Ma	Location *	LS
Category	Earthen Levee		GPS Latitude/Longitude		
			Start	End	
Item	Vegetation		37.266193 °	37.272905 °	
			-120.288037 °	-120.280283 °	
DWR ID	DWR_NA0013_03_s_2016_16				
Comment Code					
V1 : Control annual grass and weeds on the levee slopes and easements.					
Inspector Comment					
Control the weed growth on the landside slope.

Looking upstream from levee mile 0.60- 1.25 landside slope.

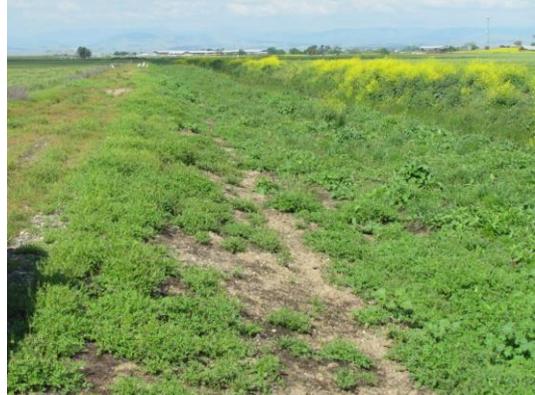
Photo 1 of 1 : SP_2016_NA0013_333_17_20160506_00028.jpg

Looking upstream from the waterside slope levee mile 0.60- 1.41.

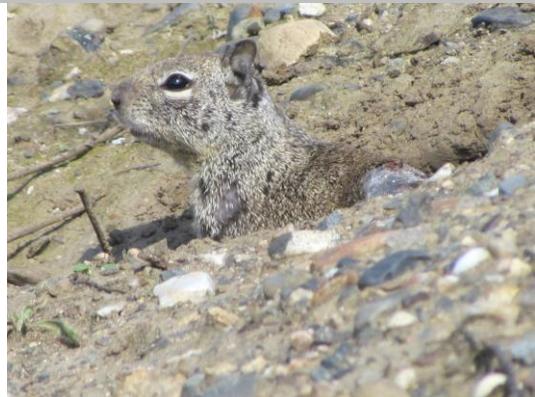
Photo 1 of 1 : SP_2016_NA0013_333_20_20160506_00029.jpg

Looking upstream from levee mile 1.22 active rodents seen in area.

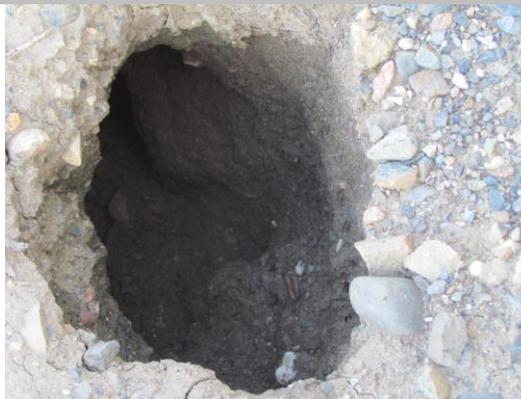
Photo 1 of 1 : SP_2016_NA0013_333_21_20160506_00030.jpg

Rodent holes in crown roadway.

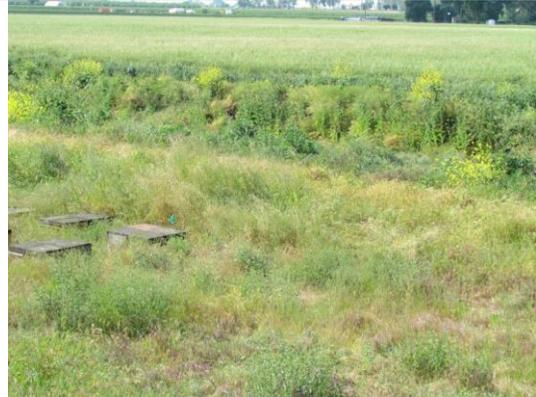
Photo 1 of 1 : SP_2016_NA0013_334_9_20160510_00025.jpg

NA0013 Unit 4 Levee mile 0.02 -0.14 landside and crown roadway covered with unwanted tall weeds. This section is more of a patrol road and not considered a levee. The actual levee begins once you cross Mission.

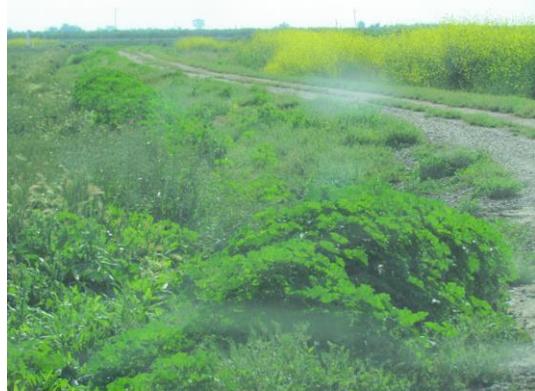
Photo 1 of 1 : SP_2016_NA0013_334_14_20160510_00026.jpg

NA0013 Unit 4 looking downstream landside slope over grown with tall unwanted weeds.

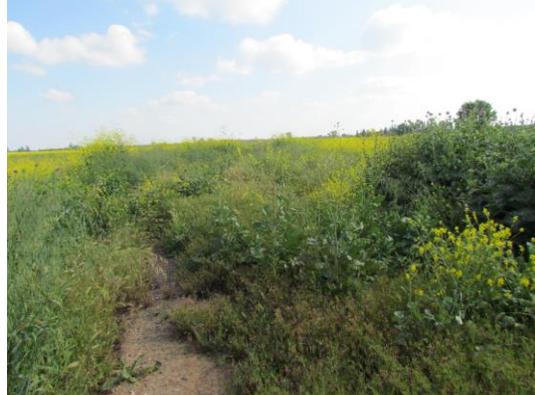
Photo 1 of 1 : SP_2016_NA0013_334_18_20160510_00028.jpg

NA0013 Unit 4 looking downstream at the crown roadway weeds taller than 4.0 foot covering the entire levee section, crown and both slopes.

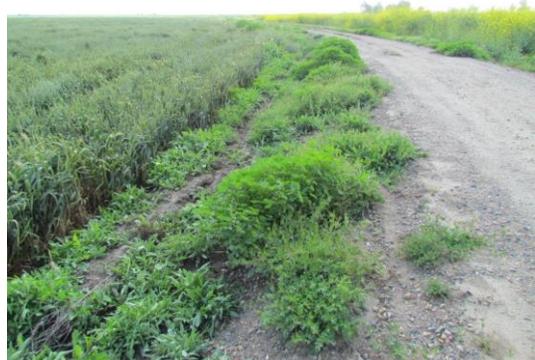
Photo 1 of 1 : SP_2016_NA0013_334_16_20160510_00027.jpg

LM Start	1.06	Rating **	U	Issue No.	16
LM End	1.42	Issue Type +	Ma	Location *	LS
Category	Earthen Levee		GPS Latitude/Longitude		
			Start	End	
Item	Vegetation		37.262560 °	37.257311 °	
			-120.288510 °	-120.288288 °	
DWR ID	DWR_NA0013_04_s_2016_16				
Comment Code					
V1 : Control annual grass and weeds on the levee slopes and easements.					
Inspector Comment					
Control the tall unwanted weeds on the landside levee slope.

NA0013 Unit 4 levee miles 1.06- 1.42 tall unwanted weeds covering the shoulder and landside slope.
