**Flood Control Project Maintenance**  
**2010 Structure Summary Report**  
**Overall Unit and Item Ratings**

**Merced Streams Group**

**Black Rascal Creek Drop Structure**

**Owens Creek Siphon Structure**

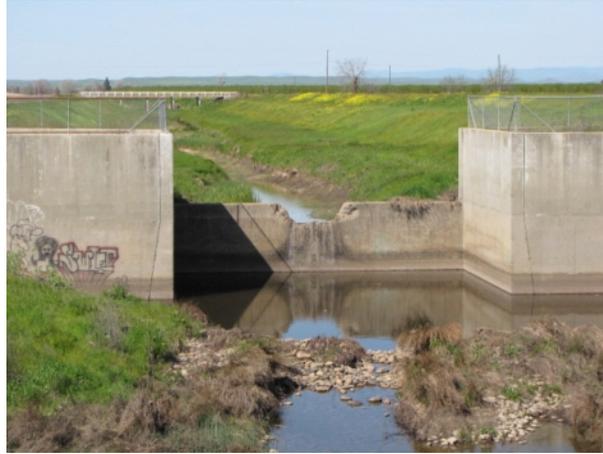
Levee Mile Report Line	1
Start Levee Mile	0.00
End Levee Mile	0.00
Location	Land Side
Category	Structures
Item	Photo Documentation
<p>This photo shows the structure from downstream across from Bear Creek. You can see the conditions of the structure from this view.</p>	
<p>phillips_t_20100812_010.jpg</p>

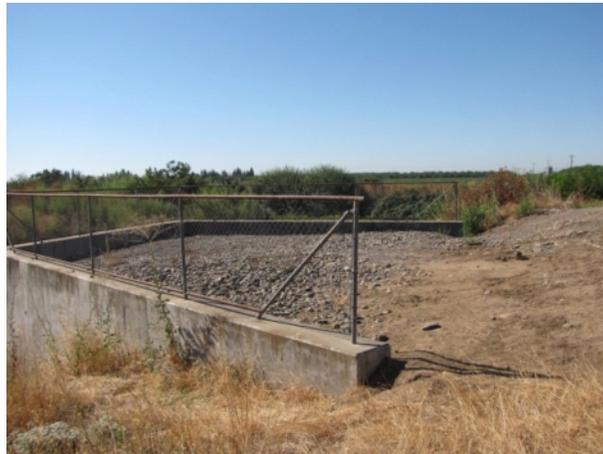
Levee Mile Report Line	1
Start Levee Mile	0.00
End Levee Mile	0.00
Location	Land Side
Category	Structures
Item	Photo Documentation
<p>Right bank of structure, safety wire good</p>	
<p>phillips_t_20100831_023.jpg</p>

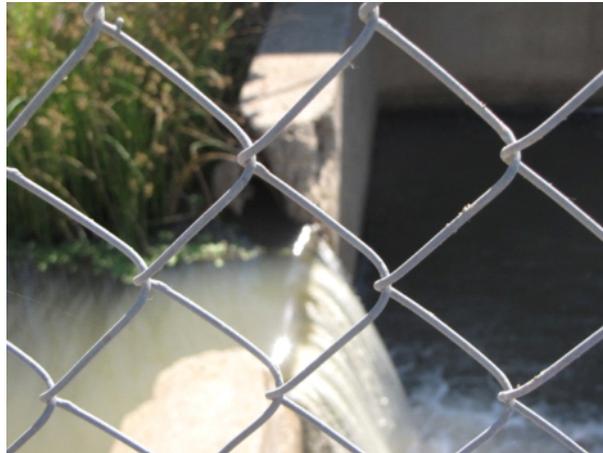
Levee Mile Report Line	1
Start Levee Mile	0.00
End Levee Mile	0.00
Location	Land Side
Category	Structures
Item	Photo Documentation
<p>This photo shows the spill way viewed from R/B Unit 1.</p>	
<p>phillips_t_20100902_047.jpg</p>

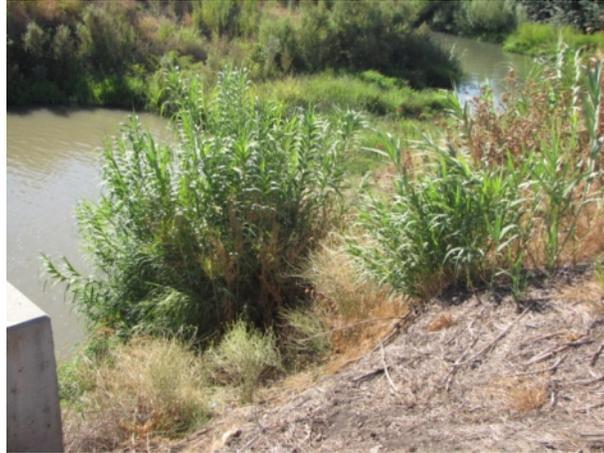
Levee Mile Report Line	2
Start Levee Mile	0.00
End Levee Mile	0.00
Location	Land Side
Category	Structures
Item	Vegetation & Obstructions
Bambo present on R/B downstream end of structure.	
phillips_t_20100901_031.jpg

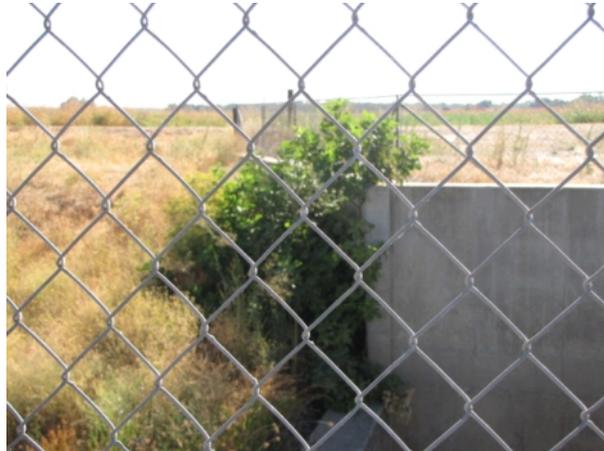
Levee Mile Report Line	2
Start Levee Mile	0.00
End Levee Mile	0.00
Location	Land Side
Category	Structures
Item	Vegetation & Obstructions
Standing on R/B Unit 1 looking across channel upstream side at L/B unit 2 structure are Fig trees. These trees should be removed.37.31473N - 120,39583N.	
phillips_t_20100901_032.jpg

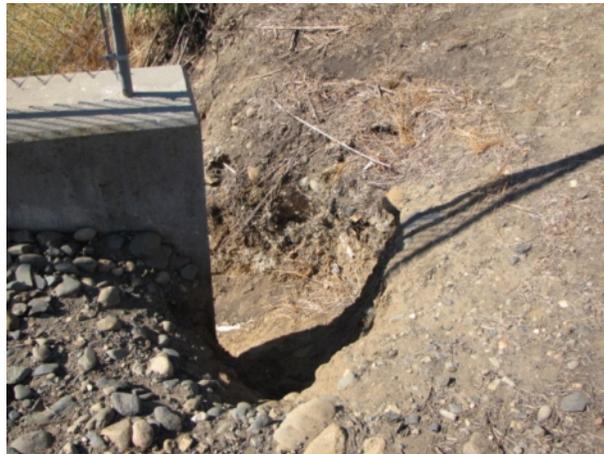
Levee Mile Report Line	5
Start Levee Mile	0.00
End Levee Mile	0.00
Location	Land Side
Category	Structures
Item	Erosion / Bank Caving
Erosion present on L/B downstream of concrete structure.	
phillips_t_20100901_033.jpg

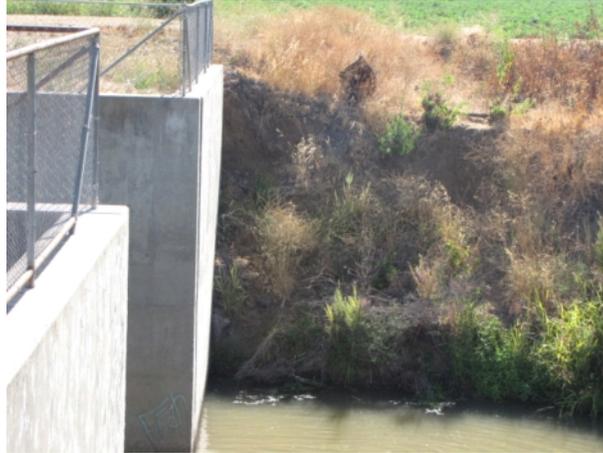
Levee Mile Report Line	5
Start Levee Mile	0.00
End Levee Mile	0.00
Location	Land Side
Category	Structures
Item	Erosion / Bank Caving
<p>Standing on Unit1 downstream of structure looking over at Unit 2 bank erosion has occurred downstream. Its hidden by the wild growth. 37.31458N -120.39583W</p> <p>phillips_t_20100901_034.jpg</p>

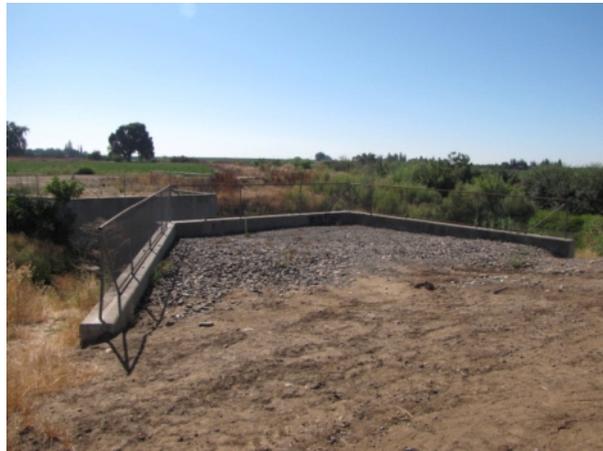
Levee Mile Report Line	19
Start Levee Mile	0.00
End Levee Mile	0.00
Location	Land Side
Category	Structures
Item	Security Fencing
<p>This view shows safety fence of both RB and LB side of structure, UNIT 1 in view and Unit 2 across channel in back ground.</p> <p>phillips_t_20100831_024.jpg</p>

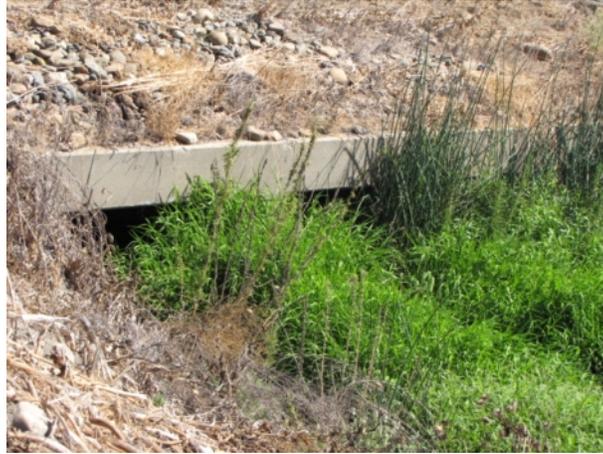
Levee Mile Report Line	2
Start Levee Mile	0.00
End Levee Mile	0.00
Location	Land Side
Category	Structures
Item	Vegetation & Obstructions
Outlet (discharge) end down stream of structure vegetation is present.	
phillips_t_20100901_036.jpg

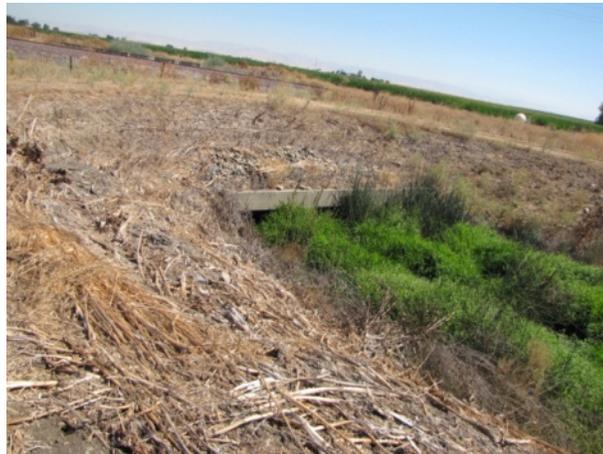
Levee Mile Report Line	2
Start Levee Mile	0.00
End Levee Mile	0.00
Location	Land Side
Category	Structures
Item	Vegetation & Obstructions
Standing on downstream end of unit 3 looking back at the growth at discharge end of structure.	
phillips_t_20100901_037.jpg

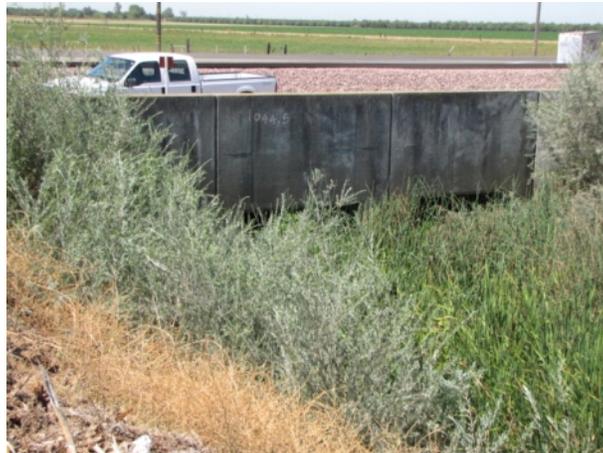
Levee Mile Report Line	2
Start Levee Mile	0.00
End Levee Mile	0.00
Location	Land Side
Category	Structures
Item	Vegetation & Obstructions
Standing on unit 4 upstream there are small willow trees and tules in channel at the inlet, left bank right bank and in channel. 37.26316N - 120.28819W.	
phillips_t_20100901_038.jpg

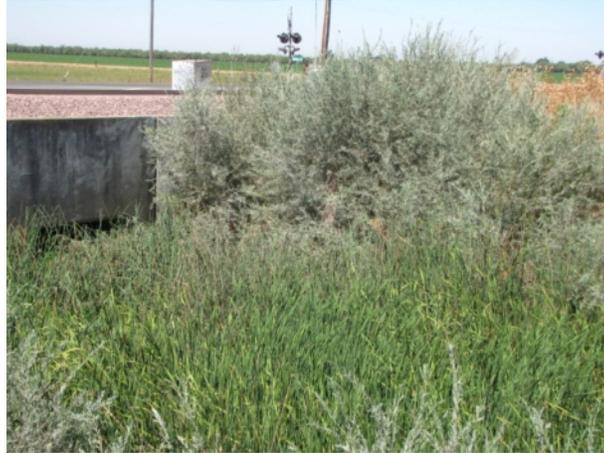
Levee Mile Report Line	2
Start Levee Mile	0.00
End Levee Mile	0.00
Location	Land Side
Category	Structures
Item	Vegetation & Obstructions
<p>Standing on left bank unit 4 shooting back across channel to unit 3 willows over taking the bank blocking the inlet.</p>	
<p>phillips_t_20100901_039.jpg</p>

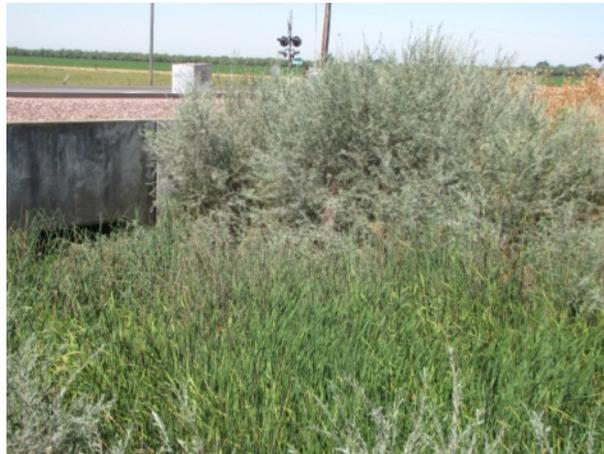
Levee Mile Report Line	3
Start Levee Mile	0.00
End Levee Mile	0.00
Location	Land Side
Category	Structures
Item	Shoaling / Sedimentation
<p>This photo shows not only vegetation but it also shows where the tules are growing there is great amount of sedimentation that is not visible because of that growth.</p>	
<p>phillips_t_20100902_040.jpg</p>
