Flood Control Project Maintenance
2012 Structure Summary Report
Overall Unit and Item Ratings

Merced Streams Group

Black Rascal Creek Drop Structure

Owens Creek Siphon Structure

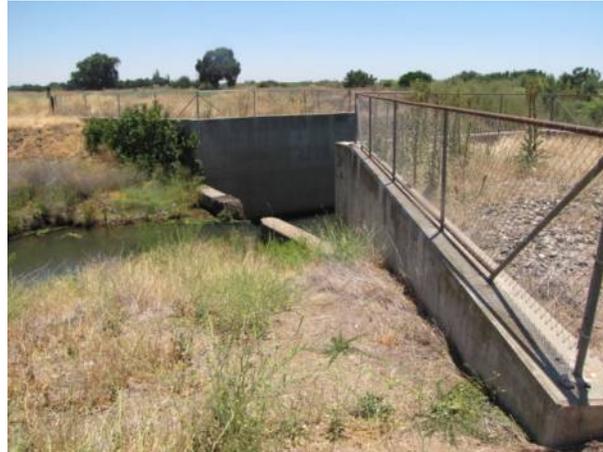
| Levee Mile Report Line | 1 |

| Black Rascal Creek Drop Structure viewed from unit 1 right bank. Photo taken 7-10-2012. | |

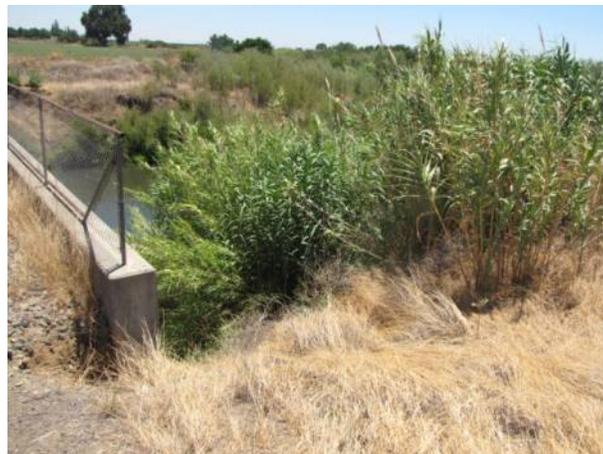
| Levee Mile Report Line | 2 |

| LIR No. | Levee Mile | | Category | Item | Location | Rating | Action/Comment | GPS Latitude/Longitude | | Issue No. |
|---|---|---|---|---|---|---|--|---|---|---|
| 2 | 0.00 | 0.00 | Structures | Vegetation & Obstructions | | M | Inspector Comments: The vegetation growing around the structure need to be maintained. To date July 10th 2012. Veg (bambo) growing on downstream side of structure right bank. | 37.314750 ° -120.396294 ° | 37.314750 ° -120.396294 ° | 2 Y |

| Right bank downstream of Black Rascal Drop Structure Bambo is taking over the waterward bank. Photo taken 7-10-2012. | |

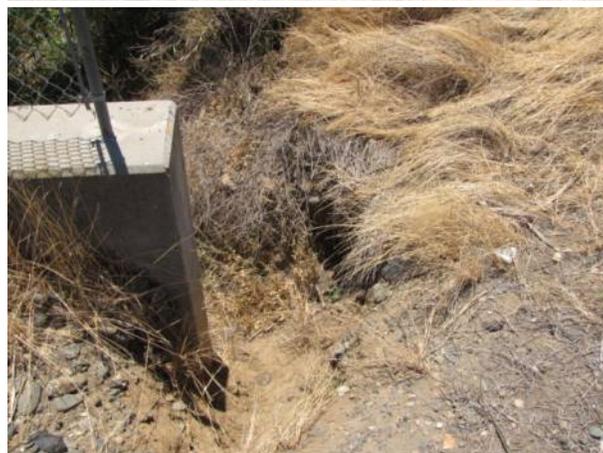
| Levee Mile Report Line | 4 |

| LIR No. | Levee Mile | | Category | Item | Location | Rating | Action/Comment | GPS Latitude/Longitude | | Issue No. |
|---|---|---|---|---|---|---|--|---|---|---|
| 4 | 0.00 | 0.00 | Structures | Erosion / Bank Caving | | M | Inspector Comments: There is erosion on unit 1 downstream end of structure along the slope caused by pedestrians, also over across channel to unit 2 there is erosion on bank downstream of structure. Repairs are needed. | 37.314620 ° -120.396270 ° | 37.314620 ° -120.396270 ° | 4 Y |

| This foot erosion remains, no repairs made. Photo taken 7-10-2012. | |

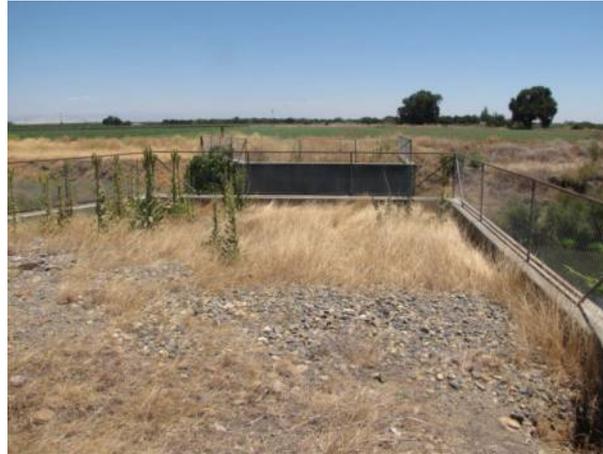
| Levee Mile Report Line | 23 |

This photo shows both sides right bank and left bank security fences are good, no defects. Photo taken 7-10-2012.

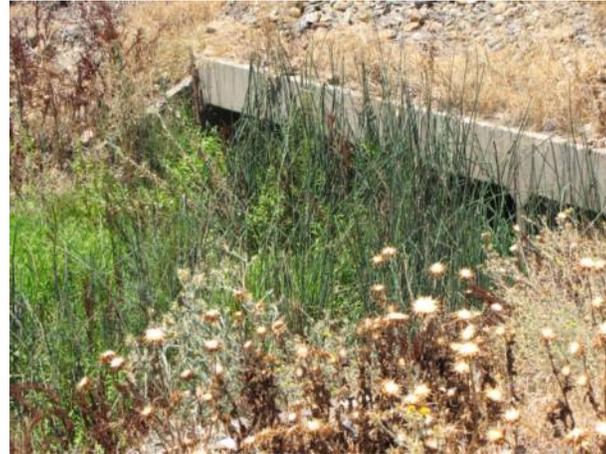
| Levee Mile Report Line | 1 |

| LMR No. | Levee Mile | | Category | Item | Location | Rating | Action/Comment | GPS Latitude/Longitude | | Issue No. |
|---|---|---|---|---|---|---|--|---|---|---|
| 1 | 0.00 | 0.00 | Structures | Photo Documentation | | N | Inspector Comments: This structure has two separate parts, an inlet on the side of the railroad tracks, and an outlet on the side of the highway. The coordinates for this issue are for the inlet of Owen Creek Siphon Structure. | 37.262880 ° -120.287860 ° | 37.262880 ° -120.287860 ° | 1 Y |

Owens Creek Siphon Structure viewed from unit 4 outlet end of structure. Photo taken 7-10-2012.

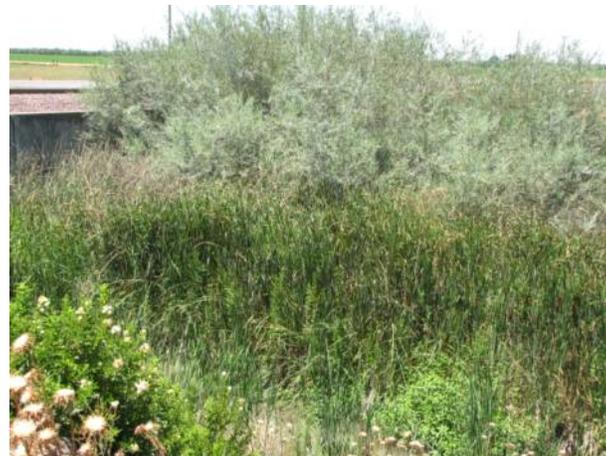
| Levee Mile Report Line | 2 |

| LMR No. | Levee Mile | | Category | Item | Location | Rating | Action/Comment | GPS Latitude/Longitude | | Issue No. |
|---|---|---|---|---|---|---|--|---|---|---|
| 2 | 0.00 | 0.00 | Structures | Vegetation & Obstructions | | M | Inspector Comments: Log jams, snags, vegetation growth (such as cat tails, bull rushes, bushes or saplings) or other obstructions block approximately 25% of the FCW. The coordinates for this issue is for the outlet side of the structure. | 37.262343 ° -120.285349 ° | 37.262343 ° -120.285349 ° | 2 Y |

Wild growth of willow trees and tullies choking off inlet side on structure. Remove the wild growth. Photo taken 7-10-2012.

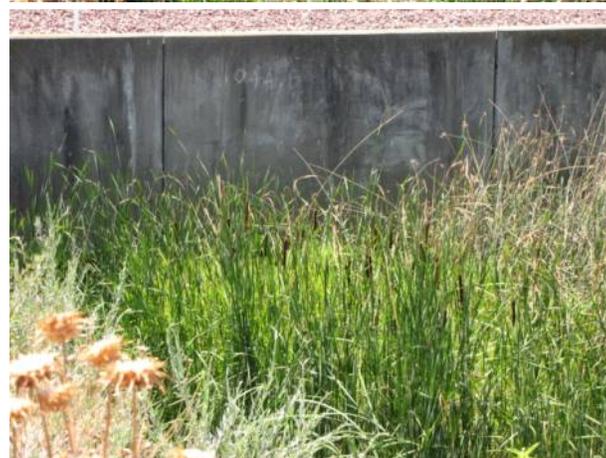
| Levee Mile Report Line | 7 |

| LMR No. | Levee Mile | | Category | Item | Location | Rating | Action/Comment | GPS Latitude/Longitude | | Issue No. |
|---|---|---|---|---|---|---|--|---|---|---|
| 7 | 0.00 | 0.00 | Structures | Culverts: Inlets / Outlets | | U | Inspector Comments: Accumulated debris, sediment or vegetation blocks more than 10% of the culvert opening, impairing the culvert's capacity and hydraulic effectiveness. | 37.262880 ° -120.287860 ° | 37.262880 ° -120.287860 ° | 7 Y |

View shows the blockage of the inlet. Photo taken 7-10-2012.
