Flood Control Project Maintenance
2014 Structure Summary Report
Overall Unit and Item Ratings

Merced Streams Group

Black Rascal Creek Drop Structure

2014 Structure Inspection Results

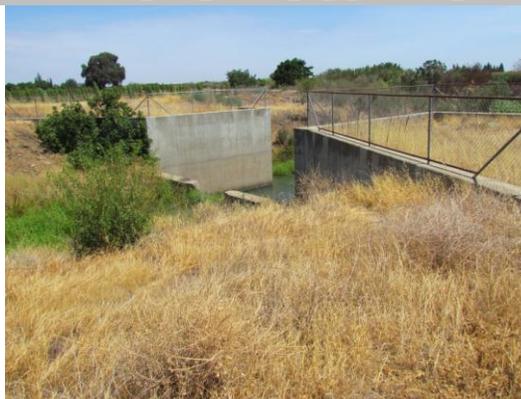
Photo 1 of 1 : ST_2014_NA0013_28_1_20140818_00005.jpg

LM Start	0.00	Rating **	N	Issue No.	1
LM End	0.00	Issue Type +	Ma	Location *	
Category	Structures & Concrete Lined Channels			GPS Latitude/Longitude	
				Start	End
Item	Photo Documentation			37.314750 °	37.314750 °
				-120.396397 °	-120.396294 °
DWR ID	DWR_NA0013_28_t_2012_1				
Action/Comments

Black Rascal Creek Drop Structure viewed from the right bank of Unit 1.

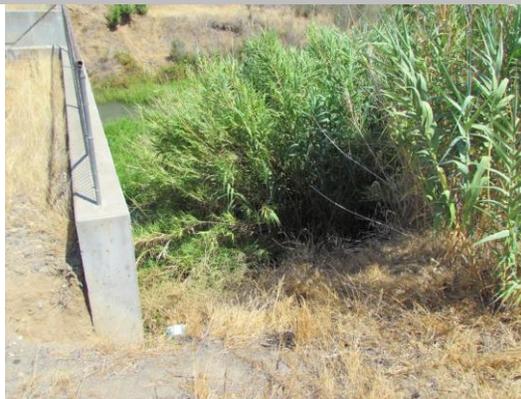
Photo 1 of 2 : ST_2014_NA0013_28_2_20140818_00006.jpg

LM Start	0.00	Rating **	M	Issue No.	2
LM End	0.00	Issue Type +	Ma	Location *	
Category	Structures & Concrete Lined Channels			GPS Latitude/Longitude	
				Start	End
Item	Vegetation & Obstructions			37.314750 °	37.314750 °
				-120.396294 °	-120.396294 °
DWR ID	DWR_NA0013_28_t_2012_2				
Action/Comments					
Inspector Comments: The vegetation growing around the structure need to be removed both Unit 1 and Unit 2.

Right bank downstream of Black Rascal Drop Structure wild growth of arundo present on slope.

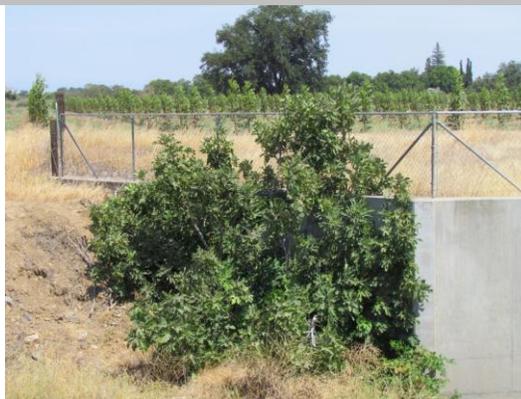
Photo 2 of 2 : ST_2014_NA0013_28_2_20140818_00009.jpg

Wild trees growing on the upstream side of concrete abutment on Unit 2 Left bank view from Unit 1 Right bank of Black Rascal Drop Structure.

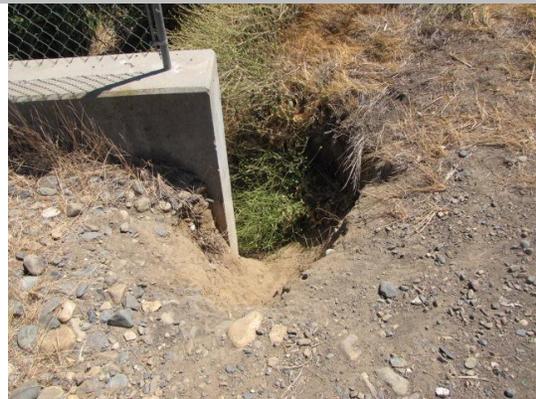
Photo 1 of 2 : ST_2014_NA0013_28_4_20140707_00003.jpg

LM Start	0.00	Rating **	M	Issue No.	4
LM End	0.00	Issue Type +	Ma	Location *	
Category	Structures & Concrete Lined Channels		GPS Latitude/Longitude		
			Start	End	
Item	Erosion / Bank Caving		37.314620 °	37.314620 °	
			-120.396294 °	-120.396270 °	
DWR ID	DWR_NA0013_28_t_2012_4				
Action/Comments					
Inspector Comments: There is erosion on unit 1 at the downstream end of structure along the slope caused by pedestrians. There is also erosion on the bank of unit 2 downstream of structure. Repairs are needed.

Foot erosion remains from last inspection. Photo taken 7-16-2013.

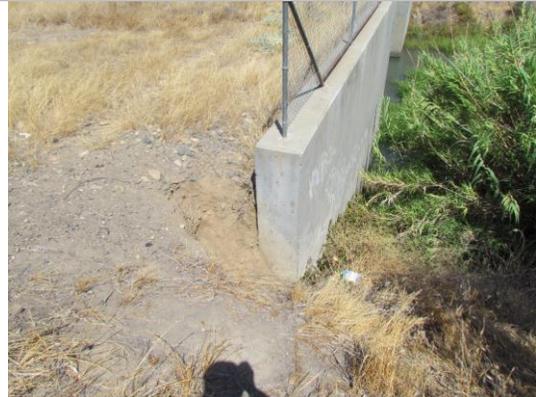
Photo 2 of 2 : ST_2014_NA0013_28_4_20140818_00007.jpg

LM Start	0.00	Rating **	M	Issue No.	4 (cont)
LM End	0.00	Issue Type +	Ma	Location *	
Category	Structures & Concrete Lined Channels			GPS Latitude/Longitude	
				Start	End
Item	Erosion / Bank Caving			37.314620 °	37.314620 °
				-120.396294 °	-120.396270 °
DWR ID	DWR_NA0013_28_t_2012_4				
Action/Comments					
Inspector Comments: There is erosion on unit 1 at the downstream end of structure along the slope caused by pedestrians. There is also erosion on the bank of unit 2 downstream of structure. Repairs are needed.

Foot traffic erosion reported in last two inspections has not been repaired.

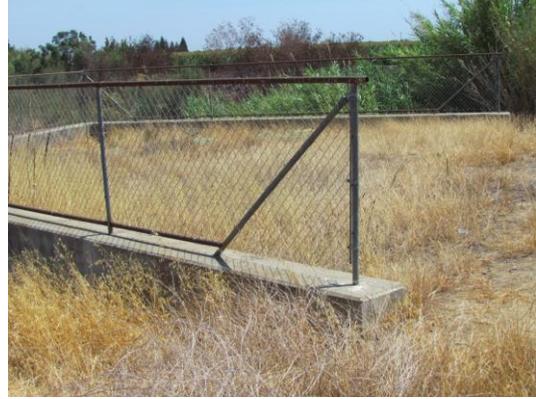
Photo 1 of 1 : ST_2014_NA0013_28_18_20140818_00008.jpg

LM Start	0.00	Rating **	A	Issue No.	18
LM End	0.00	Issue Type +	Ma	Location *	
Category	Structures & Concrete Lined Channels		GPS Latitude/Longitude		
			Start	End	
Item	Security Fencing		37.314750 °	37.314750 °	
			-120.396294 °	-120.396294 °	
DWR ID	DWR_NA0013_28_t_2012_18				
Action/Comments					
Inspector Comments: Safety / security fencing is good condition and provides protection against falling or unauthorized access.

Security fence is in good condition.

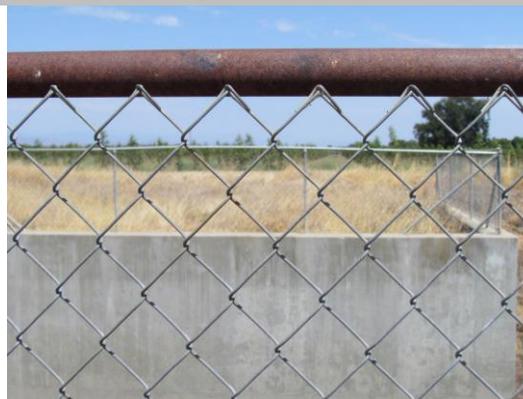
Photo 1 of 1 : ST_2014_NA0013_28_23_20140818_00010.jpg

LM Start	0.00	Rating **	A	Issue No.	23
LM End	0.00	Issue Type +	Ma	Location *	
Category	Structures & Concrete Lined Channels		GPS Latitude/Longitude		
			Start	End	
Item	Safety		37.314750 °	37.314750 °	
			-120.396294 °	-120.396294 °	
DWR ID	DWR_NA0013_28_t_2012_23				
Action/Comments					
Inspector Comments: There are no safety hazards that would endanger personnel.

Looking across channel to the Left bank at the safety fence around the structure there is no damage.

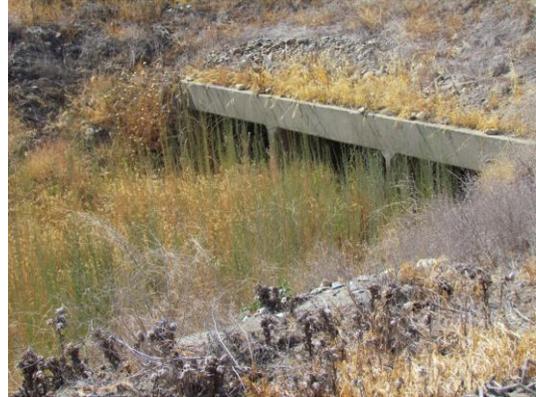
Photo 1 of 1 : ST_2014_NA0013_51_1_20140818_00004.jpg

LM Start	0.00	Rating **	N	Issue No.	1
LM End	0.00	Issue Type +	Ma	Location *	
Category	Structures & Concrete Lined Channels		GPS Latitude/Longitude		
			Start	End	
Item	Photo Documentation		37.262880 °	37.262880 °	
			-120.287860 °	-120.287860 °	
DWR ID	DWR_NA0013_51_t_2012_1				
Action/Comments					
Inspector Comments: This structure has an inlet on the side of the railroad tracks opposite Hwy 140 and an outlet on the downstream side of the highway Hwy 140. The coordinates for this issue are for the inlet of Owen Creek Siphon Structure.

Owens Creek Siphon Outlet.

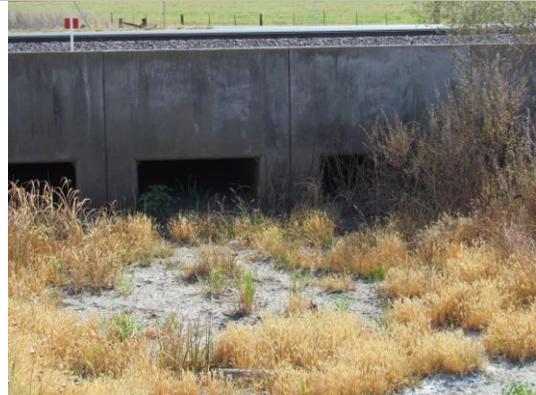
Photo 1 of 1 : ST_2014_NA0013_51_2_20140818_00005.jpg

LM Start	0.00	Rating **	M	Issue No.	2
LM End	0.00	Issue Type +	Ma	Location *	
Category	Structures & Concrete Lined Channels		GPS Latitude/Longitude		
			Start	End	
Item	Vegetation & Obstructions		37.262880 °	37.262880 °	
			-120.287860 °	-120.287860 °	
DWR ID	DWR_NA0013_51_t_2012_2				
Action/Comments					
Inspector Comments: Log jams, snags, vegetation growth (such as cat tails, bull rushes, bushes or saplings) or other obstructions block approximately 25% of the FCW. The coordinates for this issue are for the outlet side of the structure.

The vegetation has been from around the inlet upstream side of Owens Creek.

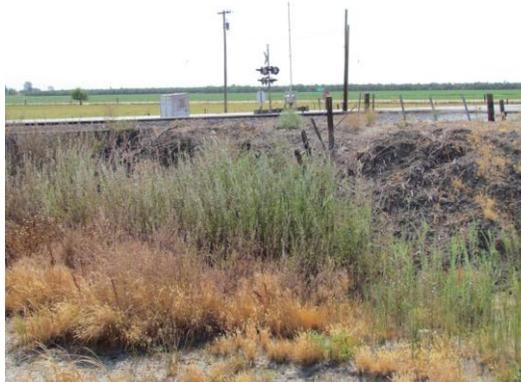
Photo 1 of 1 : ST_2014_NA0013_51_7_20140818_00006.jpg

LM Start	0.00	Rating **	M	Issue No.	7
LM End	0.00	Issue Type +	Ma	Location *	
Category	Structures & Concrete Lined Channels		GPS Latitude/Longitude		
			Start	End	
Item	Culverts: Inlets / Outlets		37.262880 °	37.262880 °	
			-120.287860 °	-120.287860 °	
DWR ID	DWR_NA0013_51_t_2012_7				
Action/Comments					
Inspector Comments: The County had cleaned the vegetation from the channel inlet upstream of structure, but new growth of willow trees has grown back on right bank of structure.

The inlet is visibly blocked on the right bank side where vegetation has grown back.
