**Flood Control Project Maintenance**  
**2015 Structure Summary Report**  
**Overall Unit and Item Ratings**

**Merced Streams Group**

**Black Rascal Creek Drop Structure**

**2015 Structure Inspection Results**

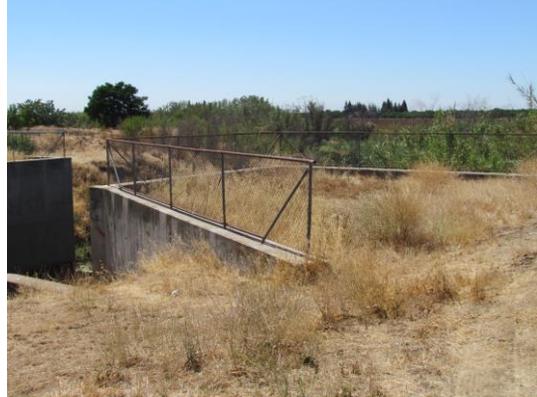
Photo 1 of 1 : ST\_2015\_NA0013\_28\_1\_20150813\_00008.jpg

Black Rascal Creek Drop Structure viewed from upstream right bank of Unit 1.

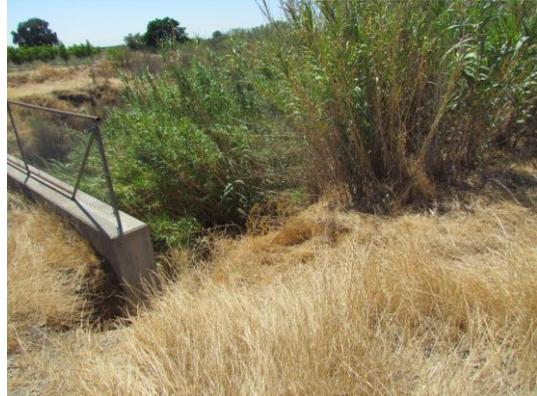
Photo 1 of 1 : ST\_2015\_NA0013\_28\_2\_20150813\_00009.jpg

LM Start	<b>0.00</b>	Rating **	M	Issue No.	<b>2</b>
LM End	<b>0.00</b>	Issue Type +	Ma	Location *	
Category	Structures & Concrete Lined Channels		GPS Latitude/Longitude		
			Start	End	
Item	Vegetation & Obstructions		37.314750 °	37.314750 °	
			-120.396294 °	-120.396294 °	
DWR ID	DWR_NA0013_28_t_2012_2				
Action/Comments					
Inspector Comments: The vegetation growing around the structure needs to be removed.

Right bank downstream of Black Rascal Drop Structure arundo covering the bank.

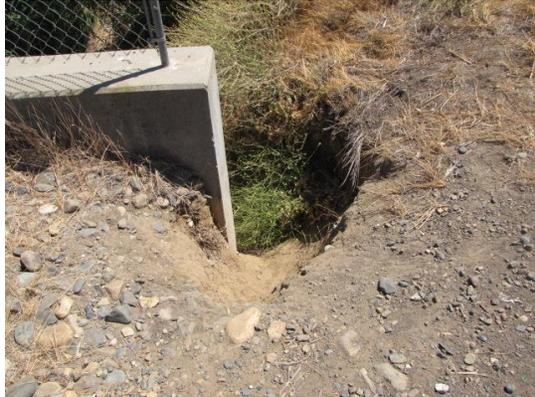
Photo 1 of 2 : ST\_2015\_NA0013\_28\_4\_20150720\_00005.jpg

LM Start	<b>0.00</b>	Rating **	M	Issue No.	<b>4</b>
LM End	<b>0.00</b>	Issue Type +	Ma	Location *	
Category	Structures & Concrete Lined Channels		GPS Latitude/Longitude		
			Start	End	
Item	Erosion / Bank Caving		37.314620 °	37.314620 °	
			-120.396294 °	-120.396270 °	
DWR ID	DWR_NA0013_28_t_2012_4				
Action/Comments					
Inspector Comments: There is erosion on unit 1 at the downstream end of structure along the slope caused by pedestrians. There is also erosion on the bank of unit 2 downstream of structure. Repairs are needed.

Foot erosion remains from last inspection.

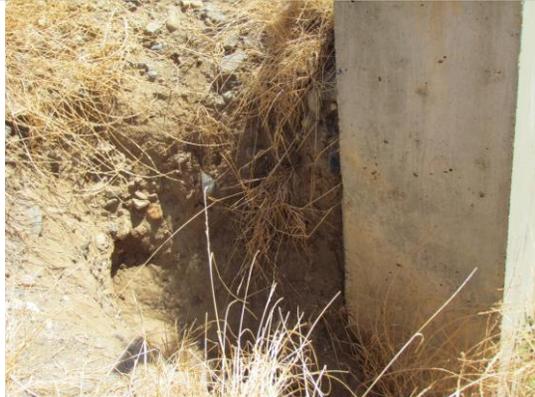
Photo 2 of 2 : ST\_2015\_NA0013\_28\_4\_20150813\_00010.jpg

Foot erosion remains at the downstream side of the concrete wall right bank.

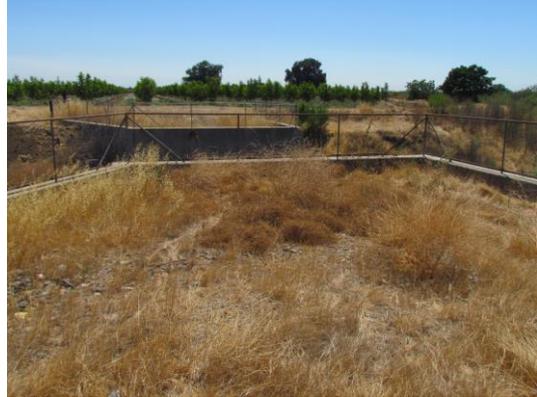
Photo 1 of 1 : ST\_2015\_NA0013\_28\_18\_20150813\_00011.jpg

LM Start	<b>0.00</b>	Rating **	A	Issue No.	<b>18</b>
LM End	<b>0.00</b>	Issue Type +	Ma	Location *	
Category	Structures & Concrete Lined Channels		GPS Latitude/Longitude		
			Start	End	
Item	Security Fencing		37.314750 °	37.314750 °	
			-120.396294 °	-120.396294 °	
DWR ID	DWR_NA0013_28_t_2012_18				
Action/Comments					
Inspector Comments: Safety / security fencing is good condition and provides protection against falling or unauthorized access.

View of security fences both banks unit 1 and across channel to unit 2.

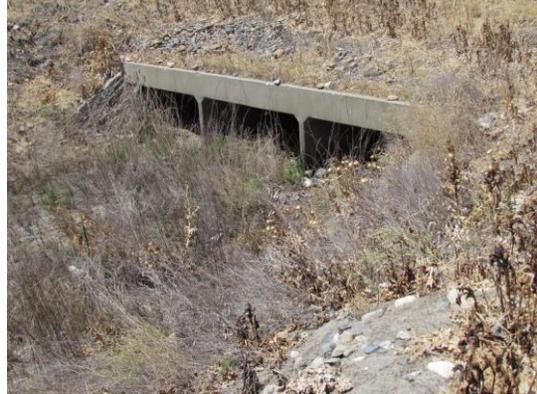
Photo 1 of 1 : ST\_2015\_NA0013\_51\_1\_20150813\_00004.jpg

Owens Creek Siphon Outlet.

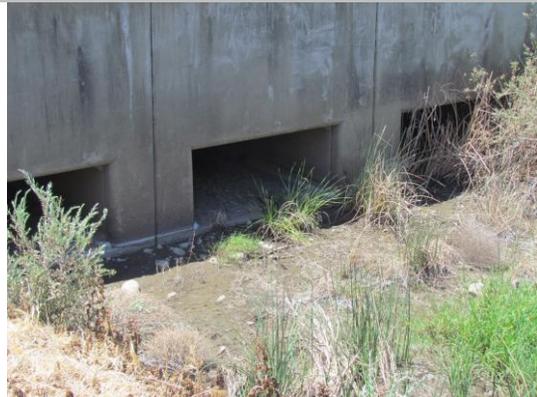
Photo 1 of 1 : ST\_2015\_NA0013\_51\_2\_20150813\_00005.jpg

LM Start	<b>0.00</b>	Rating **	A	Issue No.	<b>2</b>
LM End	<b>0.00</b>	Issue Type +	Ma	Location *	
Category	Structures & Concrete Lined Channels		GPS Latitude/Longitude		
			Start	End	
Item	Vegetation & Obstructions		37.262880 °	37.262880 °	
			-120.287860 °	-120.287860 °	
DWR ID	DWR_NA0013_51_t_2012_2				
Action/Comments					
Inspector Comments: The District removed the vegetation from the inlet.

Vegetation present at the inlet but does not block the flow.

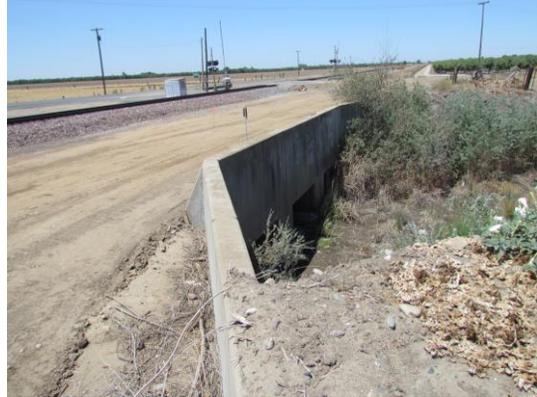
Photo 1 of 1 : ST\_2015\_NA0013\_51\_7\_20150813\_00006.jpg

LM Start	<b>0.00</b>	Rating **	M	Issue No.	<b>7</b>
LM End	<b>0.00</b>	Issue Type +	Ma	Location *	
Category	Structures & Concrete Lined Channels		GPS Latitude/Longitude		
			Start	End	
Item	Culverts: Inlets / Outlets		37.262880 °	37.262880 °	
			-120.287860 °	-120.287860 °	
DWR ID	DWR_NA0013_51_t_2012_7				
Action/Comments					
Inspector Comments: The Maintaining Agency had removed the growth from the upstream side of structure, the willows are regrowing on the right bank and does not block the flow.

The inlet has growth on the left bank, flow is not impeded.
