**Flood Control Project Maintenance  
Levee Inspections**

**Fall 2011 Levee Maintenance Deficiency Summary Report**

**Murphy Slough at M&T Ranch**

**Levee Inspection Report By Mile - Fall 2011**

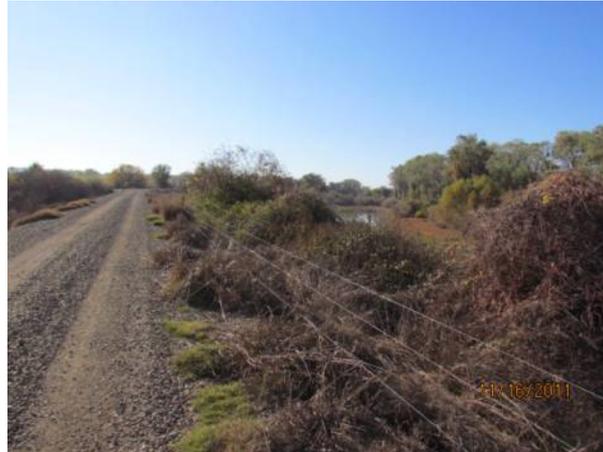
Levee Mile Report Line	1
Start Levee Mile	0.00
End Levee Mile	0.20
Location	Water Side
Category	Earthen Levee
Item	Vegetation
View of the vegetation along the W/S slope.	
rduffey_f_20111121_472.jpg

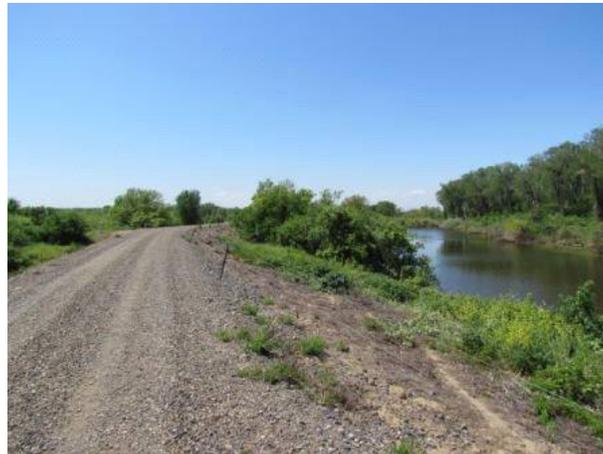
Levee Mile Report Line	2
Start Levee Mile	0.00
End Levee Mile	0.20
Location	Water Side
Category	Earthen Levee
Item	Vegetation
View of the vegetation along the waterside slope of the levee.	
rduffey_f_20111121_486.jpg

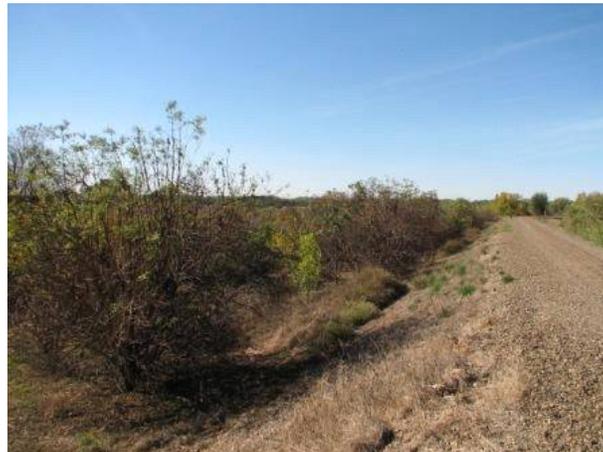
Levee Mile Report Line	3
Start Levee Mile	0.00
End Levee Mile	0.30
Location	Land Side
Category	Earthen Levee
Item	Vegetation
View of the elderberries along the l/s toe.	
rduffey_f_20111121_487.jpg
