**Flood Control Project Maintenance
Levee Inspections**

Fall 2010 Levee Maintenance Deficiency Summary Report

Murphy Slough at M&T Ranch

Levee Inspection Report By Mile - Fall 2010

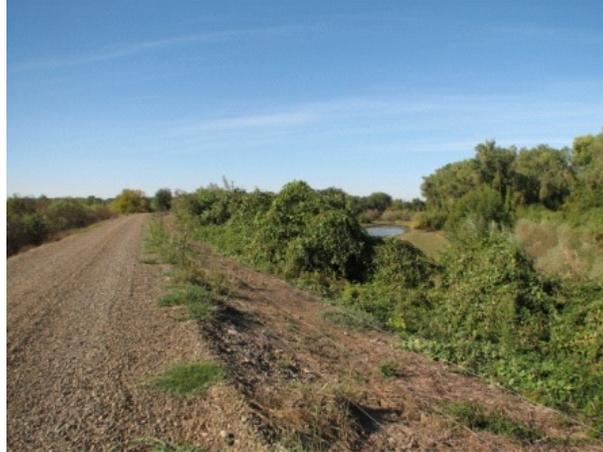
LMR No.	Levee Mile		Category	Item	* Location	** Rating	Action/Comment	GPS Latitude/Longitude		Issue No.
	Start	End						Start	End	Photo
1	0.00	0.20	Earthen Levee	Vegetation	WS	M	Elderberries are blocking visibility and flood fight capability.	39.666988 ° -121.960993 °	39.666988 ° -121.960993 °	5 Y
2	0.00	0.30	Earthen Levee	Vegetation	LS	M	Elderberries are blocking visibility and flood fight capability.	39.667708 ° -121.959817 °	39.666983 ° -121.960997 °	4 Y

Levee Mile Report Line	1
Start Levee Mile	0.00
End Levee Mile	0.20
Location	Water Side
Category	Earthen Levee
Item	Vegetation
View of the vegetation along the waterside slope of the levee.	
rduffey_f_20101101_241.jpg

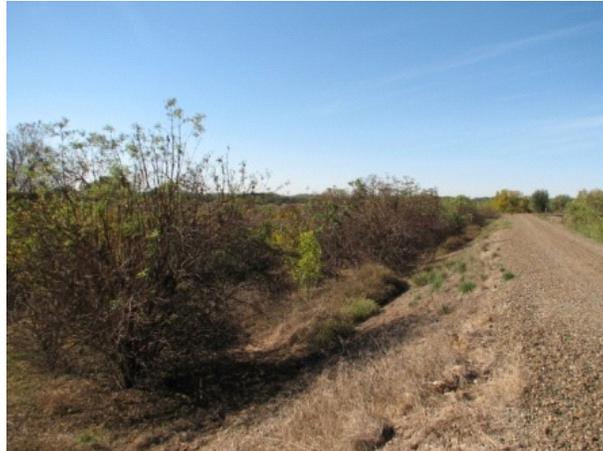
Levee Mile Report Line	2
Start Levee Mile	0.00
End Levee Mile	0.30
Location	Land Side
Category	Earthen Levee
Item	Vegetation
View of the elderberries along the l/s toe.	
rduffey_f_20101101_240.jpg
