**Flood Control Project Maintenance  
Levee Inspections**

**Fall 2008 Levee Maintenance Deficiency Summary Report**

**Plumas County**

Waterway			Bank	Unit Miles
Unit No. 01 North Fork Feather River			Left	1.90
	Spring (March - May)	Summer (June - August)	Fall (September - November)	Winter (December - February)
Date of Inspection	4/10/2008		10/14/2008	
DWR Inspector	Bob Duffey		Bob Duffey	
Accompanied By				
Unit Maintenance Rating (Fall Only)			A

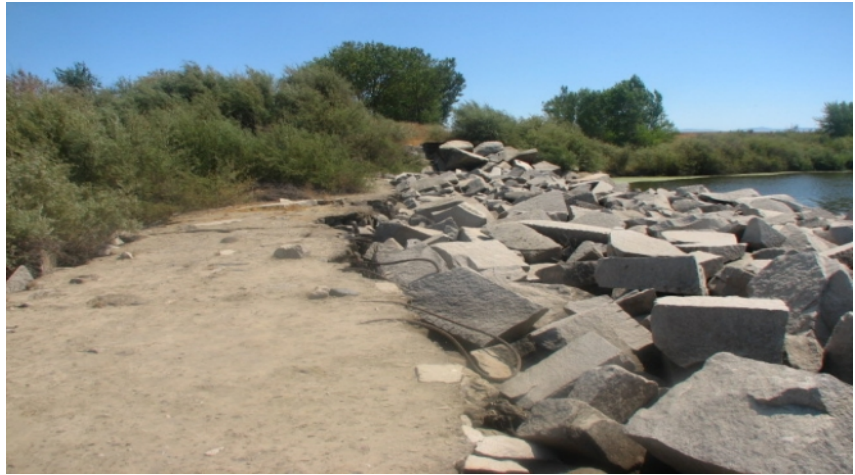
Levee Mile Report Line	1
Start Levee Mile	0.00
End Levee Mile	0.00
Location	
Category	Earthen Levee
Item	Erosion / Bank Caving
Looking at minor tilting/settlement/erosion on the upstream & downstream side of the Dam

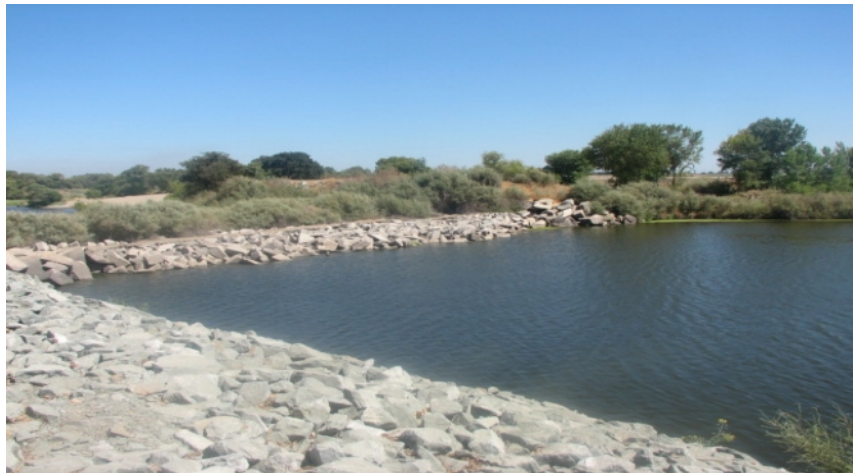
Levee Mile Report Line	2
Start Levee Mile	0.00
End Levee Mile	0.00
Location	
Category	Earthen Levee
Item	Erosion / Bank Caving
Looking at downstream side of dam

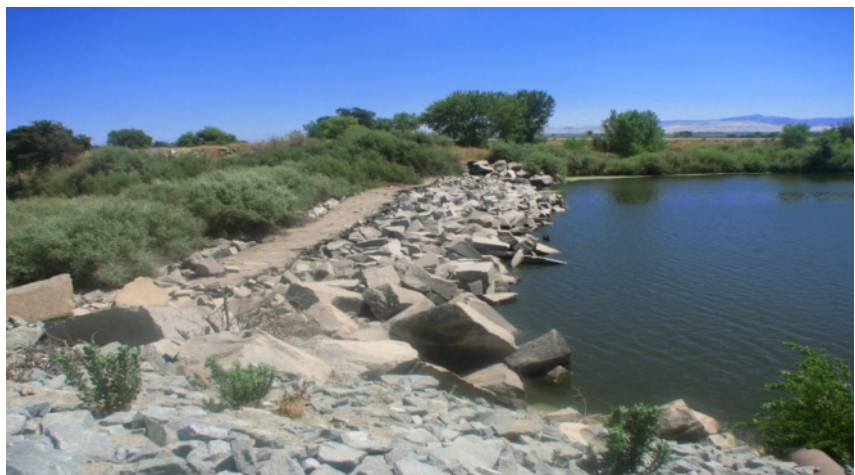
Levee Mile Report Line	2
Start Levee Mile	0.00
End Levee Mile	0.00
Location	
Category	Earthen Levee
Item	Erosion / Bank Caving
Looking at overgrowth of willow on the downstream side of the Dam
