**Flood Control Project Maintenance
Levee Inspections**

Fall 2011 Levee Maintenance Deficiency Summary Report

Sacramento River Basin

Plumas County

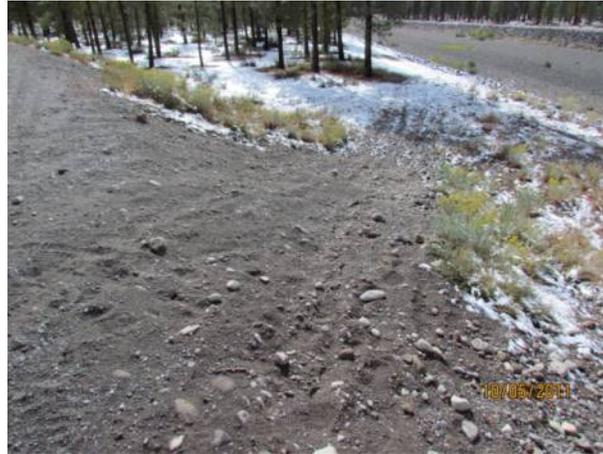
rduffey_f_20111128_546.jpg

Levee Mile Report Line	1
Start Levee Mile	0.55
End Levee Mile	0.55
Location	Water Side
Category	Earthen Levee
Item	Slope Stability

View of the vehicle erosion along the W/S toe.

LMIR No.	Levee Mile		Category	Item	* Location	** Rating	Action/Comment	GPS Latitude/Longitude		Issue No. Photo
	Start	End						Start	End	
1	0.55	0.55	Earthen Levee	Slope Stability	WS	M	Repair the levee slope damaged by vehicle traffic and prevent access where possible.	40.279790 ° 40.279790 °	121.249850 ° 121.249850 °	9 Y
2	0.67	0.67	Earthen Levee	Encroachments	LS	M	Prunings	40.281340 ° 40.281340 °	121.250860 ° 121.250860 °	10 Y
3	1.27	1.43	Earthen Levee	Slope Stability	LS	U	Repair slope instability.	40.288780 ° 40.290840 °	121.254280 ° 121.255440 °	11 Y

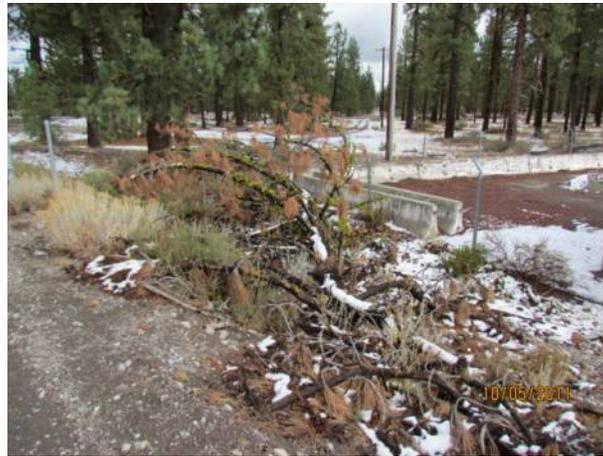
rduffey_f_20111128_547.jpg

Levee Mile Report Line	2
Start Levee Mile	0.67
End Levee Mile	0.67
Location	Land Side
Category	Earthen Levee
Item	Encroachments

View of the downed tree along the L/S slope.

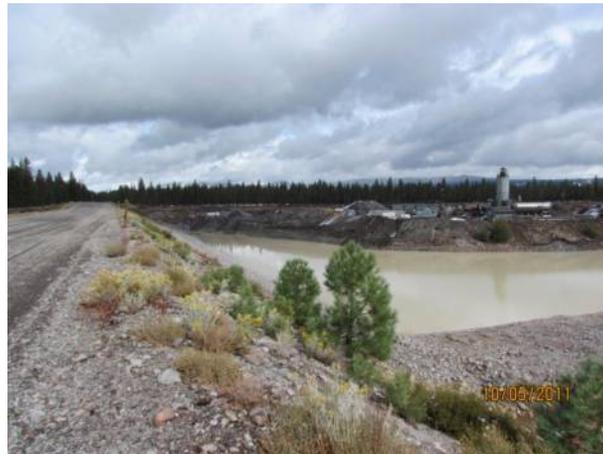
rduffey_f_20111128_548.jpg

Levee Mile Report Line	3
Start Levee Mile	1.27
End Levee Mile	1.43
Location	Land Side
Category	Earthen Levee
Item	Slope Stability

View of the gravel pit along the L/S toe.

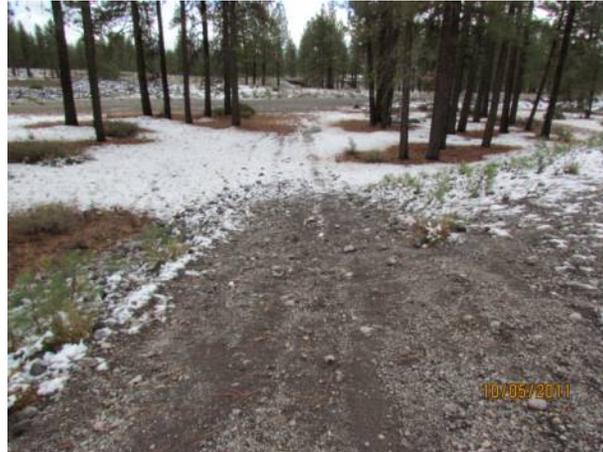
Levee Mile Report Line	1
Start Levee Mile	0.46
End Levee Mile	0.46
Location	Water Side
Category	Earthen Levee
Item	Slope Stability
View of the vehicle erosion along the W/S slope.	
rduffey_f_20111128_545.jpg

LMIR No.	Levee Mile		Category	Item	* Location	** Rating	Action/Comment	GPS Latitude/Longitude		Issue No. Photo
	Start	End						Start	End	
1	0.46	0.46	Earthen Levee	Slope Stability	WS	M	Repair the levee slope damaged by foot traffic and prevent access where possible.	40.282980 ° 40.282980 °	121.253990 ° 121.253990 °	3 Y
2	0.55	0.55	Earthen Levee	Slope Stability	LS	M	Repair the levee slope damaged by vehicle traffic and prevent access where possible.	40.281950 ° 40.281950 °	121.253710 ° 121.253710 °	4 Y
3	0.55	0.55	Earthen Levee	Slope Stability	WS	M	Repair the levee slope damaged by vehicle traffic and prevent access where possible.	40.281950 ° 40.281950 °	121.253710 ° 121.253710 °	5 Y

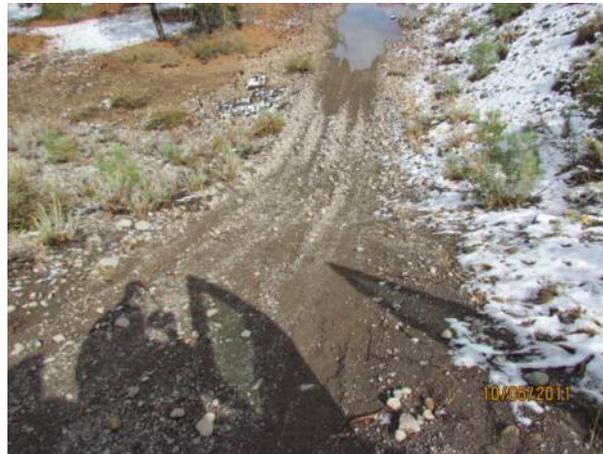
Levee Mile Report Line	2
Start Levee Mile	0.55
End Levee Mile	0.55
Location	Land Side
Category	Earthen Levee
Item	Slope Stability
View of the vehicle erosion along the L/S slope.	
rduffey_f_20111128_544.jpg

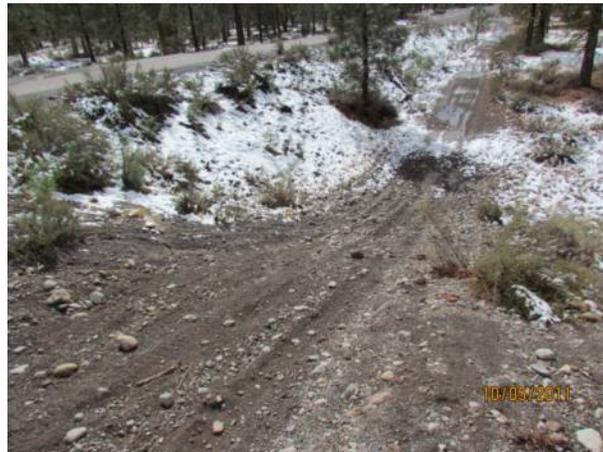
Levee Mile Report Line	3
Start Levee Mile	0.55
End Levee Mile	0.55
Location	Water Side
Category	Earthen Levee
Item	Slope Stability
View of the vehicle erosion along the W/S slope.	
rduffey_f_20111128_543.jpg
