**Flood Control Project Maintenance
Levee Inspections**

Fall 2012 Levee Maintenance Deficiency Summary Report

Plumas County

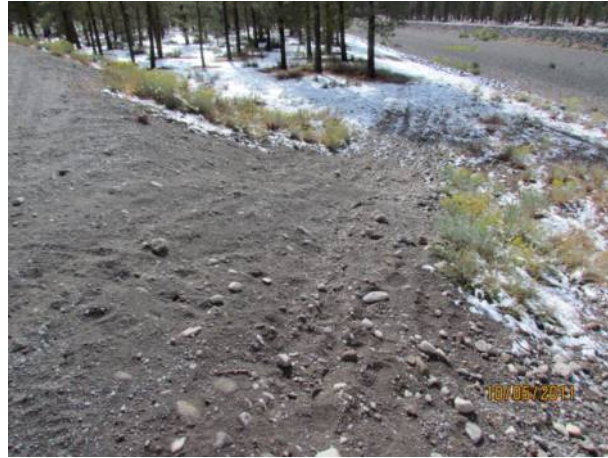
Levee Mile Report Line	4
Start Levee Mile	0.55
End Levee Mile	0.55
Location	Water Side
Category	Earthen Levee
Item	Slope Stability

View of the vehicle erosion along the W/S toe.

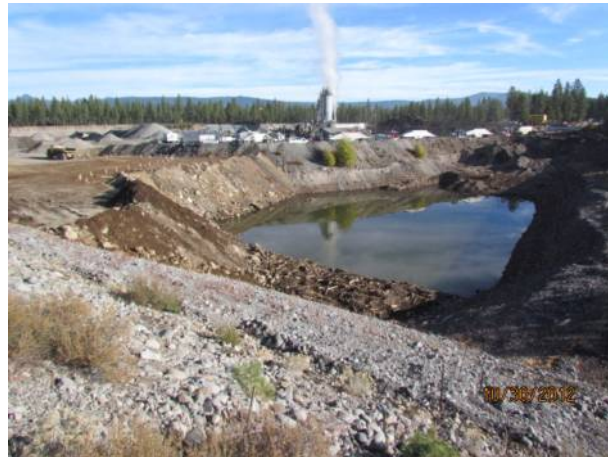
Levee Mile Report Line	6
Start Levee Mile	1.27
End Levee Mile	1.43
Location	Land Side
Category	Earthen Levee
Item	Slope Stability

View of the landowner starting to fill in the hole at the gravel pit

40.281340 °	121.250860 °	
							DWR ID: DWR_NA0015_01_s_2012_10			
6	1.27	1.43	Earthen Levee	Slope Stability	LS Ma	U	S1 : Repair slope instability.	40.288780 °	121.254280 °	11

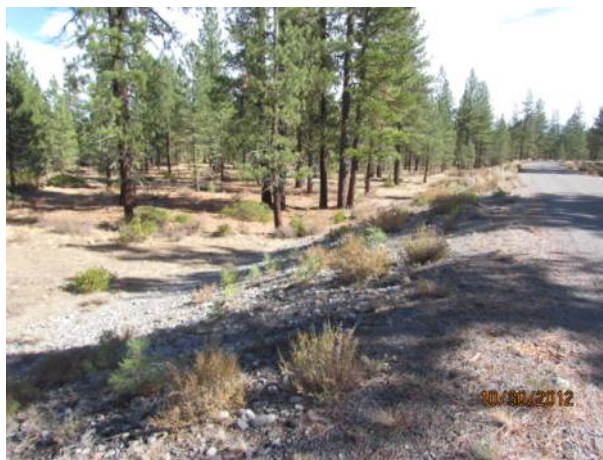
Levee Mile Report Line	1
Start Levee Mile	0.02
End Levee Mile	0.62
Location	Water Side
Category	Earthen Levee
Item	Vegetation

View of the small pine trees that need to be removed from the waterside slope.

LMR No.	Levee Mile		Category	Item	Location *	Rating **	Action/Comment	GPS Latitude/Longitude		Issue No. Photo
	Start	End						Start	End	
1	0.02	0.62	Earthen Levee	Vegetation	WS	M Ma	V2 : Remove the wild growth other than native grasses from the levee slopes. Inspector Comments: Mow or remove the pine trees from the slope	40.286415 ° -121.259613 °	40.281054 ° -121.252789 °	2 Y
DWR ID: DWR_NA0015_02_f_2012_2										
2	0.02	0.62	Earthen Levee	Vegetation	LS	M Ma	V2 : Remove the wild growth other than native grasses from the levee slopes. Inspector Comments: Mow or remove the pine trees from the slope.	40.286415 ° -121.259613 °	40.281053 ° -121.252792 °	1 Y
DWR ID: DWR_NA0015_02_f_2012_1										
3	0.46	0.46	Earthen Levee	Slope Stability	WS	M Ma	S2 : Repair the levee slope damaged by foot traffic and prevent access where possible.	40.282980 ° 40.282980 °	121.253990 ° 121.253990 °	3 Y
DWR ID: DWR_NA0015_02_s_2012_3

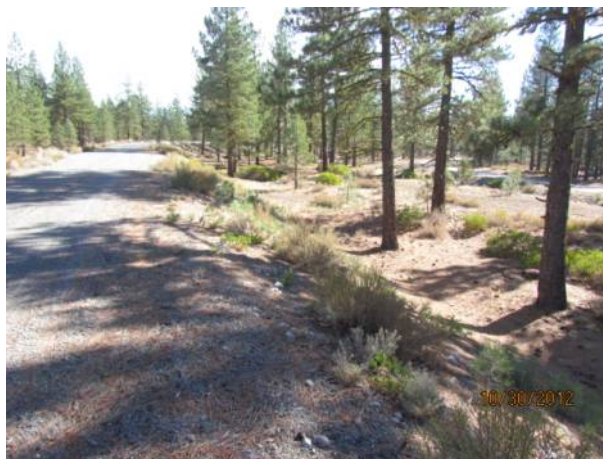
Levee Mile Report Line	2
Start Levee Mile	0.02
End Levee Mile	0.62
Location	Land Side
Category	Earthen Levee
Item	Vegetation

View of the small pine trees that need to be removed from the landside slope.

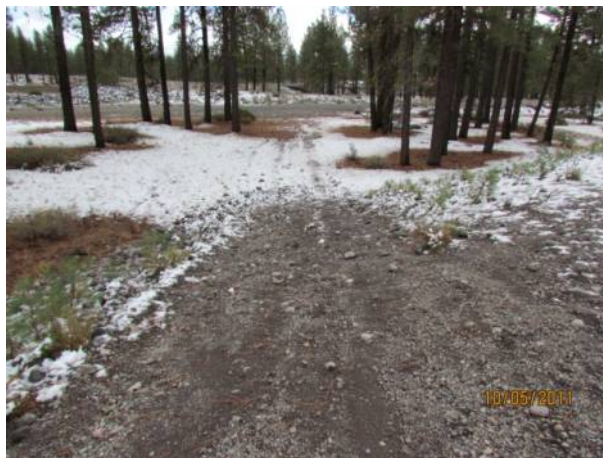
Levee Mile Report Line	3
Start Levee Mile	0.46
End Levee Mile	0.46
Location	Water Side
Category	Earthen Levee
Item	Slope Stability

View of the vehicle erosion along the W/S slope.

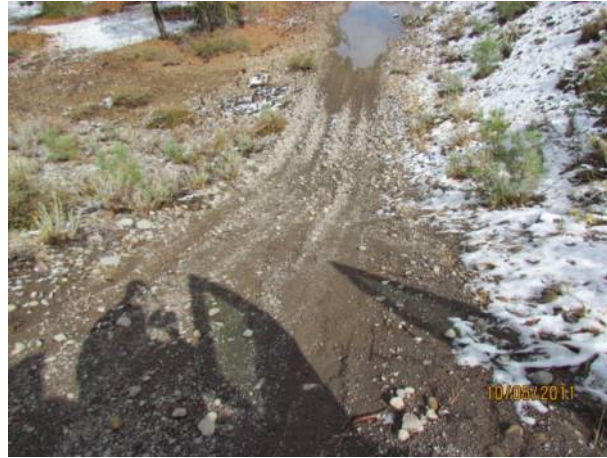
Levee Mile Report Line	4
Start Levee Mile	0.55
End Levee Mile	0.55
Location	Land Side
Category	Earthen Levee
Item	Slope Stability

View of the vehicle erosion along the L/S slope.

4	0.55	0.55	Earthen Levee	Slope Stability	LS	M Ma	S3 : Repair the levee slope damaged by vehicle traffic and prevent access where possible.	40.281950 ° 40.281950 °	121.253710 ° 121.253710 °	4 Y
DWR ID: DWR_NA0015_02_s_2012_4										
5	0.55	0.55	Earthen Levee	Slope Stability	WS	M Ma	S3 : Repair the levee slope damaged by vehicle traffic and prevent access where possible.	40.281950 ° 40.281950 °	121.253710 ° 121.253710 °	5 Y
DWR ID: DWR_NA0015_02_s_2012_5

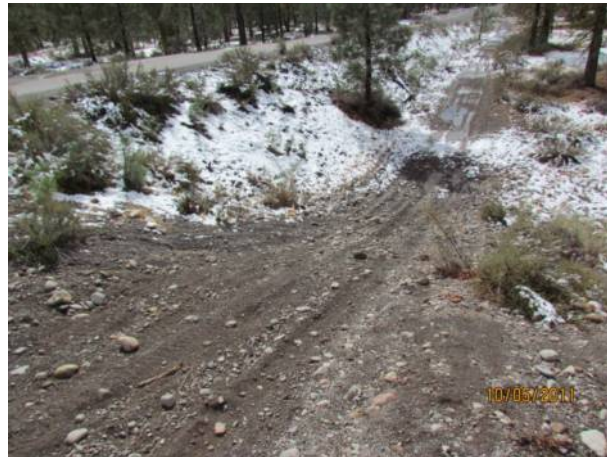
Levee Mile Report Line	5
Start Levee Mile	0.55
End Levee Mile	0.55
Location	Water Side
Category	Earthen Levee
Item	Slope Stability

View of the vehicle erosion along the W/S slope.
