**Flood Control Project Maintenance
Levee Inspections**

Fall 2013 Levee Maintenance Deficiency Summary Report

Plumas County

Levee Inspection Report By Mile - Fall 2013

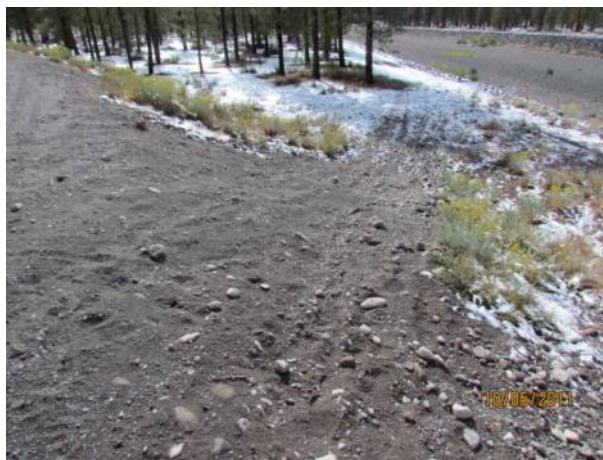
Levee Mile Report Line	4
Start Levee Mile	0.55
End Levee Mile	0.55
Location	Water Side
Category	Earthen Levee
Item	Slope Stability

View of the vehicle erosion along the W/S toe.

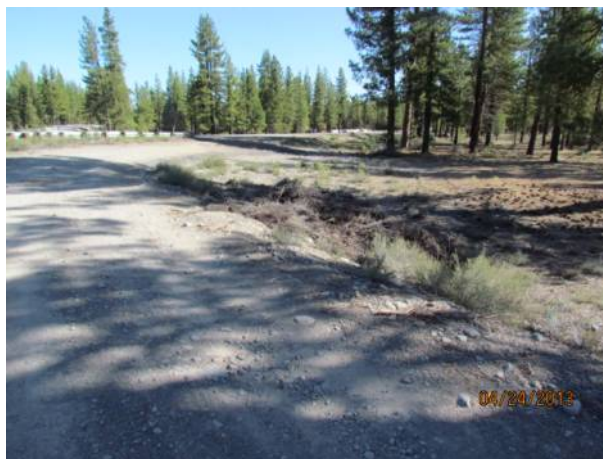
Levee Mile Report Line	5
Start Levee Mile	0.68
End Levee Mile	0.68
Location	Land Side
Category	Earthen Levee
Item	Encroachments

View of the prunings along the landside slope.

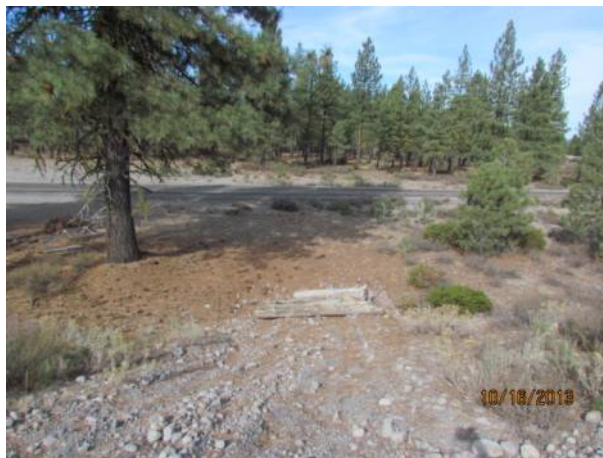
Levee Mile Report Line	6
Start Levee Mile	0.97
End Levee Mile	0.97
Location	Water Side
Category	Earthen Levee
Item	Slope Stability

View of the vehicle erosion along the slope of the levee.

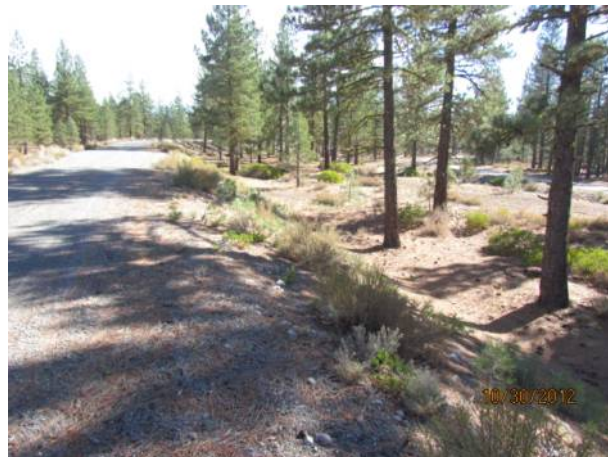
Levee Mile Report Line	2
Start Levee Mile	0.02
End Levee Mile	0.62
Location	Land Side
Category	Earthen Levee
Item	Vegetation
View of the small pine trees that need to be removed from the landside slope.	
rduffey_f_20130919_996.JPG

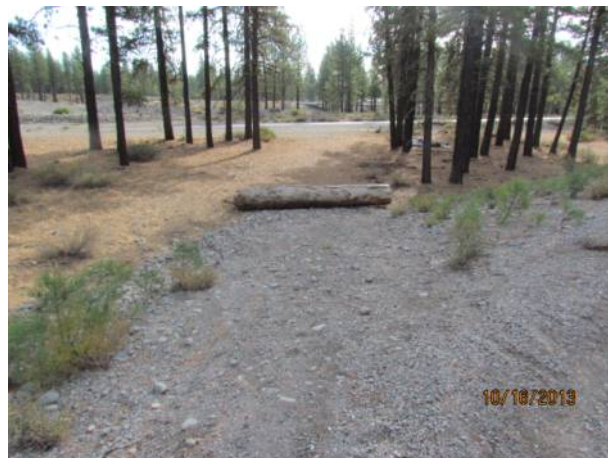
Levee Mile Report Line	3
Start Levee Mile	0.44
End Levee Mile	0.44
Location	Water Side
Category	Earthen Levee
Item	Slope Stability
View of the vehicle erosion along the slope of the levee.	
rduffey_f_20131021_106.JPG

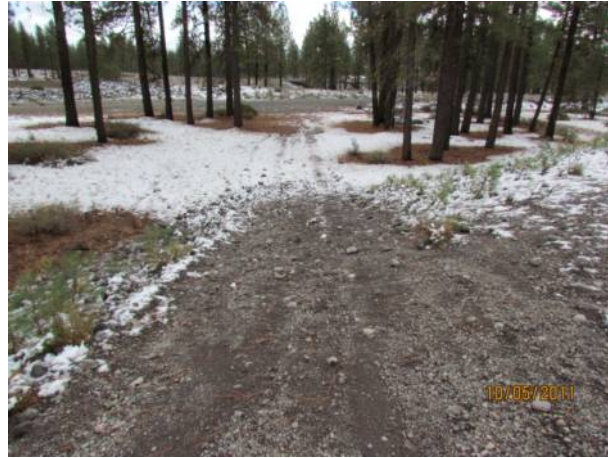
Levee Mile Report Line	4
Start Levee Mile	0.46
End Levee Mile	0.46
Location	Water Side
Category	Earthen Levee
Item	Slope Stability

View of the vehicle erosion along the W/S slope.

4	0.46	0.46	Earthen Levee	Slope Stability	WS	M Ma	S2 : Repair the levee slope damaged by foot traffic and prevent access where possible.	40.282980 ° 40.282980 °	121.253990 ° 121.253990 °	3 Y
DWR ID: DWR_NA0015_02_s_2012_3										
5	0.55	0.55	Earthen Levee	Slope Stability	LS	M Ma	S3 : Repair the levee slope damaged by vehicle traffic and prevent access where possible.	40.281950 ° 40.281950 °	121.253710 ° 121.253710 °	4 Y
DWR ID: DWR_NA0015_02_s_2012_4										
6	0.55	0.55	Earthen Levee	Slope Stability	WS	M Ma	S3 : Repair the levee slope damaged by vehicle traffic and prevent access where possible.	40.281950 ° 40.281950 °	121.253710 ° 121.253710 °	5 Y
DWR ID: DWR_NA0015_02_s_2012_5

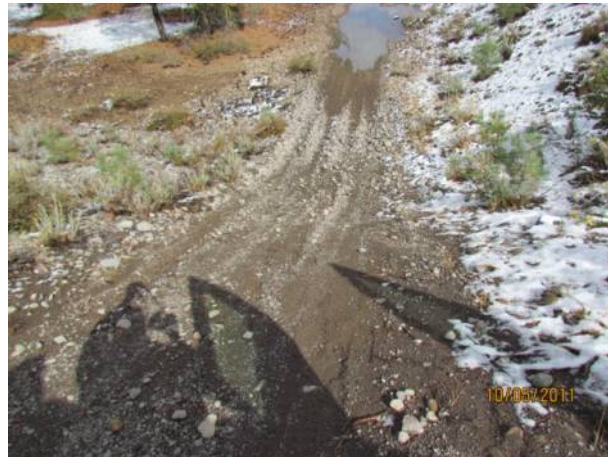
Levee Mile Report Line	5
Start Levee Mile	0.55
End Levee Mile	0.55
Location	Land Side
Category	Earthen Levee
Item	Slope Stability

View of the vehicle erosion along the L/S slope.

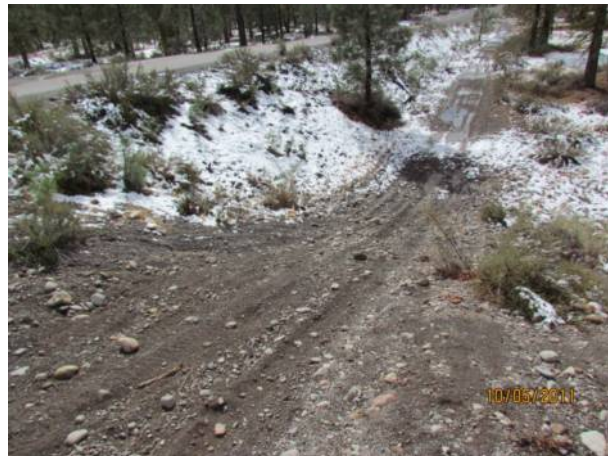
Levee Mile Report Line	6
Start Levee Mile	0.55
End Levee Mile	0.55
Location	Water Side
Category	Earthen Levee
Item	Slope Stability

View of the vehicle erosion along the W/S slope.
