**Flood Control Project Maintenance
Levee Inspections**

Fall 2014 Levee Maintenance Deficiency Summary Report

Sacramento River Basin

Plumas County

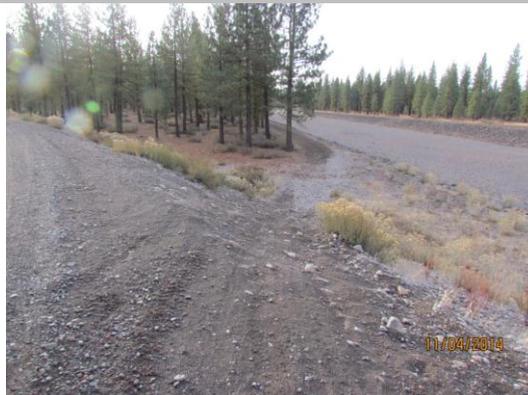
Photo 1 of 1 : FA_2014_NA0015_337_9_20141112_00004.jpg

LM Start	0.55	Rating **	M	Issue No.	9
LM End	0.55	Issue Type +	Ma	Location *	WS
Category	Earthen Levee		GPS Latitude/Longitude		
			Start	End	
Item	Slope Stability		40.279790 °	121.249850 °	
			40.279790 °	121.249850 °	
DWR ID	DWR_NA0015_01_s_2012_9				
Action/Comments					
Repair the levee slope damaged by vehicle traffic and prevent access where possible.

View of the vehicle erosion along the waterside toe.

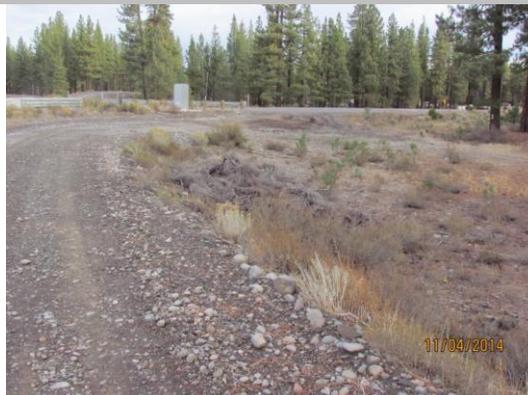
Photo 1 of 1 : FA_2014_NA0015_337_4_20141112_00005.jpg

LM Start	0.68	Rating **	M	Issue No.	4
LM End	0.68	Issue Type +	En	Location *	LS
Category	Earthen Levee		GPS Latitude/Longitude		
			Start	End	
Item	Encroachments		40.281480 °	40.281480 °	
			-121.250928 °	-121.250928 °	
DWR ID	DWR_NA0015_01_s_2013_4				
Action/Comments					
Prunings

View of the pruning along the landside slope.

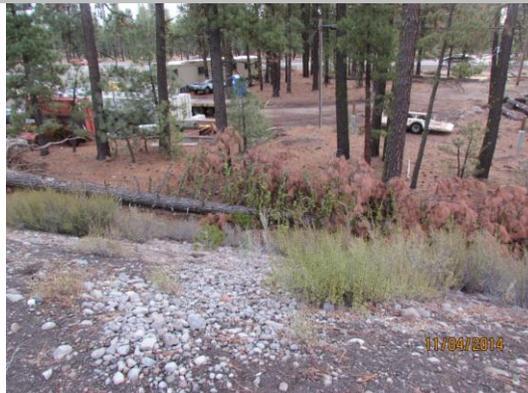
Photo 1 of 1 : FA_2014_NA0015_337_6_20141112_00006.jpg

LM Start	0.80	Rating **	M	Issue No.	6
LM End	0.80	Issue Type +	En	Location *	LS
Category	Earthen Levee		GPS Latitude/Longitude		
			Start	End	
Item	Encroachments		40.283163 °	40.283163 °	
			-121.251293 °	-121.251293 °	
DWR ID	DWR_NA0015_01_f_2014_6				
Action/Comments					
Tree or limb

View of the tree along the landside toe.

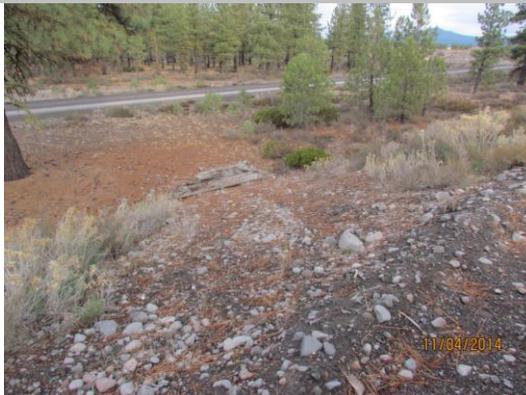
Photo 1 of 1 : FA_2014_NA0015_337_5_20141112_00007.jpg

LM Start	0.97	Rating **	M	Issue No.	5
LM End	0.97	Issue Type +	Ma	Location *	WS
Category	Earthen Levee		GPS Latitude/Longitude		
			Start	End	
Item	Slope Stability		40.285363 °	40.285363 °	
			-121.251973 °	-121.251973 °	
DWR ID	DWR_NA0015_01_f_2013_5				
Action/Comments					
Repair the levee slope damaged by vehicle traffic and prevent access where possible.

View of the vehicle erosion along the waterside slope.

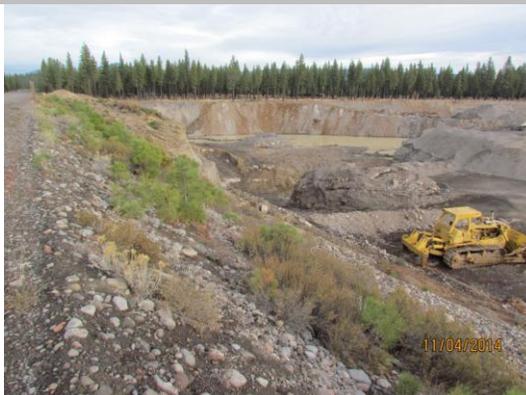
Photo 1 of 1 : FA_2014_NA0015_337_7_20141112_00008.jpg

LM Start	1.41	Rating **	U	Issue No.	7
LM End	1.50	Issue Type +	Ma	Location *	LS
Category	Earthen Levee		GPS Latitude/Longitude		
			Start	End	
Item	Slope Stability		40.290758 °	40.291987 °	
			-121.255402 °	-121.256072 °	
DWR ID	DWR_NA0015_01_f_2014_7				
Action/Comments					
Repair slope instability. Inspector Comments: The landowner needs to replace the material that has been removed from the toe of the levee.

View of the area where the contractor has removed the material from toe of the levee.

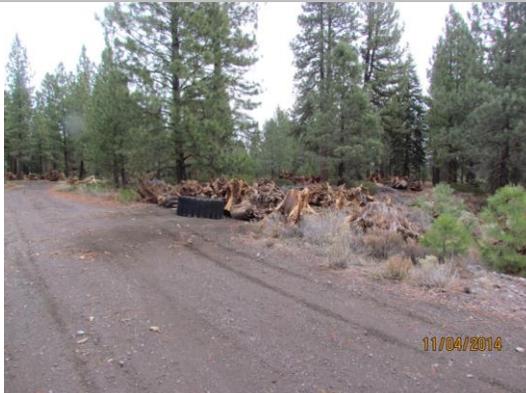
Photo 1 of 1 : FA_2014_NA0015_337_8_20141112_00009.jpg

LM Start	1.86	Rating **	M	Issue No.	8
LM End	1.86	Issue Type +	En	Location *	LS
Category	Earthen Levee		GPS Latitude/Longitude		
			Start	End	
Item	Encroachments		40.296910 °	40.296910 °	
			-121.257280 °	-121.257280 °	
DWR ID	DWR_NA0015_01_f_2014_8				
Action/Comments					
Tree or limb

Remove the tree stumps from the slope of the levee.

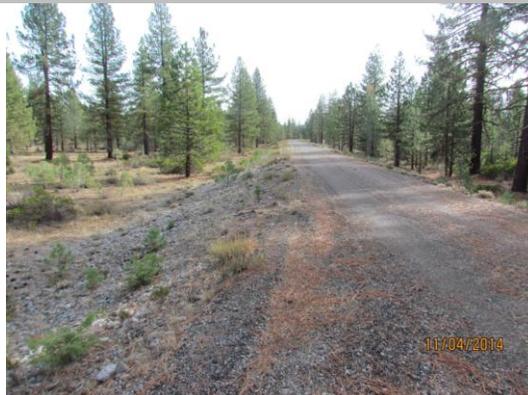
Photo 1 of 1 : FA_2014_NA0015_338_2_20141112_00007.jpg

LM Start	0.02	Rating **	M	Issue No.	2
LM End	0.62	Issue Type +	Ma	Location *	WS
Category	Earthen Levee		GPS Latitude/Longitude		
			Start	End	
Item	Vegetation		40.286415 °	40.281054 °	
			-121.259613 °	-121.252789 °	
DWR ID	DWR_NA0015_02_f_2012_2				
Action/Comments					
Remove the wild growth other than native grasses from the levee slopes. Inspector Comments: Mow or remove the pine trees from the slope.

View of the small pine trees that need to be removed from the waterside slope.

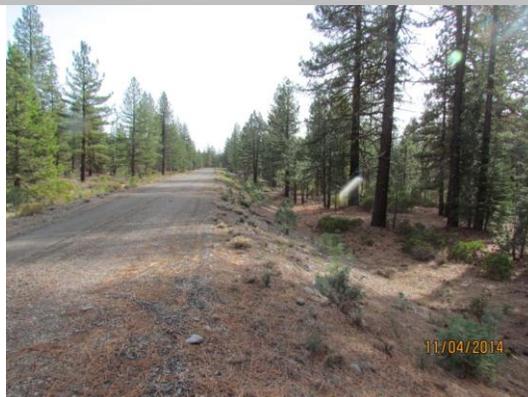
Photo 1 of 1 : FA_2014_NA0015_338_1_20141112_00008.jpg

LM Start	0.02	Rating **	M	Issue No.	1
LM End	0.62	Issue Type +	Ma	Location *	LS
Category	Earthen Levee		GPS Latitude/Longitude		
			Start	End	
Item	Vegetation		40.286415 °	40.281053 °	
			-121.259613 °	-121.252792 °	
DWR ID	DWR_NA0015_02_f_2012_1				
Action/Comments					
Remove the wild growth other than native grasses from the levee slopes. Inspector Comments: Mow or remove the pine trees from the slope.

View of the small pine trees growing on the landside slope.

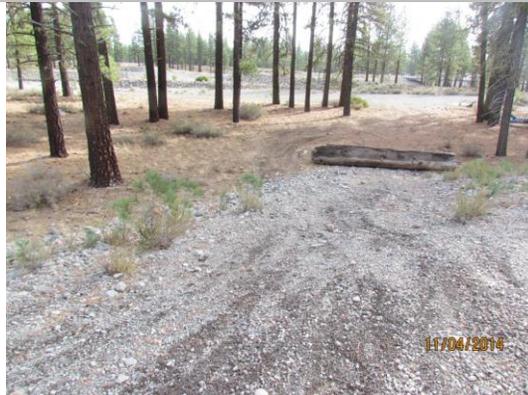
Photo 1 of 1 : FA_2014_NA0015_338_6_20141112_00009.jpg

LM Start	0.44	Rating **	M	Issue No.	6
LM End	0.44	Issue Type +	Ma	Location *	WS
Category	Earthen Levee		GPS Latitude/Longitude		
			Start	End	
Item	Slope Stability		40.283059 °	40.283059 °	
			-121.253989 °	-121.253989 °	
DWR ID	DWR_NA0015_02_f_2013_6				
Action/Comments					
Repair the levee slope damaged by vehicle traffic and prevent access where possible.

View of the vehicle erosion on the landside slope.

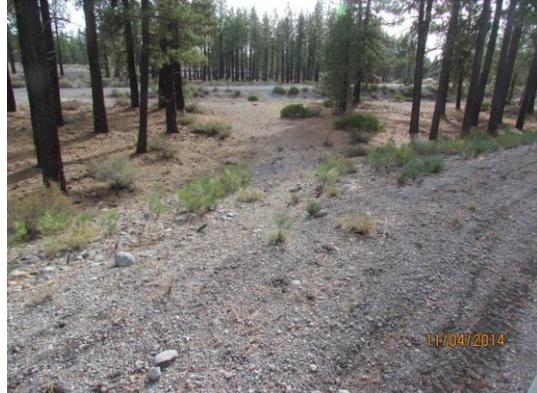
Photo 1 of 1 : FA_2014_NA0015_338_3_20141112_00010.jpg

LM Start	0.46	Rating **	M	Issue No.	3
LM End	0.46	Issue Type +	Ma	Location *	WS
Category	Earthen Levee		GPS Latitude/Longitude		
			Start	End	
Item	Slope Stability		40.282980 °	121.253990 °	
			40.282980 °	121.253990 °	
DWR ID	DWR_NA0015_02_s_2012_3				
Action/Comments					
Repair the levee slope damaged by foot traffic and prevent access where possible.

View of the vehicle erosion along the waterside slope.

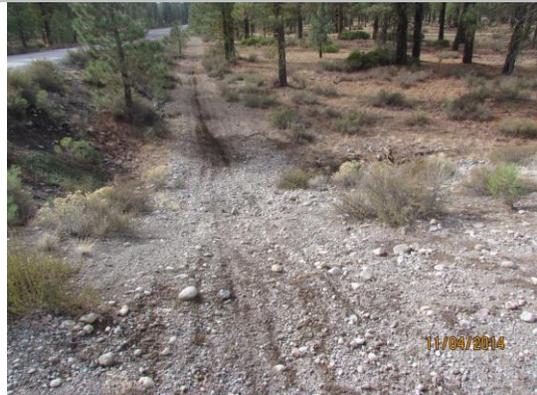
Photo 1 of 1 : FA_2014_NA0015_338_4_20141112_00012.jpg

LM Start	0.55	Rating **	M	Issue No.	4
LM End	0.55	Issue Type +	Ma	Location *	LS
Category	Earthen Levee		GPS Latitude/Longitude		
			Start	End	
Item	Slope Stability		40.281950 °	121.253710 °	
			40.281950 °	121.253710 °	
DWR ID	DWR_NA0015_02_s_2012_4				
Action/Comments					
Repair the levee slope damaged by vehicle traffic and prevent access where possible.

View of the erosion along the landside slope.

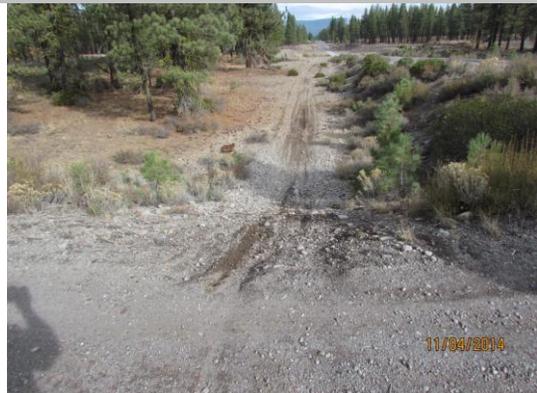
Photo 1 of 1 : FA_2014_NA0015_338_5_20141112_00011.jpg

LM Start	0.55	Rating **	M	Issue No.	5
LM End	0.55	Issue Type +	Ma	Location *	WS
Category	Earthen Levee		GPS Latitude/Longitude		
			Start	End	
Item	Slope Stability		40.281950 °	121.253710 °	
			40.281950 °	121.253710 °	
DWR ID	DWR_NA0015_02_s_2012_5				
Action/Comments					
Repair the levee slope damaged by vehicle traffic and prevent access where possible.

View of the vehicle erosion on the waterside slope.
