**Flood Control Project Maintenance  
Levee Inspections**

**Fall 2015 Levee Maintenance Deficiency Summary Report**

**Sacramento River Basin**

**Plumas County**

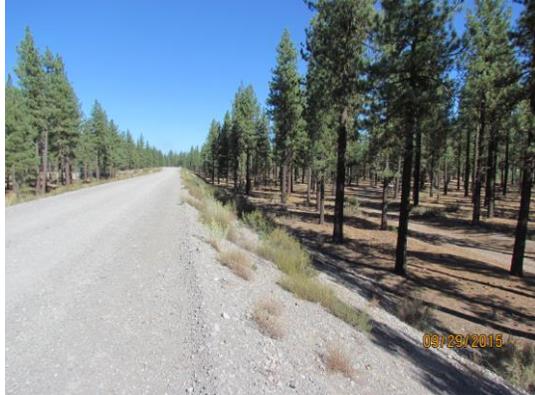
Photo 1 of 1 : FA\_2015\_NA0015\_337\_11\_20151012\_00010.jpg

LM Start	<b>0.00</b>	Rating **	M	Issue No.	<b>11</b>
LM End	<b>1.89</b>	Issue Type +	Ma	Location *	LS
Category	Earthen Levee		GPS Latitude/Longitude		
			Start	End	
Item	Vegetation		40.273168 °	40.297283 °	
			-121.244783 °	-121.257025 °	
DWR ID	DWR_NA0015_01_f_2015_11				
Action/Comments					
Remove the wild growth other than native grasses from the levee slopes. Inspector Comments: Remove the small pine trees and other vegetation from the levee slope.

Remove the small pine trees and other vegetation from the levee slope.

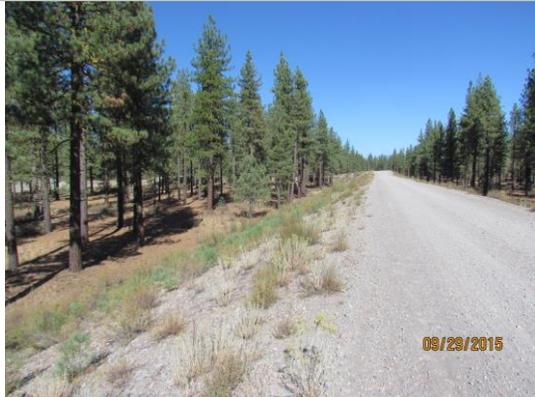
Photo 1 of 1 : FA\_2015\_NA0015\_337\_12\_20151012\_00009.jpg

LM Start	<b>0.00</b>	Rating **	M	Issue No.	<b>12</b>
LM End	<b>1.89</b>	Issue Type +	Ma	Location *	WS
Category	Earthen Levee		GPS Latitude/Longitude		
			Start	End	
Item	Vegetation		40.273168 °	40.297283 °	
			-121.244783 °	-121.257025 °	
DWR ID	DWR_NA0015_01_f_2015_12				
Action/Comments					
Remove the wild growth other than native grasses from the levee slopes. Inspector Comments: Remove all small pine trees and other vegetation from the levee slope.

View of the small pine trees and other vegetation on the slope.

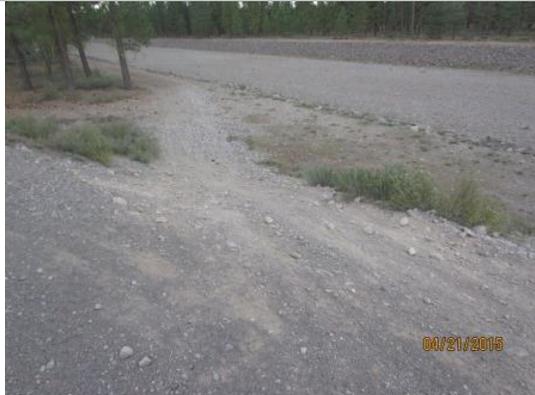
Photo 1 of 1 : FA\_2015\_NA0015\_337\_9\_20150910\_00007.jpg

LM Start	<b>0.55</b>	Rating **	M	Issue No.	<b>9</b>
LM End	<b>0.55</b>	Issue Type +	Ma	Location *	WS
Category	Earthen Levee		GPS Latitude/Longitude		
			Start	End	
Item	Slope Stability		40.279790 °	121.249850 °	
			40.279790 °	121.249850 °	
DWR ID	DWR_NA0015_01_s_2012_9				
Action/Comments					
Repair the levee slope damaged by vehicle traffic and prevent access where possible.

View of the vehicle erosion along the waterside toe.

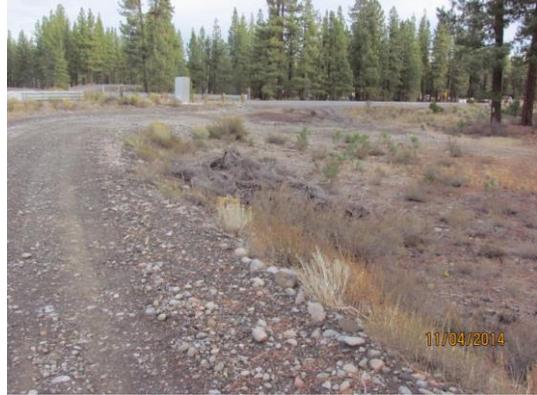
Photo 1 of 1 : FA\_2015\_NA0015\_337\_4\_20150910\_00001.jpg

LM Start	<b>0.68</b>	Rating **	M	Issue No.	<b>4</b>
LM End	<b>0.68</b>	Issue Type +	En	Location *	LS
Category	Earthen Levee		GPS Latitude/Longitude		
			Start	End	
Item	Encroachments		40.281480 °	40.281480 °	
			-121.250928 °	-121.250928 °	
DWR ID	DWR_NA0015_01_s_2013_4				
Action/Comments					
Prunings

View of the prunings along the landside slope.

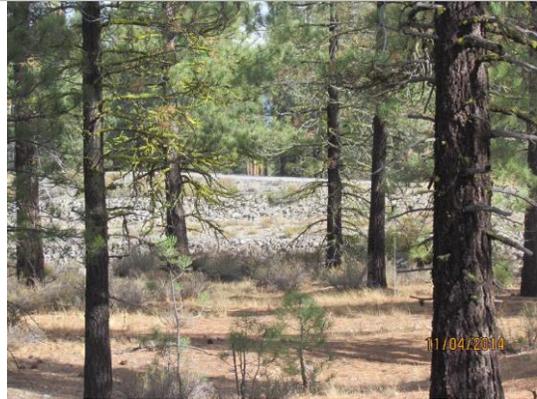
Photo 1 of 3 : UCIP\_FA\_2015\_5995.jpg

LM Start	<b>0.77</b>	Rating **	M	Issue No.	<b>13</b>
LM End	<b>0.77</b>	Issue Type +	En	Location *	LS
Category	Supplemental		GPS Latitude/Longitude		
			Start	End	
Item	DWR UCIP Field Study		40.282683 °	40.282683 °	
			-121.251453 °	-121.251453 °	
DWR ID					
Action/Comments					
Inspector Comments: FS_ID:42643 DS_ID:23039 EP_NO: N/A FS_HLM: 0.77 Repair Type: Non-Urgent Crossing Status: Indicator Found UCIP Comments: Need to contact owner to determine additional information about crossing. Need depth of conduit and permit issued. FIELD_STRUCT_DESC: Underground telephone cable through the levee and across the channel. Elevation unknown. FS Date: 11/04/2014

View of landward slope.

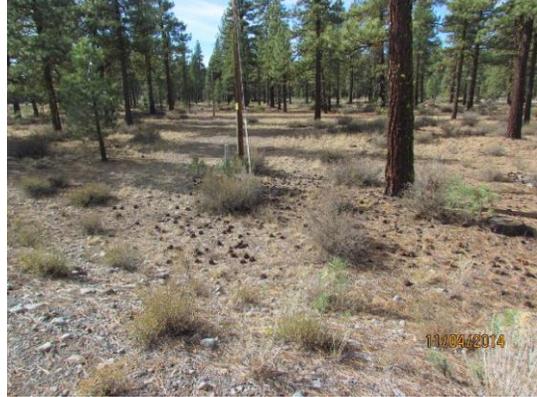
Photo 2 of 3 : UCIP\_FA\_2015\_5996.jpg

LM Start	<b>0.77</b>	Rating **	M	Issue No.	<b>13 (cont)</b>
LM End	<b>0.77</b>	Issue Type +	En	Location *	LS
Category	Supplemental			GPS Latitude/Longitude	
				Start	End
Item	DWR UCIP Field Study			40.282683 °	40.282683 °
DWR ID				-121.251453 °	-121.251453 °
Action/Comments					
Inspector Comments: FS_ID:42643 DS_ID:23039 EP_NO: N/A FS_HLM: 0.77 Repair Type: Non-Urgent Crossing Status: Indicator Found UCIP Comments: Need to contact owner to determine additional information about crossing. Need depth of conduit and permit issued. FIELD_STRUCT_DESC: Underground telephone cable through the levee and across the channel. Elevation unknown. FS Date: 11/04/2014

View of conduit pole located on landward side. Photo taken from right bank.

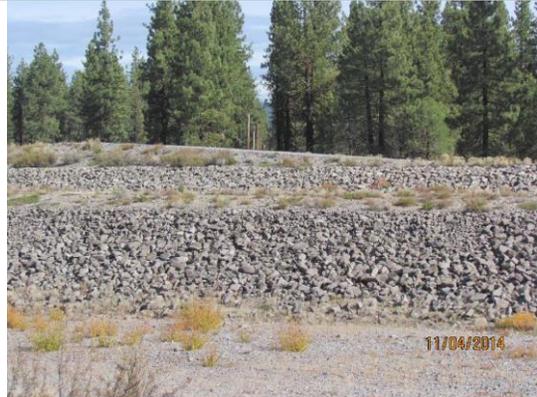
Photo 3 of 3 : UCIP\_FA\_2015\_5997.jpg

View of levee, ramp, and posts visible between trees.

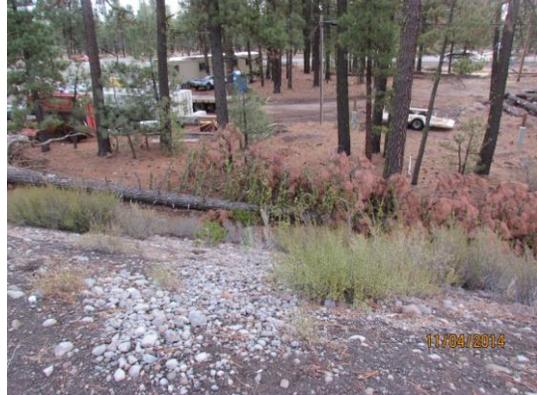
Photo 1 of 1 : FA\_2015\_NA0015\_337\_6\_20150910\_00003.jpg

LM Start	<b>0.80</b>	Rating **	M	Issue No.	<b>6</b>
LM End	<b>0.80</b>	Issue Type +	En	Location *	LS
Category	Earthen Levee		GPS Latitude/Longitude		
			Start	End	
Item	Encroachments		40.283163 °	40.283163 °	
			-121.251293 °	-121.251293 °	
DWR ID	DWR_NA0015_01_f_2014_6				
Action/Comments					
Tree or limb

View of the tree limb along the landside toe.

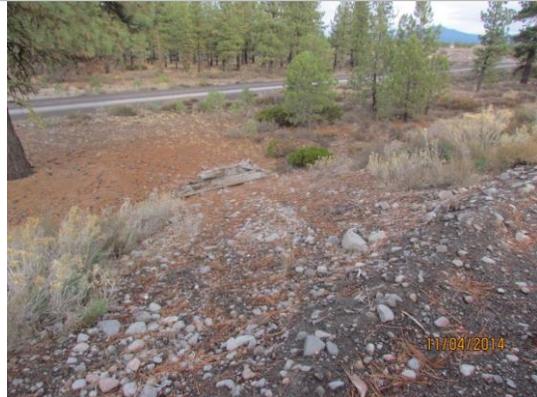
Photo 1 of 1 : FA\_2015\_NA0015\_337\_5\_20150910\_00002.jpg

LM Start	<b>0.96</b>	Rating **	M	Issue No.	<b>5</b>
LM End	<b>0.96</b>	Issue Type +	Ma	Location *	WS
Category	Earthen Levee		GPS Latitude/Longitude		
			Start	End	
Item	Slope Stability		40.285363 °	40.285363 °	
			-121.251973 °	-121.251973 °	
DWR ID	DWR_NA0015_01_f_2013_5				
Action/Comments					
Repair the levee slope damaged by vehicle traffic and prevent access where possible.

View of the vehicle erosion along the waterside slope.

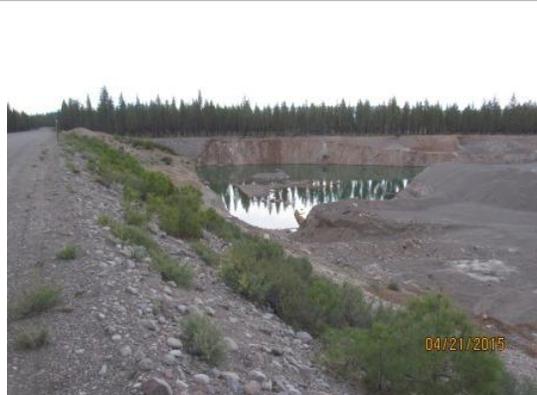
Photo 1 of 2 : FA\_2015\_NA0015\_337\_7\_20150910\_00004.jpg

LM Start	<b>1.41</b>	Rating **	U	Issue No.	<b>7</b>
LM End	<b>1.50</b>	Issue Type +	Ma	Location *	LS
Category	Earthen Levee		GPS Latitude/Longitude		
			Start	End	
Item	Slope Stability		40.290758 °	40.291987 °	
			-121.255402 °	-121.256072 °	
DWR ID	DWR_NA0015_01_f_2014_7				
Action/Comments					
Repair slope instability. Inspector Comments: The landowner needs to replace the material that has been removed from the toe of the levee.

View of the area where the contractor has removed the material from toe of the levee.

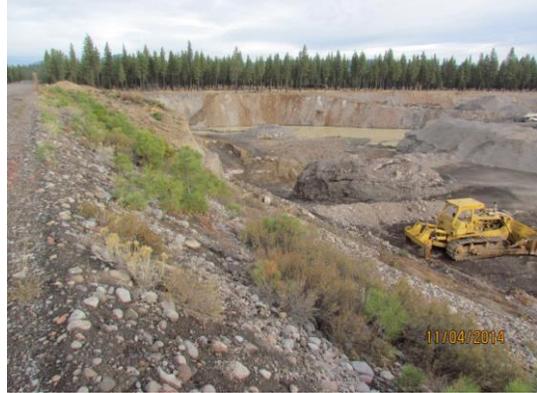
Photo 2 of 2 : FA\_2015\_NA0015\_337\_7\_20150910\_00005.jpg

LM Start	<b>1.41</b>	Rating **	U	Issue No.	<b>7 (cont)</b>
LM End	<b>1.50</b>	Issue Type +	Ma	Location *	LS
Category	Earthen Levee		GPS Latitude/Longitude		
			Start	End	
Item	Slope Stability		40.290758 °	40.291987 °	
			-121.255402 °	-121.256072 °	
DWR ID	DWR_NA0015_01_f_2014_7				
Action/Comments					
Repair slope instability. Inspector Comments: The landowner needs to replace the material that has been removed from the toe of the levee.

View of the area where the contractor has removed the material from toe of the levee.

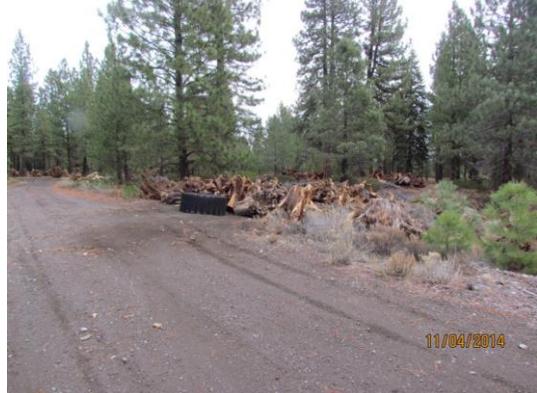
Photo 1 of 1 : FA\_2015\_NA0015\_337\_8\_20150910\_00006.jpg

LM Start	<b>1.86</b>	Rating **	M	Issue No.	<b>8</b>
LM End	<b>1.86</b>	Issue Type +	En	Location *	LS
Category	Earthen Levee		GPS Latitude/Longitude		
			Start	End	
Item	Encroachments		40.296910 °	40.296910 °	
			-121.257280 °	-121.257280 °	
DWR ID	DWR_NA0015_01_f_2014_8				
Action/Comments					
Tree or limb

Remove the tree stumps from the slope of the levee.

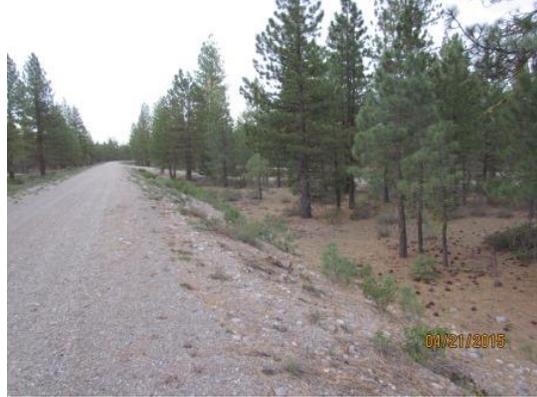
Photo 1 of 2 : FA\_2015\_NA0015\_338\_1\_20150910\_00001.jpg

LM Start	<b>0.03</b>	Rating **	M	Issue No.	<b>1</b>
LM End	<b>1.36</b>	Issue Type +	Ma	Location *	LS
Category	Earthen Levee		GPS Latitude/Longitude		
			Start	End	
Item	Vegetation		40.286415 °	40.271743 °	
			-121.259613 °	-121.246805 °	
DWR ID	DWR_NA0015_02_f_2012_1				
Action/Comments					
Remove the wild growth other than native grasses from the levee slopes. Inspector Comments: Mow or remove the pine trees and other vegetation from the slope.

View of the small pine trees growing on the landside slope.

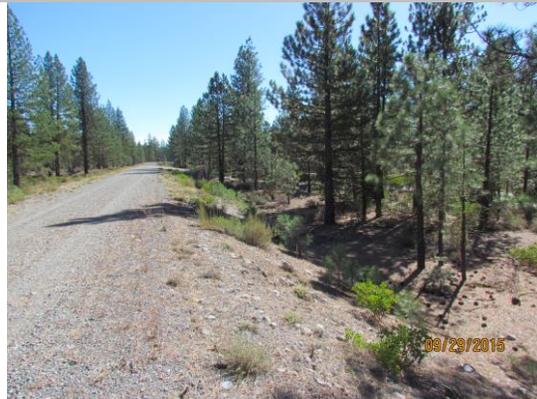
Photo 2 of 2 : FA\_2015\_NA0015\_338\_1\_20151012\_00009.jpg

View of the small pine trees and other vegetation growing on the slope.

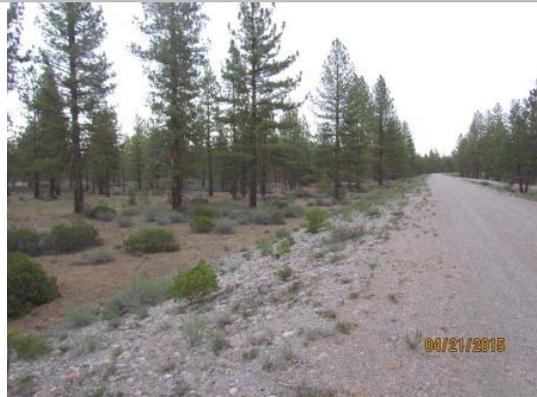
Photo 1 of 2 : FA\_2015\_NA0015\_338\_2\_20150910\_00002.jpg

LM Start	<b>0.03</b>	Rating **	M	Issue No.	<b>2</b>
LM End	<b>1.36</b>	Issue Type +	Ma	Location *	WS
Category	Earthen Levee		GPS Latitude/Longitude		
			Start	End	
Item	Vegetation		40.286415 °	40.271743 °	
			-121.259613 °	-121.246805 °	
DWR ID	DWR_NA0015_02_f_2012_2				
Action/Comments					
Remove the wild growth other than native grasses from the levee slopes. Inspector Comments: Mow or remove the pine trees and other vegetation from the slope.

View of the small pine trees growing on the waterside slope.

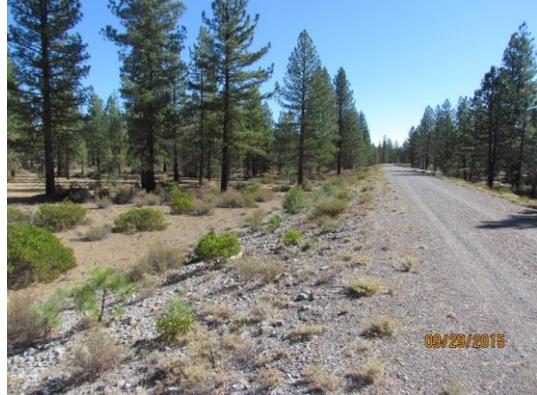
Photo 2 of 2 : FA\_2015\_NA0015\_338\_2\_20151012\_00008.jpg

LM Start	<b>0.03</b>	Rating **	M	Issue No.	<b>2 (cont)</b>
LM End	<b>1.36</b>	Issue Type +	Ma	Location *	WS
Category	Earthen Levee			GPS Latitude/Longitude	
				Start	End
Item	Vegetation			40.286415 °	40.271743 °
				-121.259613 °	-121.246805 °
DWR ID	DWR_NA0015_02_f_2012_2				
Action/Comments					
Remove the wild growth other than native grasses from the levee slopes. Inspector Comments: Mow or remove the pine trees and other vegetation from the slope.

View of the small pine trees and other vegetation growing on the slope.

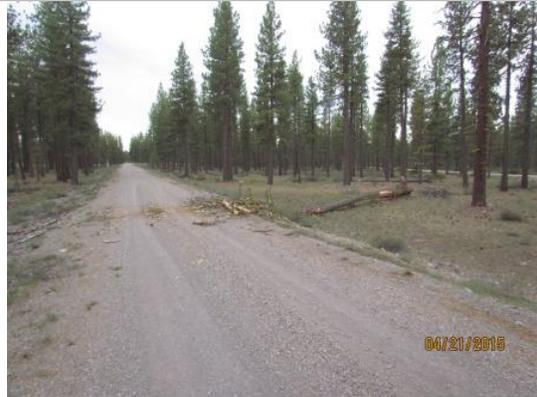
Photo 1 of 1 : FA\_2015\_NA0015\_338\_9\_20150910\_00007.jpg

LM Start	<b>0.31</b>	Rating **	M	Issue No.	<b>9</b>
LM End	<b>0.31</b>	Issue Type +	En	Location *	LS
Category	Earthen Levee			GPS Latitude/Longitude	
				Start	End
Item	Encroachments			40.284993 °	40.284993 °
				-121.255133 °	-121.255133 °
DWR ID	DWR_NA0015_02_s_2015_9				
Action/Comments					
Tree or limb Inspector Comments: Remove the pine tree from the landside slope.

View of the pine tree that has fallen onto the landside slope.

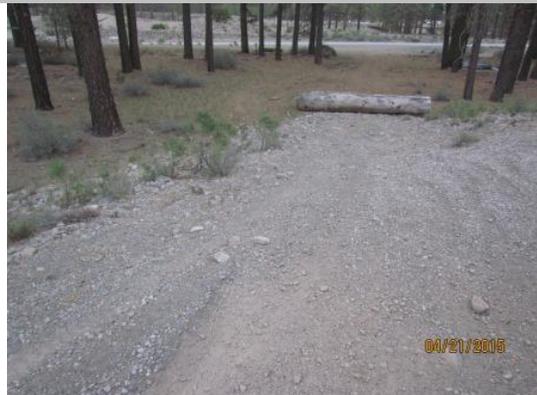
Photo 1 of 2 : FA\_2015\_NA0015\_338\_6\_20150910\_00005.jpg

LM Start	<b>0.46</b>	Rating **	M	Issue No.	<b>6</b>
LM End	<b>0.46</b>	Issue Type +	Ma	Location *	WS
Category	Earthen Levee			GPS Latitude/Longitude	
				Start	End
Item	Slope Stability			40.283059 °	40.283059 °
				-121.253989 °	-121.253989 °
DWR ID	DWR_NA0015_02_f_2013_6				
Action/Comments					
Repair the levee slope damaged by vehicle traffic and prevent access where possible.

View of the vehicle erosion on the waterside slope.

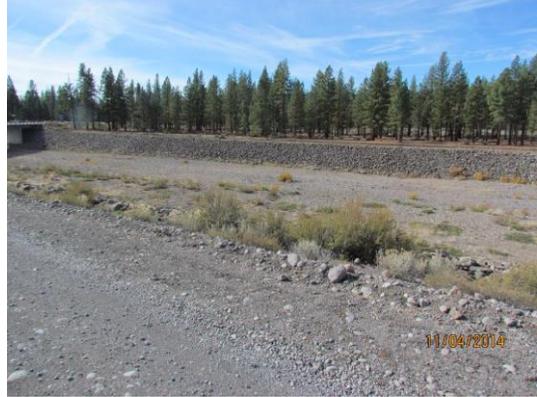
Photo 1 of 3 : UCIP\_FA\_2015\_5998.jpg

LM Start	<b>0.65</b>	Rating **	M	Issue No.	<b>10</b>
LM End	<b>0.65</b>	Issue Type +	En	Location *	WS
Category	Supplemental			GPS Latitude/Longitude	
				Start	End
Item	DWR UCIP Field Study			40.280737 °	40.280737 °
				-121.252512 °	-121.252512 °
DWR ID					
Action/Comments					
Inspector Comments: FS_ID:42644 DS_ID:23040 EP_NO: N/A FS_HLM: 0.64 Repair Type: Non-Urgent Crossing Status: Indicator Found UCIP Comments: Need to contact owner to determine additional information about crossing. Need depth of conduit and permit issued. FIELD_STRUCT_DESC: Underground telephone cable through the levee and across the channel. Elevation unknown. FS Date: 11/04/2014

View of waterward side.

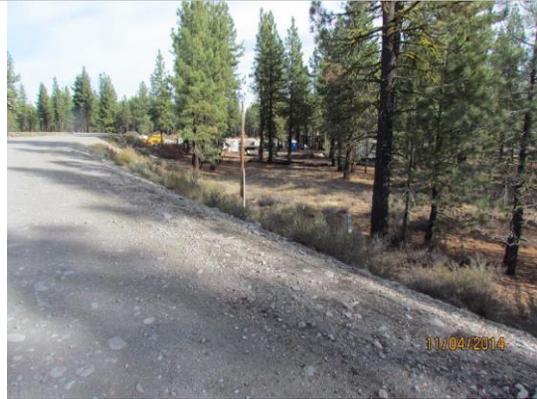
Photo 2 of 3 : UCIP\_FA\_2015\_5999.jpg

View of landward side conduit pole located at landward toe. Photo taken from the left bank.

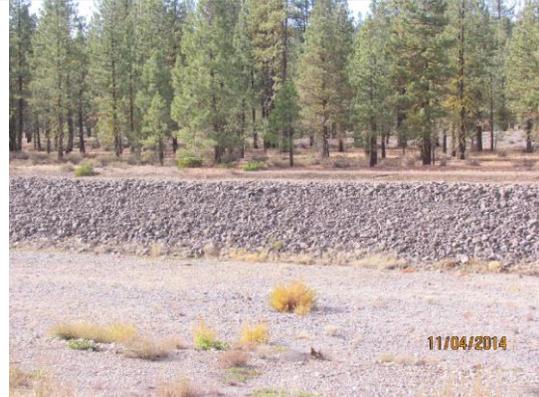
Photo 3 of 3 : UCIP\_FA\_2015\_6000.jpg

LM Start	<b>0.65</b>	Rating **	M	Issue No.	<b>10 (cont)</b>
LM End	<b>0.65</b>	Issue Type +	En	Location *	WS
Category	Supplemental			GPS Latitude/Longitude	
				Start	End
Item	DWR UCIP Field Study			40.280737 °	40.280737 °
				-121.252512 °	-121.252512 °
DWR ID					
Action/Comments					
Inspector Comments: FS_ID:42644 DS_ID:23040 EP_NO: N/A FS_HLM: 0.64 Repair Type: Non-Urgent Crossing Status: Indicator Found

View of opposite bank.
