**Flood Control Project Maintenance
Levee Inspections**

Fall 2016 Levee Maintenance Deficiency Summary Report

Sacramento River Basin

Plumas County

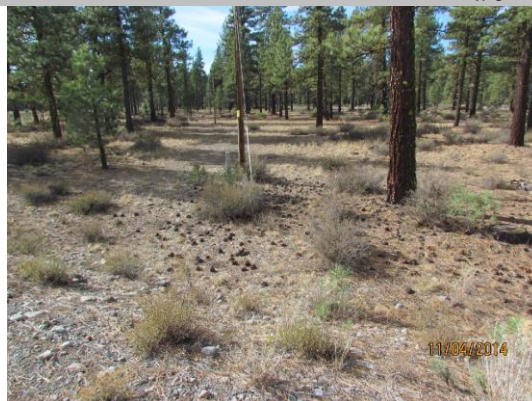
Photo 1 of 2 : UCIP_FA_2016_42643_72981.jpg

LM Start	0.77	Rating **	M	Issue No.	16
LM End	0.77	Issue Type +	En	Location *	LS
Category	Supplemental			GPS Latitude/Longitude	
				Start	End
Item	DWR UCIP Field Study			40.282683 °	40.282683 °
				-121.251453 °	-121.251453 °
DWR ID

FS_ID:42643
DS_ID:23039
EP_NO: N/A
Repair Type: Non-Urgent
Crossing Status: Indicator Found
UCIP Comments: Need to contact owner to determine additional information about crossing. Need depth of conduit and permit issued.
FIELD_STRUCT_DESC: Underground telephone cable through the levee and across the channel. Elevation unknown.
FS Date: 11/4/2014

View of conduit pole located on landward side. Photo taken from right bank.

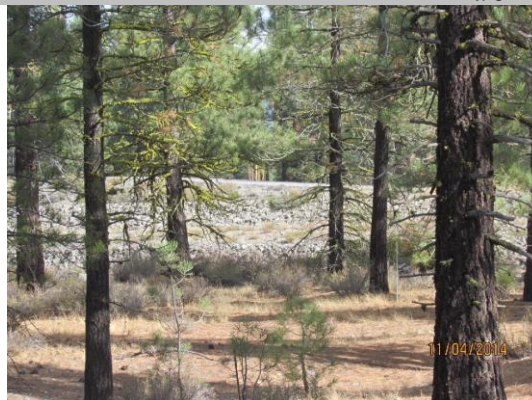
Photo 2 of 2 : UCIP_FA_2016_42643_72980.jpg

View of landward slope.

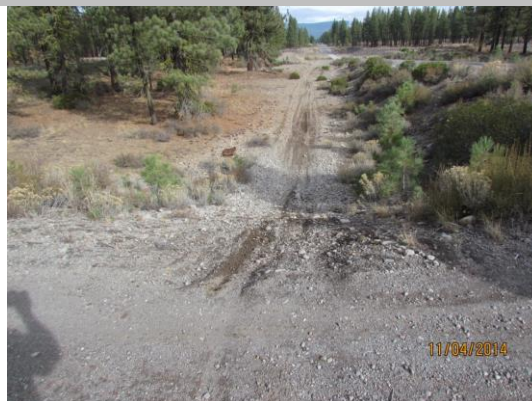
Photo 1 of 1 : FA_2016_NA0015_338_5_20160823_00006.jpg

LM Start	0.55	Rating **	M	Issue No.	5
LM End	0.55	Issue Type +	Ma	Location *	WS
Category	Earthen Levee			GPS Latitude/Longitude	
				Start	End
Item	Slope Stability			40.281950 °	121.253710 °
				40.281950 °	121.253710 °
DWR ID	DWR_NA0015_02_s_2012_5				
Comment Code					
S3 : Repair the levee slope damaged by vehicle traffic and prevent access where possible.					
Inspector Comment

View of the vehicle erosion on the waterside slope.

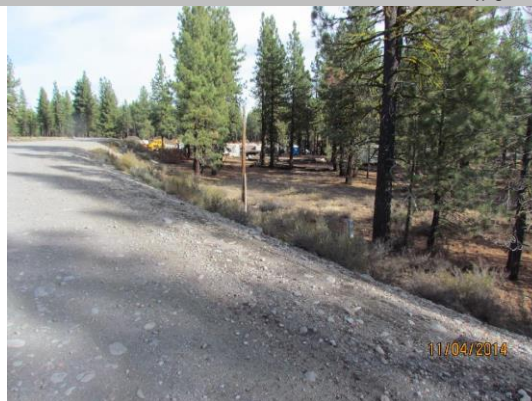
Photo 1 of 2 : UCIP_FA_2016_42644_72984.jpg

LM Start	0.66	Rating **	M	Issue No.	10
LM End	0.66	Issue Type +	En	Location *	WS
Category	Supplemental			GPS Latitude/Longitude	
				Start	End
Item	DWR UCIP Field Study			40.280737 °	40.280737 °
				-121.252512 °	-121.252512 °
DWR ID					
Comment Code					
Inspector Comment					
FS_ID:42644 DS_ID:23040 EP_NO: N/A Repair Type: Non-Urgent Crossing Status: Indicator Found UCIP Comments: Need to contact owner to determine additional information about crossing. Need depth of conduit and permit issued. FIELD_STRUCT_DESC: Underground telephone cable through the levee and across the channel. Elevation unknown. FS Date: 11/4/2014

View of landward side conduit pole located at landward toe. Photo taken from the left bank.

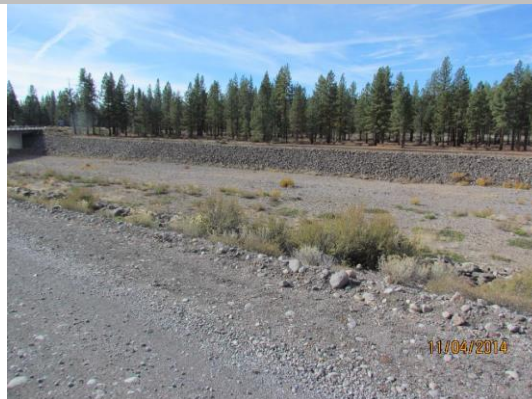
Photo 2 of 2 : UCIP_FA_2016_42644_72983.jpg

LM Start	0.66	Rating **	M	Issue No.	10 (cont)
LM End	0.66	Issue Type +	En	Location *	WS
Category	Supplemental			GPS Latitude/Longitude	
				Start	End
Item	DWR UCIP Field Study			40.280737 °	40.280737 °
				-121.252512 °	-121.252512 °
DWR ID					
Comment Code					
Inspector Comment					
FS_ID:42644					
DS_ID:23040					
EP_NO: N/A					
Repair Type: Non-Urgent					
Crossing Status: Indicator Found					
UCIP Comments: Need to contact owner to determine additional information about crossing. Need depth of conduit and permit issued.					
FIELD_STRUCT_DESC: Underground telephone cable through the levee and across the channel. Elevation unknown.					
FS Date: 11/4/2014

View of waterward side.
