**Flood Control Project Maintenance
Levee Inspections**

Fall 2017 Levee Maintenance Deficiency Summary Report

**Flood Control Project Maintenance
Levee Inspections**
LMA District Cover Sheet
Fall 2017 Levee Inspection Results

Plumas County

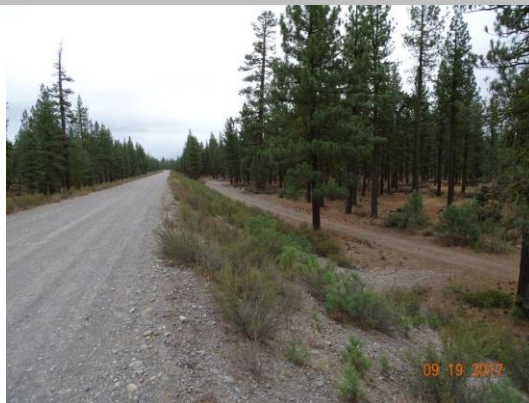
Photo 1 of 1 : FA_2017_NA0015_337_11_20171006_00017.jpg

LM Start	0.00	Rating **	M	Issue No.	11
LM End	1.89	Issue Type +	Ma	Location *	LS
Category	Earthen Levee			GPS Latitude/Longitude	
				Start	End
Item	Vegetation			40.273168 °	40.297283 °
				-121.244783 °	-121.257025 °
DWR ID	DWR_NA0015_01_f_2015_11				
Comment Code					
V2 : Remove the wild growth other than native grasses from the levee slopes.					
Inspector Comment					
Remove the small pine trees and other vegetation from the levee slope.

View of the small pine trees and other vegetation on the landside slope.

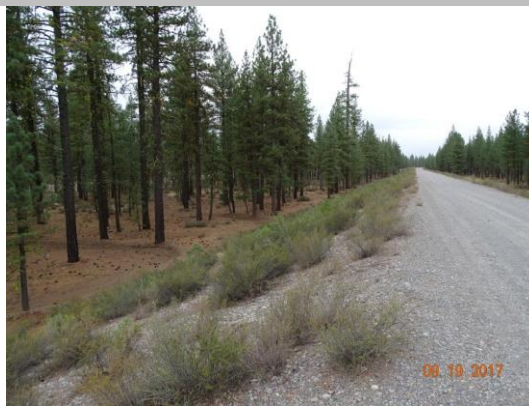
Photo 1 of 1 : FA_2017_NA0015_337_12_20171006_00016.jpg

LM Start	0.00	Rating **	M	Issue No.	12
LM End	1.89	Issue Type +	Ma	Location *	WS
Category	Earthen Levee			GPS Latitude/Longitude	
				Start	End
Item	Vegetation			40.273168 °	40.297283 °
				-121.244783 °	-121.257025 °
DWR ID	DWR_NA0015_01_f_2015_12				
Comment Code					
V2 : Remove the wild growth other than native grasses from the levee slopes.					
Inspector Comment					
Remove all small pine trees and other vegetation from the levee slope.

View of the small pine trees and other vegetation on the waterside slope.

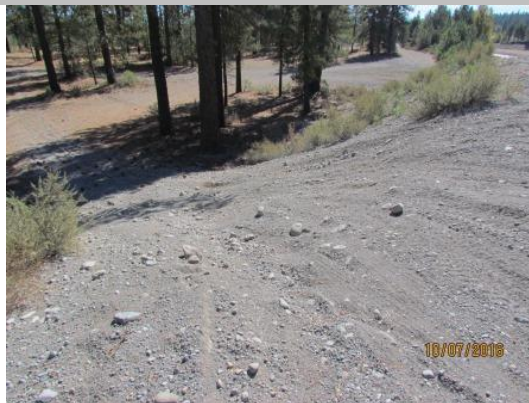
Photo 1 of 1 : FA_2017_NA0015_337_15_20170911_00011.jpg

LM Start	0.01	Rating **	M	Issue No.	15
LM End	0.01	Issue Type +	Ma	Location *	LS
Category	Earthen Levee			GPS Latitude/Longitude	
				Start	End
Item	Slope Stability			40.273274 °	40.273274 °
				-121.244779 °	-121.244779 °
DWR ID	DWR_NA0015_01_f_2016_15				
Comment Code					
S3 : Repair the levee slope damaged by vehicle traffic and prevent access where possible.					
Inspector Comment

View of the damaged slope by vehicle traffic.

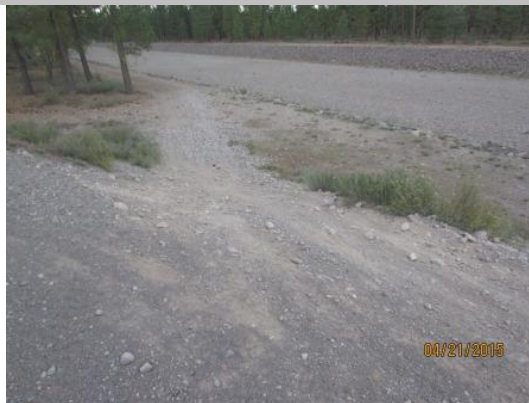
Photo 1 of 1 : FA_2017_NA0015_337_9_20170911_00006.jpg

LM Start	0.55	Rating **	M	Issue No.	9
LM End	0.55	Issue Type +	Ma	Location *	WS
Category	Earthen Levee			GPS Latitude/Longitude	
				Start	End
Item	Slope Stability			40.279790 °	121.249850 °
				40.279790 °	121.249850 °
DWR ID	DWR_NA0015_01_s _ 2012_9				
Comment Code					
S3 : Repair the levee slope damaged by vehicle traffic and prevent access where possible.					
Inspector Comment

View of the vehicle erosion along the waterside toe.

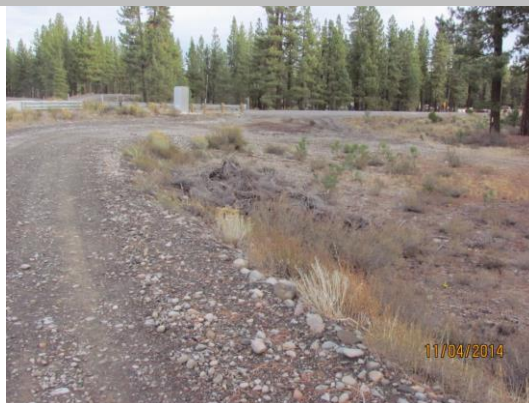
Photo 1 of 1 : FA_2017_NA0015_337_4_20170911_00001.jpg

LM Start	0.68	Rating **	M	Issue No.	4
LM End	0.68	Issue Type +	Ma	Location *	LS
Category	Earthen Levee			GPS Latitude/Longitude	
				Start	End
Item	Encroachments			40.281480 °	40.281480 °
				-121.250928 °	-121.250928 °
DWR ID	DWR_NA0015_01_s _ 2013_4				
Comment Code					
PR : Prunings					
Inspector Comment

View of the prunings along the landside slope.

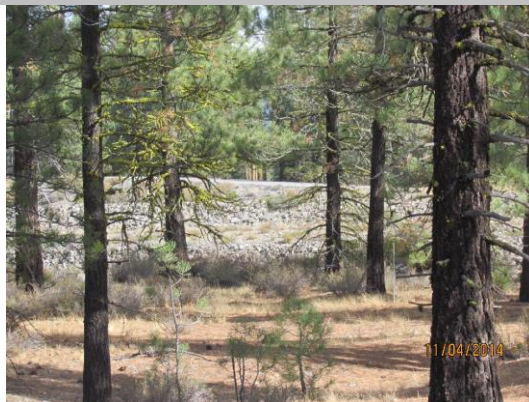
Photo 2 of 3 : UCIP_FA_2017_42643_72980.jpg

LM Start	0.77	Rating **	M	Issue No.	18 (cont)
LM End	0.77	Issue Type +	En	Location *

View of landward slope.

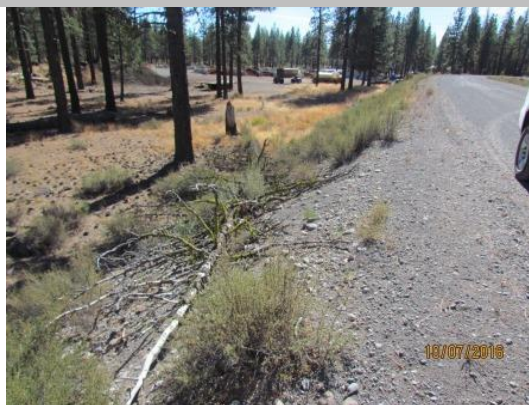
Photo 1 of 1 : FA_2017_NA0015_337_13_20170911_00009.jpg

LM Start	0.88	Rating **	M	Issue No.	13
LM End	0.88	Issue Type +	En	Location *	LS
Category	Earthen Levee			GPS Latitude/Longitude	
				Start	End
Item	Encroachments			40.284309 °	40.284309 °
				-121.251541 °	-121.251541 °
DWR ID	DWR_NA0015_01_f_2016_13				
Comment Code					
TR : Tree or limb					
Inspector Comment					
Remove the fallen tree from the levee slope.

View of the fallen tree on the landside slope.

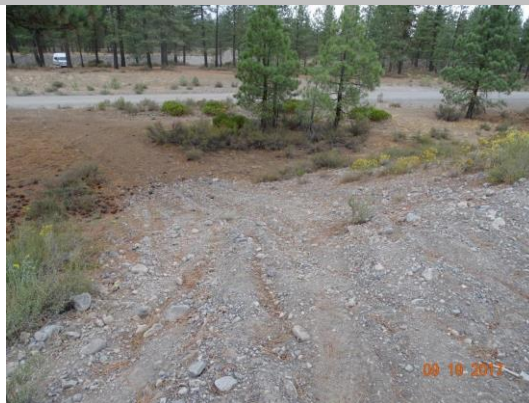
Photo 1 of 1 : FA_2017_NA0015_337_10_20171006_00018.jpg

LM Start	0.93	Rating **	A/W	Issue No.	10
LM End	0.93	Issue Type +	Ma	Location *	WS
Category	Earthen Levee			GPS Latitude/Longitude	
				Start	End
Item	Slope Stability			40.284955 °	40.284955 °
				-121.251945 °	-121.251945 °
DWR ID	DWR_NA0015_01_f_2017_10				
Comment Code					
S3 : Repair the levee slope damaged by vehicle traffic and prevent access where possible.					
Inspector Comment					
Repair the vehicle erosion along the waterside slope.

View of the vehicle erosion along the waterside slope.

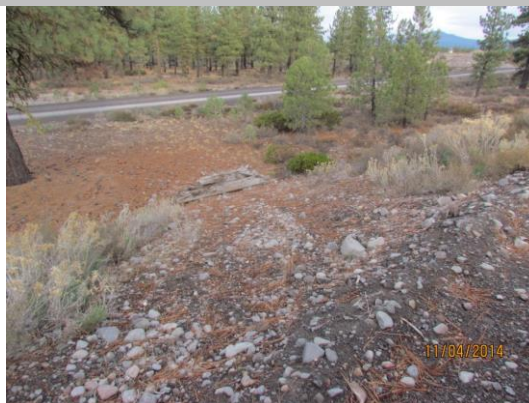
Photo 1 of 1 : FA_2017_NA0015_337_5_20170911_00002.jpg

LM Start	0.96	Rating **	A/W	Issue No.	5
LM End	0.96	Issue Type +	Ma	Location *	WS
Category	Earthen Levee			GPS Latitude/Longitude	
				Start	End
Item	Slope Stability			40.285363 °	40.285363 °
				-121.251973 °	-121.251973 °
DWR ID	DWR_NA0015_01_f_2013_5				
Comment Code					
S3 : Repair the levee slope damaged by vehicle traffic and prevent access where possible.					
Inspector Comment

View of the vehicle erosion along the waterside slope.

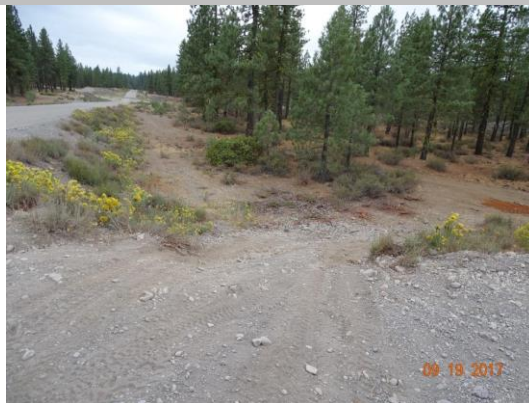
Photo 1 of 1 : FA_2017_NA0015_337_17_20171006_00019.jpg

LM Start	1.04	Rating **	A/W	Issue No.	17
LM End	1.04	Issue Type +	Ma	Location *	WS
Category	Earthen Levee			GPS Latitude/Longitude	
				Start	End
Item	Slope Stability			40.286302 °	40.286302 °
				-121.252233 °	-121.252233 °
DWR ID	DWR_NA0015_01_f_2017_17				
Comment Code					
S3 : Repair the levee slope damaged by vehicle traffic and prevent access where possible.					
Inspector Comment					
Repair the vehicle erosion along the waterside slope.

View of the vehicle erosion along the waterside slope.

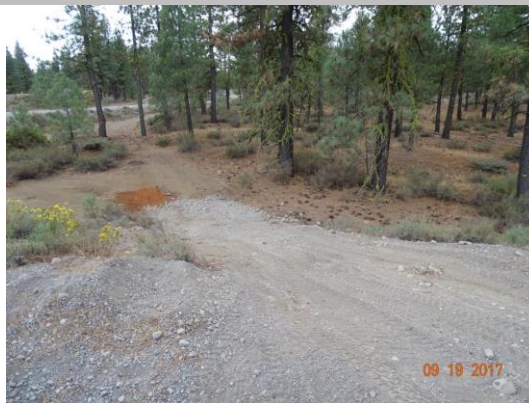
Photo 1 of 1 : FA_2017_NA0015_337_14_20171006_00020.jpg

LM Start	1.05	Rating **	A/W	Issue No.	14
LM End	1.05	Issue Type +	Ma	Location *	WS
Category	Earthen Levee			GPS Latitude/Longitude	
				Start	End
Item	Slope Stability			40.286337 °	40.286337 °
				-121.252460 °	-121.252460 °
DWR ID	DWR_NA0015_01_f_2017_14				
Comment Code					
S3 : Repair the levee slope damaged by vehicle traffic and prevent access where possible.					
Inspector Comment					
Repair the vehicle erosion along the waterside slope.

View of the vehicle erosion along the waterside slope.

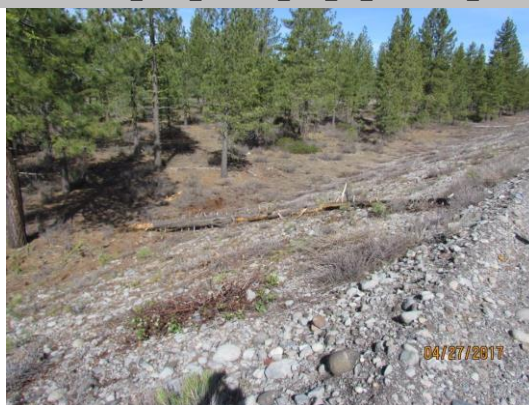
Photo 1 of 1 : FA_2017_NA0015_337_16_20170911_00012.jpg

LM Start	1.17	Rating **	M	Issue No.	16
LM End	1.17	Issue Type +	Ma	Location *	WS
Category	Earthen Levee			GPS Latitude/Longitude	
				Start	End
Item	Encroachments			40.287722 °	40.287722 °
				-121.253510 °	-121.253510 °
DWR ID	DWR_NA0015_01_s_2017_16				
Comment Code					
TR : Tree or limb					
Inspector Comment					
Remove the tree from the landside slope and toe.

View of the tree along the landside slope and toe.

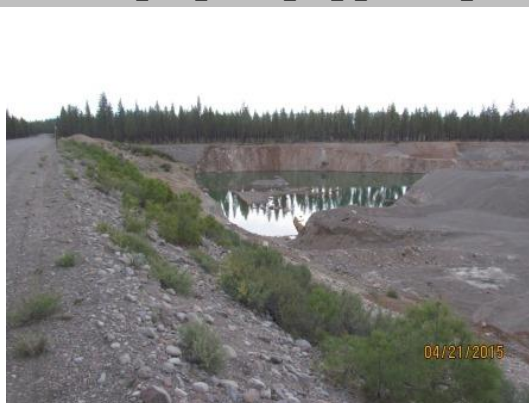
Photo 1 of 2 : FA_2017_NA0015_337_7_20170911_00003.jpg

LM Start	1.41	Rating **	U	Issue No.	7
LM End	1.50	Issue Type +	En	Location *	LS
Category	Earthen Levee			GPS Latitude/Longitude	
				Start	End
Item	Encroachments			40.290758 °	40.291987 °
				-121.255402 °	-121.256072 °
DWR ID	DWR_NA0015_01_f_2014_7				
Comment Code					
MA : Material					
Inspector Comment					
The landowner needs to replace the material that has been removed from the toe of the levee.

View of the area where the contractor has removed the material from toe of the levee.

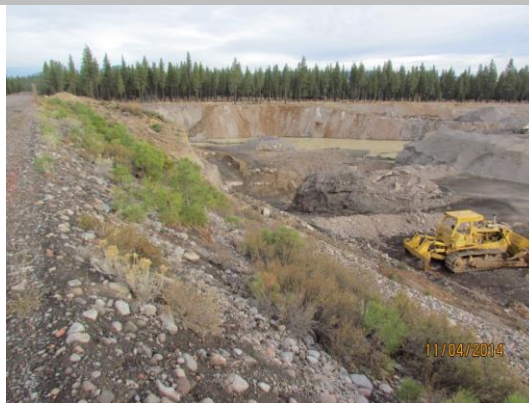
Photo 2 of 2 : FA_2017_NA0015_337_7_20170911_00004.jpg

LM Start	1.41	Rating **	U	Issue No.	7 (cont)	
LM End	1.50	Issue Type +	En	Location *	LS	
Category	Earthen Levee			GPS Latitude/Longitude		
				Start		End
Item	Encroachments			40.290758 °	40.291987 °	
				-121.255402 °	-121.256072 °	
DWR ID	DWR_NA0015_01_f_2014_7					
Comment Code						
MA : Material						
Inspector Comment						
The landowner needs to replace the material that has been removed from the toe of the levee.

View of the area where the contractor has removed the material from toe of the levee.

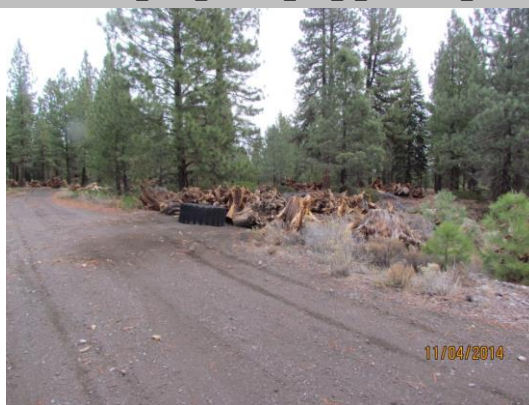
Photo 1 of 1 : FA_2017_NA0015_337_8_20170911_00005.jpg

LM Start	1.86	Rating **	M	Issue No.	8
LM End	1.86	Issue Type +	En	Location *	LS
Category	Earthen Levee			GPS Latitude/Longitude	
				Start	End
Item	Encroachments			40.296910 °	40.296910 °
				-121.257280 °	-121.257280 °
DWR ID	DWR_NA0015_01_f_2014_8				
Comment Code					
TR : Tree or limb					
Inspector Comment					
Remove the tree stumps from the slope of the levee.

View of the tree stumps at the levee slope.

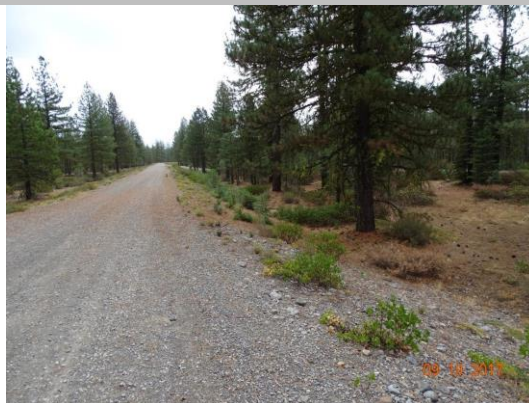
Photo 1 of 1 : FA_2017_NA0015_338_2_20171006_00012.jpg

LM Start	0.00	Rating **	M	Issue No.	2
LM End	1.36	Issue Type +	Ma	Location *	LS
Category	Earthen Levee			GPS Latitude/Longitude	
				Start	End
Item	Vegetation			40.286462 °	40.271792 °
				-121.260082 °	-121.246722 °
DWR ID	DWR_NA0015_02_f_2017_2				
Comment Code					
V2 : Remove the wild growth other than native grasses from the levee slopes.					
Inspector Comment					
Remove the small pine trees and vegetation from the landside slope.

View of the small pine trees and vegetation along the landside slope.

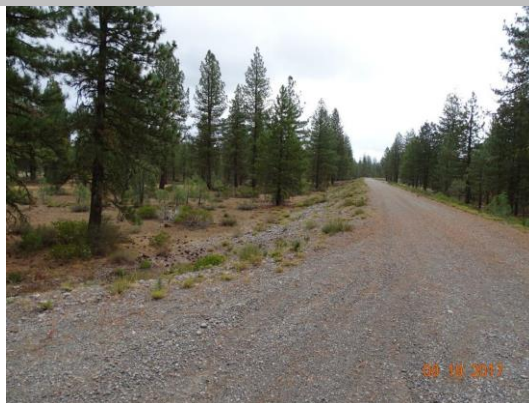
Photo 1 of 1 : FA_2017_NA0015_338_3_20171006_00013.jpg

LM Start	0.00	Rating **	M	Issue No.	3
LM End	1.36	Issue Type +	Ma	Location *	WS
Category	Earthen Levee			GPS Latitude/Longitude	
				Start	End
Item	Vegetation			40.286462 °	40.271792 °
				-121.260082 °	-121.246722 °
DWR ID	DWR_NA0015_02_f_2017_3				
Comment Code					
V2 : Remove the wild growth other than native grasses from the levee slopes.					
Inspector Comment					
Remove the small pine trees and vegetation from the waterside slope.

View other small pine trees and vegetation along the waterside slope.

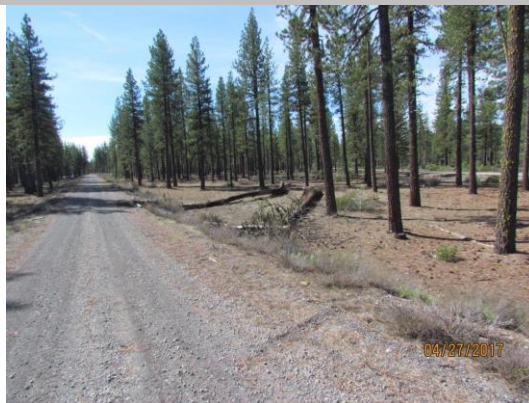
Photo 1 of 2 : FA_2017_NA0015_338_9_20170911_00005.jpg

LM Start	0.31	Rating **	M	Issue No.	9
LM End	0.31	Issue Type +	En	Location *	LS
Category	Earthen Levee			GPS Latitude/Longitude	
				Start	End
Item	Encroachments			40.284993 °	40.284993 °
				-121.255133 °	-121.255133 °
DWR ID	DWR_NA0015_02_s_2015_9				
Comment Code					
TR : Tree or limb					
Inspector Comment					
Remove the pine trees from the landside slope.

View of the pine trees that has fallen onto the landside slope.

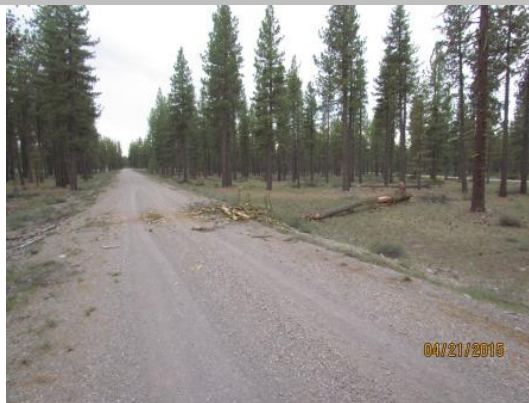
Photo 2 of 2 : FA_2017_NA0015_338_9_20170911_00006.jpg

LM Start	0.31	Rating **	M	Issue No.	9 (cont)	
LM End	0.31	Issue Type +	En	Location *	LS	
Category	Earthen Levee			GPS Latitude/Longitude		
				Start		End
Item	Encroachments			40.284993 °	40.284993 °	
				-121.255133 °	-121.255133 °	
DWR ID	DWR_NA0015_02_s_2015_9					
Comment Code						
TR : Tree or limb						
Inspector Comment						
Remove the pine trees from the landside slope.

View of the pine tree that has fallen onto the landside slope.

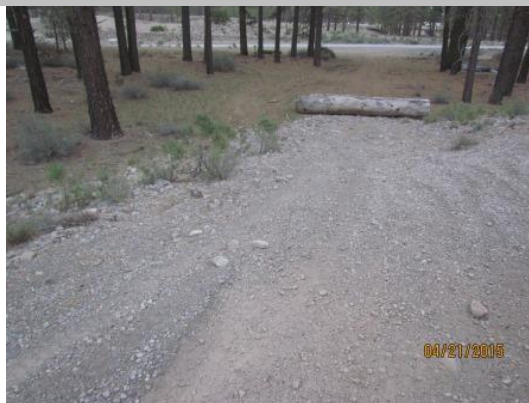
Photo 1 of 2 : FA_2017_NA0015_338_6_20170911_00003.jpg

LM Start	0.46	Rating **	M	Issue No.	6
LM End	0.46	Issue Type +	Ma	Location *	WS
Category	Earthen Levee			GPS Latitude/Longitude	
				Start	End
Item	Slope Stability			40.283059 °	40.283059 °
				-121.253989 °	-121.253989 °
DWR ID	DWR_NA0015_02_f_2013_6				
Comment Code					
S3 : Repair the levee slope damaged by vehicle traffic and prevent access where possible.					
Inspector Comment

View of the vehicle erosion on the waterside slope.

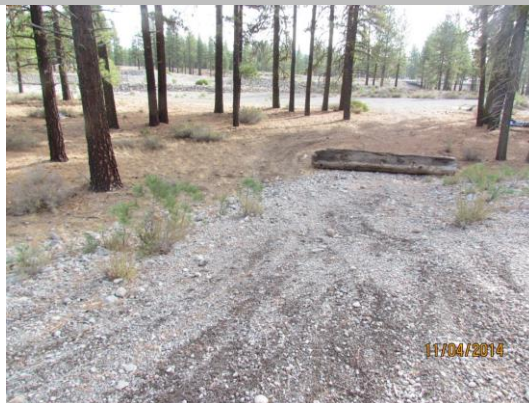
Photo 2 of 2 : FA_2017_NA0015_338_6_20170911_00004.jpg

LM Start	0.46	Rating **	M	Issue No.	6 (cont)
LM End	0.46	Issue Type +	Ma	Location *	WS

View of the vehicle erosion on the landside slope.

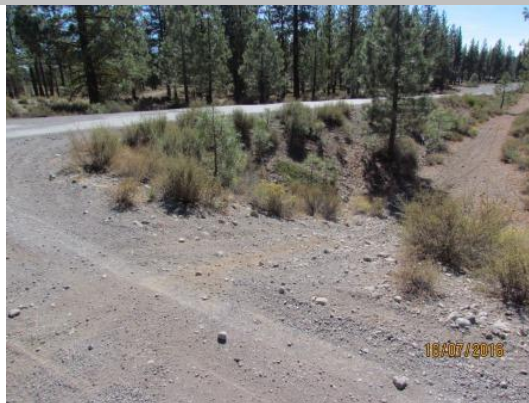
Photo 1 of 1 : FA_2017_NA0015_338_4_20170911_00001.jpg

LM Start	0.55	Rating **	M	Issue No.	4
LM End	0.55	Issue Type +	Ma	Location *	LS
Category	Earthen Levee			GPS Latitude/Longitude	
				Start	End
Item	Slope Stability			40.281950 °	121.253710 °
				40.281950 °	121.253710 °
DWR ID	DWR_NA0015_02_s _ 2012_4				
Comment Code					
S3 : Repair the levee slope damaged by vehicle traffic and prevent access where possible.					
Inspector Comment

View of the slope instability cause by vehicle along the landside slope.

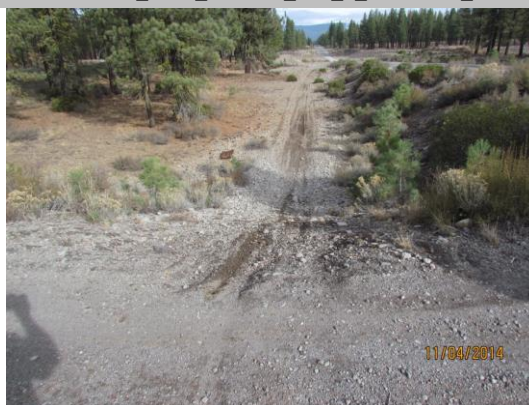
Photo 1 of 1 : FA_2017_NA0015_338_5_20170911_00002.jpg

LM Start	0.55	Rating **	M	Issue No.	5
LM End	0.55	Issue Type +	Ma	Location *	WS
Category	Earthen Levee			GPS Latitude/Longitude	
				Start	End
Item	Slope Stability			40.281950 °	121.253710 °
				40.281950 °	121.253710 °
DWR ID	DWR_NA0015_02_s _ 2012_5				
Comment Code					
S3 : Repair the levee slope damaged by vehicle traffic and prevent access where possible.					
Inspector Comment

View of the vehicle erosion on the waterside slope.

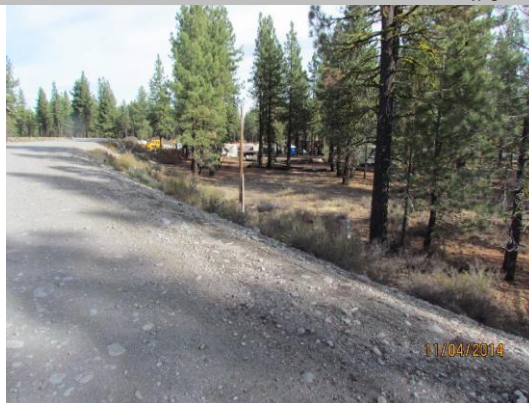
Photo 1 of 3 : UCIP_FA_2017_42644_72984.jpg

LM Start	0.66	Rating **	M	Issue No.	10
LM End	0.66	Issue Type +	En	Location *	
Category	Supplemental			GPS Latitude/Longitude	
				Start	End
Item	DWR UCIP Field Study			40.280737 °	40.280737 °
				-121.252512 °	-121.252512 °
DWR ID					
Comment Code					
Inspector Comment					
FS_ID:42644 DS_ID:23040 EP_NO: N/A Repair Type: Non-Urgent Crossing Status: Indicator Found UCIP Comments: Need to contact owner to determine additional information about crossing. Need depth of conduit and permit issued. FIELD_STRUCT_DESC: Underground telephone cable through the levee and across the channel. Elevation unknown. FS Date: 11/4/2014

View of landward side conduit pole located at landward toe. Photo taken from the left bank.

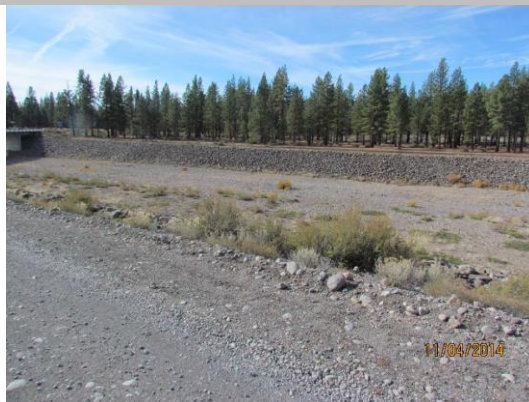
Photo 2 of 3 : UCIP_FA_2017_42644_72983.jpg

LM Start	0.66	Rating **	M	Issue No.	10 (cont)
LM End	0.66	Issue Type +	En	Location *

View of waterward side.

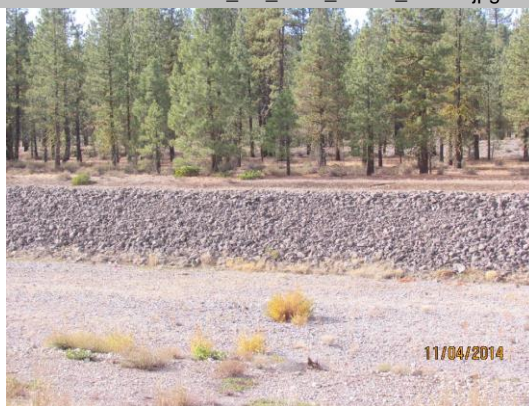
Photo 3 of 3 : UCIP_FA_2017_42644_72985.jpg

LM Start	0.66	Rating **	M	Issue No.	10 (cont)	
LM End	0.66	Issue Type +	En	Location *		
Category	Supplemental			GPS Latitude/Longitude		
				Start	End	
Item	DWR UCIP Field Study			40.280737 °	40.280737 °	
				-121.252512 °	-121.252512 °	
DWR ID						
Comment Code						
Inspector Comment						
FS_ID:42644 DS_ID:23040 EP_NO: N/A Repair Type: Non-Urgent Crossing Status: Indicator Found UCIP Comments: Need to contact owner to determine additional information about crossing. Need depth of conduit and permit issued. FIELD_STRUCT_DESC: Underground telephone cable through the levee and across the channel. Elevation unknown. FS Date: 11/4/2014

View of opposite bank.
