**Flood Control Project Maintenance
Levee Inspections**

Fall 2018 Levee Maintenance Deficiency Summary Report

Sacramento River Basin

Plumas County

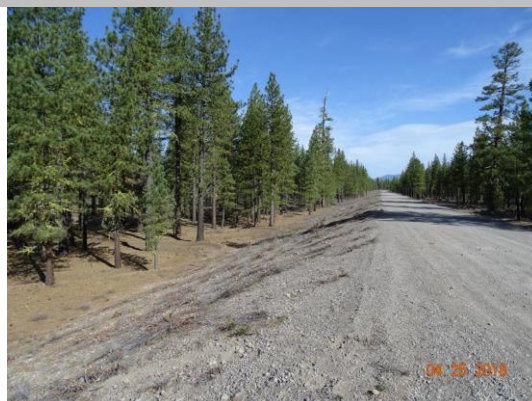
Photo 1 of 2 : FA_2018_NA0015_337_12_20180905_00005.jpg

LM Start	0.00	Rating **	A	Issue No.	12
LM End	0.78	Issue Type +	Ma	Location *	WS
Category	Earthen Levee			GPS Latitude/Longitude	
				Start	End
Item	Vegetation			40.273168 °	40.282842 °
				-121.244783 °	-121.251338 °
DWR ID	DWR_NA0015_01_f_2015_12				
Comment Code					
V2 : Remove the wild growth other than native grasses from the levee slopes.					
Inspector Comment					
The small pine trees and other vegetation was removed from the levee slope.

View of the removed pine trees and other vegetation from the waterside slope.

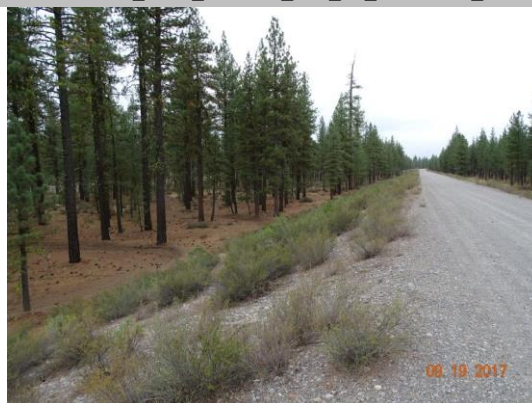
Photo 2 of 2 : FA_2018_NA0015_337_12_20180905_00006.jpg

View of the small pine trees and other vegetation on the waterside slope.

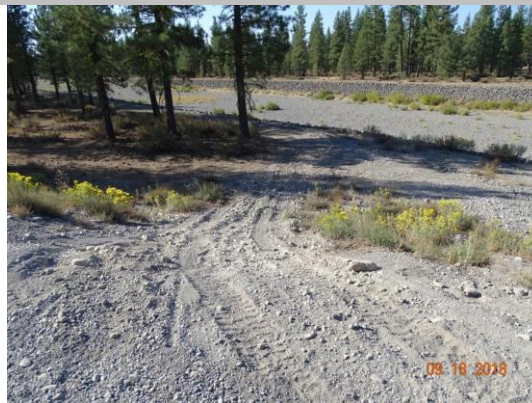
Photo 1 of 1 : FA_2018_NA0015_337_8_20181001_00013.jpg

LM Start	0.54	Rating **	M	Issue No.	8
LM End	0.54	Issue Type +	Ma	Location *	WS
Category	Earthen Levee			GPS Latitude/Longitude	
				Start	End
Item	Slope Stability			40.279775 °	40.279775 °
				-121.249648 °	-121.249648 °
DWR ID	DWR_NA0015_01_f_2018_8				
Comment Code					
S3 : Repair the levee slope damaged by vehicle traffic and prevent access where possible.					
Inspector Comment					
Repair the vehicle erosion on the waterside slope.

View of vehicle erosion on the waterside slope.

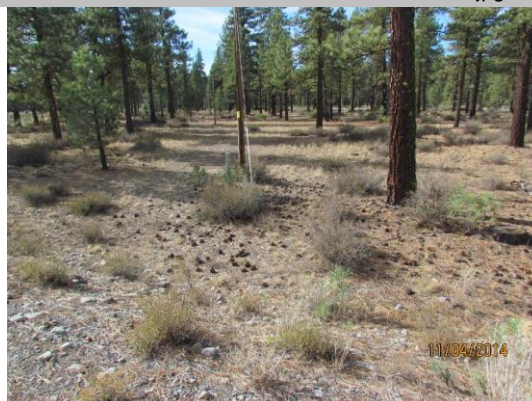
Photo 1 of 3 : UCIP_FA_2018_42643_72981.jpg

LM Start	0.77	Rating **	M	Issue No.	20
LM End	0.77	Issue Type +	En	Location *	
Category	Supplemental			GPS Latitude/Longitude	
				Start	End
Item	DWR UCIP Field Study			40.282683 °	40.282683 °
				-121.251453 °	-121.251453 °
DWR ID	23039				
Comment Code					
Inspector Comment					
FS_ID:42643 DS_ID:23039 EP_NO: N/A Repair Type: Non-Urgent Crossing Status: Indicator Found UCIP Comments: 11/04/2014 Need to contact owner to determine additional information about crossing. Need depth of conduit and permit issued. (DWR UCIP - O. Magana) FIELD_STRUCT_DESC: Telephone cable of an unknown size or material through the levee and across the channel, at an unknown depth. [Additional Reference(s): DWR Levee Log, 2005]. FS Date: 11/4/2014

View of conduit pole located on landward side. Photo taken from right bank.

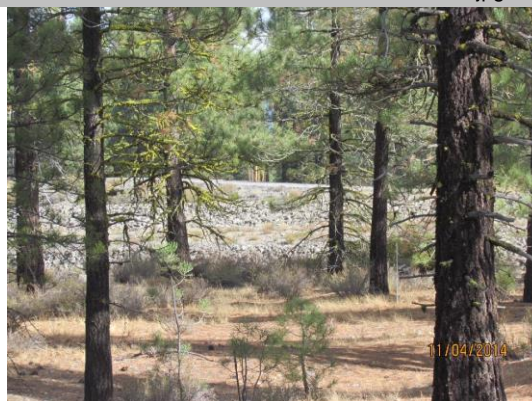
Photo 2 of 3 : UCIP_FA_2018_42643_72980.jpg

View of landward slope.

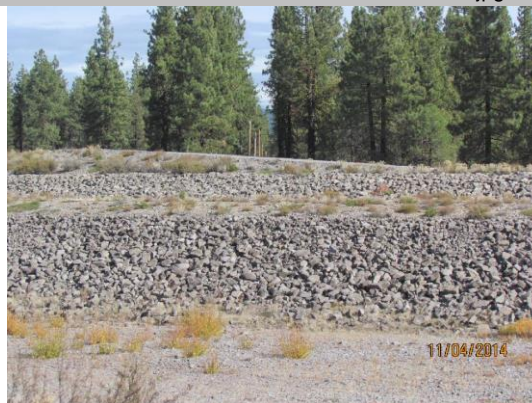
Photo 3 of 3 : UCIP_FA_2018_42643_72982.jpg

View of levee, ramp, and posts visible between trees.

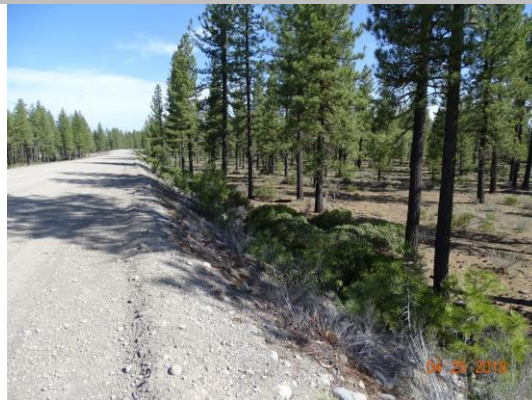
Photo 1 of 1 : FA_2018_NA0015_337_18_20180905_00009.jpg

LM Start	0.79	Rating **	M	Issue No.	18
LM End	1.88	Issue Type +	Ma	Location *	LS
Category	Earthen Levee			GPS Latitude/Longitude	
				Start	End
Item	Vegetation			40.282962 °	40.297068 °
				-121.251307 °	-121.257120 °
DWR ID	DWR_NA0015_01_s_2018_18				
Comment Code					
V2 : Remove the wild growth other than native grasses from the levee slopes.					
Inspector Comment					
Remove the small pine trees and vegetation from the landside slope.

View of the small pine trees and vegetation along the landside slope.

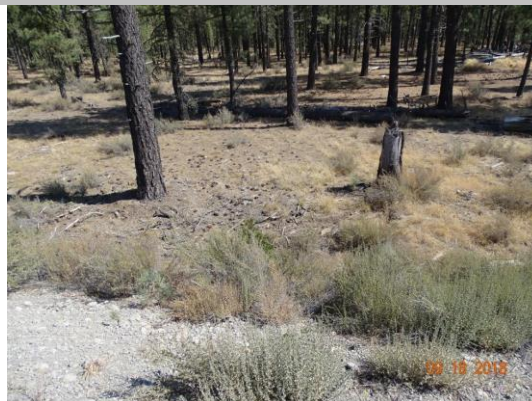
Photo 1 of 1 : FA_2018_NA0015_337_13_20181001_00015.jpg

LM Start	0.88	Rating **	M	Issue No.	13
LM End	0.88	Issue Type +	En	Location *	LS
Category	Earthen Levee			GPS Latitude/Longitude	
				Start	End
Item	Encroachments			40.284309 °	40.284309 °
				-121.251541 °	-121.251541 °
DWR ID	DWR_NA0015_01_f_2016_13				
Comment Code					
TR : Tree or limb					
Inspector Comment					
The fallen tree was removed from the levee slope.

View of the remove trees from the landside slope.

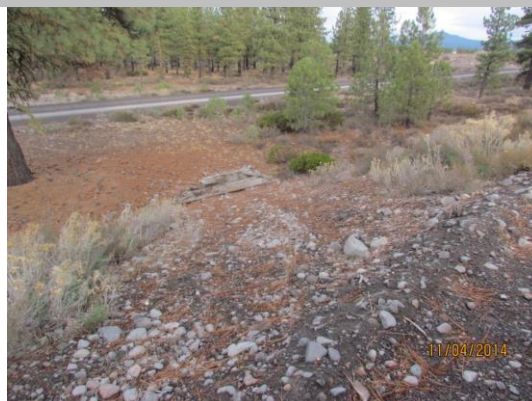
Photo 1 of 1 : FA_2018_NA0015_337_5_20180905_00002.jpg

LM Start	0.96	Rating **	A/W	Issue No.	5
LM End	0.96	Issue Type +	Ma	Location *	WS
Category	Earthen Levee			GPS Latitude/Longitude	
				Start	End
Item	Slope Stability			40.285363°	40.285363°
				-121.251973°	-121.251973°
DWR ID	DWR_NA0015_01_f_2013_5				
Comment Code					
S3 : Repair the levee slope damaged by vehicle traffic and prevent access where possible.					
Inspector Comment

View of the vehicle erosion along the waterside slope.

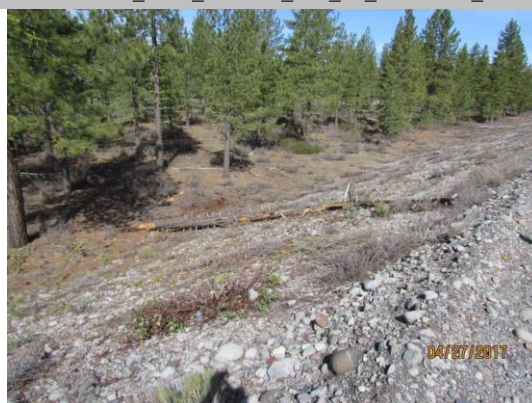
Photo 1 of 1 : FA_2018_NA0015_337_16_20180905_00008.jpg

LM Start	1.17	Rating **	M	Issue No.	16
LM End	1.17	Issue Type +	Ma	Location *	WS
Category	Earthen Levee			GPS Latitude/Longitude	
				Start	End
Item	Encroachments			40.287722°	40.287722°
				-121.253510°	-121.253510°
DWR ID	DWR_NA0015_01_s_2017_16				
Comment Code					
TR : Tree or limb					
Inspector Comment					
Remove the tree from the landside slope and toe.

View of the tree along the landside slope and toe.

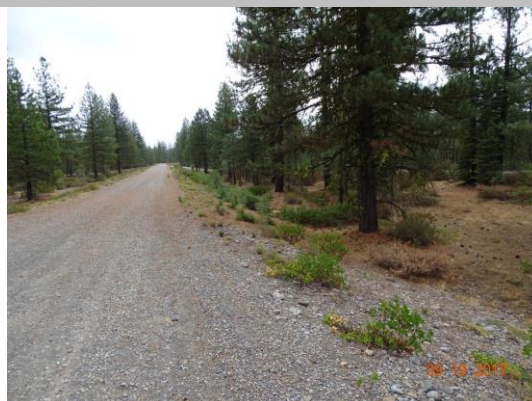
Photo 1 of 1 : FA_2018_NA0015_338_2_20180905_00001.jpg

LM Start	0.00	Rating **	M	Issue No.	2
LM End	0.71	Issue Type +	Ma	Location *	LS
Category	Earthen Levee			GPS Latitude/Longitude	
				Start	End
Item	Vegetation			40.286462 °	40.279948 °
				-121.260082 °	-121.252118 °
DWR ID	DWR_NA0015_02_f_2017_2				
Comment Code					
V2 : Remove the wild growth other than native grasses from the levee slopes.					
Inspector Comment					
Remove the small pine trees and vegetation from the landside slope.

View of the small pine trees and vegetation along the landside slope.

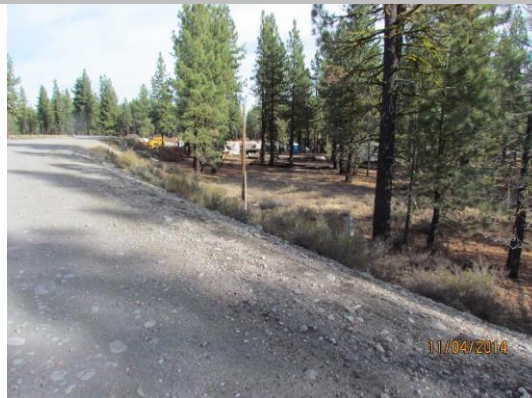
Photo 1 of 3 : UCIP_FA_2018_42644_72984.jpg

LM Start	0.66	Rating **	M	Issue No.	8	
LM End	0.66	Issue Type +	En	Location *		
Category	Supplemental			GPS Latitude/Longitude		
				Start	End	
Item	DWR UCIP Field Study			40.280737°	40.280737°	
				-121.252512°	-121.252512°	
DWR ID	23040					
Comment Code						
Inspector Comment						
FS_ID:42644						
DS_ID:23040						
EP_NO: N/A						
Repair Type: Non-Urgent						
Crossing Status: Indicator Found						
UCIP Comments: 11/04/2014 Need to contact owner to determine additional information about crossing. Need depth of conduit and permit issued. (DWR UCIP - O. Magana)						
FIELD_STRUCT_DESC: Telephone cable of an unknown size or material through the levee and across the channel, at an unknown depth. [Additional Reference(s): DWR Levee Log, 2005].						
FS Date: 11/4/2014

View of landward side conduit pole located at landward toe. Photo taken from the left bank.

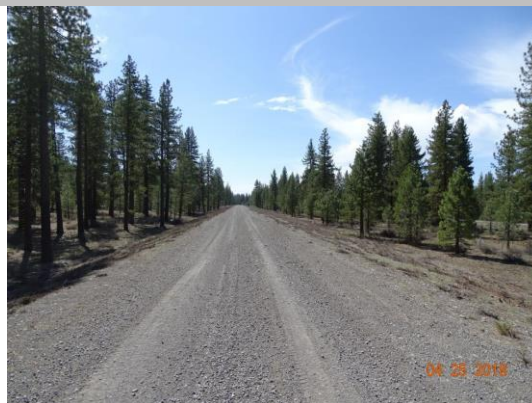
Photo 1 of 1 : FA_2018_NA0015_338_7_20180905_00007.jpg

LM Start	0.71	Rating **	A	Issue No.	7
LM End	1.36	Issue Type +	Ma	Location *	LS
Category	Earthen Levee			GPS Latitude/Longitude	
				Start	End
Item	Vegetation			40.279948 °	40.271748 °
				-121.252118 °	-121.246737 °
DWR ID	DWR_NA0015_02_s_2018_7				
Comment Code					
V2 : Remove the wild growth other than native grasses from the levee slopes.					
Inspector Comment					
Small pine trees were removed from the landside slope.

View of the removed small pine trees from the landside slope.
