**Flood Control Project Maintenance  
Levee Inspections**

**Fall 2019 Levee Maintenance Deficiency Summary Report**

**Plumas County**

Waterway	Bank	Unit Miles	Inspection Start/End	Inspector
Unit No. 01 North Fork Feather River	Left	1.89	10/21/2019 10/21/2019	Sterling York

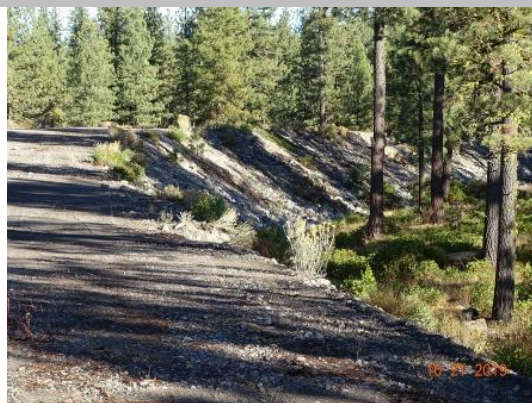
Photo 1 of 1 : FA\_2019\_NA0015\_337\_5\_20191029\_00007.jpg

LM Start	0.00	Rating **	A	Issue No.	5
LM End	1.86	Issue Type +	Ma	Location *	LS
Category	Earthen Levee			GPS Latitude/Longitude	
				Start	End
Item	Vegetation			40.273190 °	40.296893 °
				-121.244775 °	-121.257239 °
DWR ID	DWR_NA0015_01_f_2019_5				
Comment Code					
V1 : Control annual grass and weeds on the levee slopes and easements.					
Inspector Comment					
The annual vegetation is well maintained, Fall 2019.

View looking upstream landside of the well maintained annual vegetation, Fall 2019.

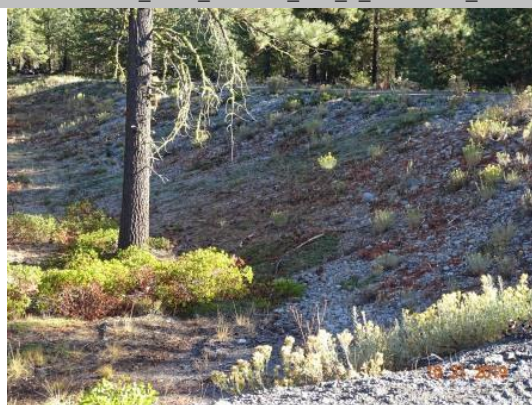
Photo 1 of 1 : FA\_2019\_NA0015\_337\_6\_20191029\_00008.jpg

LM Start	0.00	Rating **	A	Issue No.	6
LM End	1.86	Issue Type +	Ma	Location *	WS
Category	Earthen Levee			GPS Latitude/Longitude	
				Start	End
Item	Vegetation			40.273190 °	40.296896 °
				-121.244775 °	-121.257236 °
DWR ID	DWR_NA0015_01_f_2019_6				
Comment Code					
V1 : Control annual grass and weeds on the levee slopes and easements.					
Inspector Comment					
The annual vegetation is well maintained, Fall 2019.

View looking upstream waterside of the well maintained annual vegetation, Fall 2019.

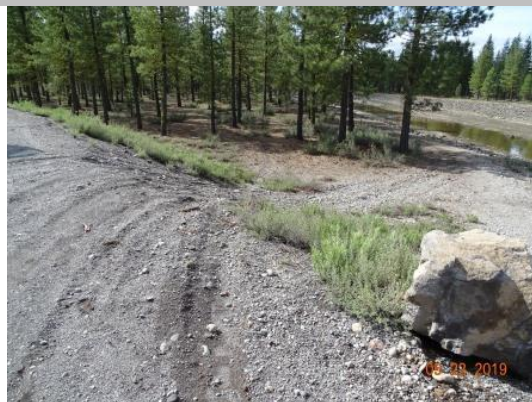
Photo 1 of 1 : FA\_2019\_NA0015\_337\_8\_20190904\_00001.jpg

LM Start	0.54	Rating **	A/W	Issue No.	8
LM End	0.54	Issue Type +	Ma	Location *	WS
Category	Earthen Levee			GPS Latitude/Longitude	
				Start	End
Item	Slope Stability			40.279775 °	40.279775 °
				-121.249648 °	-121.249648 °
DWR ID	DWR_NA0015_01_f_2018_8				
Comment Code					
S3 : Repair the levee slope damaged by vehicle traffic and prevent access where possible.					
Inspector Comment					
The vehicle erosion on the waterside slope is not a threat to the levee slope but should be monitored, Fall 2019.

View of vehicle erosion on the waterside slope, Spring 2019

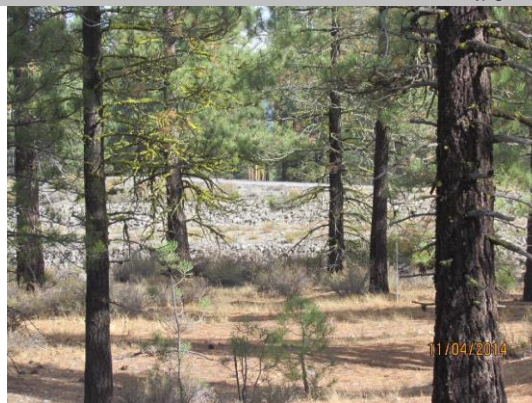
Photo 2 of 3 : UCIP\_FA\_2019\_42643\_72980.jpg

View of landward slope.

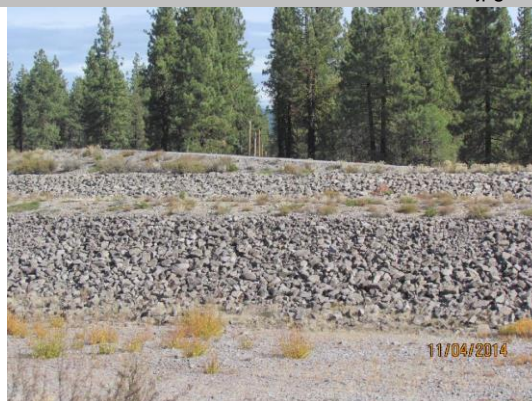
Photo 3 of 3 : UCIP\_FA\_2019\_42643\_72982.jpg

LM Start	0.77	Rating **	M	Issue No.	20 (cont)	
LM End	0.77	Issue Type +	En	Location *		
Category	Supplemental			GPS Latitude/Longitude		
				Start	End	
Item	DRAFT DWR UCIP Field Study			40.282683°	40.282683°	
				-121.251453°	-121.251453°	
DWR ID	23039					
Comment Code						
Inspector Comment						
DS_ID:23039						
FS_ID:42643						
EP_NO: N/A						
Repair Type: Non-Urgent						
Crossing Status: Indicator Found						
UCIP Comments: 11/04/2014 Need to contact owner to determine additional information about crossing. Need depth of conduit and permit issued. (DWR UCIP - O. Magana)						
FIELD_STRUCT_DESC: Telephone cable of an unknown size or material through the levee and across the channel, at an unknown depth. [Additional Reference(s): DWR Levee Log, 2005].						
FS Date: 11/4/2014

View of levee, ramp, and posts visible between trees.

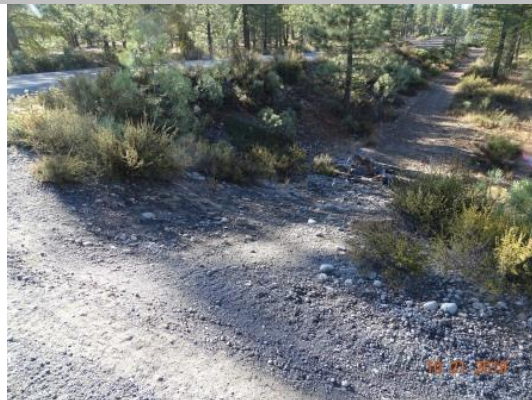
Photo 1 of 1 : FA\_2019\_NA0015\_338\_4\_20191029\_00010.jpg

LM Start	0.55	Rating **	M	Issue No.	4
LM End	0.55	Issue Type +	Ma	Location *	LS
Category	Earthen Levee			GPS Latitude/Longitude	
				Start	End
Item	Slope Stability			40.281950 °	40.281950 °
				-121.253710 °	-121.253710 °
DWR ID	DWR_NA0015_02_s_2012_4				
Comment Code					
S3 : Repair the levee slope damaged by vehicle traffic and prevent access where possible.					
Inspector Comment					
There is no sign of slope instability but should be monitored for the next year. The access has been blocked, Fall 2019.

View of the undesignated vehicle access along the landside slope, there is no sign of slope instability but should be monitored for the next year, Fall 2019.

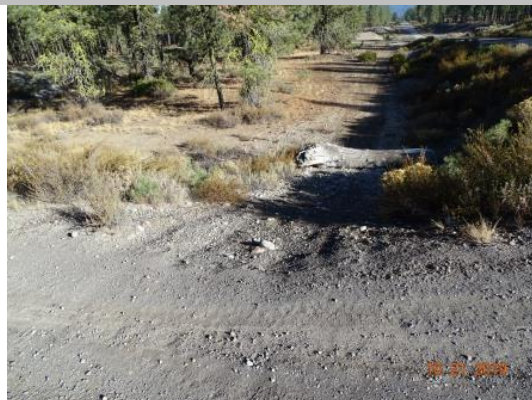
Photo 1 of 1 : FA\_2019\_NA0015\_338\_5\_20191029\_00009.jpg

LM Start	0.55	Rating **	A/W	Issue No.	5
LM End	0.55	Issue Type +	Ma	Location *	WS
Category	Earthen Levee			GPS Latitude/Longitude	
				Start	End
Item	Slope Stability			40.281950 °	40.281950 °
				-121.253710 °	-121.253710 °
DWR ID	DWR_NA0015_02_s_2012_5				
Comment Code					
S3 : Repair the levee slope damaged by vehicle traffic and prevent access where possible.					
Inspector Comment					
There is no sign of slope instability but should be monitored for the next year. The access has been blocked, Fall 2019.

View of the undesignated vehicle access along the waterside slope, there is no sign of slope instability but should be monitored for the next year, Fall 2019.

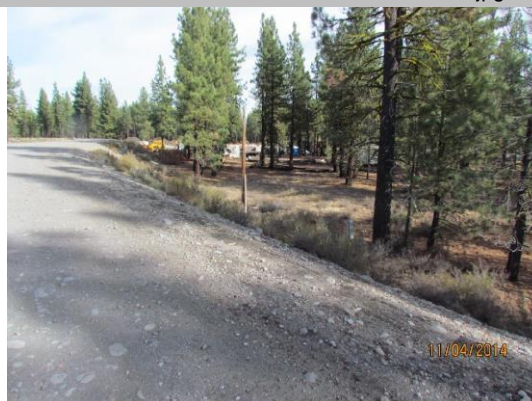
Photo 1 of 3 : UCIP\_FA\_2019\_42644\_72984.jpg

LM Start	0.66	Rating **	M	Issue No.	6	
LM End	0.66	Issue Type +	En	Location *		
Category	Supplemental			GPS Latitude/Longitude		
				Start	End	
Item	DRAFT DWR UCIP Field Study			40.280737°	40.280737°	
				-121.252512°	-121.252512°	
DWR ID	23040					
Comment Code						
Inspector Comment						
DS_ID:23040						
FS_ID:42644						
EP_NO: N/A						
Repair Type: Non-Urgent						
Crossing Status: Indicator Found						
UCIP Comments: 11/04/2014 Need to contact owner to determine additional information about crossing. Need depth of conduit and permit issued. (DWR UCIP - O. Magana)						
FIELD_STRUCT_DESC: Telephone cable of an unknown size or material through the levee and across the channel, at an unknown depth. [Additional Reference(s): DWR Levee Log, 2005].						
FS Date: 11/4/2014

View of landward side conduit pole located at landward toe. Photo taken from the left bank.

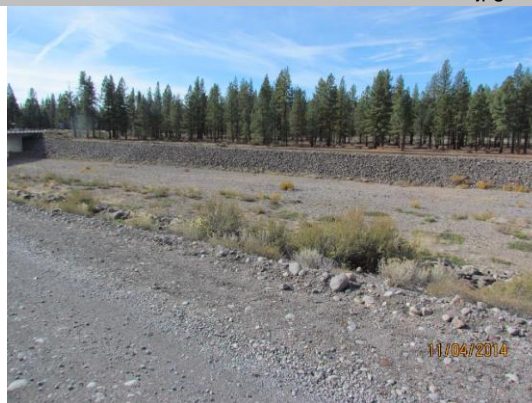
Photo 2 of 3 : UCIP\_FA\_2019\_42644\_72983.jpg

View of waterward side.

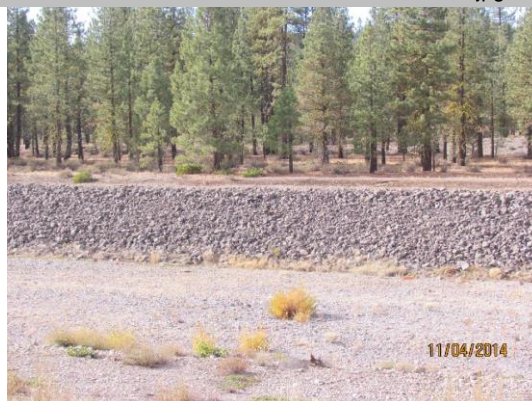
Photo 3 of 3 : UCIP\_FA\_2019\_42644\_72985.jpg

LM Start	0.66	Rating **	M	Issue No.	6 (cont)	
LM End	0.66	Issue Type +	En	Location *		
Category	Supplemental			GPS Latitude/Longitude		
				Start	End	
Item	DRAFT DWR UCIP Field Study			40.280737°	40.280737°	
				-121.252512°	-121.252512°	
DWR ID	23040					
Comment Code						
Inspector Comment						
DS_ID:23040 FS_ID:42644 EP_NO: N/A Repair Type: Non-Urgent Crossing Status: Indicator Found UCIP Comments: 11/04/2014 Need to contact owner to determine additional information about crossing. Need depth of conduit and permit issued. (DWR UCIP - O. Magana) FIELD_STRUCT_DESC: Telephone cable of an unknown size or material through the levee and across the channel, at an unknown depth. [Additional Reference(s): DWR Levee Log, 2005]. FS Date: 11/4/2014

View of opposite bank.
