Flood Control Project Maintenance Levee Inspections

Fall 2020 Levee Maintenance Deficiency Summary Report

Sacramento River Basin

Plumas County

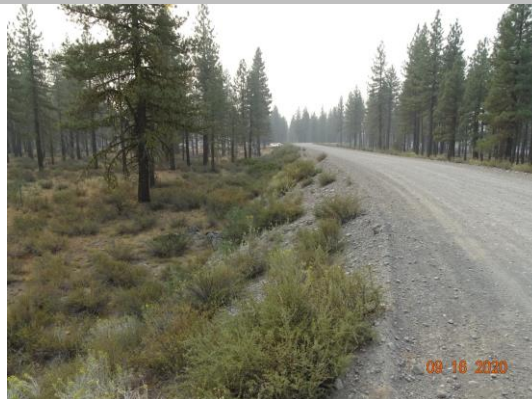
Photo 1 of 1 : FA_2020_NA0015_337_6_20200929_00006.jpg

LM Start	0.03	Rating **	A	Issue No.	6
LM End	1.87	Issue Type +	Ma	Location *	WS
Category	Earthen Levee			GPS Latitude/Longitude	
				Start	End
Item	Vegetation			40.273599 °	40.297020 °
				-121.244961 °	-121.257189 °
DWR ID	DWR_NA0015_01_f_2020_6				
Comment Code					
V1 : Control annual grass and weeds on the levee slopes and easements.					
Inspector Comment					
Annual vegetation is maintained, Fall 2020

View of annual vegetation on landside, Fall 2020.

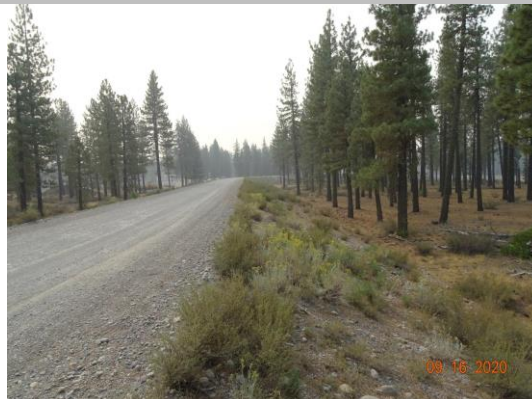
Photo 1 of 1 : FA_2020_NA0015_337_5_20200929_00007.jpg

LM Start	0.06	Rating **	A	Issue No.	5
LM End	1.87	Issue Type +	Ma	Location *	LS
Category	Earthen Levee			GPS Latitude/Longitude	
				Start	End
Item	Vegetation			40.273943 °	40.296977 °
				-121.245185 °	-121.257200 °
DWR ID	DWR_NA0015_01_f_2020_5				
Comment Code					
V1 : Control annual grass and weeds on the levee slopes and easements.					
Inspector Comment					
Annual vegetation is maintained, Fall 2020.

View of annual vegetation on waterside, Fall 2020.

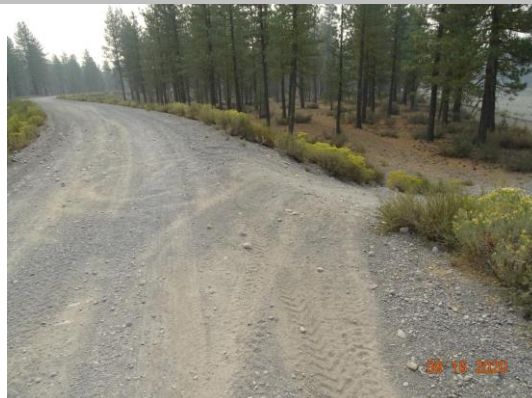
Photo 1 of 1 : FA_2020_NA0015_337_8_20200929_00005.jpg

LM Start	0.54	Rating **	A/W	Issue No.	8
LM End	0.54	Issue Type +	Ma	Location *	WS
Category	Earthen Levee			GPS Latitude/Longitude	
				Start	End
Item	Slope Stability			40.279775 °	40.279775 °
				-121.249648 °	-121.249648 °
DWR ID	DWR_NA0015_01_f_2018_8				
Comment Code					
S3 : Repair the levee slope damaged by vehicle traffic and prevent access where possible.					
Inspector Comment					
The vehicle erosion on the waterside slope is not a threat to the levee slope but should be monitored. Fall 2020.

View of vehicle erosion on the waterside slope, Fall 2020

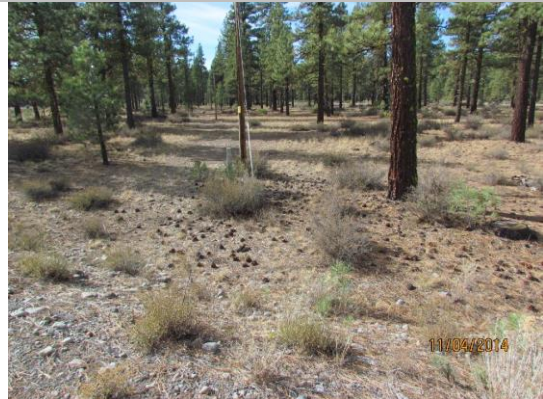
Photo 1 of 3 : UCIP_FA_2020_42643_72981.jpg

LM Start	0.77	Rating **	M	Issue No.	9	
LM End	0.77	Issue Type +	En	Location *		
Category	Supplemental			GPS Latitude/Longitude		
				Start	End	
Item	DWR UCIP Field Study			40.282683 °	40.282683 °	
				-121.251453 °	-121.251453 °	
DWR ID	23039					
Comment Code						
Inspector Comment						
DS_ID:23039 FS_ID:42643 EP_NO: N/A Repair Type: Non-Urgent EVAL Issue: Crossing Status: Indicator Found UCIP Comments: 11/04/2014 Need to contact owner to determine additional information about crossing. Need depth of conduit and permit issued. (DWR UCIP - O. Magana) FIELD_STRUCT_DESC: Telephone cable of an unknown size or material through the levee and across the channel, at an unknown depth. [Additional Reference(s): DWR Levee Log, 2005]. FS Date: 11/4/2014

View of conduit pole located on landward side. Photo taken from right bank.

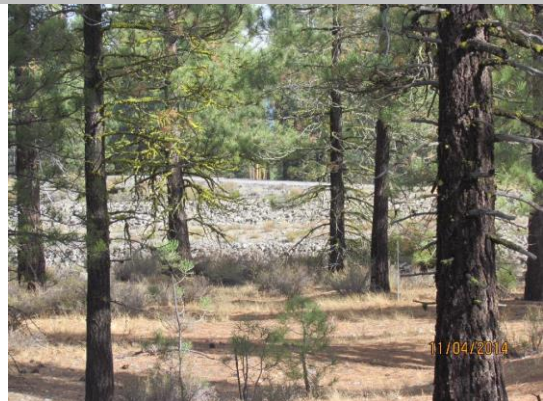
Photo 2 of 3 : UCIP_FA_2020_42643_72980.jpg

View of landward slope.

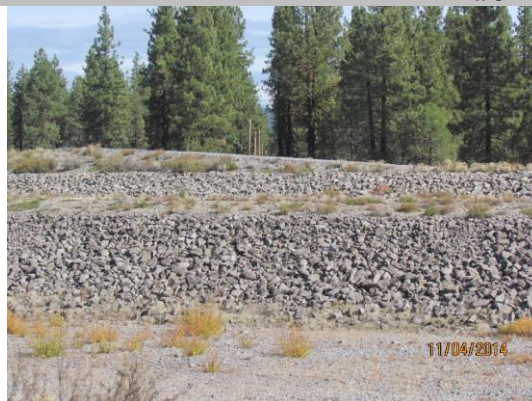
Photo 3 of 3 : UCIP_FA_2020_42643_72982.jpg

View of levee, ramp, and posts visible between trees.

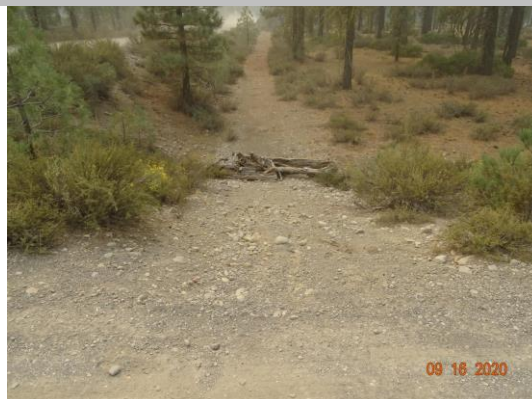
Photo 1 of 1 : FA_2020_NA0015_338_4_20200929_00007.jpg

LM Start	0.55	Rating **	A/W	Issue No.	4
LM End	0.55	Issue Type +	Ma	Location *	LS
Category	Earthen Levee			GPS Latitude/Longitude	
				Start	End
Item	Slope Stability			40.281950 °	40.281950 °
				-121.253710 °	-121.253710 °
DWR ID	DWR_NA0015_02_s_2012_4				
Comment Code					
S3 : Repair the levee slope damaged by vehicle traffic and prevent access where possible.					
Inspector Comment					
There is no sign of slope instability but should be monitored for the next year. The access has been blocked, Fall 2019.

View of the undesignated vehicle access along the landside slope, there is no sign of slope instability but should be monitored for the next year, Fall 2020.

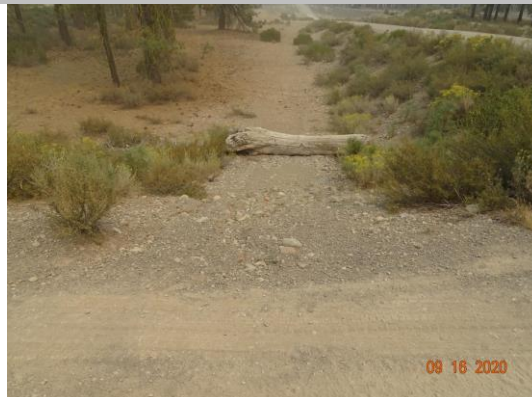
Photo 1 of 1 : FA_2020_NA0015_338_5_20200929_00006.jpg

LM Start	0.55	Rating **	A/W	Issue No.	5
LM End	0.55	Issue Type +	Ma	Location *	WS
Category	Earthen Levee			GPS Latitude/Longitude	
				Start	End
Item	Slope Stability			40.281950 °	40.281950 °
				-121.253710 °	-121.253710 °
DWR ID	DWR_NA0015_02_s_2012_5				
Comment Code					
S3 : Repair the levee slope damaged by vehicle traffic and prevent access where possible.					
Inspector Comment					
There is no sign of slope instability but should be monitored for the next year. The access has been blocked, Fall 2019.

View of the undesignated vehicle access along the waterside slope, there is no sign of slope instability but should be monitored for the next year, Fall 2020.

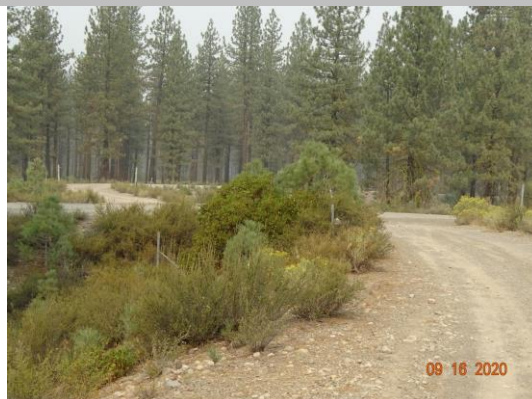
Photo 1 of 1 : FA_2020_NA0015_338_6_20200929_00008.jpg

LM Start	0.58	Rating **	M	Issue No.	6
LM End	0.58	Issue Type +	Ma	Location *	LS
Category	Earthen Levee			GPS Latitude/Longitude	
				Start	End
Item	Trim / Thin Trees			40.281759 °	40.281759 °
				-121.253207 °	-121.253207 °
DWR ID	DWR_NA0015_02_f_2020_6				
Comment Code					
T2 : Thin trees to allow visibility of the ground and room to flood fight.					
Inspector Comment					
Small trees on the landside slope should be removed, Fall 2020.

View of small trees on the landside that should be removed, Fall 2020

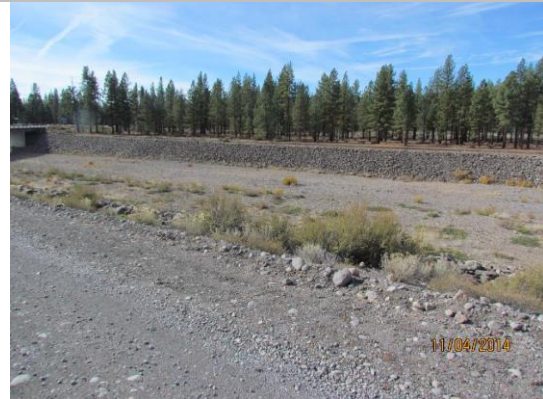
Photo 2 of 3 : UCIP_FA_2020_42644_72983.jpg

View of waterward side.

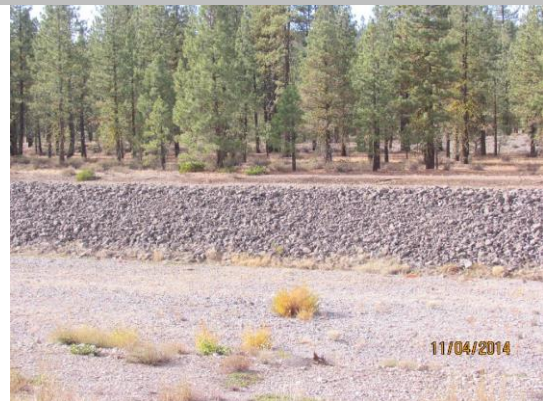
Photo 3 of 3 : UCIP_FA_2020_42644_72985.jpg

View of opposite bank.
