## Flood Control Project Maintenance Levee Inspections

### Fall 2021 Levee Maintenance Deficiency Summary Report

#### Sacramento River Basin

# Plumas County

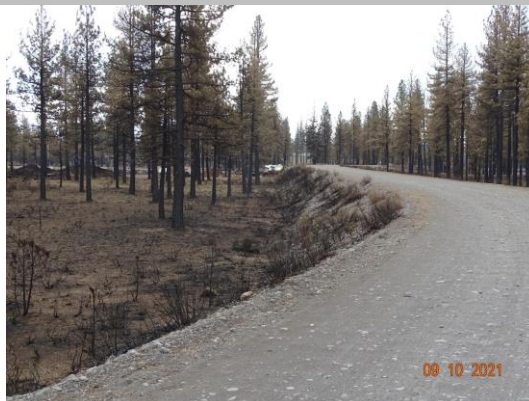
Photo 1 of 1 : FA\_2021\_NA0015\_337\_5\_20210921\_00005.jpg

LM Start	0.01	Rating **	A	Issue No.	5
LM End	1.81	Issue Type +	Ma	Location *	LS
Category	Earthen Levee			GPS Latitude/Longitude	
				Start	End
Item	Vegetation			40.273291 °	40.296129 °
				-121.244810 °	-121.257436 °
DWR ID	DWR_NA0015_01_f_2021_5				
Comment Code					
V1 : Control annual grass and weeds on the levee slopes and easements.					
Inspector Comment					
Annual vegetation is well maintained, Fall 2021.

View of annual vegetation on the landside slope, Fall 2021.

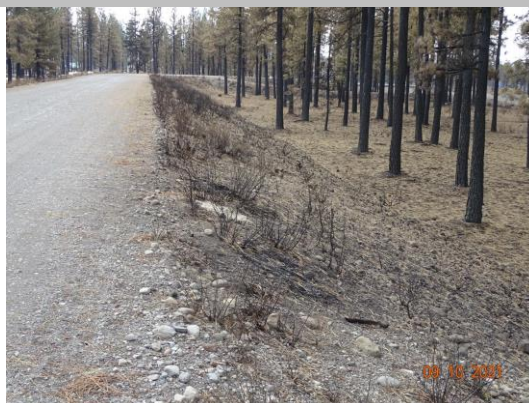
Photo 1 of 1 : FA\_2021\_NA0015\_337\_6\_20210921\_00006.jpg

LM Start	0.01	Rating **	A	Issue No.	6
LM End	1.81	Issue Type +	Ma	Location *	WS
Category	Earthen Levee			GPS Latitude/Longitude	
				Start	End
Item	Vegetation			40.273295 °	40.296135 °
				-121.244802 °	-121.257443 °
DWR ID	DWR_NA0015_01_f_2021_6				
Comment Code					
V1 : Control annual grass and weeds on the levee slopes and easements.					
Inspector Comment					
Annual vegetation is well maintained, Fall 2021.

View of annual vegetation on the waterside slope, Fall 2021.

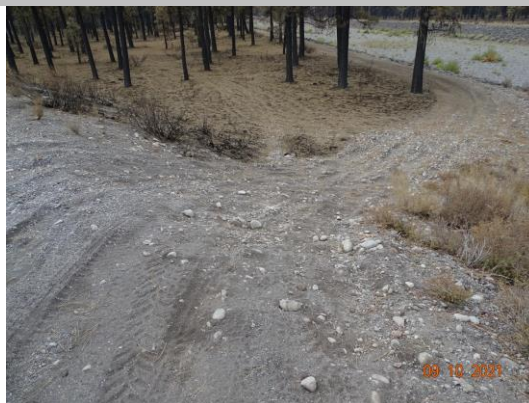
Photo 1 of 1 : FA\_2021\_NA0015\_337\_8\_20210921\_00007.jpg

LM Start	0.54	Rating **	A/W	Issue No.	8
LM End	0.54	Issue Type +	Ma	Location *	WS
Category	Earthen Levee			GPS Latitude/Longitude	
				Start	End
Item	Slope Stability			40.279775 °	40.279775 °
				-121.249648 °	-121.249648 °
DWR ID	DWR_NA0015_01_f_2018_8				
Comment Code					
S3 : Repair the levee slope damaged by vehicle traffic and prevent access where possible.					
Inspector Comment					
The vehicle erosion on the waterside slope is not a threat to the levee slope but should be monitored. Fall 2021.

View of vehicle erosion on the waterside slope, Fall 2021.

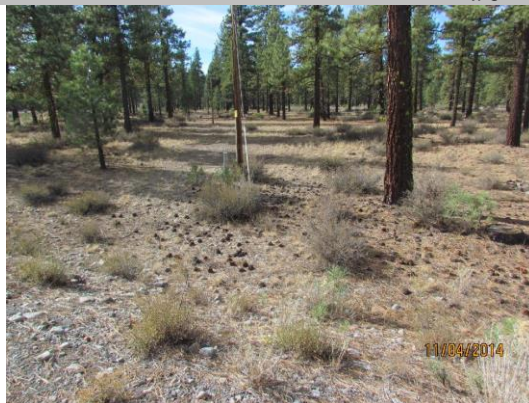
Photo 1 of 3 : UCIP\_FA\_2021\_42643\_72981.jpg

LM Start	0.77	Rating **	M	Issue No.	9	
LM End	0.77	Issue Type +	En	Location *		
Category	Supplemental			GPS Latitude/Longitude		
				Start	End	
Item	DWR UCIP Field Study			40.282683 °	40.282683 °	
				-121.251453 °	-121.251453 °	
DWR ID	23039					
Comment Code						
Inspector Comment						
DS_ID:23039 FS_ID:42643 EP_NO: N/A Repair Type: Non-Urgent EVAL Issue: Crossing Status: Indicator Found UCIP Comments: 11/04/2014 Need to contact owner to determine additional information about crossing. Need depth of conduit and permit issued. (DWR UCIP - O. Magana) FIELD_STRUCT_DESC: Telephone cable of an unknown size or material through the levee and across the channel, at an unknown depth. [Additional Reference(s): DWR Levee Log, 2005]. FS Date: 11/4/2014

View of conduit pole located on landward side. Photo taken from right bank.

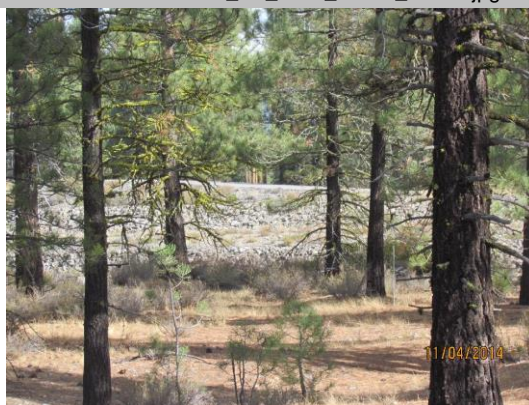
Photo 2 of 3 : UCIP\_FA\_2021\_42643\_72980.jpg

View of landward slope.

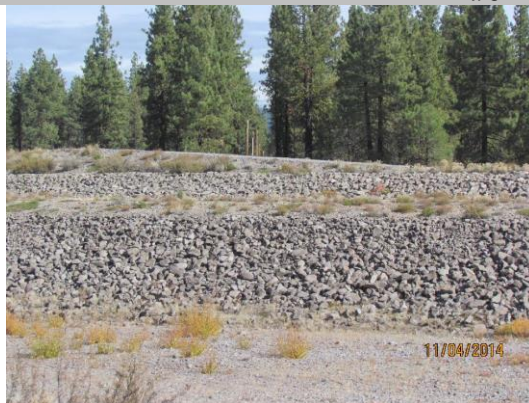
Photo 3 of 3 : UCIP\_FA\_2021\_42643\_72982.jpg

View of levee, ramp, and posts visible between trees.

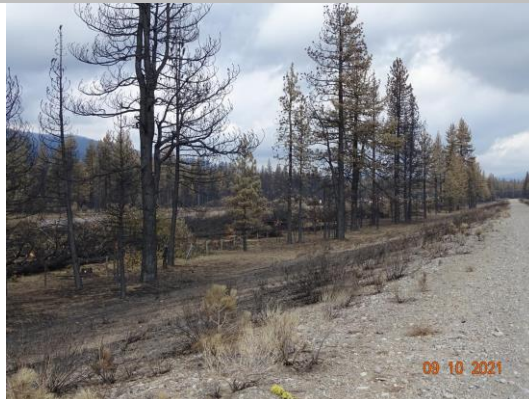
Photo 1 of 1 : FA\_2021\_NA0015\_338\_3\_20210921\_00004.jpg

LM Start	0.03	Rating **	A	Issue No.	3
LM End	1.33	Issue Type +	Ma	Location *	LS
Category	Earthen Levee			GPS Latitude/Longitude	
				Start	End
Item	Vegetation			40.286426 °	40.272128 °
				-121.259596 °	-121.247093 °
DWR ID	DWR_NA0015_02_f_2021_3				
Comment Code					
V1 : Control annual grass and weeds on the levee slopes and easements.					
Inspector Comment					
Annual vegetation is well maintained, Fall 2021.

View of annual vegetation on the landside slope, Fall 2021.

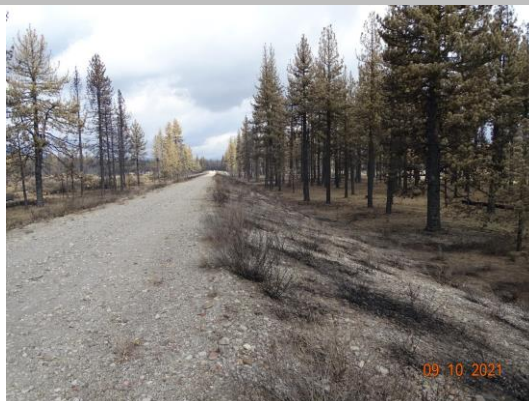
Photo 1 of 1 : FA\_2021\_NA0015\_338\_2\_20210921\_00005.jpg

LM Start	0.03	Rating **	A	Issue No.	2
LM End	1.33	Issue Type +	Ma	Location *	WS
Category	Earthen Levee			GPS Latitude/Longitude	
				Start	End
Item	Vegetation			40.286425 °	40.272127 °
				-121.259593 °	-121.247092 °
DWR ID	DWR_NA0015_02_f_2021_2				
Comment Code					
V1 : Control annual grass and weeds on the levee slopes and easements.					
Inspector Comment					
Annual vegetation is well maintained, Fall 2021.

View of annual vegetation on the waterside slope, Fall 2021.

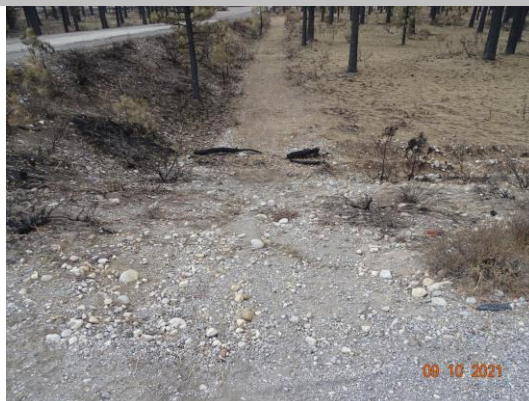
Photo 1 of 1 : FA\_2021\_NA0015\_338\_4\_20210921\_00006.jpg

LM Start	0.54	Rating **	M	Issue No.	4
LM End	0.54	Issue Type +	Ma	Location *	LS
Category	Earthen Levee			GPS Latitude/Longitude	
				Start	End
Item	Slope Stability			40.281959 °	40.281959 °
				-121.253714 °	-121.253714 °
DWR ID	DWR_NA0015_02_f_2021_4				
Comment Code					
S1 : Repair slope instability.					
Inspector Comment					
Unauthorized vehicle access is causing rutting on the levee slope, the control log placed by the LMA burned out due to the Dixie Fire and should be replaced. Fall 2021.

View of rutting on the landside slope caused by unauthorized vehicle access, Fall 2021.

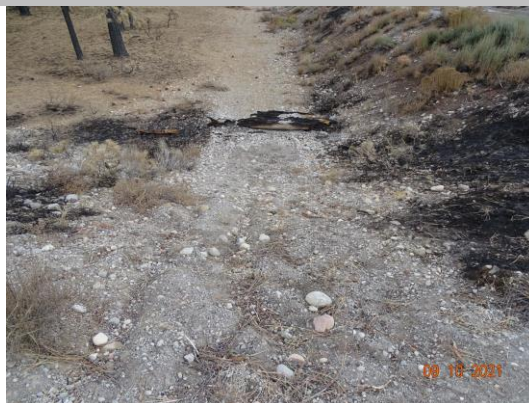
Photo 1 of 1 : FA\_2021\_NA0015\_338\_5\_20210921\_00007.jpg

LM Start	0.54	Rating **	M	Issue No.	5
LM End	0.54	Issue Type +	Ma	Location *	WS
Category	Earthen Levee			GPS Latitude/Longitude	
				Start	End
Item	Slope Stability			40.281954 °	40.281954 °
				-121.253695 °	-121.253695 °
DWR ID	DWR_NA0015_02_f_2021_5				
Comment Code					
S1 : Repair slope instability.					
Inspector Comment					
Unauthorized vehicle access is causing rutting on the levee slope, the control log placed by the LMA burned out due to the Dixie Fire and should be replaced, Fall 2021.

View of rutting caused by unauthorized vehicle access on the waterside slope, Fall 2021.

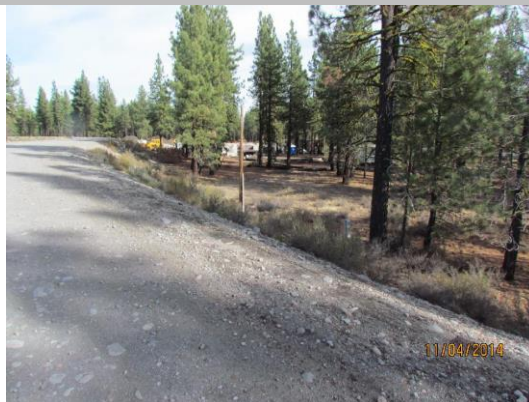
Photo 1 of 3 : UCIP\_FA\_2021\_42644\_72984.jpg

LM Start	0.66	Rating **	M	Issue No.	6	
LM End	0.66	Issue Type +	En	Location *		
Category	Supplemental			GPS Latitude/Longitude		
				Start	End	
Item	DWR UCIP Field Study			40.280737 °	40.280737 °	
				-121.252512 °	-121.252512 °	
DWR ID	23040					
Comment Code						
Inspector Comment						
DS_ID:23040 FS_ID:42644 EP_NO: N/A Repair Type: Non-Urgent EVAL Issue: Crossing Status: Indicator Found UCIP Comments: 11/04/2014 Need to contact owner to determine additional information about crossing. Need depth of conduit and permit issued. (DWR UCIP - O. Magana) FIELD_STRUCT_DESC: Telephone cable of an unknown size or material through the levee and across the channel, at an unknown depth. [Additional Reference(s): DWR Levee Log, 2005]. FS Date: 11/4/2014

View of landward side conduit pole located at landward toe. Photo taken from the left bank.

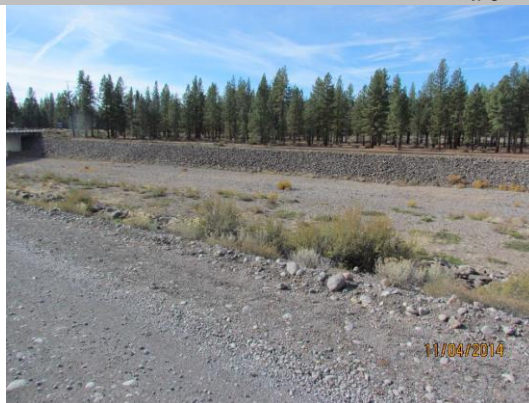
Photo 2 of 3 : UCIP\_FA\_2021\_42644\_72983.jpg

View of waterward side.

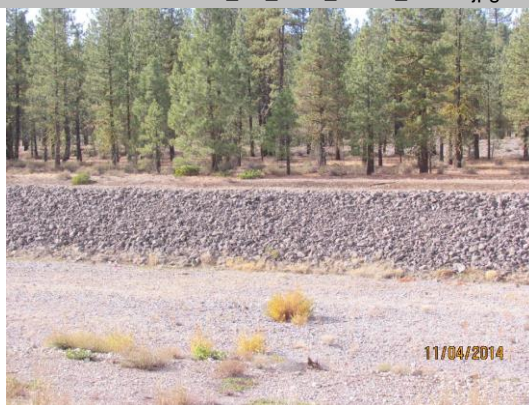
Photo 3 of 3 : UCIP\_FA\_2021\_42644\_72985.jpg

View of opposite bank.
