**Flood Control Project Maintenance
Levee Inspections**

Fall 2022 Levee Maintenance Deficiency Summary Report

Sacramento River Basin

Plumas County

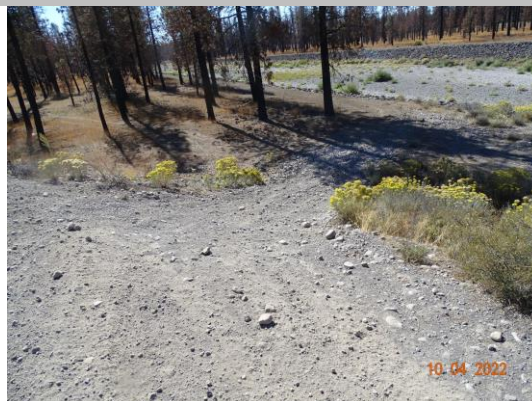
Photo 1 of 1 : FA_2022_NA0015_337_8_20221005_00003.jpg

LM Start	0.54	Rating **	A/W	Issue No.	8
LM End	0.54	Issue Type +	Ma	Location *	WS
Category	Earthen Levee			GPS Latitude/Longitude	
				Start	End
Item	Erosion / Vehicle Traffic			40.279775 °	40.279775 °
				-121.249648 °	-121.249648 °
DWR ID	DWR_NA0015_01_f_2018_8				
Comment Code					
E6 : Repair the levee slope damaged by vehicle traffic and prevent access where possible.					
Inspector Comment					
The vehicle erosion on the waterside slope is not a threat to the levee slope but should be monitored. Fall 2022.

View of vehicle erosion on the waterside slope, Fall 2022.

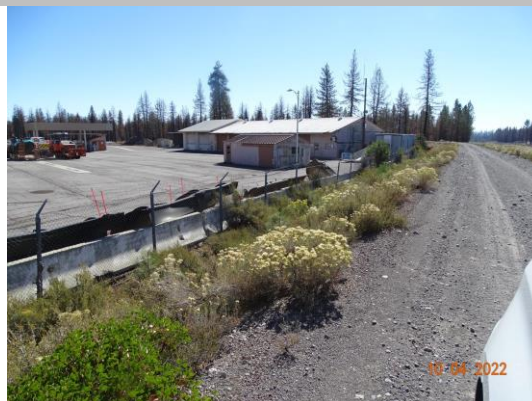
Photo 1 of 1 : FA_2022_NA0015_337_5_20221005_00002.jpg

LM Start	0.57	Rating **	M	Issue No.	5
LM End	0.65	Issue Type +	Ma	Location *	LS
Category	Earthen Levee			GPS Latitude/Longitude	
				Start	End
Item	Vegetation			40.280077 °	40.281024 °
				-121.250129 °	-121.250668 °
DWR ID	DWR_NA0015_01_f_2022_5				
Comment Code					
V1 : Control annual grass and weeds on the levee slopes and easements.					
Inspector Comment					
The annual vegetation on the landside slope needs to be maintained, Fall 2022.

View of annual vegetation on the landside slope, Fall 2022.

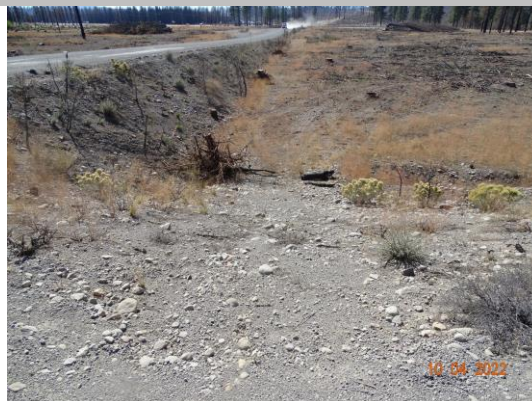
Photo 1 of 1 : FA_2022_NA0015_338_4_20221005_00003.jpg

LM Start	0.54	Rating **	M	Issue No.	4
LM End	0.54	Issue Type +	Ma	Location *	LS
Category	Earthen Levee			GPS Latitude/Longitude	
				Start	End
Item	Erosion / Vehicle Traffic			40.281959 °	40.281959 °
				-121.253714 °	-121.253714 °
DWR ID	DWR_NA0015_02_f_2021_4				
Comment Code					
E6 : Repair the levee slope damaged by vehicle traffic and prevent access where possible.					
Inspector Comment					
Unauthorized vehicle access is causing rutting on the levee slope, the control log placed by the LMA burned out due to the Dixie Fire and should be replaced. Fall 2022.

View of rutting on the landside slope caused by unauthorized vehicle access, Fall 2022.

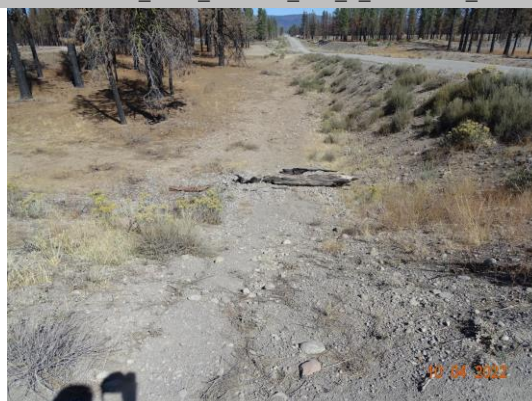
Photo 1 of 1 : FA_2022_NA0015_338_5_20221005_00004.jpg

LM Start	0.54	Rating **	M	Issue No.	5
LM End	0.54	Issue Type +	Ma	Location *	WS
Category	Earthen Levee			GPS Latitude/Longitude	
				Start	End
Item	Erosion / Vehicle Traffic			40.281954 °	40.281954 °
				-121.253695 °	-121.253695 °
DWR ID	DWR_NA0015_02_f_2021_5				
Comment Code					
E6 : Repair the levee slope damaged by vehicle traffic and prevent access where possible.					
Inspector Comment					
Unauthorized vehicle access is causing rutting on the levee slope, the control log placed by the LMA burned out due to the Dixie Fire and should be replaced, Fall 2022.

View of rutting caused by unauthorized vehicle access on the waterside slope, Fall 2022.

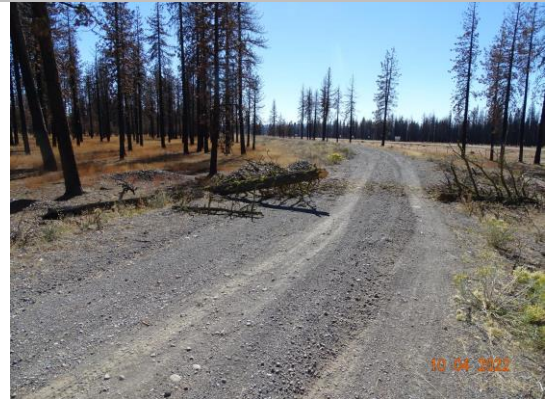
Photo 1 of 1 : FA_2022_NA0015_338_2_20221005_00005.jpg

LM Start	0.78	Rating **	M	Issue No.	2
LM End	0.78	Issue Type +	Ma	Location *	WS
Category	Earthen Levee			GPS Latitude/Longitude	
				Start	End
Item	Trim / Thin Trees			40.278954 °	40.278954 °
				-121.252208 °	-121.252208 °
DWR ID	DWR_NA0015_02_f_2022_2				
Comment Code					
T2 : Tree or limb.					
Inspector Comment					
Tree on the waterside slope is limiting access on the levee crown and needs to be removed, Fall 2022.

View looking downstream of a fallen tree on the waterside slope, Fall 2022.
