**Flood Control Project Maintenance  
Levee Inspections  
Fall 2023 Levee Maintenance Deficiency Summary Report**

**Sacramento River Basin**

**Levee Inspection Report By Mile - Fall 2023**

Waterway	Bank	Unit Miles	Inspection Start/End	Inspector
Unit No. 01 North Fork Feather River	Left	1.89	10/26/2023 10/26/2023	Brooks Weisser

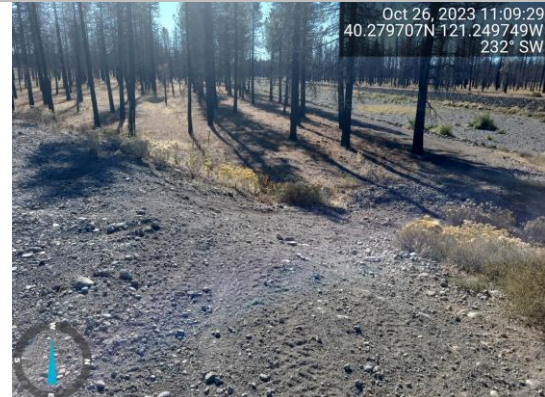
Photo 1 of 1 : FA\_2023\_NA0015\_337\_8\_20231027\_00002.jpg

LM Start	0.54	Rating **	A/W	Issue No.	8
LM End	0.54	Issue Type +	Ma	Location *	WS
Category	Earthen Levee			GPS Latitude/Longitude	
				Start	End
Item	Erosion / Vehicle Traffic			40.279775°	40.279775°
				-121.249648°	-121.249648°
DWR ID	DWR_NA0015_01_f_2018_8				
Comment Code					
E6 : Repair the levee slope damaged by vehicle traffic and prevent access where possible.					
Inspector Comment					
The vehicle erosion on the waterside slope is not a threat to the levee slope but should be monitored, Fall 2023.

View of vehicle erosion on the waterside slope, Fall 2023.

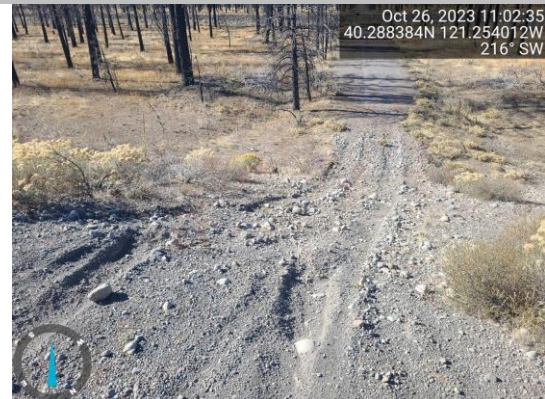
Photo 1 of 1 : FA\_2023\_NA0015\_337\_4\_20231027\_00003.jpg

LM Start	1.22	Rating **	A/W	Issue No.	4
LM End	1.22	Issue Type +	Ma	Location *	WS
Category	Earthen Levee			GPS Latitude/Longitude	
				Start	End
Item	Erosion / Vehicle Traffic			40.288382°	40.288382°
				-121.253977°	-121.253977°
DWR ID	DWR_NA0015_01_f_2023_4				
Comment Code					
E6 : Repair the levee slope damaged by vehicle traffic and prevent access where possible.					
Inspector Comment					
The vehicle erosion on the waterside slope is not a threat to the levee slope but should be monitored, Fall 2023.

View of vehicle erosion on the waterside slope, Fall 2023.

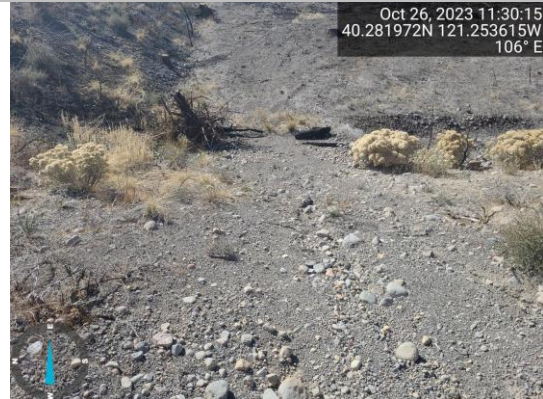
Photo 1 of 1 : FA\_2023\_NA0015\_338\_4\_20231027\_00004.jpg

LM Start	0.54	Rating **	M	Issue No.	4
LM End	0.54	Issue Type +	Ma	Location *	LS
Category	Earthen Levee			GPS Latitude/Longitude	
				Start	End
Item	Erosion / Vehicle Traffic			40.281959°	40.281959°
				-121.253714°	-121.253714°
DWR ID	DWR_NA0015_02_f_2021_4				
Comment Code					
E6 : Repair the levee slope damaged by vehicle traffic and prevent access where possible.					
Inspector Comment					
Unauthorized vehicle access is causing rutting on the levee slope, the control log placed by the LMA burned out due to the Dixie Fire and should be replaced, Fall 2023.

View of rutting on the landside slope caused by unauthorized vehicle access, Fall 2023.

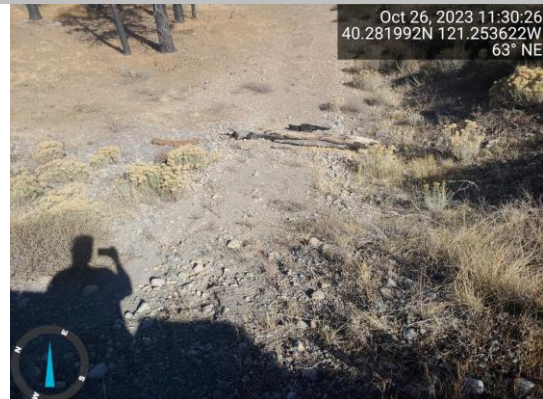
Photo 1 of 1 : FA\_2023\_NA0015\_338\_5\_20231027\_00005.jpg

LM Start	0.54	Rating **	M	Issue No.	5
LM End	0.54	Issue Type +	Ma	Location *	WS
Category	Earthen Levee			GPS Latitude/Longitude	
				Start	End
Item	Erosion / Vehicle Traffic			40.281954°	40.281954°
				-121.253695°	-121.253695°
DWR ID	DWR_NA0015_02_f_2021_5				
Comment Code					
E6 : Repair the levee slope damaged by vehicle traffic and prevent access where possible.					
Inspector Comment					
Unauthorized vehicle access is causing rutting on the levee slope, the control log placed by the LMA burned out due to the Dixie Fire and should be replaced, Fall 2023.

View of rutting caused by unauthorized vehicle access on the waterside slope, Fall 2023.

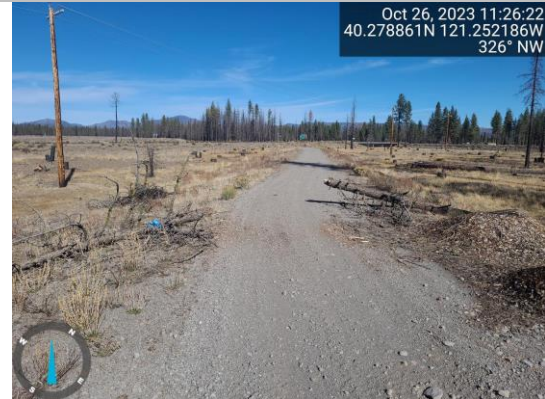
Photo 1 of 1 : FA\_2023\_NA0015\_338\_2\_20231027\_00006.jpg

LM Start	0.78	Rating **	M	Issue No.	2
LM End	0.78	Issue Type +	Ma	Location *	WS
Category	Earthen Levee			GPS Latitude/Longitude	
				Start	End
Item	Trim / Thin Trees			40.278954°	40.278954°
				-121.252208°	-121.252208°
DWR ID	DWR_NA0015_02_f_2022_2				
Comment Code					
T2 : Tree or limb.					
Inspector Comment					
Tree on the waterside slope is limiting access on the levee crown and needs to be removed, Fall 2023.

View looking upstream of a fallen tree on the waterside slope, Fall 2023.
