Flood Control Project Maintenance Levee Inspections

Fall 2024 Levee Maintenance Deficiency Summary Report

Sacramento River Basin

Plumas County

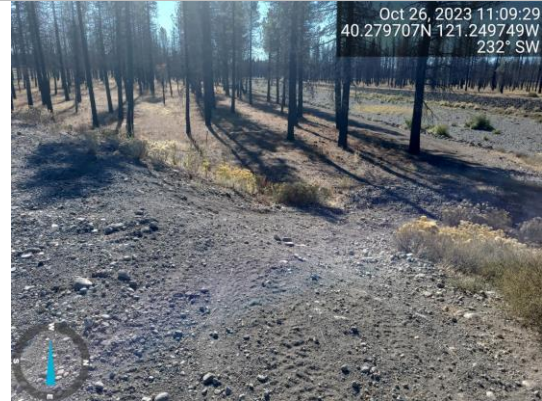
Photo 1 of 1 : FA_2024_NA0015_337_8_20240829_00002.jpg

LM Start	0.54	Rating **	A/W	Issue No.	8
LM End	0.54	Issue Type +	Ma	Location *	WS
Category	Earthen Levee			GPS Latitude/Longitude	
				Start	End
Item	Erosion / Vehicle Traffic			40.279775 °	40.279775 °
				-121.249648 °	-121.249648 °
DWR ID	DWR_NA0015_01_f_2018_8				
Comment Code					
E6 : Repair the levee slope damaged by vehicle traffic and prevent access where possible.					
Inspector Comment					
The vehicle erosion on the waterside slope is not a threat to the levee slope but should be monitored, Fall 2024.

View of vehicle erosion on the waterside slope, Fall 2024.

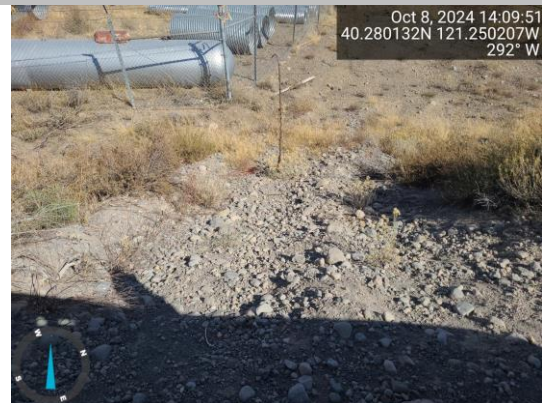
Photo 1 of 1 : FA_2024_NA0015_337_9_20241018_00006.jpg

LM Start	0.58	Rating **	A/W	Issue No.	9
LM End	0.58	Issue Type +	Ma	Location *	LS
Category	Earthen Levee			GPS Latitude/Longitude	
				Start	End
Item	Erosion / Vehicle Traffic			40.280155°	40.280155°
				-121.250211°	-121.250211°
DWR ID	DWR_NA0015_01_f_2024_9				
Comment Code					
E6 : Repair the levee slope damaged by vehicle traffic and prevent access where possible.					
Inspector Comment					
The vehicle erosion on the landside slope is not a threat to the levee slope but should be monitored, Fall 2024.

View of vehicle erosion on the landside slope, Fall 2024.

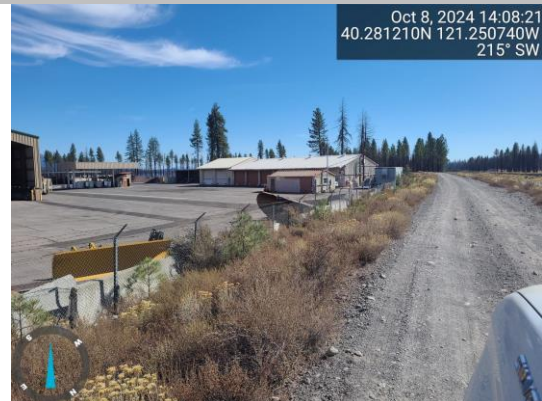
Photo 1 of 1 : FA_2024_NA0015_337_7_20241018_00005.jpg

LM Start	0.58	Rating **	M	Issue No.	7
LM End	0.67	Issue Type +	Ma	Location *	LS
Category	Earthen Levee			GPS Latitude/Longitude	
				Start	End
Item	Vegetation			40.280155°	40.281314°
				-121.250211°	-121.250841°
DWR ID	DWR_NA0015_01_f_2024_7				
Comment Code					
V1 : Control annual grass and weeds on the levee slopes and easements.					
Inspector Comment					
Vegetation on the landside slope need to be maintained, Fall 2024.

View of vegetation on the landside slope, Fall 2024.

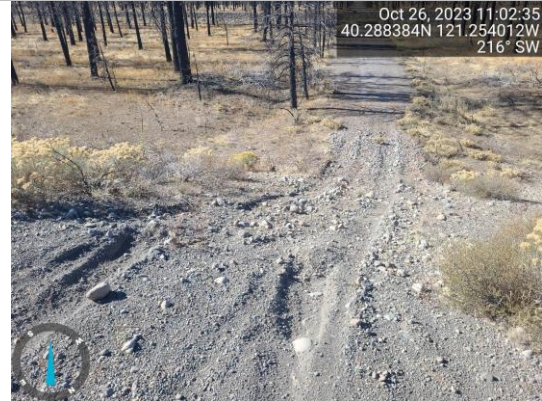
Photo 1 of 1 : FA_2024_NA0015_337_4_20240829_00001.jpg

LM Start	1.22	Rating **	A/W	Issue No.	4
LM End	1.22	Issue Type +	Ma	Location *	WS
Category	Earthen Levee			GPS Latitude/Longitude	
				Start	End
Item	Erosion / Vehicle Traffic			40.288382 °	40.288382 °
				-121.253977 °	-121.253977 °
DWR ID	DWR_NA0015_01_f_2023_4				
Comment Code					
E6 : Repair the levee slope damaged by vehicle traffic and prevent access where possible.					
Inspector Comment					
The vehicle erosion on the waterside slope is not a threat to the levee slope but should be monitored, Fall 2024.

View of vehicle erosion on the waterside slope, Fall 2023.

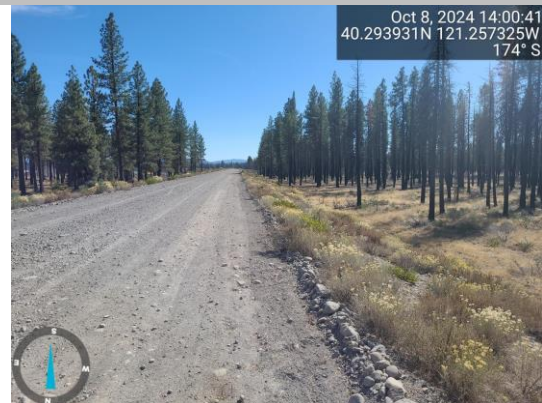
Photo 1 of 1 : FA_2024_NA0015_337_5_20241018_00003.jpg

LM Start	1.30	Rating **	M	Issue No.	5
LM End	1.68	Issue Type +	Ma	Location *	WS
Category	Earthen Levee			GPS Latitude/Longitude	
				Start	End
Item	Vegetation			40.289346 °	40.294278 °
				-121.254583 °	-121.257479 °
DWR ID	DWR_NA0015_01_f_2024_5				
Comment Code					
V1 : Control annual grass and weeds on the levee slopes and easements.					
Inspector Comment					
Vegetation on the waterside slope needs to be maintained, Fall 2024.

View of vegetation on the waterside slope, Fall 2024.

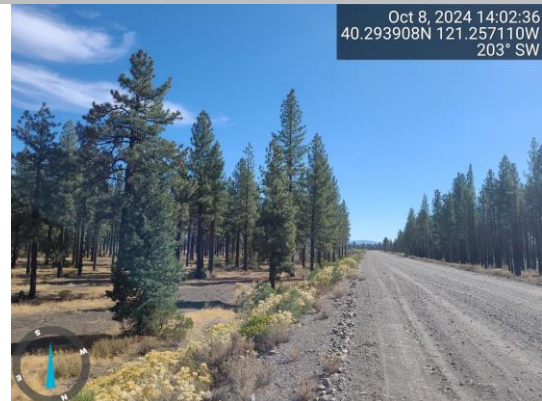
Photo 1 of 1 : FA_2024_NA0015_337_6_20241018_00004.jpg

LM Start	1.48	Rating **	M	Issue No.	6
LM End	1.65	Issue Type +	Ma	Location *	LS
Category	Earthen Levee			GPS Latitude/Longitude	
				Start	End
Item	Vegetation			40.291703 °	40.293875 °
				-121.255936 °	-121.257216 °
DWR ID	DWR_NA0015_01_f_2024_6				
Comment Code					
V1 : Control annual grass and weeds on the levee slopes and easements.					
Inspector Comment					
Vegetation on the landside slope need to be maintained, Fall 2024.

View of vegetation on the landside slope, Fall 2024.

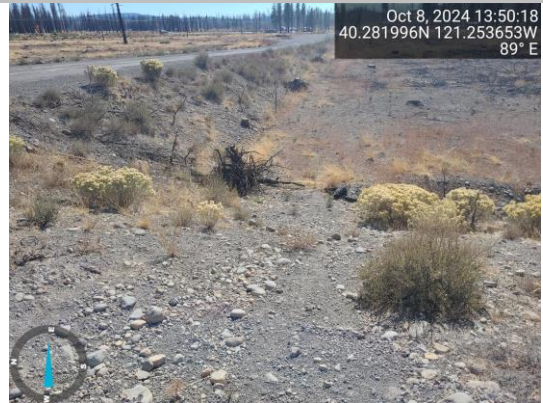
Photo 1 of 1 : FA_2024_NA0015_338_4_20241018_00003.jpg

LM Start	0.54	Rating **	A/W	Issue No.	4
LM End	0.54	Issue Type +	Ma	Location *	LS
Category	Earthen Levee			GPS Latitude/Longitude	
				Start	End
Item	Erosion / Vehicle Traffic			40.281959 °	40.281959 °
				-121.253714 °	-121.253714 °
DWR ID	DWR_NA0015_02_f_2021_4				
Comment Code					
E6 : Repair the levee slope damaged by vehicle traffic and prevent access where possible.					
Inspector Comment					
The vehicle erosion on the landside slope is not a threat to the levee slope but should be monitored, Fall 2024.

View of rutting on the landside slope caused by unauthorized vehicle access, Fall 2024.

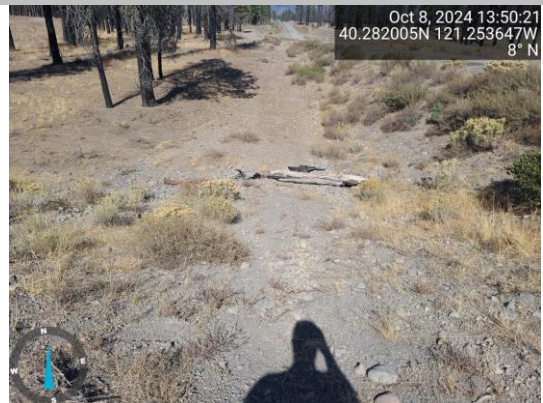
Photo 1 of 1 : FA_2024_NA0015_338_5_20241018_00004.jpg

LM Start	0.54	Rating **	A/W	Issue No.	5
LM End	0.54	Issue Type +	Ma	Location *	WS
Category	Earthen Levee			GPS Latitude/Longitude	
				Start	End
Item	Erosion / Vehicle Traffic			40.281954 °	40.281954 °
				-121.253695 °	-121.253695 °
DWR ID	DWR_NA0015_02_f_2021_5				
Comment Code					
E6 : Repair the levee slope damaged by vehicle traffic and prevent access where possible.					
Inspector Comment					
The vehicle erosion on the waterside slope is not a threat to the levee slope but should be monitored, Fall 2024.

View of rutting caused by unauthorized vehicle access on the waterside slope, Fall 2024.
