**Flood Control Project Maintenance
Levee Inspections**
LMA District Cover Sheet
Spring 2014 Levee Inspection Results

Plumas County

Levee Inspection Report By Mile - Spring 2014

Waterway	Bank	Unit Miles	Inspection Start/End	Inspector
Unit No. 01 North Fork Feather River	Left	1.89	04/09/2014 04/09/2014	Bob Duffey

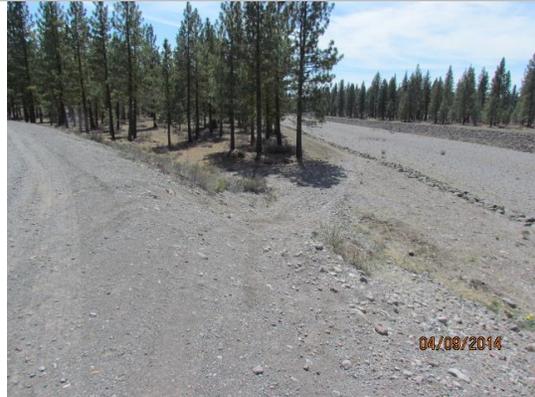
Photo 1 of 1 : rduffey_s_20140428_205.jpg

LM Start	0.55	Rating **	M	Issue No.	9
LM End	0.55	Issue Type +	Ma	Location *	WS
Category	Earthen Levee		GPS Latitude/Longitude		
			Start	End	
Item	Slope Stability		40.279790 °	121.249850 °	
			40.279790 °	121.249850 °	
DWR ID	DWR_NA0015_01_s_2012_9				
Action/Comments					
Repair the levee slope damaged by vehicle traffic and prevent access where possible.

View of the vehicle erosion along the waterside toe.

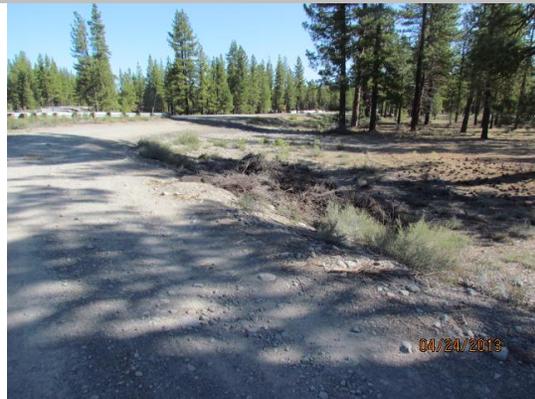
Photo 1 of 1 : rduffey_s_20140304_580.jpg

LM Start	0.68	Rating **	M	Issue No.	4
LM End	0.68	Issue Type +	En	Location *	LS
Category	Earthen Levee		GPS Latitude/Longitude		
			Start	End	
Item	Encroachments		40.281480 °	40.281480 °	
			-121.250928 °	-121.250928 °	
DWR ID	DWR_NA0015_01_s_2013_4				
Action/Comments					
Prunings

View of the prunings along the landside slope.

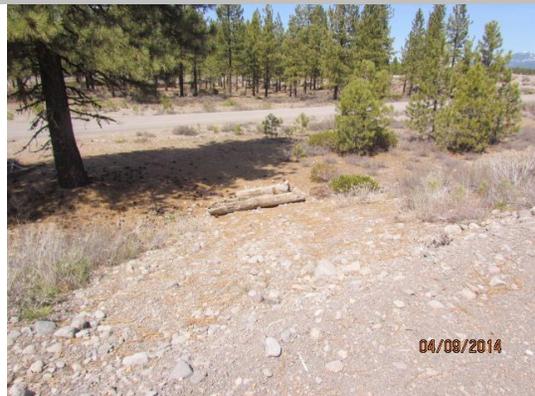
Photo 1 of 1 : rduffey_s_20140428_207.jpg

LM Start	0.97	Rating **	M	Issue No.	5
LM End	0.97	Issue Type +	Ma	Location *	WS
Category	Earthen Levee		GPS Latitude/Longitude		
			Start	End	
Item	Slope Stability		40.285363 °	40.285363 °	
			-121.251973 °	-121.251973 °	
DWR ID	DWR_NA0015_01_f_2013_5				
Action/Comments					
Repair the levee slope damaged by vehicle traffic and prevent access where possible.

View of the vehicle erosion along the waterside slope.

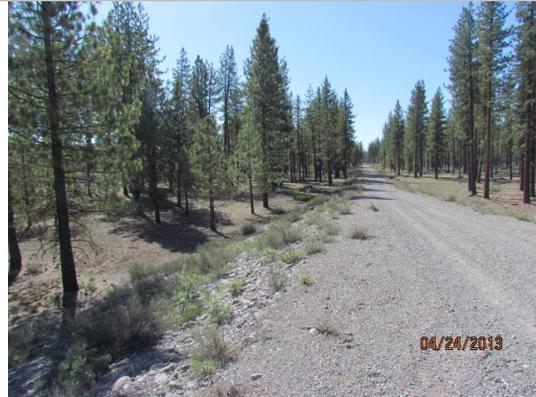
Photo 1 of 1 : rduffey_s_20140304_584.jpg

LM Start	0.02	Rating **	M	Issue No.	2
LM End	0.62	Issue Type +	Ma	Location *	WS
Category	Earthen Levee			GPS Latitude/Longitude	
				Start	End
Item	Vegetation			40.286415 °	40.281054 °
				-121.259613 °	-121.252789 °
DWR ID	DWR_NA0015_02_f_2012_2				
Action/Comments					
Remove the wild growth other than native grasses from the levee slopes. Inspector Comments: Mow or remove the pine trees from the slope.

View of the small pine trees that need to be removed from the waterside slopes.

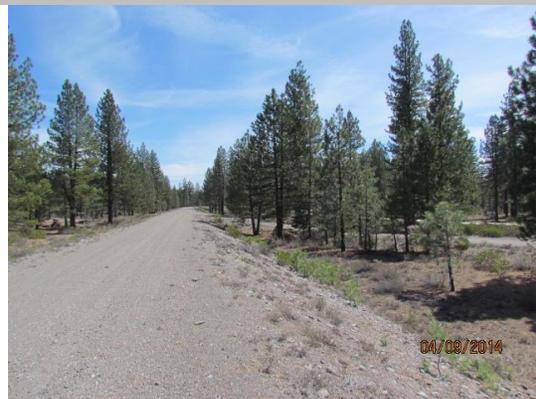
Photo 1 of 1 : rduffey_s_20140428_209.jpg

LM Start	0.02	Rating **	M	Issue No.	1
LM End	0.62	Issue Type +	Ma	Location *	LS
Category	Earthen Levee			GPS Latitude/Longitude	
				Start	End
Item	Vegetation			40.286415 °	40.281053 °
				-121.259613 °	-121.252792 °
DWR ID	DWR_NA0015_02_f_2012_1				
Action/Comments					
Remove the wild growth other than native grasses from the levee slopes. Inspector Comments: Mow or remove the pine trees from the slope.

View of the small pine trees growing on the landside slope.

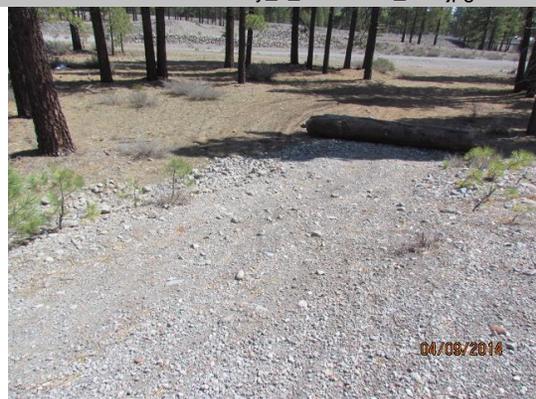
Photo 1 of 1 : rduffey_s_20140428_210.jpg

LM Start	0.44	Rating **	M	Issue No.	6
LM End	0.44	Issue Type +	Ma	Location *	WS
Category	Earthen Levee			GPS Latitude/Longitude	
				Start	End
Item	Slope Stability			40.283059 °	40.283059 °
				-121.253989 °	-121.253989 °
DWR ID	DWR_NA0015_02_f_2013_6				
Action/Comments					
Repair the levee slope damaged by vehicle traffic and prevent access where possible.

View of the vehicle erosion on the waterside slope.

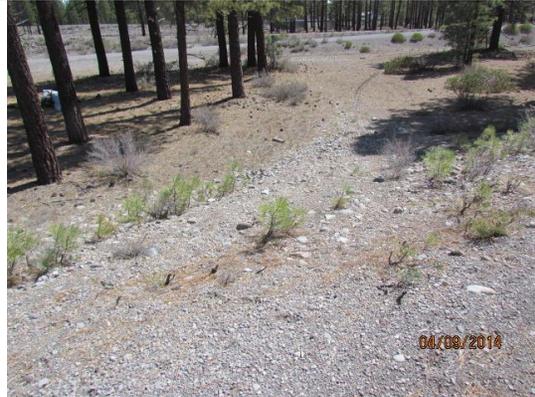
Photo 1 of 1 : rduffey_s_20140428_211.jpg

LM Start	0.46	Rating **	M	Issue No.	3
LM End	0.46	Issue Type +	Ma	Location *	WS
Category	Earthen Levee		GPS Latitude/Longitude		
			Start	End	
Item	Slope Stability		40.282980 °	121.253990 °	
			40.282980 °	121.253990 °	
DWR ID	DWR_NA0015_02_s_2012_3				
Action/Comments					
Repair the levee slope damaged by foot traffic and prevent access where possible.

View of the vehicle erosion along the waterside slope.

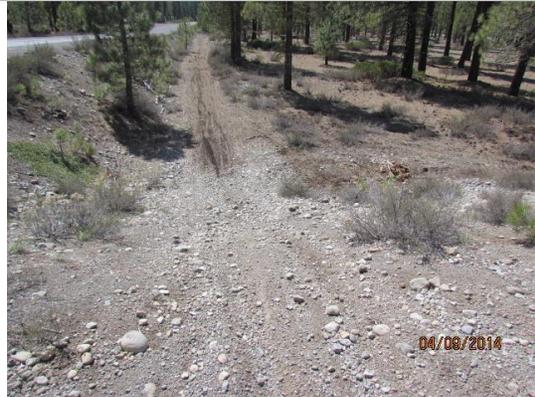
Photo 1 of 1 : rduffey_s_20140428_214.jpg

LM Start	0.55	Rating **	M	Issue No.	4
LM End	0.55	Issue Type +	Ma	Location *	LS
Category	Earthen Levee		GPS Latitude/Longitude		
			Start	End	
Item	Slope Stability		40.281950 °	121.253710 °	
			40.281950 °	121.253710 °	
DWR ID	DWR_NA0015_02_s_2012_4				
Action/Comments					
Repair the levee slope damaged by vehicle traffic and prevent access where possible.

View of the vehicle erosion along the landside slope.

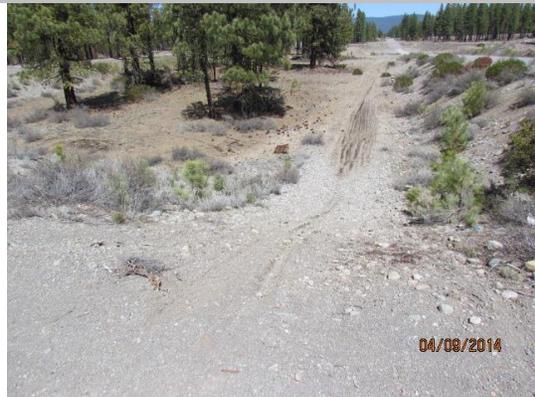
Photo 1 of 1 : rduffey_s_20140428_213.jpg

LM Start	0.55	Rating **	M	Issue No.	5
LM End	0.55	Issue Type +	Ma	Location *	WS
Category	Earthen Levee		GPS Latitude/Longitude		
			Start	End	
Item	Slope Stability		40.281950 °	121.253710 °	
			40.281950 °	121.253710 °	
DWR ID	DWR_NA0015_02_s_2012_5				
Action/Comments					
Repair the levee slope damaged by vehicle traffic and prevent access where possible.

View of the vehicle erosion on the waterside slope.
