**Flood Control Project Maintenance
Levee Inspections**
LMA District Cover Sheet
Spring 2015 Levee Inspection Results

Plumas County

Waterway	Bank	Unit Miles
Unit No. 01 North Fork Feather River	Left	1.89

Levee Inspection Report By Mile - Spring 2015

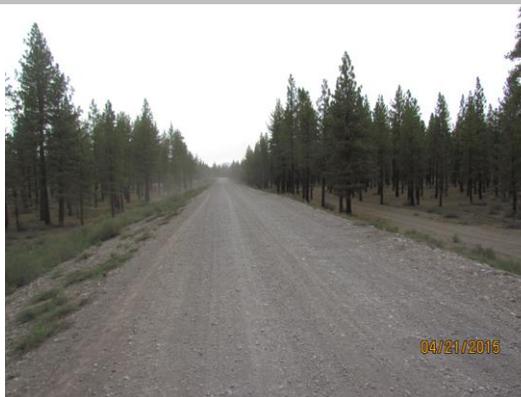
Photo 1 of 1 : SP_2015_NA0015_337_10_20150428_00007.jpg

LM Start	0.11	Rating **	M	Issue No.	10
LM End	0.11	Issue Type +	Ma	Location *	LS
Category	Earthen Levee		GPS Latitude/Longitude		
			Start	End	
Item	Vegetation		40.274537 °	40.274537 °	
			-121.245557 °	-121.245557 °	
DWR ID	DWR_NA0015_01_s_2015_10				
Action/Comments					
Remove the wild growth other than native grasses from the levee slopes. Inspector Comments: Remove the small pine trees from both slopes.

View of the small pine trees growing on both slopes.

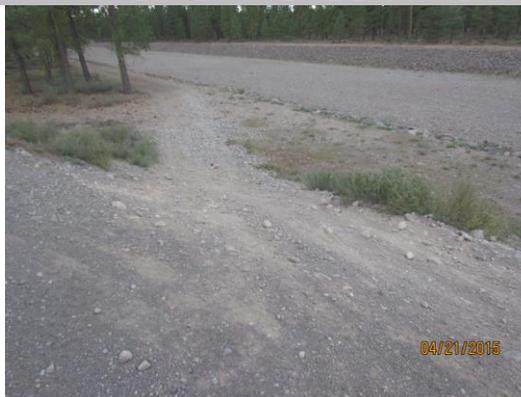
Photo 1 of 1 : SP_2015_NA0015_337_9_20150428_00008.jpg

LM Start	0.55	Rating **	M	Issue No.	9
LM End	0.55	Issue Type +	Ma	Location *	WS
Category	Earthen Levee		GPS Latitude/Longitude		
			Start	End	
Item	Slope Stability		40.279790 °	121.249850 °	
			40.279790 °	121.249850 °	
DWR ID	DWR_NA0015_01_s_2012_9				
Action/Comments					
Repair the levee slope damaged by vehicle traffic and prevent access where possible.

View of the vehicle erosion along the waterside toe.

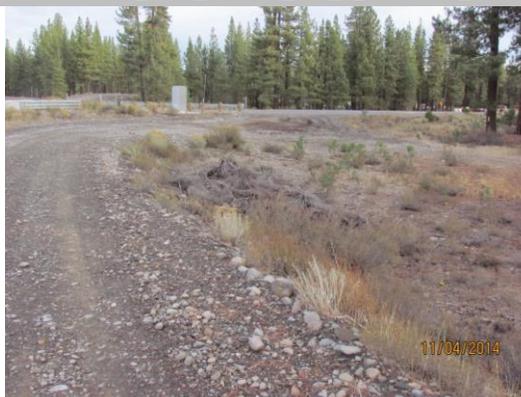
Photo 1 of 1 : SP_2015_NA0015_337_4_20150310_00001.jpg

LM Start	0.68	Rating **	M	Issue No.	4
LM End	0.68	Issue Type +	En	Location *	LS
Category	Earthen Levee		GPS Latitude/Longitude		
			Start	End	
Item	Encroachments		40.281480 °	40.281480 °	
			-121.250928 °	-121.250928 °	
DWR ID	DWR_NA0015_01_s_2013_4				
Action/Comments					
Prunings

View of the prunings along the landside slope.

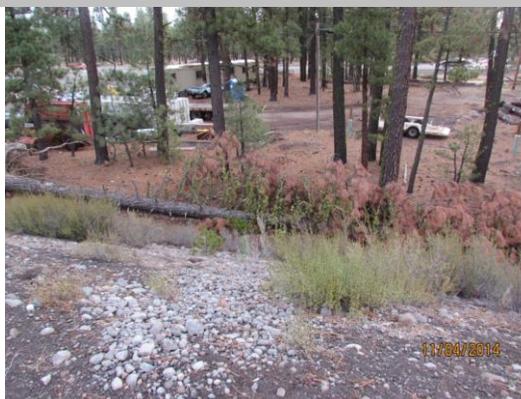
Photo 1 of 1 : SP_2015_NA0015_337_6_20150310_00003.jpg

LM Start	0.80	Rating **	M	Issue No.	6
LM End	0.80	Issue Type +	En	Location *	LS
Category	Earthen Levee		GPS Latitude/Longitude		
			Start	End	
Item	Encroachments		40.283163 °	40.283163 °	
			-121.251293 °	-121.251293 °	
DWR ID	DWR_NA0015_01_f_2014_6				
Action/Comments					
Tree or limb

View of the tree along the landside toe.

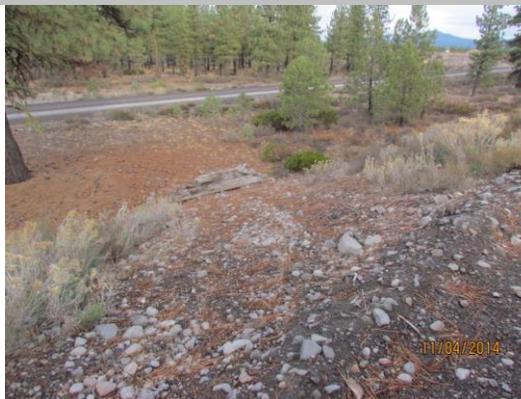
Photo 1 of 1 : SP_2015_NA0015_337_5_20150310_00002.jpg

LM Start	0.96	Rating **	M	Issue No.	5
LM End	0.96	Issue Type +	Ma	Location *	WS
Category	Earthen Levee		GPS Latitude/Longitude		
			Start	End	
Item	Slope Stability		40.285363 °	40.285363 °	
			-121.251973 °	-121.251973 °	
DWR ID	DWR_NA0015_01_f_2013_5				
Action/Comments					
Repair the levee slope damaged by vehicle traffic and prevent access where possible.

View of the vehicle erosion along the waterside slope.

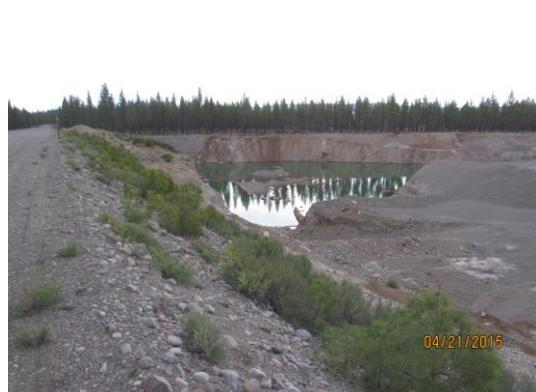
Photo 2 of 2 : SP_2015_NA0015_337_7_20150428_00009.jpg

View of the area where the contractor has removed the material from toe of the levee.

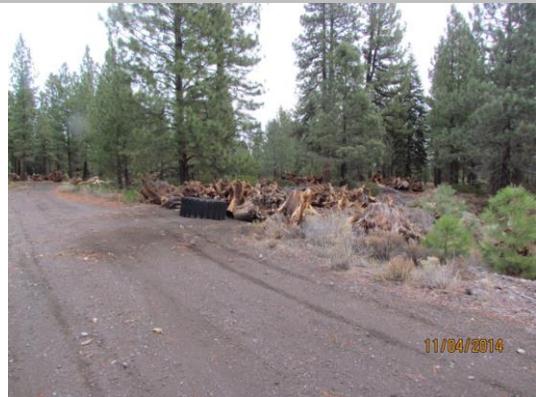
Photo 1 of 1 : SP_2015_NA0015_337_8_20150310_00005.jpg

LM Start	1.86	Rating **	M	Issue No.	8
LM End	1.86	Issue Type +	En	Location *	LS
Category	Earthen Levee		GPS Latitude/Longitude		
			Start	End	
Item	Encroachments		40.296910 °	40.296910 °	
			-121.257280 °	-121.257280 °	
DWR ID	DWR_NA0015_01_f_2014_8				
Action/Comments					
Tree or limb

Remove the tree stumps from the slope of the levee.

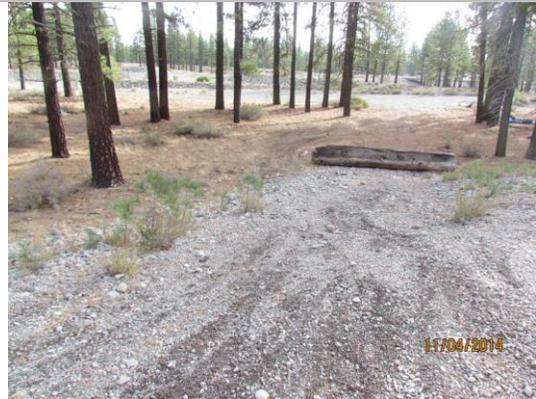
Photo 1 of 2 : SP_2015_NA0015_338_6_20150310_00006.jpg

LM Start	0.46	Rating **	M	Issue No.	6
LM End	0.46	Issue Type +	Ma	Location *	WS
Category	Earthen Levee		GPS Latitude/Longitude		
			Start	End	
Item	Slope Stability		40.283059 °	40.283059 °	
			-121.253989 °	-121.253989 °	
DWR ID	DWR_NA0015_02_f_2013_6				
Action/Comments					
Repair the levee slope damaged by vehicle traffic and prevent access where possible.

View of the vehicle erosion on the landside slope.

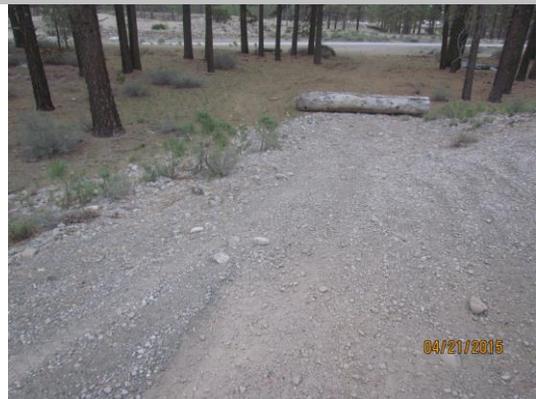
Photo 2 of 2 : SP_2015_NA0015_338_6_20150428_00011.jpg

View of the vehicle erosion on the waterside slope.

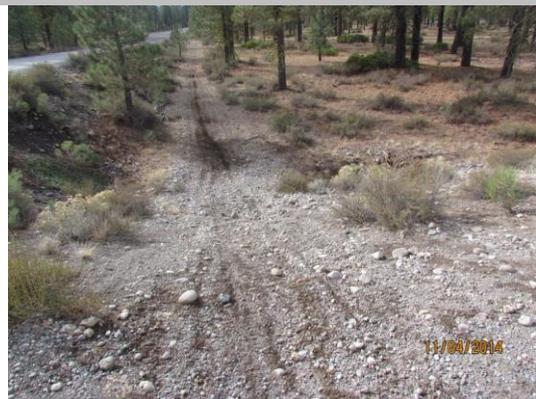
Photo 1 of 1 : SP_2015_NA0015_338_4_20150310_00004.jpg

LM Start	0.55	Rating **	M	Issue No.	4
LM End	0.55	Issue Type +	Ma	Location *	LS
Category	Earthen Levee		GPS Latitude/Longitude		
			Start	End	
Item	Slope Stability		40.281950 °	121.253710 °	
			40.281950 °	121.253710 °	
DWR ID	DWR_NA0015_02_s_2012_4				
Action/Comments					
Repair the levee slope damaged by vehicle traffic and prevent access where possible.

View of the erosion along the landside slope.

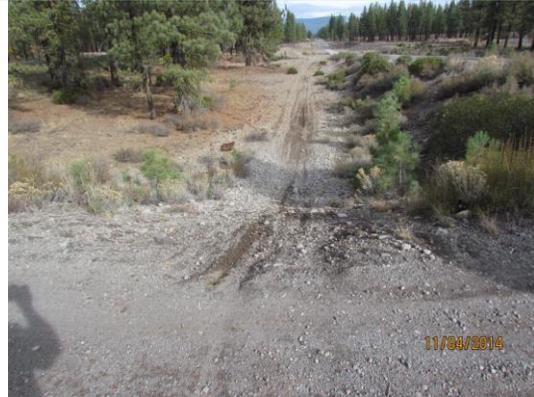
Photo 1 of 1 : SP_2015_NA0015_338_5_20150310_00005.jpg

LM Start	0.55	Rating **	M	Issue No.	5
LM End	0.55	Issue Type +	Ma	Location *	WS
Category	Earthen Levee		GPS Latitude/Longitude		
			Start	End	
Item	Slope Stability		40.281950 °	121.253710 °	
			40.281950 °	121.253710 °	
DWR ID	DWR_NA0015_02_s_2012_5				
Action/Comments					
Repair the levee slope damaged by vehicle traffic and prevent access where possible.

View of the vehicle erosion on the waterside slope.
