**Flood Control Project Maintenance
Levee Inspections**
LMA District Cover Sheet
Spring 2016 Levee Inspection Results

Plumas County

Levee Inspection Report By Mile - Spring 2016

Waterway	Bank	Unit Miles	Inspection Start/End	Inspector
Unit No. 01 North Fork Feather River	Left	1.89	04/27/2016 04/27/2016	Keith Millard

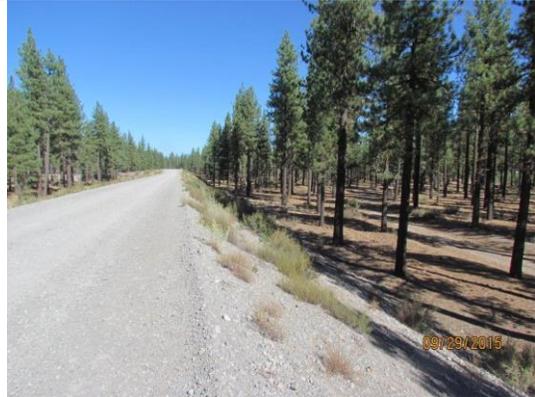
Photo 1 of 1 : SP_2016_NA0015_337_11_20160316_00008.jpg

LM Start	0.00	Rating **	M	Issue No.	11
LM End	1.89	Issue Type +	Ma	Location *	LS
Category	Earthen Levee		GPS Latitude/Longitude		
			Start	End	
Item	Vegetation		40.273168 °	40.297283 °	
			-121.244783 °	-121.257025 °	
DWR ID	DWR_NA0015_01_f_2015_11				
Comment Code					
V2 : Remove the wild growth other than native grasses from the levee slopes.					
Inspector Comment					
Remove the small pine trees and other vegetation from the levee slope.

Remove the small pine trees and other vegetation from the levee slope.

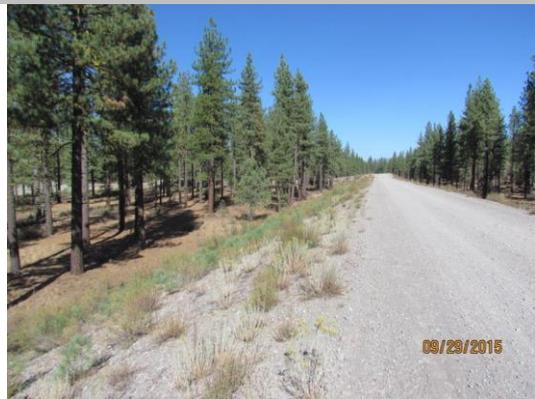
Photo 1 of 1 : SP_2016_NA0015_337_12_20160316_00009.jpg

LM Start	0.00	Rating **	M	Issue No.	12
LM End	1.89	Issue Type +	Ma	Location *	WS
Category	Earthen Levee		GPS Latitude/Longitude		
			Start	End	
Item	Vegetation		40.273168 °	40.297283 °	
			-121.244783 °	-121.257025 °	
DWR ID	DWR_NA0015_01_f_2015_12				
Comment Code					
V2 : Remove the wild growth other than native grasses from the levee slopes.					
Inspector Comment					
Remove all small pine trees and other vegetation from the levee slope.

View of the small pine trees and other vegetation on the slope.

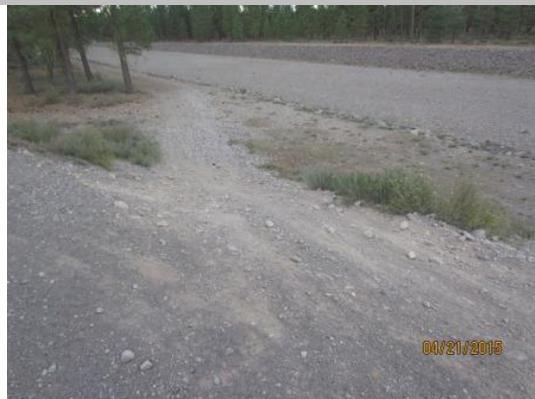
Photo 1 of 1 : SP_2016_NA0015_337_9_20160316_00007.jpg

LM Start	0.55	Rating **	M	Issue No.	9
LM End	0.55	Issue Type +	Ma	Location *	WS
Category	Earthen Levee		GPS Latitude/Longitude		
			Start	End	
Item	Slope Stability		40.279790 °	121.249850 °	
			40.279790 °	121.249850 °	
DWR ID	DWR_NA0015_01_s_2012_9				
Comment Code					
S3 : Repair the levee slope damaged by vehicle traffic and prevent access where possible.					
Inspector Comment

View of the vehicle erosion along the waterside toe.

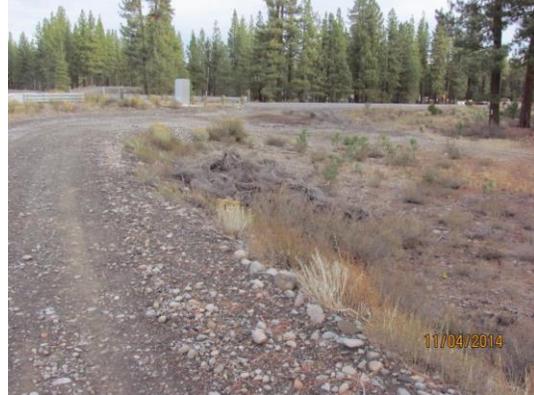
Photo 1 of 1 : SP_2016_NA0015_337_4_20160316_00001.jpg

LM Start	0.68	Rating **	M	Issue No.	4
LM End	0.68	Issue Type +	Ma	Location *	LS
Category	Earthen Levee		GPS Latitude/Longitude		
			Start	End	
Item	Encroachments		40.281480 °	40.281480 °	
			-121.250928 °	-121.250928 °	
DWR ID	DWR_NA0015_01_s_2013_4				
Comment Code					
PR : Prunings					
Inspector Comment

View of the prunings along the landside slope.

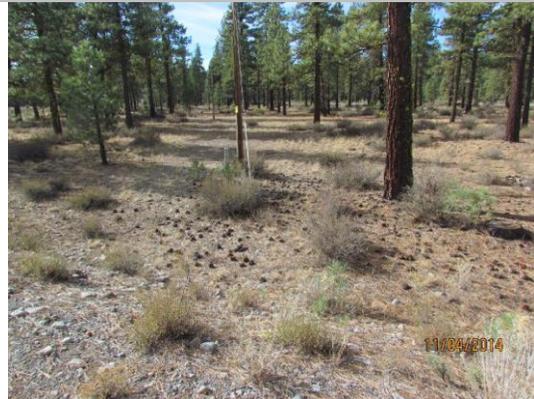
Photo 1 of 2 : UCIP_SP_2016_42643_72981.jpg

LM Start	0.77	Rating **	M	Issue No.	13
LM End	0.77	Issue Type +	En	Location *	LS
Category	Supplemental		GPS Latitude/Longitude		
			Start	End	
Item	DWR UCIP Field Study		40.282683 °	40.282683 °	
			-121.251453 °	-121.251453 °	
DWR ID					
Comment Code					
Inspector Comment					
FS_ID:42643 DS_ID:23039 EP_NO: N/A Repair Type: Non-Urgent Crossing Status: Indicator Found UCIP Comments: Need to contact owner to determine additional information about crossing. Need depth of conduit and permit issued. FIELD_STRUCT_DESC: Underground telephone cable through the levee and across the channel. Elevation unknown. FS Date: 11/4/2014

View of conduit pole located on landward side. Photo taken from right bank.

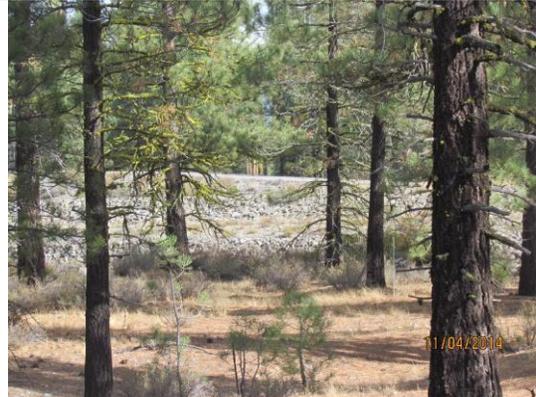
Photo 2 of 2 : UCIP_SP_2016_42643_72980.jpg

LM Start	0.77	Rating **	M	Issue No.	13 (cont)
LM End	0.77	Issue Type +	En	Location *	LS
Category	Supplemental			GPS Latitude/Longitude	
				Start	End
Item	DWR UCIP Field Study			40.282683 °	40.282683 °
				-121.251453 °	-121.251453 °
DWR ID					
Comment Code					
Inspector Comment					
FS_ID:42643 DS_ID:23039 EP_NO: N/A Repair Type: Non-Urgent Crossing Status: Indicator Found UCIP Comments: Need to contact owner to determine additional information about crossing. Need depth of conduit and permit issued. FIELD_STRUCT_DESC: Underground telephone cable through the levee and across the channel. Elevation unknown. FS Date: 11/4/2014

View of landward slope.

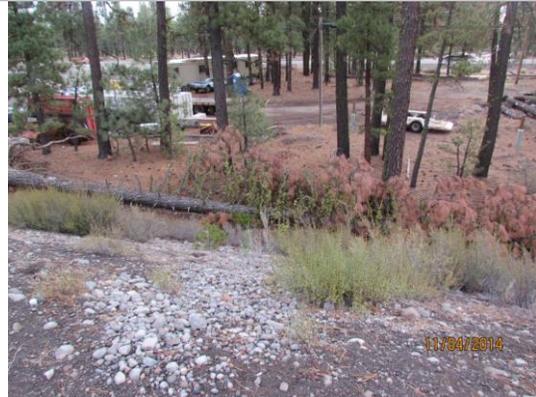
Photo 1 of 1 : SP_2016_NA0015_337_6_20160316_00003.jpg

LM Start	0.80	Rating **	M	Issue No.	6
LM End	0.80	Issue Type +	En	Location *	LS
Category	Earthen Levee			GPS Latitude/Longitude	
				Start	End
Item	Encroachments			40.283163 °	40.283163 °
				-121.251293 °	-121.251293 °
DWR ID	DWR_NA0015_01_f_2014_6				
Comment Code					
TR : Tree or limb					
Inspector Comment

View of the tree limb along the landside toe.

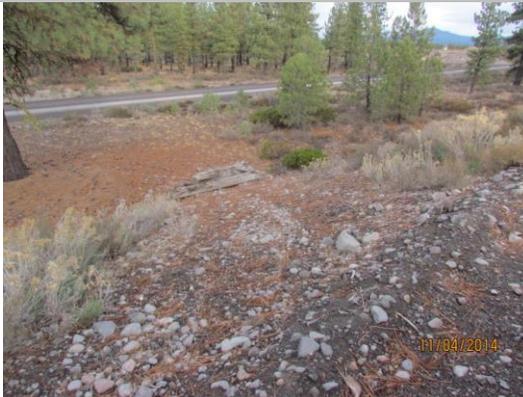
Photo 1 of 1 : SP_2016_NA0015_337_5_20160316_00002.jpg

LM Start	0.96	Rating **	A/W	Issue No.	5
LM End	0.96	Issue Type +	Ma	Location *	WS
Category	Earthen Levee		GPS Latitude/Longitude		
			Start	End	
Item	Slope Stability		40.285363 °	40.285363 °	
			-121.251973 °	-121.251973 °	
DWR ID	DWR_NA0015_01_f_2013_5				
Comment Code					
S3 : Repair the levee slope damaged by vehicle traffic and prevent access where possible.					
Inspector Comment

View of the vehicle erosion along the waterside slope.

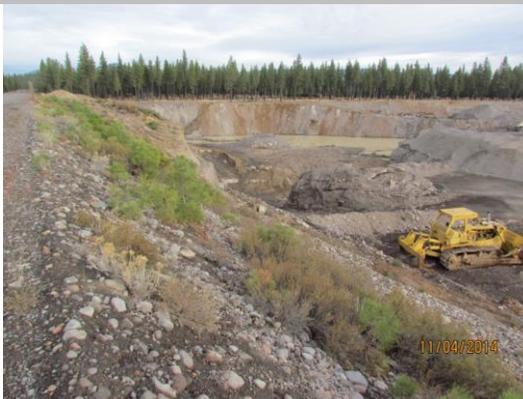
Photo 1 of 2 : SP_2016_NA0015_337_7_20160316_00004.jpg

LM Start	1.41	Rating **	U	Issue No.	7
LM End	1.50	Issue Type +	Ma	Location *	LS
Category	Earthen Levee		GPS Latitude/Longitude		
			Start	End	
Item	Slope Stability		40.290758 °	40.291987 °	
			-121.255402 °	-121.256072 °	
DWR ID	DWR_NA0015_01_f_2014_7				
Comment Code					
S1 : Repair slope instability.					
Inspector Comment					
The landowner needs to replace the material that has been removed from the toe of the levee.

View of the area where the contractor has removed the material from toe of the levee.

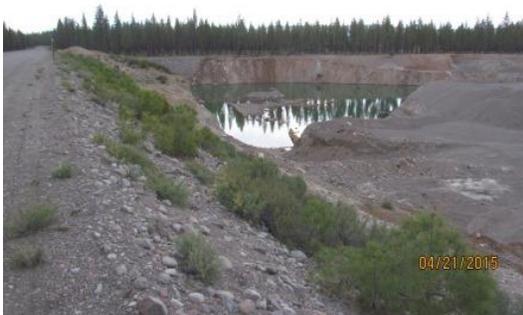
Photo 2 of 2 : SP_2016_NA0015_337_7_20160316_00005.jpg

LM Start	1.41	Rating **	U	Issue No.	7 (cont)
LM End	1.50	Issue Type +	Ma	Location *	LS

View of the area where the contractor has removed the material from toe of the levee.

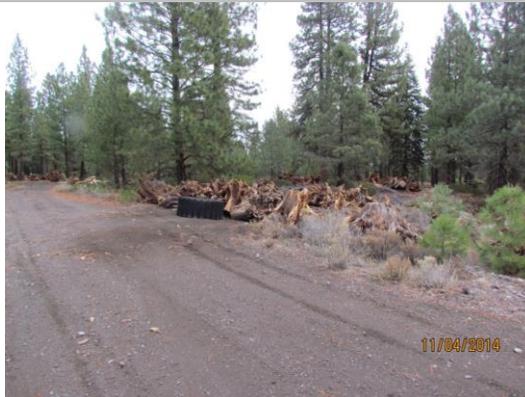
Photo 1 of 1 : SP_2016_NA0015_337_8_20160316_00006.jpg

LM Start	1.86	Rating **	M	Issue No.	8
LM End	1.86	Issue Type +	En	Location *	LS
Category	Earthen Levee		GPS Latitude/Longitude		
			Start	End	
Item	Encroachments		40.296910 °	40.296910 °	
			-121.257280 °	-121.257280 °	
DWR ID	DWR_NA0015_01_f_2014_8				
Comment Code					
TR : Tree or limb					
Inspector Comment

Remove the tree stumps from the slope of the levee.

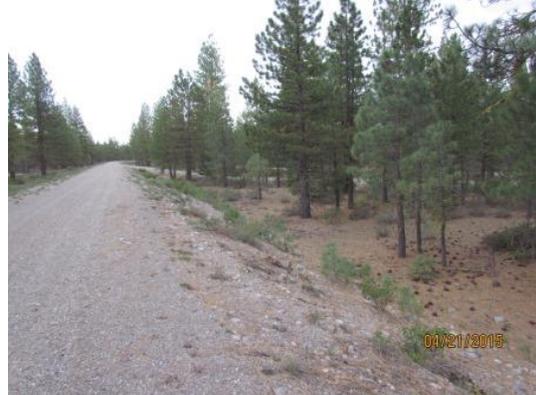
Photo 1 of 2 : SP_2016_NA0015_338_1_20160316_00001.jpg

LM Start	0.03	Rating **	M	Issue No.	1
LM End	1.36	Issue Type +	Ma	Location *	LS
Category	Earthen Levee			GPS Latitude/Longitude	
				Start	End
Item	Vegetation			40.286415 °	40.271743 °
				-121.259613 °	-121.246805 °
DWR ID	DWR_NA0015_02_f_2012_1				
Comment Code					
V2 : Remove the wild growth other than native grasses from the levee slopes.					
Inspector Comment					
Mow or remove the pine trees and other vegetation from the slope.

View of the small pine trees growing on the landside slope.

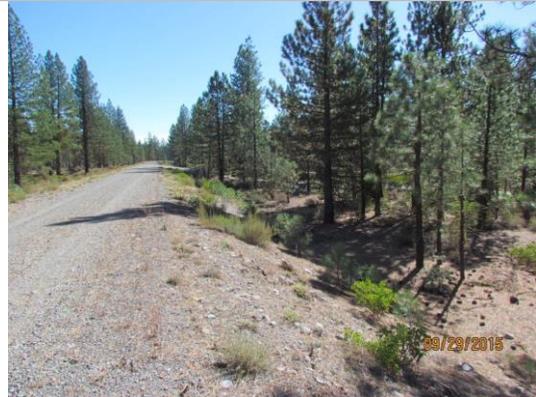
Photo 2 of 2 : SP_2016_NA0015_338_1_20160316_00002.jpg

LM Start	0.03	Rating **	M	Issue No.	1 (cont)
LM End	1.36	Issue Type +	Ma	Location *	LS

View of the small pine trees and other vegetation growing on the slope.

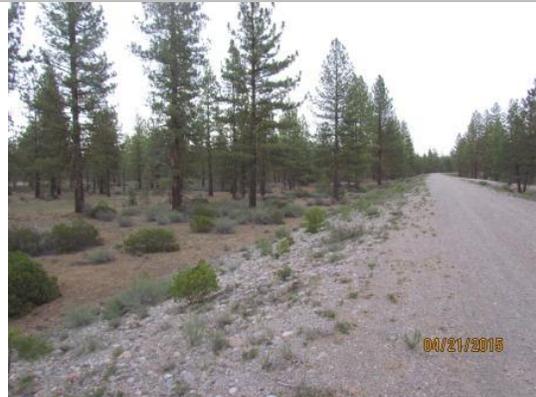
Photo 1 of 2 : SP_2016_NA0015_338_2_20160316_00003.jpg

LM Start	0.03	Rating **	M	Issue No.	2
LM End	1.36	Issue Type +	Ma	Location *	WS
Category	Earthen Levee			GPS Latitude/Longitude	
				Start	End
Item	Vegetation			40.286415 °	40.271743 °
				-121.259613 °	-121.246805 °
DWR ID	DWR_NA0015_02_f_2012_2				
Comment Code					
V2 : Remove the wild growth other than native grasses from the levee slopes.					
Inspector Comment					
Mow or remove the pine trees and other vegetation from the slope.

View of the small pine trees growing on the waterside slope.

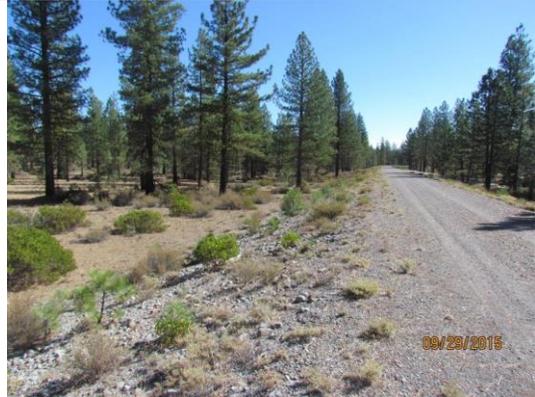
Photo 2 of 2 : SP_2016_NA0015_338_2_20160316_00004.jpg

LM Start	0.03	Rating **	M	Issue No.	2 (cont)
LM End	1.36	Issue Type +	Ma	Location *	WS
Category	Earthen Levee		GPS Latitude/Longitude		
			Start	End	
Item	Vegetation		40.286415 °	40.271743 °	
			-121.259613 °	-121.246805 °	
DWR ID	DWR_NA0015_02_f_2012_2				
Comment Code					
V2 : Remove the wild growth other than native grasses from the levee slopes.					
Inspector Comment					
Mow or remove the pine trees and other vegetation from the slope.

View of the small pine trees and other vegetation growing on the slope.

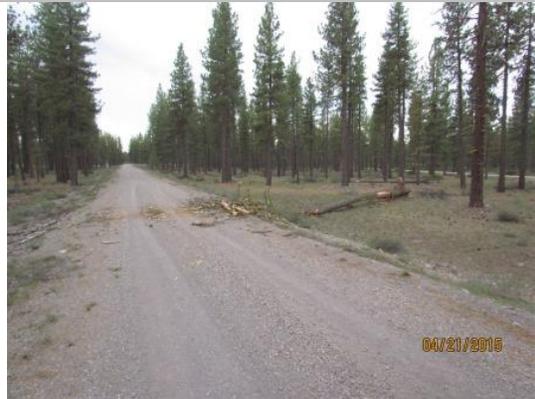
Photo 1 of 1 : SP_2016_NA0015_338_9_20160316_00009.jpg

LM Start	0.31	Rating **	M	Issue No.	9
LM End	0.31	Issue Type +	En	Location *	LS
Category	Earthen Levee		GPS Latitude/Longitude		
			Start	End	
Item	Encroachments		40.284993 °	40.284993 °	
			-121.255133 °	-121.255133 °	
DWR ID	DWR_NA0015_02_s_2015_9				
Comment Code					
TR : Tree or limb					
Inspector Comment					
Remove the pine tree from the landside slope.

View of the pine tree that has fallen onto the landside slope.

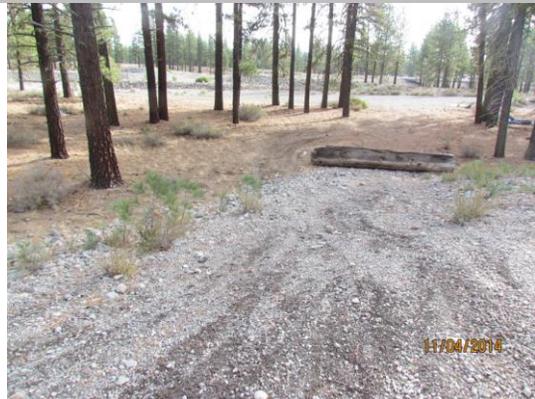
Photo 1 of 2 : SP_2016_NA0015_338_6_20160316_00007.jpg

LM Start	0.46	Rating **	M	Issue No.	6
LM End	0.46	Issue Type +	Ma	Location *	WS
Category	Earthen Levee		GPS Latitude/Longitude		
			Start	End	
Item	Slope Stability		40.283059 °	40.283059 °	
			-121.253989 °	-121.253989 °	
DWR ID	DWR_NA0015_02_f_2013_6				
Comment Code					
S3 : Repair the levee slope damaged by vehicle traffic and prevent access where possible.					
Inspector Comment

View of the vehicle erosion on the landside slope.

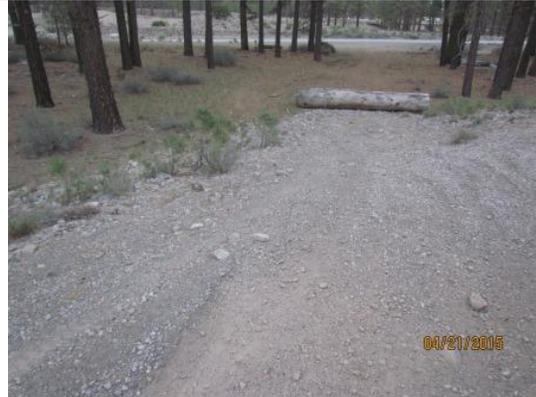
Photo 2 of 2 : SP_2016_NA0015_338_6_20160316_00008.jpg

LM Start	0.46	Rating **	M	Issue No.	6 (cont)
LM End	0.46	Issue Type +	Ma	Location *	WS
Category	Earthen Levee		GPS Latitude/Longitude		
			Start	End	
Item	Slope Stability		40.283059 °	40.283059 °	
			-121.253989 °	-121.253989 °	
DWR ID	DWR_NA0015_02_f_2013_6				
Comment Code					
S3 : Repair the levee slope damaged by vehicle traffic and prevent access where possible.					
Inspector Comment

View of the vehicle erosion on the waterside slope.

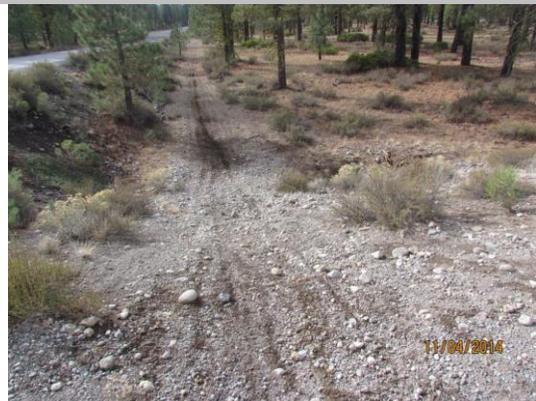
Photo 1 of 1 : SP_2016_NA0015_338_4_20160316_00005.jpg

LM Start	0.55	Rating **	M	Issue No.	4
LM End	0.55	Issue Type +	Ma	Location *	LS
Category	Earthen Levee		GPS Latitude/Longitude		
			Start	End	
Item	Slope Stability		40.281950 °	121.253710 °	
			40.281950 °	121.253710 °	
DWR ID	DWR_NA0015_02_s_2012_4				
Comment Code					
S3 : Repair the levee slope damaged by vehicle traffic and prevent access where possible.					
Inspector Comment

View of the slope instability cause by vehicle along the landside slope.

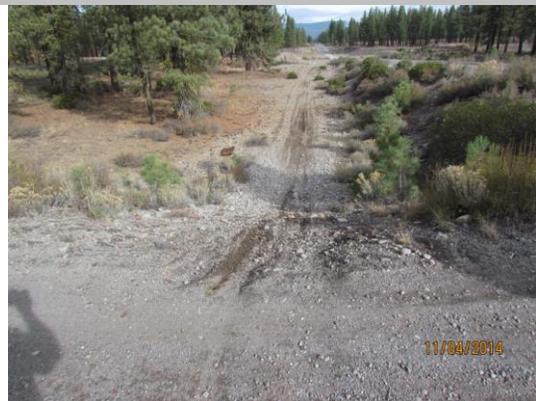
Photo 1 of 1 : SP_2016_NA0015_338_5_20160316_00006.jpg

LM Start	0.55	Rating **	M	Issue No.	5
LM End	0.55	Issue Type +	Ma	Location *	WS
Category	Earthen Levee		GPS Latitude/Longitude		
			Start	End	
Item	Slope Stability		40.281950 °	121.253710 °	
			40.281950 °	121.253710 °	
DWR ID	DWR_NA0015_02_s_2012_5				
Comment Code					
S3 : Repair the levee slope damaged by vehicle traffic and prevent access where possible.					
Inspector Comment

View of the vehicle erosion on the waterside slope.

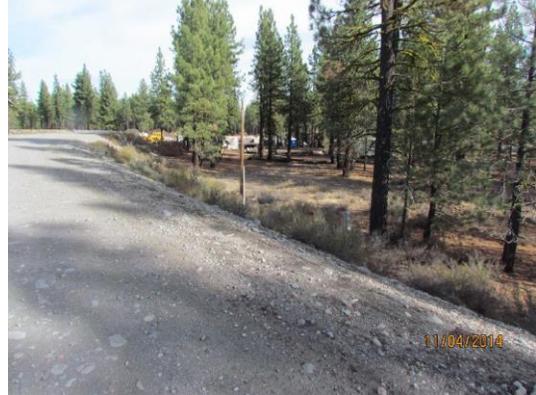
Photo 1 of 2 : UCIP_SP_2016_42644_72984.jpg

LM Start	0.66	Rating **	M	Issue No.	10
LM End	0.66	Issue Type +	En	Location *	WS
Category	Supplemental			GPS Latitude/Longitude	
				Start	End
Item	DWR UCIP Field Study			40.280737 °	40.280737 °
				-121.252512 °	-121.252512 °
DWR ID					
Comment Code					
Inspector Comment					
FS_ID:42644 DS_ID:23040 EP_NO: N/A Repair Type: Non-Urgent Crossing Status: Indicator Found UCIP Comments: Need to contact owner to determine additional information about crossing. Need depth of conduit and permit issued. FIELD_STRUCT_DESC: Underground telephone cable through the levee and across the channel. Elevation unknown. FS Date: 11/4/2014

View of landward side conduit pole located at landward toe. Photo taken from the left bank.

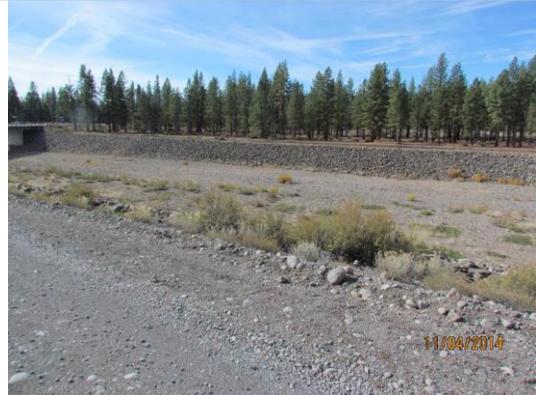
Photo 2 of 2 : UCIP_SP_2016_42644_72983.jpg

LM Start	0.66	Rating **	M	Issue No.	10 (cont)
LM End	0.66	Issue Type +	En	Location *	WS

View of waterward side.
