**Flood Control Project Maintenance  
Levee Inspections**

**Maintenance Issue Types Only, Levee Inspection Report By Mile - Fall 2014**

**Plumas County**

Waterway	Bank	Unit Miles	Inspection Start/End	Inspector
Unit No. 01 North Fork Feather River	Left	1.89	11/04/2014 11/04/2014	Bob Duffey

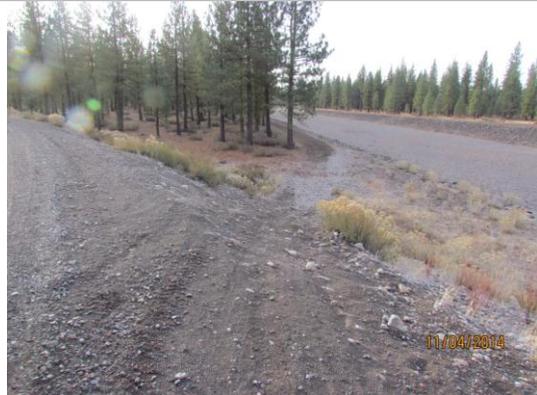
Photo 1 of 1 : FA\_2014\_NA0015\_337\_9\_20141112\_00004.jpg

View of the vehicle erosion along the waterside toe.

LM Start	<b>0.55</b>	Rating **	M	Issue No.	<b>9</b>
LM End	<b>0.55</b>	Issue Type +	Ma	Location *	WS
Category	Earthen Levee		GPS Latitude/Longitude		
			Start	End	
Item	Slope Stability		40.279790 °	121.249850 °	
			40.279790 °	121.249850 °	
DWR ID	DWR_NA0015_01_s_2012_9				
Action/Comments					
Repair the levee slope damaged by vehicle traffic and prevent access where possible.

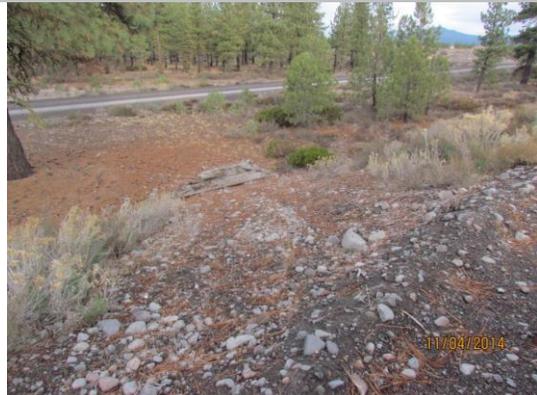
Photo 1 of 1 : FA\_2014\_NA0015\_337\_5\_20141112\_00007.jpg

View of the vehicle erosion along the waterside slope.

LM Start	<b>0.97</b>	Rating **	M	Issue No.	<b>5</b>
LM End	<b>0.97</b>	Issue Type +	Ma	Location *	WS
Category	Earthen Levee		GPS Latitude/Longitude		
			Start	End	
Item	Slope Stability		40.285363 °	40.285363 °	
			-121.251973 °	-121.251973 °	
DWR ID	DWR_NA0015_01_f_2013_5				
Action/Comments					
Repair the levee slope damaged by vehicle traffic and prevent access where possible.

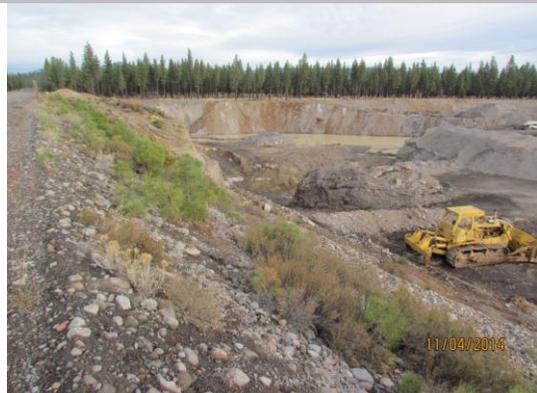
Photo 1 of 1 : FA\_2014\_NA0015\_337\_7\_20141112\_00008.jpg

View of the area where the contractor has removed the material from toe of the levee.

LM Start	<b>1.41</b>	Rating **	U	Issue No.	<b>7</b>
LM End	<b>1.50</b>	Issue Type +	Ma	Location *	LS
Category	Earthen Levee		GPS Latitude/Longitude		
			Start	End	
Item	Slope Stability		40.290758 °	40.291987 °	
			-121.255402 °	-121.256072 °	
DWR ID	DWR_NA0015_01_f_2014_7				
Action/Comments					
Repair slope instability. Inspector Comments: The landowner needs to replace the material that has been removed from the toe of the levee.

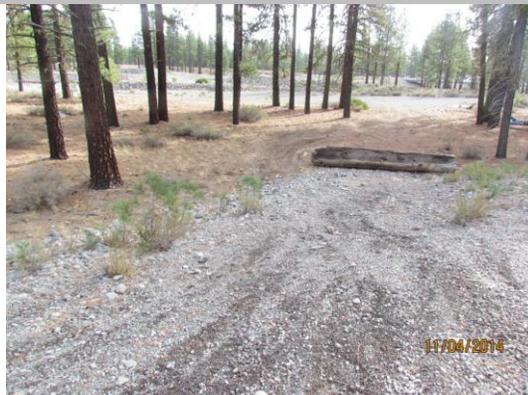
Photo 1 of 1 : FA\_2014\_NA0015\_338\_6\_20141112\_00009.jpg

View of the vehicle erosion on the landside slope.

LM Start	<b>0.44</b>	Rating **	M	Issue No.	<b>6</b>
LM End	<b>0.44</b>	Issue Type +	Ma	Location *	WS
Category	Earthen Levee		GPS Latitude/Longitude		
			Start	End	
Item	Slope Stability		40.283059 °	40.283059 °	
			-121.253989 °	-121.253989 °	
DWR ID	DWR_NA0015_02_f_2013_6				
Action/Comments					
Repair the levee slope damaged by vehicle traffic and prevent access where possible.
