**Flood Control Project Maintenance
Levee Inspections**

Maintenance Issue Types Only, Levee Inspection Report By Mile - Spring 2015

Plumas County

Waterway	Bank	Unit Miles	Inspection Start/End	Inspector
Unit No. 01 North Fork Feather River	Left	1.89	04/22/2015 04/22/2015	Bob Duffey

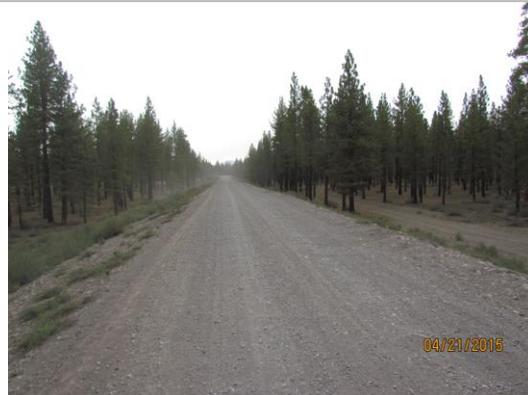
Photo 1 of 1 : SP_2015_NA0015_337_10_20150428_00007.jpg

LM Start	0.11	Rating **	M	Issue No.	10
LM End	0.11	Issue Type +	Ma	Location *	LS
Category	Earthen Levee		GPS Latitude/Longitude		
			Start	End	
Item	Vegetation		40.274537 °	40.274537 °	
			-121.245557 °	-121.245557 °	
DWR ID	DWR_NA0015_01_s_2015_10				
Action/Comments					
Remove the wild growth other than native grasses from the levee slopes. Inspector Comments: Remove the small pine trees from both slopes.

View of the small pine trees growing on both slopes.

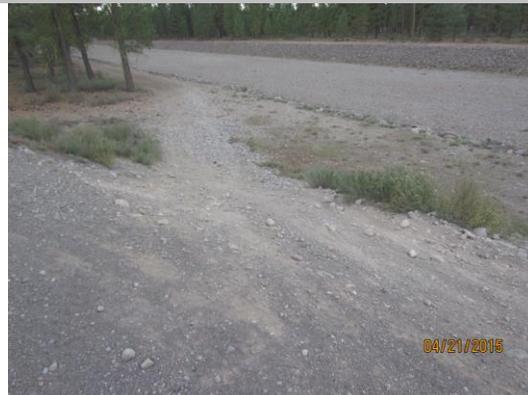
Photo 1 of 1 : SP_2015_NA0015_337_9_20150428_00008.jpg

LM Start	0.55	Rating **	M	Issue No.	9
LM End	0.55	Issue Type +	Ma	Location *	WS
Category	Earthen Levee		GPS Latitude/Longitude		
			Start	End	
Item	Slope Stability		40.279790 °	121.249850 °	
			40.279790 °	121.249850 °	
DWR ID	DWR_NA0015_01_s_2012_9				
Action/Comments					
Repair the levee slope damaged by vehicle traffic and prevent access where possible.

View of the vehicle erosion along the waterside toe.

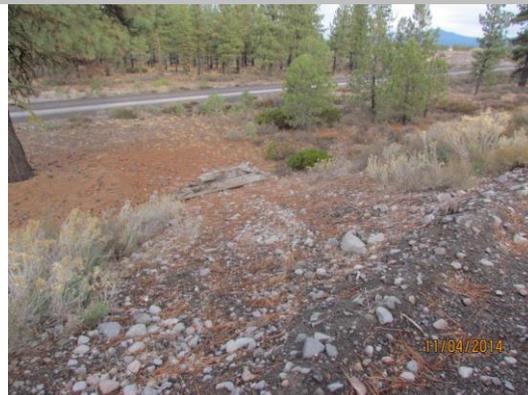
Photo 1 of 1 : SP_2015_NA0015_337_5_20150310_00002.jpg

LM Start	0.96	Rating **	M	Issue No.	5
LM End	0.96	Issue Type +	Ma	Location *	WS
Category	Earthen Levee		GPS Latitude/Longitude		
			Start	End	
Item	Slope Stability		40.285363 °	40.285363 °	
			-121.251973 °	-121.251973 °	
DWR ID	DWR_NA0015_01_f_2013_5				
Action/Comments					
Repair the levee slope damaged by vehicle traffic and prevent access where possible.

View of the vehicle erosion along the waterside slope.

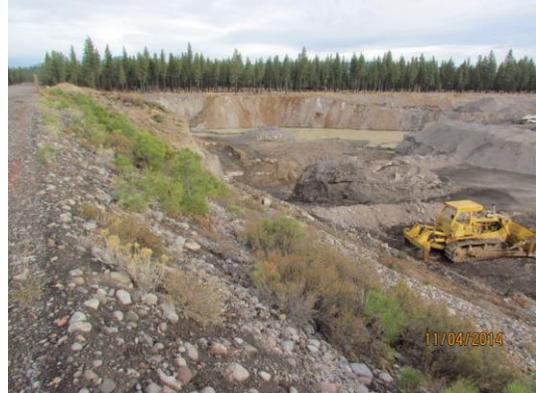
Photo 1 of 2 : SP_2015_NA0015_337_7_20150310_00004.jpg

LM Start	1.41	Rating **	U	Issue No.	7
LM End	1.50	Issue Type +	Ma	Location *	LS
Category	Earthen Levee			GPS Latitude/Longitude	
				Start	End
Item	Slope Stability			40.290758 °	40.291987 °
				-121.255402 °	-121.256072 °
DWR ID	DWR_NA0015_01_f_2014_7				
Action/Comments					
Repair slope instability. Inspector Comments: The landowner needs to replace the material that has been removed from the toe of the levee.

View of the area where the contractor has removed the material from toe of the levee.

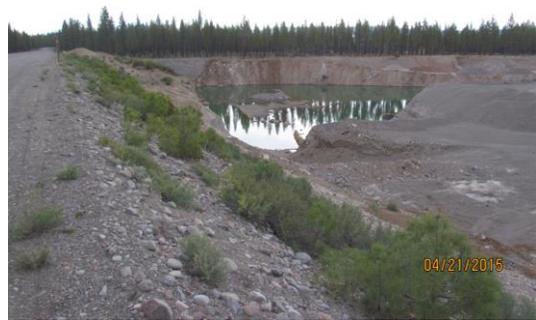
Photo 2 of 2 : SP_2015_NA0015_337_7_20150428_00009.jpg

LM Start	1.41	Rating **	U	Issue No.	7 (cont)
LM End	1.50	Issue Type +	Ma	Location *	LS

View of the area where the contractor has removed the material from toe of the levee.

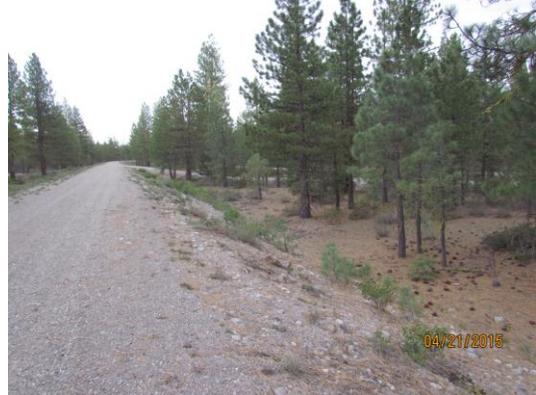
Photo 1 of 1 : SP_2015_NA0015_338_1_20150428_00008.jpg

LM Start	0.03	Rating **	M	Issue No.	1
LM End	0.63	Issue Type +	Ma	Location *	LS
Category	Earthen Levee			GPS Latitude/Longitude	
				Start	End
Item	Vegetation			40.286415 °	40.281053 °
				-121.259613 °	-121.252792 °
DWR ID	DWR_NA0015_02_f_2012_1				
Action/Comments					
Remove the wild growth other than native grasses from the levee slopes. Inspector Comments: Mow or remove the pine trees from the slope.

View of the small pine trees growing on the landside slope.

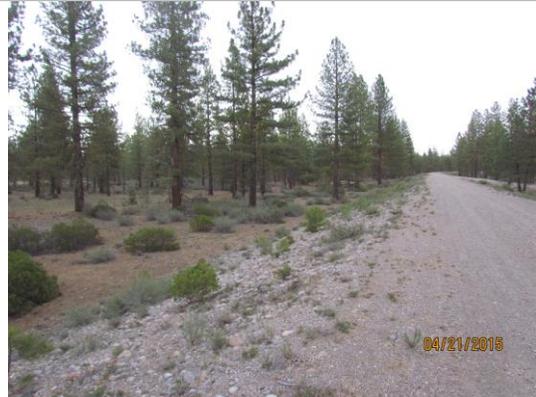
Photo 1 of 1 : SP_2015_NA0015_338_2_20150428_00009.jpg

LM Start	0.03	Rating **	M	Issue No.	2
LM End	0.63	Issue Type +	Ma	Location *	WS
Category	Earthen Levee			GPS Latitude/Longitude	
				Start	End
Item	Vegetation			40.286415 °	40.281054 °
				-121.259613 °	-121.252789 °
DWR ID	DWR_NA0015_02_f_2012_2				
Action/Comments					
Remove the wild growth other than native grasses from the levee slopes. Inspector Comments: Mow or remove the pine trees from the slope.

View of the small pine trees growing on the waterside slope.

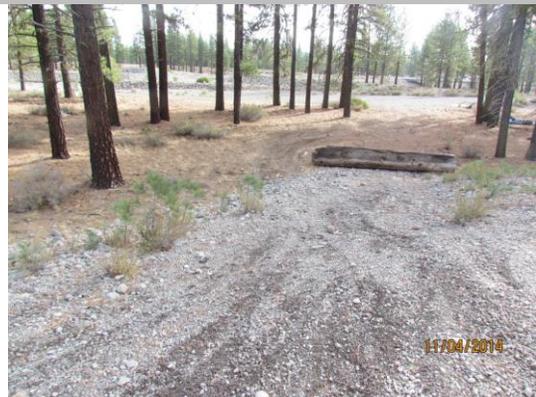
Photo 1 of 2 : SP_2015_NA0015_338_6_20150310_00006.jpg

LM Start	0.46	Rating **	M	Issue No.	6
LM End	0.46	Issue Type +	Ma	Location *	WS
Category	Earthen Levee			GPS Latitude/Longitude	
				Start	End
Item	Slope Stability			40.283059 °	40.283059 °
				-121.253989 °	-121.253989 °
DWR ID	DWR_NA0015_02_f_2013_6				
Action/Comments					
Repair the levee slope damaged by vehicle traffic and prevent access where possible.

View of the vehicle erosion on the landside slope.

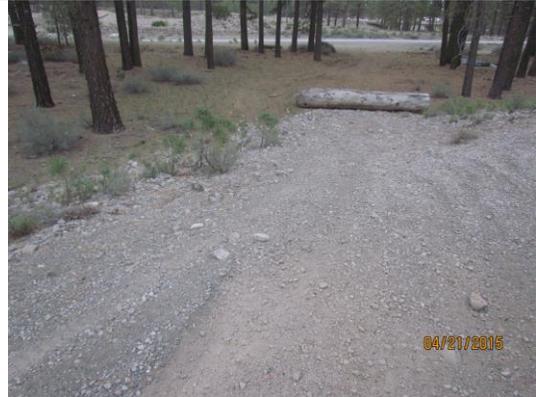
Photo 2 of 2 : SP_2015_NA0015_338_6_20150428_00011.jpg

LM Start	0.46	Rating **	M	Issue No.	6 (cont)
LM End	0.46	Issue Type +	Ma	Location *	WS
Category	Earthen Levee			GPS Latitude/Longitude	
				Start	End
Item	Slope Stability			40.283059 °	40.283059 °
				-121.253989 °	-121.253989 °
DWR ID	DWR_NA0015_02_f_2013_6				
Action/Comments					
Repair the levee slope damaged by vehicle traffic and prevent access where possible.

View of the vehicle erosion on the waterside slope.

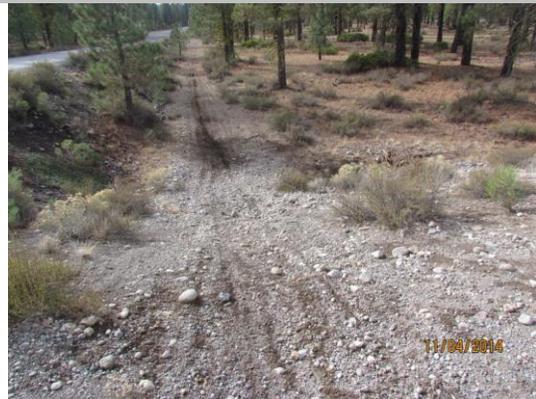
Photo 1 of 1 : SP_2015_NA0015_338_4_20150310_00004.jpg

LM Start	0.55	Rating **	M	Issue No.	4
LM End	0.55	Issue Type +	Ma	Location *	LS
Category	Earthen Levee			GPS Latitude/Longitude	
				Start	End
Item	Slope Stability			40.281950 °	121.253710 °
				40.281950 °	121.253710 °
DWR ID	DWR_NA0015_02_s_2012_4				
Action/Comments					
Repair the levee slope damaged by vehicle traffic and prevent access where possible.

View of the erosion along the landside slope.

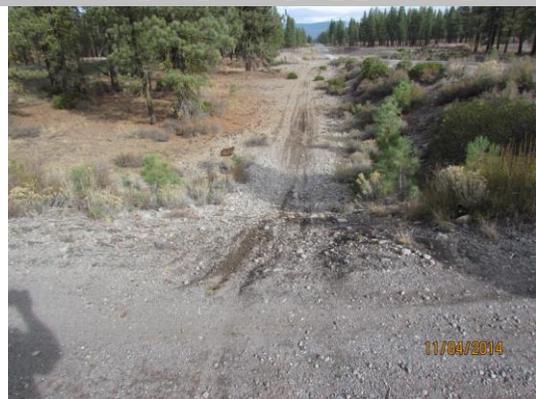
Photo 1 of 1 : SP_2015_NA0015_338_5_20150310_00005.jpg

LM Start	0.55	Rating **	M	Issue No.	5
LM End	0.55	Issue Type +	Ma	Location *	WS
Category	Earthen Levee			GPS Latitude/Longitude	
				Start	End
Item	Slope Stability			40.281950 °	121.253710 °
				40.281950 °	121.253710 °
DWR ID	DWR_NA0015_02_s_2012_5				
Action/Comments					
Repair the levee slope damaged by vehicle traffic and prevent access where possible.

View of the vehicle erosion on the waterside slope.
