Flood Control Project Maintenance
2013 Structure Summary Report
Overall Unit and Item Ratings

Plumas County

North Fork Feather River Diversion Channel Drop Structure No. 1 Through 7

Flood Control Project Maintenance
Unit Cover Sheet
2013 Structure Inspection Results

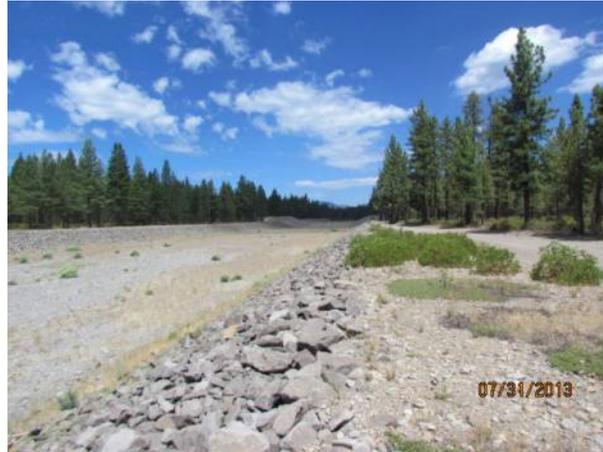
Levee Mile Report Line	14
Start Levee Mile	0.00
End Levee Mile	0.00
Location	
Category	Structures
Item	Concrete Surfaces
View of drop structure 1, looking towards the Feather River.	
rduffey_t_20130828_016.JPG

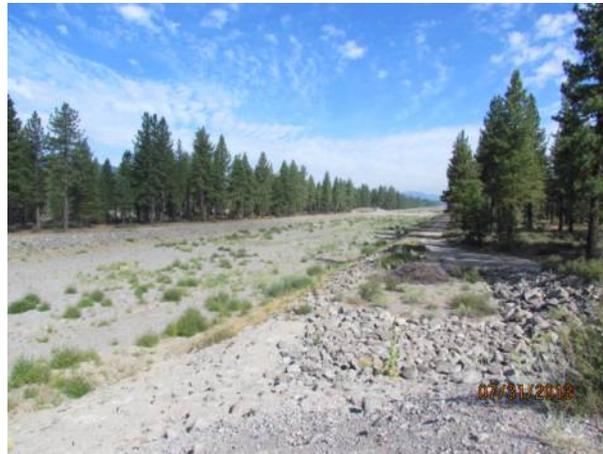
Levee Mile Report Line	23
Start Levee Mile	0.00
End Levee Mile	0.00
Location	
Category	Structures
Item	Photo Documentation
View of structure 7 looking towards 6 & 5.	
rduffey_t_20130828_017.JPG

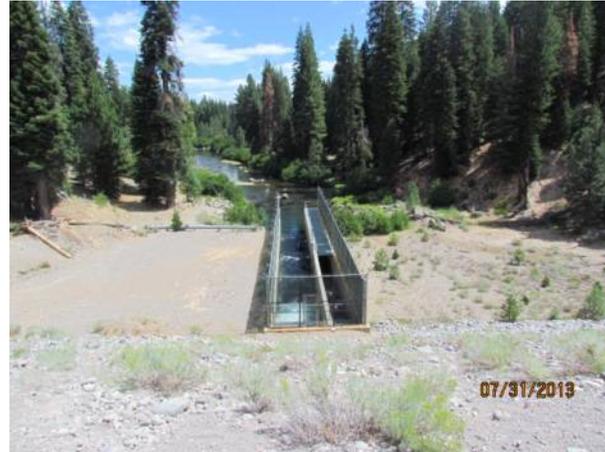
Levee Mile Report Line	1
Start Levee Mile	0.00
End Levee Mile	0.00
Location	
Category	Structures
Item	Vegetation & Obstructions
View of the outfall structure & slope of the dam.	
rduffey_t_20130828_018.JPG

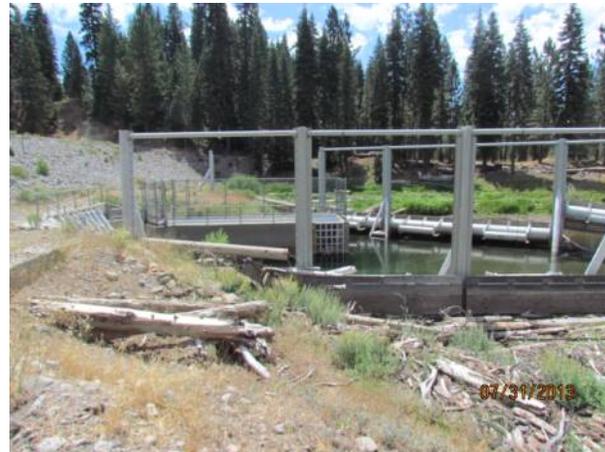
Levee Mile Report Line	5
Start Levee Mile	0.00
End Levee Mile	0.00
Location	
Category	Structures
Item	Encroachments
Remove the debris from both side of the structure.	
rduffey_t_20130828_019.JPG

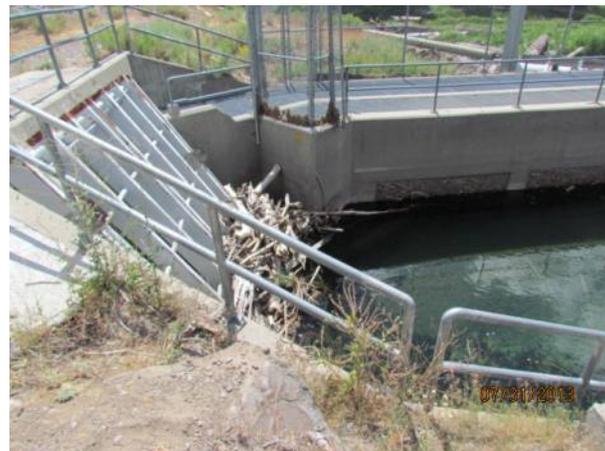
Levee Mile Report Line	9
Start Levee Mile	0.00
End Levee Mile	0.00
Location	
Category	Structures
Item	Trash Racks
View of the trash with debris blocking the flow of water.	
rduffey_t_20130828_020.JPG

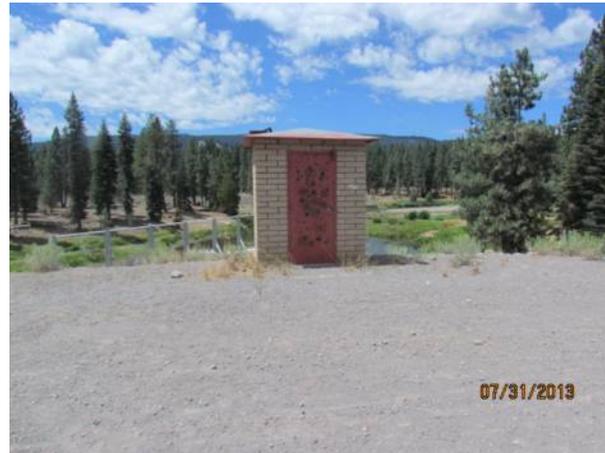
Levee Mile Report Line	12
Start Levee Mile	0.00
End Levee Mile	0.00
Location	
Category	Structures
Item	Electric Gate Operators
Gauging house on top of the dam, use discontinued due to vandalism.	
rduffey_t_20130828_022.JPG

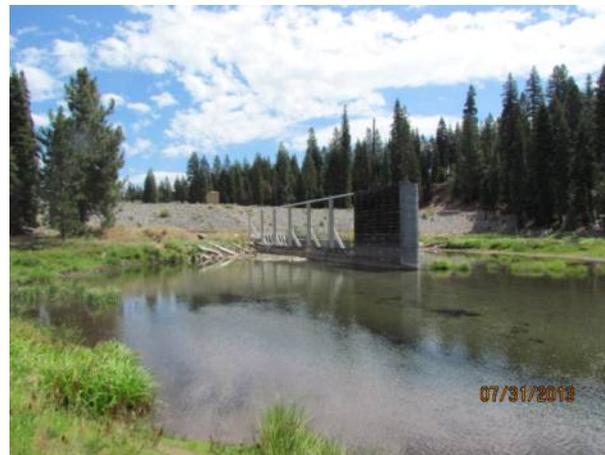
Levee Mile Report Line	23
Start Levee Mile	0.00
End Levee Mile	0.00
Location	
Category	Structures
Item	Photo Documentation
View of the dam & structure.	
rduffey_t_20130828_021.JPG
