**Flood Control Project Maintenance**  
**2014 Structure Summary Report**  
**Overall Unit and Item Ratings**

**Plumas County**

**North Fork Feather River Diversion Channel Drop Structure No. 1**

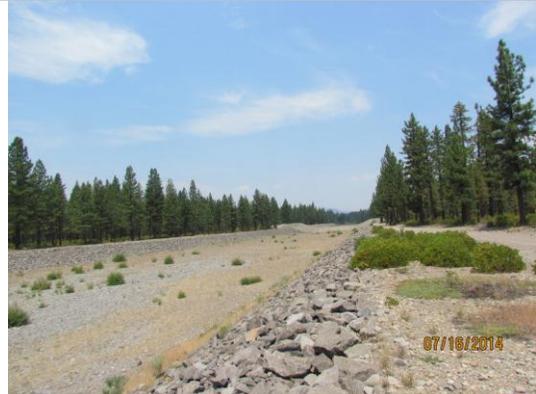
Photo 1 of 1 : ST\_2014\_NA0015\_57\_14\_20140902\_00001.jpg

LM Start	<b>0.00</b>	Rating **	A	Issue No.	<b>14</b>
LM End	<b>0.00</b>	Issue Type +	Ma	Location *	
Category	Structures & Concrete Lined Channels		GPS Latitude/Longitude		
			Start	End	
Item	Concrete Surfaces		40.299243 °	40.299243 °	
			-121.262034 °	-121.262034 °	
DWR ID	DWR_NA0015_57_t_2012_14				
Action/Comments					
Inspector Comments: The concrete surface is weathered and rough to the touch.

View of drop structure 1, looking towards the North Fork Feather River.

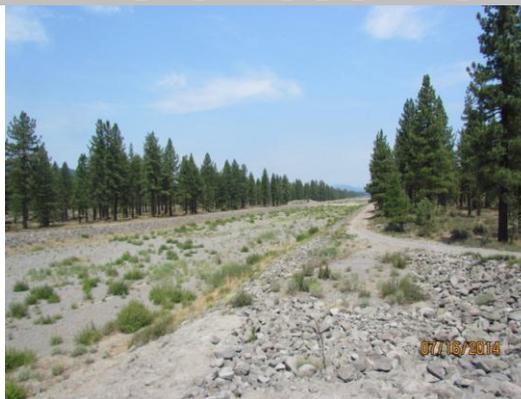
Photo 1 of 1 : ST\_2014\_NA0015\_63\_23\_20140902\_00002.jpg

View of structure No. 7 looking towards structure No. 6 & 5.

LM Start	<b>0.00</b>	Rating **	N	Issue No.	<b>23</b>
LM End	<b>0.00</b>	Issue Type +	Ma	Location *	
Category	Structures & Concrete Lined Channels		GPS Latitude/Longitude		
			Start	End	
Item	Photo Documentation		40.272544 °	40.272544 °	
			-121.246161 °	-121.246161 °	
DWR ID	DWR_NA0015_63_t_2012_23				
Action/Comments					
Inspector Comments: Spray or remove all vegetation from the channel.

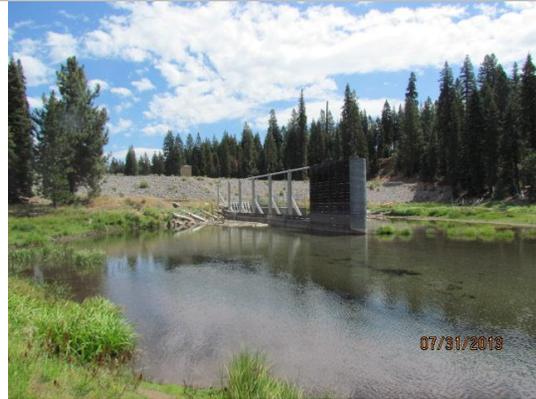
Photo 1 of 2 : ST\_2014\_NA0015\_37\_23\_20140714\_00005.jpg

View of the dam & structure.

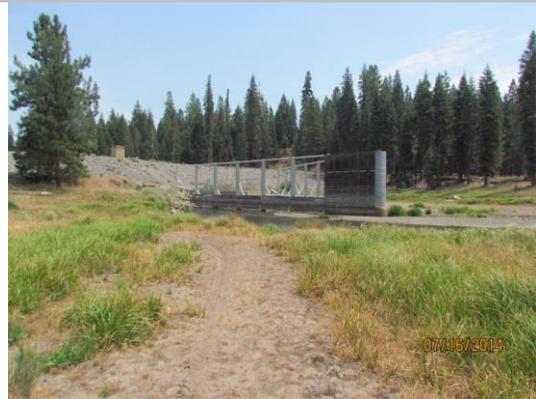
Photo 2 of 2 : ST\_2014\_NA0015\_37\_23\_20140821\_00010.jpg

View of the dam and structure.

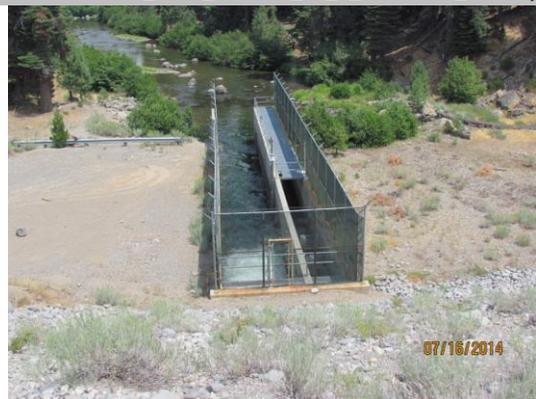
Photo 1 of 1 : ST\_2014\_NA0015\_37\_1\_20140821\_00006.jpg

View of the outfall structure and slope of the dam.

LM Start	<b>0.00</b>	Rating **	A	Issue No.	<b>1</b>
LM End	<b>0.00</b>	Issue Type +	Ma	Location *	
Category	Structures & Concrete Lined Channels			GPS Latitude/Longitude	
				Start	End
Item	Vegetation & Obstructions			40.302810 °	40.302810 °
				121.261940 °	121.261940 °
DWR ID	DWR_NA0015_37_t_2012_1				
Action/Comments					
Inspector Comments: Remove all vegetation from the face of the dam

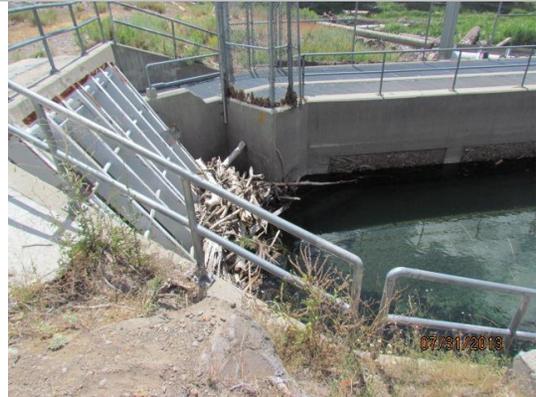
Photo 1 of 2 : ST\_2014\_NA0015\_37\_9\_20140714\_00003.jpg

View of the trash with debris blocking the flow of water previously.

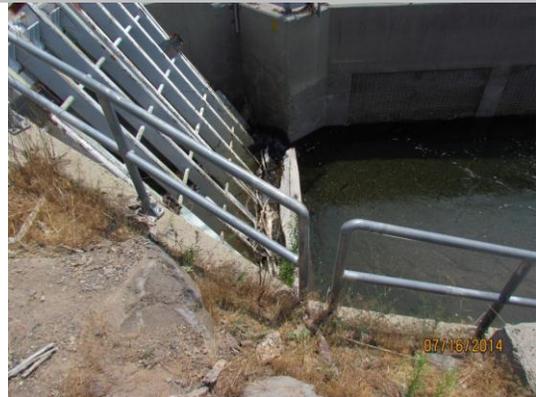
Photo 2 of 2 : ST\_2014\_NA0015\_37\_9\_20140821\_00008.jpg

LM Start	<b>0.00</b>	Rating **	A	Issue No.	<b>9</b>
LM End	<b>0.00</b>	Issue Type +	Ma	Location *	
Category	Structures & Concrete Lined Channels		GPS Latitude/Longitude		
			Start	End	
Item	Trash Racks		40.302750 °	40.302750 °	
			121.262170 °	121.262170 °	
DWR ID	DWR_NA0015_37_t_2012_9				
Action/Comments					
Inspector Comments: The debris has been removed from the trash rack.

The debris has been removed from the trash rack.

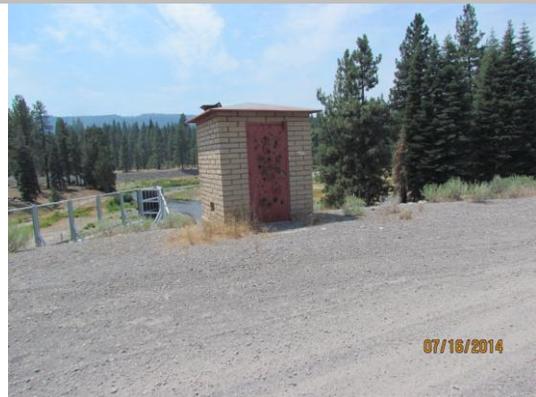
Photo 1 of 1 : ST\_2014\_NA0015\_37\_12\_20140821\_00009.jpg

Gauging house on top of the dam, use discontinued due to vandalism.
