Flood Control Project Maintenance
2015 Structure Summary Report
Overall Unit and Item Ratings

Plumas County

North Fork Feather River Diversion Channel Drop Structure No. 1

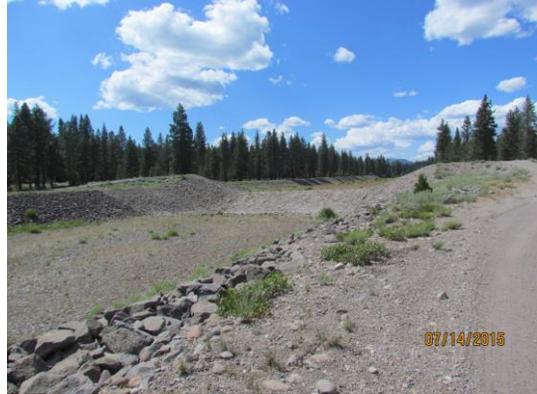
Photo 1 of 1 : ST_2015_NA0015_57_23_20150728_00002.jpg

LM Start	0.00	Rating **	N	Issue No.	23
LM End	0.00	Issue Type +	Ma	Location *	
Category	Structures & Concrete Lined Channels		GPS Latitude/Longitude		
			Start	End	
Item	Photo Documentation		40.299243 °	40.299243 °	
			-121.262034 °	-121.262034 °	
DWR ID	DWR_NA0015_57_t_2012_23				
Action/Comments					
Inspector Comments: Spray or remove all vegetation from the channel.

View of drop structure 1, looking towards the North Fork Feather River.

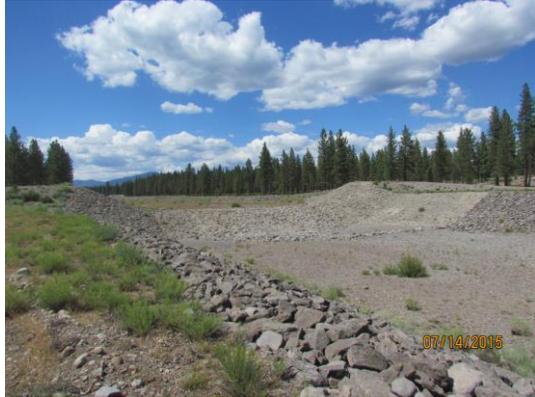
Photo 1 of 1 : ST_2015_NA0015_58_23_20150728_00001.jpg

LM Start	0.00	Rating **	N	Issue No.	23
LM End	0.00	Issue Type +	Ma	Location *	
Category	Structures & Concrete Lined Channels		GPS Latitude/Longitude		
			Start	End	
Item	Photo Documentation		40.294270 °	40.294270 °	
			-121.258935 °	-121.258935 °	
DWR ID	DWR_NA0015_58_t_2012_23				
Action/Comments					
Inspector Comments: Spray or remove all vegetation from the channel.

View of drop structure 2, looking back towards the North Fork Feather River.

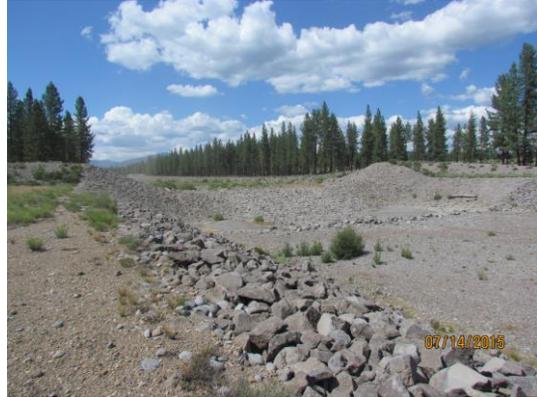
Photo 1 of 1 : ST_2015_NA0015_59_23_20150728_00001.jpg

LM Start	0.00	Rating **	N	Issue No.	23
LM End	0.00	Issue Type +	Ma	Location *	
Category	Structures & Concrete Lined Channels		GPS Latitude/Longitude		
			Start	End	
Item	Photo Documentation		40.294270 °	40.294270 °	
			-121.256375 °	-121.256375 °	
DWR ID	DWR_NA0015_59_t_2012_23				
Action/Comments					
Inspector Comments: Spray or remove all vegetation from the channel.

View of drop structure 3, looking towards drop structure 2.

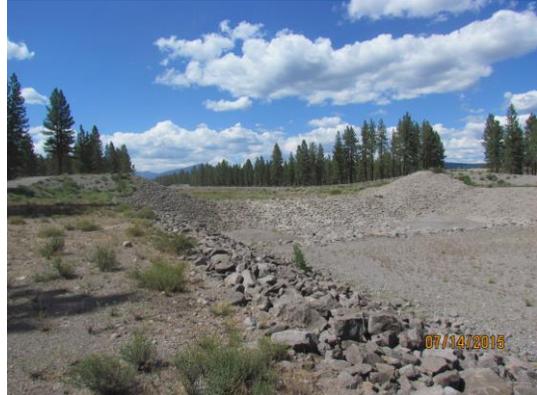
Photo 1 of 1 : ST_2015_NA0015_60_23_20150728_00001.jpg

LM Start	0.00	Rating **	N	Issue No.	23
LM End	0.00	Issue Type +	Ma	Location *	
Category	Structures & Concrete Lined Channels		GPS Latitude/Longitude		
			Start	End	
Item	Photo Documentation		40.285653 °	40.285653 °	
			-121.253902 °	-121.253902 °	
DWR ID	DWR_NA0015_60_t_2012_23				
Action/Comments					
Inspector Comments: Spray or remove all vegetation from the channel.

View of drop structure 4, looking back at drop structure 3.

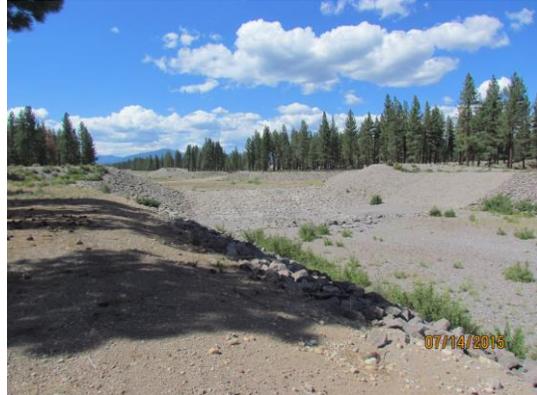
Photo 1 of 1 : ST_2015_NA0015_61_23_20150728_00001.jpg

LM Start	0.00	Rating **	N	Issue No.	23
LM End	0.00	Issue Type +	Ma	Location *	
Category	Structures & Concrete Lined Channels		GPS Latitude/Longitude		
			Start	End	
Item	Photo Documentation		40.283028 °	40.283028 °	
			-121.252348 °	-121.252348 °	
DWR ID	DWR_NA0015_61_t_2012_23				
Action/Comments					
Inspector Comments: Spray or remove all vegetation from the channel.

View of the drop structure 5, Look towards drop structure 4.

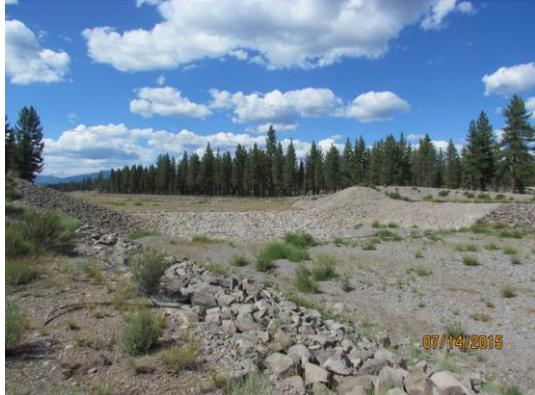
Photo 1 of 1 : ST_2015_NA0015_62_23_20150728_00001.jpg

LM Start	0.00	Rating **	N	Issue No.	23
LM End	0.00	Issue Type +	Ma	Location *	
Category	Structures & Concrete Lined Channels		GPS Latitude/Longitude		
			Start	End	
Item	Photo Documentation		40.275902 °	40.275902 °	
			-121.248142 °	-121.248142 °	
DWR ID	DWR_NA0015_62_t_2012_23				
Action/Comments					
Inspector Comments: Spray or remove all vegetation from the channel.

View of drop structure 6, looking towards drop structure 5.

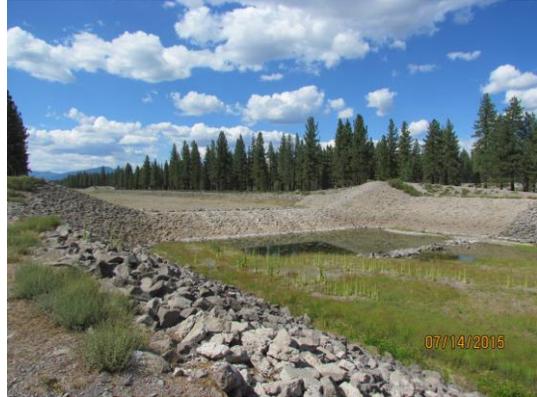
Photo 1 of 1 : ST_2015_NA0015_63_23_20150728_00003.jpg

LM Start	0.00	Rating **	N	Issue No.	23
LM End	0.00	Issue Type +	Ma	Location *	
Category	Structures & Concrete Lined Channels		GPS Latitude/Longitude		
			Start	End	
Item	Photo Documentation		40.272544 °	40.272544 °	
			-121.246161 °	-121.246161 °	
DWR ID	DWR_NA0015_63_t_2015_23				
Action/Comments					
Inspector Comments: Plumas Co. is removing all vegetation from the channel.

View of drop structure 7, looking back towards drop structure 6.

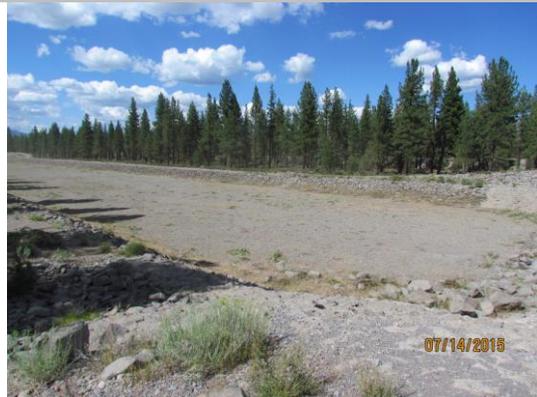
Photo 1 of 1 : ST_2015_NA0015_63_1_20150728_00004.jpg

LM Start	0.00	Rating **	A	Issue No.	1
LM End	0.00	Issue Type +	Ma	Location *	
Category	Structures & Concrete Lined Channels		GPS Latitude/Longitude		
			Start	End	
Item	Vegetation & Obstructions		40.272544 °	40.272544 °	
			-121.246161 °	-121.246161 °	
DWR ID	DWR_NA0015_63_t_2012_1				
Action/Comments					
Inspector Comments: All vegetation needs to be removed from the drop structure before winter.

Plumas Co. was removing all vegetation from the channel.

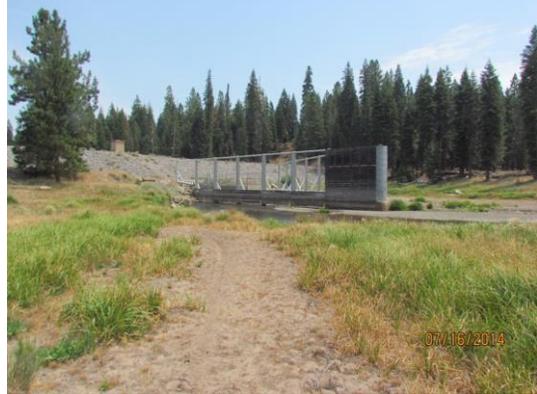
Photo 1 of 2 : ST_2015_NA0015_37_23_20150616_00006.jpg

View of the dam and structure. 2014

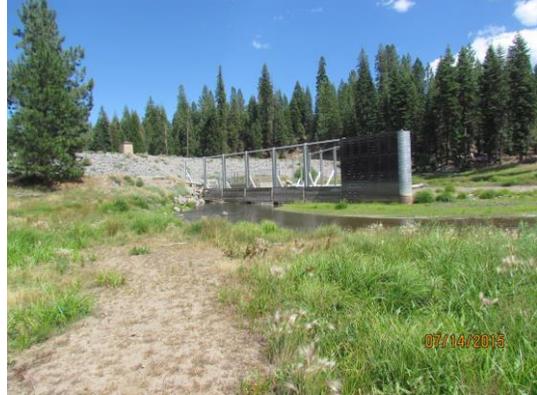
Photo 2 of 2 : ST_2015_NA0015_37_23_20150728_00012.jpg

View of the dam and structure. 2015

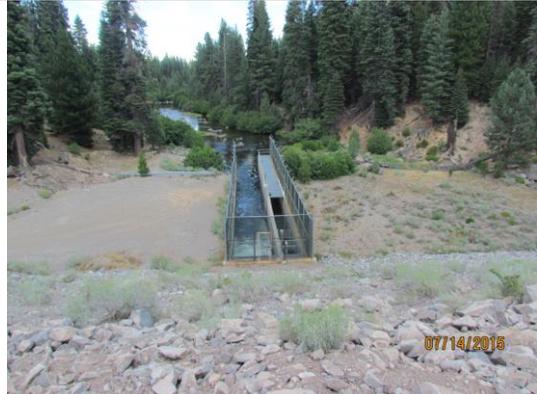
Photo 1 of 1 : ST_2015_NA0015_37_1_20150728_00008.jpg

LM Start	0.00	Rating **	A	Issue No.	1
LM End	0.00	Issue Type +	Ma	Location *	
Category	Structures & Concrete Lined Channels		GPS Latitude/Longitude		
			Start	End	
Item	Vegetation & Obstructions		40.302810 °	40.302810 °	
			-121.261940 °	-121.261940 °	
DWR ID	DWR_NA0015_37_t_2012_1				
Action/Comments					
Inspector Comments: Remove all vegetation from the face of the dam area before winter.

View of the outfall structure and slope of the dam.

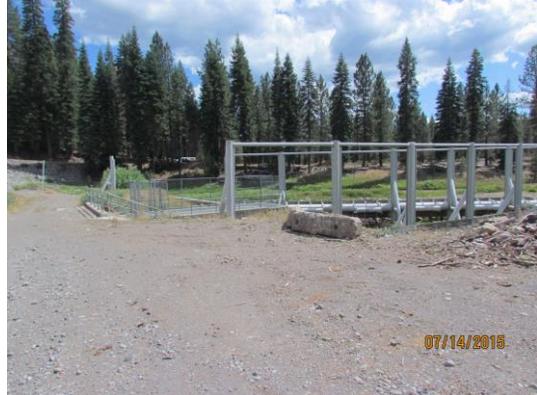
Photo 1 of 1 : ST_2015_NA0015_37_5_20150728_00009.jpg

LM Start	0.00	Rating **	A	Issue No.	5
LM End	0.00	Issue Type +	Ma	Location *	
Category	Structures & Concrete Lined Channels		GPS Latitude/Longitude		
			Start	End	
Item	Encroachments		40.302640 °	40.302640 °	
			-121.263190 °	-121.263190 °	
DWR ID	DWR_NA0015_37_t_2012_5				
Action/Comments					
Inspector Comments: Plumas Co removed all debris this spring.

Plumas Co. removed all debris from around the structure.

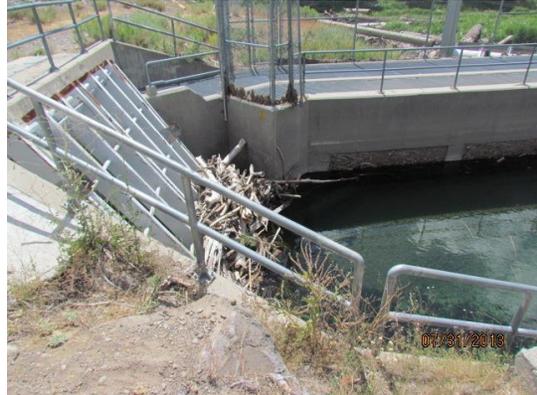
Photo 1 of 2 : ST_2015_NA0015_37_9_20150616_00004.jpg

LM Start	0.00	Rating **	A	Issue No.	9
LM End	0.00	Issue Type +	Ma	Location *	
Category	Structures & Concrete Lined Channels		GPS Latitude/Longitude		
			Start	End	
Item	Trash Racks		40.302750 °	40.302750 °	
			-121.262170 °	-121.262170 °	
DWR ID	DWR_NA0015_37_t_2012_9				
Action/Comments					
Inspector Comments: The debris has been removed from the trash rack.

View of the trash with debris blocking the flow of water previously.

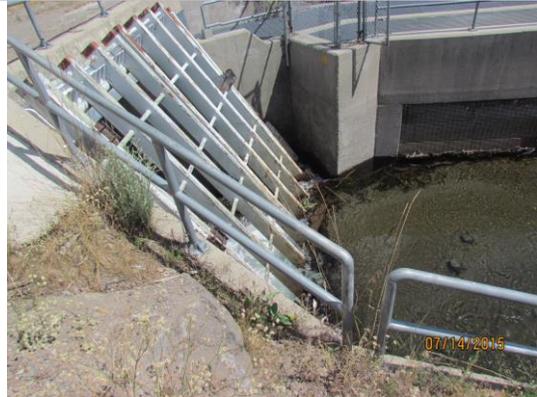
Photo 2 of 2 : ST_2015_NA0015_37_9_20150728_00010.jpg

Plumas Co. removed all debris from the trash rack.

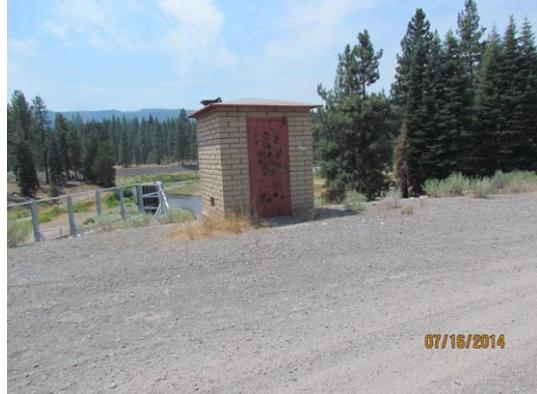
Photo 1 of 2 : ST_2015_NA0015_37_12_20150616_00005.jpg

Gauging house on top of the dam, use discontinued due to vandalism.

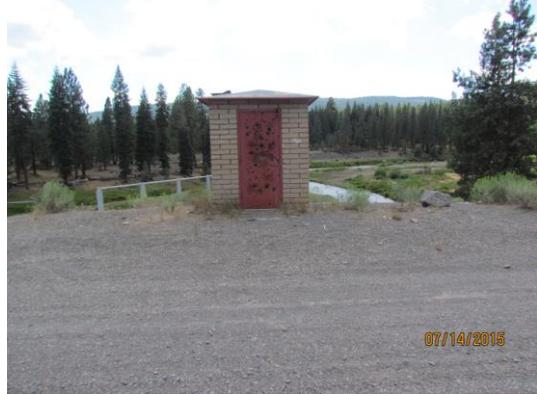
Photo 2 of 2 : ST_2015_NA0015_37_12_20150728_00011.jpg

Gauging house on top of the dam, use discontinued due to vandalism.
