**Flood Control Project Maintenance
Levee Inspections**

Fall 2010 Levee Maintenance Deficiency Summary Report

Sacramento River West Side Levee District

Levee Inspection Report By Mile - Fall 2010

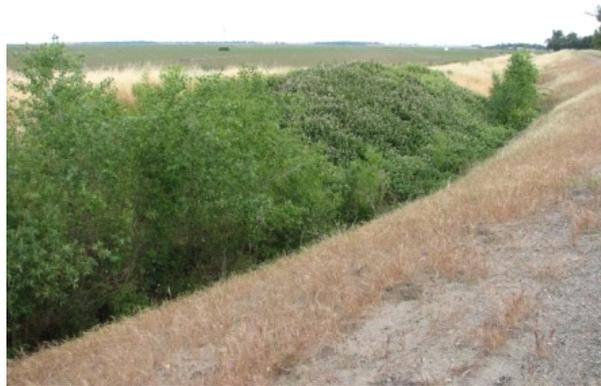
Levee Mile Report Line	1
Start Levee Mile	0.98
End Levee Mile	0.98
Location	Land Side
Category	Earthen Levee
Item	Vegetation
trees and berries	
johngw_f_20101012_066.jpg

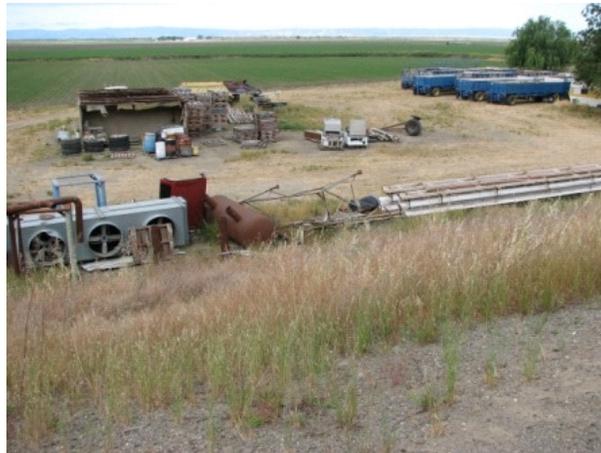
Levee Mile Report Line	2
Start Levee Mile	2.44
End Levee Mile	2.44
Location	Land Side
Category	Earthen Levee
Item	Encroachments
equipment within the easement	
johngw_f_20101012_064.jpg

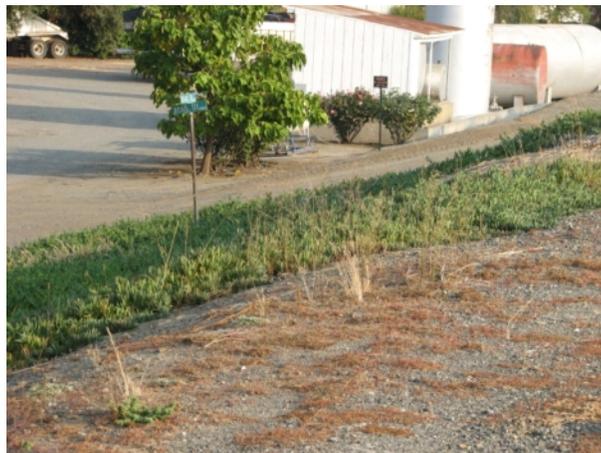
Levee Mile Report Line	3
Start Levee Mile	2.83
End Levee Mile	2.83
Location	Land Side
Category	Earthen Levee
Item	Encroachments
Landscape at River Garden Farms.	
johngw_f_20101025_251.jpg

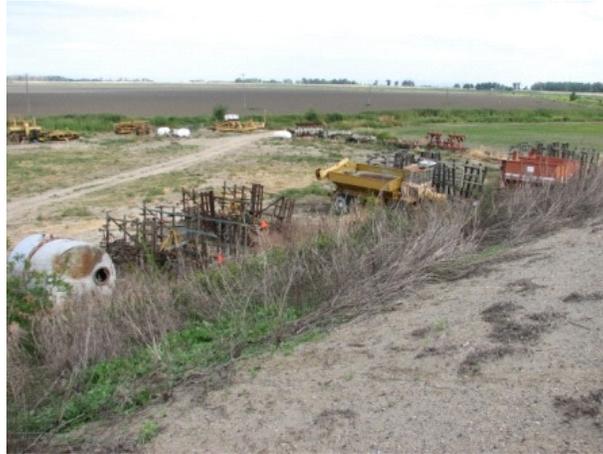
Levee Mile Report Line	4
Start Levee Mile	3.02
End Levee Mile	3.02
Location	Land Side
Category	Earthen Levee
Item	Encroachments
along toe	
johngw_f_20101012_065.jpg

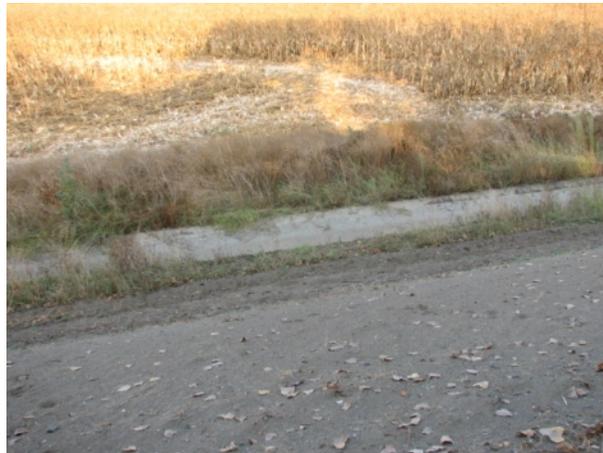
Levee Mile Report Line	5
Start Levee Mile	3.59
End Levee Mile	3.97
Location	Land Side
Category	Earthen Levee
Item	Encroachments
Concrete lined ag ditch along toe of levee.	
johngw_f_20101025_252.jpg

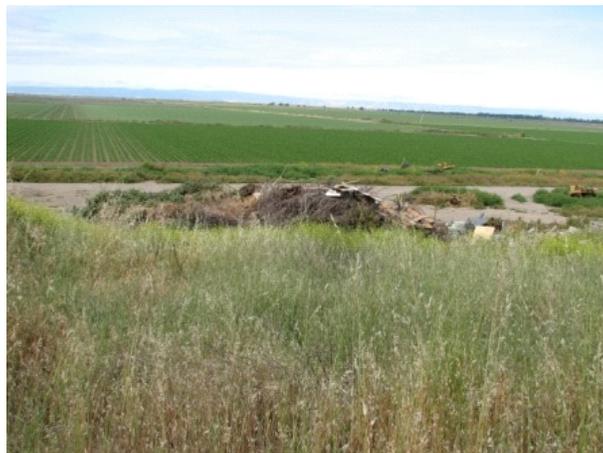
Levee Mile Report Line	6
Start Levee Mile	4.66
End Levee Mile	4.66
Location	Land Side
Category	Earthen Levee
Item	Encroachments
debris at toe also pile of concrete debris	
johngw_f_20101012_067.jpg

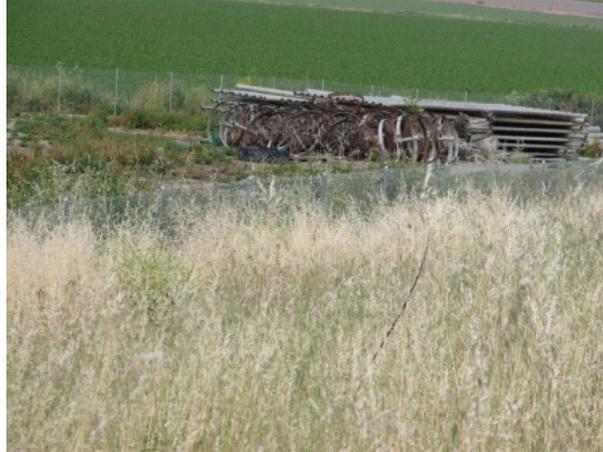
Levee Mile Report Line	7
Start Levee Mile	4.85
End Levee Mile	4.85
Location	Land Side
Category	Earthen Levee
Item	Encroachments
chain link fence along toe	
johnngw_f_20101012_068.jpg

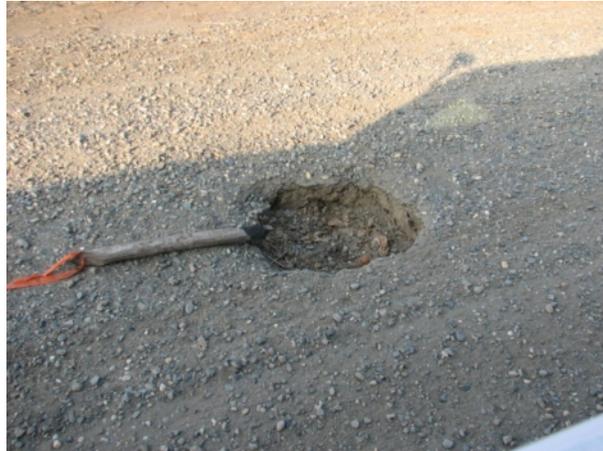
8	5.80	5.80	Earthen Levee	Crown Surface / Depressions / Rutting	CR	U	Add appropriate gravel or road base. Grade and compact. Inspector Comments: depression center of crown app.14" dia. 6" deep need to excavate and recompact.	38.865858 ° -121.747403 °	38.865858 ° -121.747403 °	1 Y
9	6.73	6.73	Earthen Levee	Animal Control	WS	M	No rodents visible, but rodent burrows visible; need to backfill and compact or grout borrows.	38.866712 ° -121.758605 °	38.866712 ° -121.758605 °	2 Y
10	8.86	8.86	Earthen Levee	Encroachments	LS	PO	Buildings	38.855440 ° -121.784173 °	38.855440 ° -121.784173 °	11 Y
11	9.29	9.29	Earthen Levee	Animal Control	LS	M	Exterminate rodents and backfill and compact or grout burrows.	38.860750 ° -121.784717 °	38.860750 ° -121.784717 °	964
12	9.32	9.32	Earthen Levee	Animal Control	LS	M	Exterminate rodents and backfill and compact or grout burrows.	38.861258 ° -121.784822 °	38.861258 ° -121.784822 °	965

Levee Mile Report Line	8
Start Levee Mile	5.80
End Levee Mile	5.80
Location	Crown
Category	Earthen Levee
Item	Crown Surface / Depressions / Rutting
Hole in the center of levee crown unknown cause of the depression. Needs to be address before winter.	
johnngw_f_20101025_253.jpg

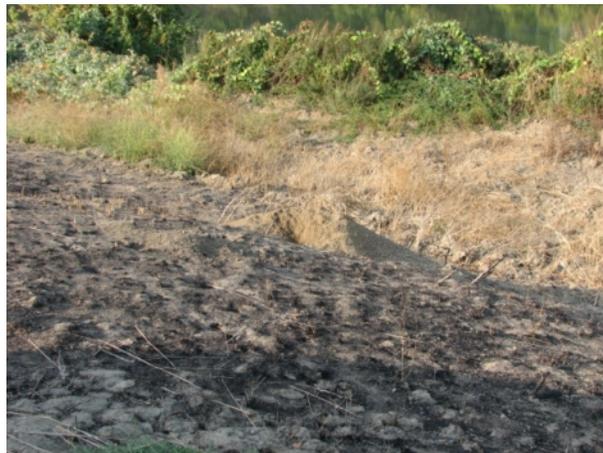
Levee Mile Report Line	9
Start Levee Mile	6.73
End Levee Mile	6.73
Location	Water Side
Category	Earthen Levee
Item	Animal Control
A fairly large rodent hole on the waterward side.	
johnngw_f_20101025_254.jpg

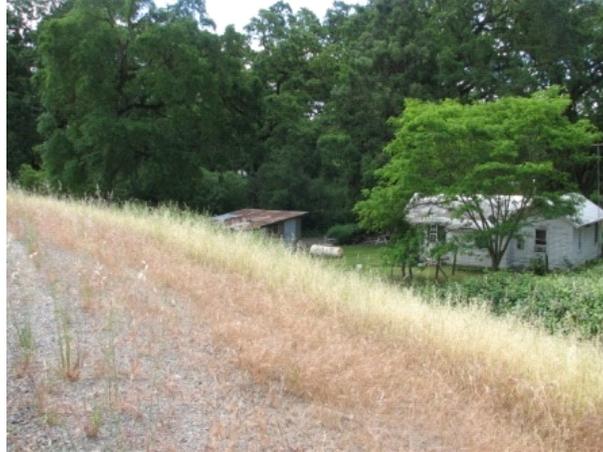
Levee Mile Report Line	10
Start Levee Mile	8.86
End Levee Mile	8.86
Location	Land Side
Category	Earthen Levee
Item	Encroachments
out building is within the easement	
johngw_f_20101012_069.jpg

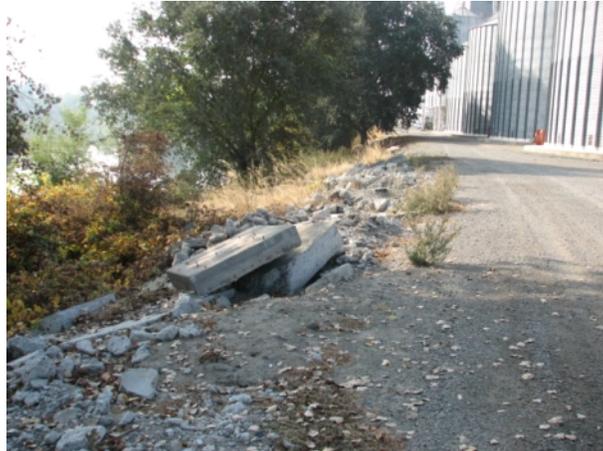
Levee Mile Report Line	17
Start Levee Mile	12.35
End Levee Mile	12.35
Location	Water Side
Category	Earthen Levee
Item	Encroachments
Concrete debris on the waterside with rebar still in the concrete. Must remove all rebar from debris or remove all debris.	
johngw_f_20101025_255.jpg

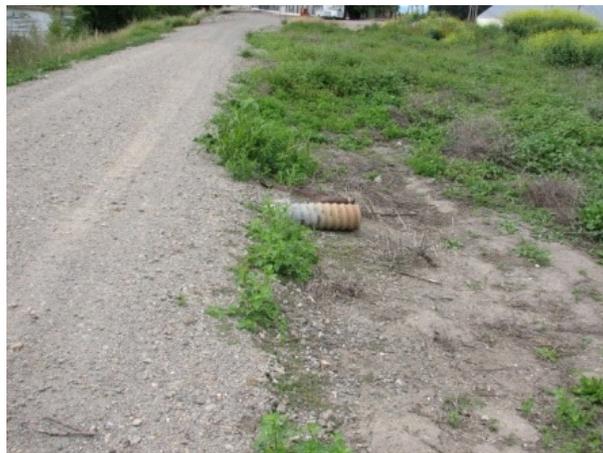
Levee Mile Report Line	18
Start Levee Mile	12.41
End Levee Mile	12.41
Location	Crown
Category	Earthen Levee
Item	Encroachments
landside view of drain pipe	
johngw_f_20101012_070.jpg

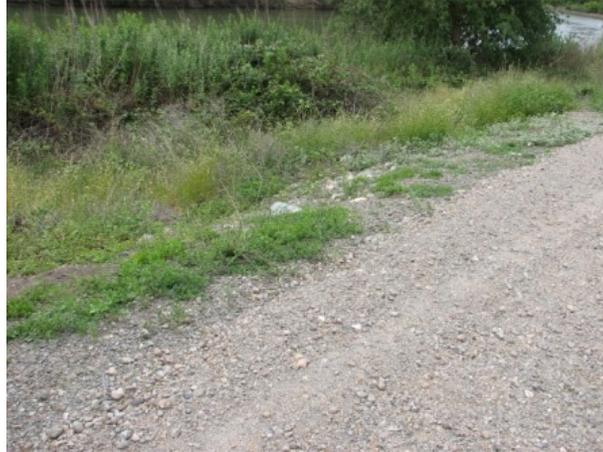
Levee Mile Report Line	18
Start Levee Mile	12.41
End Levee Mile	12.41
Location	Crown
Category	Earthen Levee
Item	Encroachments
waterside view of pipe	
johngw_f_20101012_071.jpg

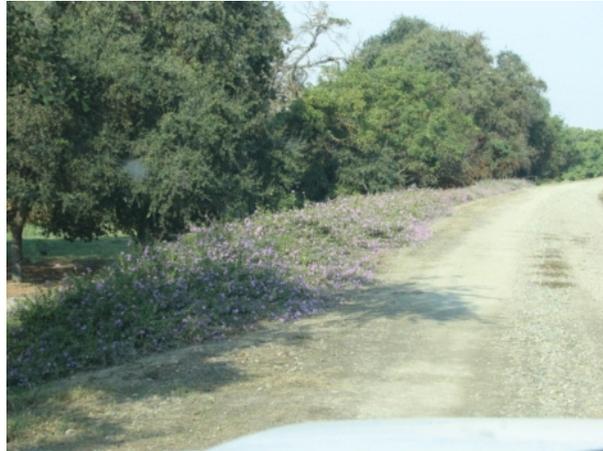
Levee Mile Report Line	24
Start Levee Mile	18.89
End Levee Mile	18.89
Location	Land Side
Category	Earthen Levee
Item	Encroachments
Groundcover and trees planted on landside levee slope.	
johngw_f_20101025_256.jpg

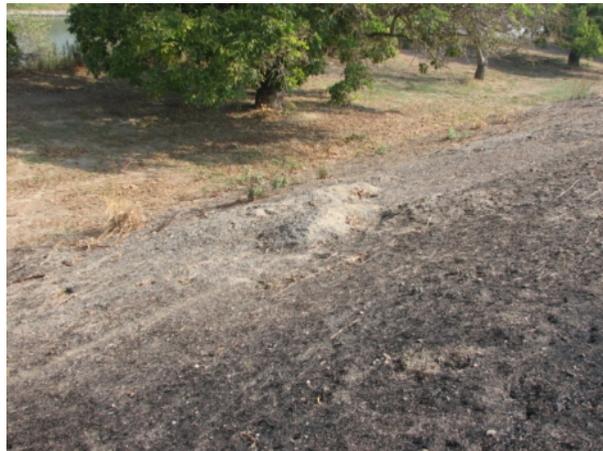
Levee Mile Report Line	41
Start Levee Mile	23.90
End Levee Mile	23.90
Location	Water Side
Category	Earthen Levee
Item	Animal Control
Rodent hole landside levee slope many in the area.	
johngw_f_20101025_257.jpg

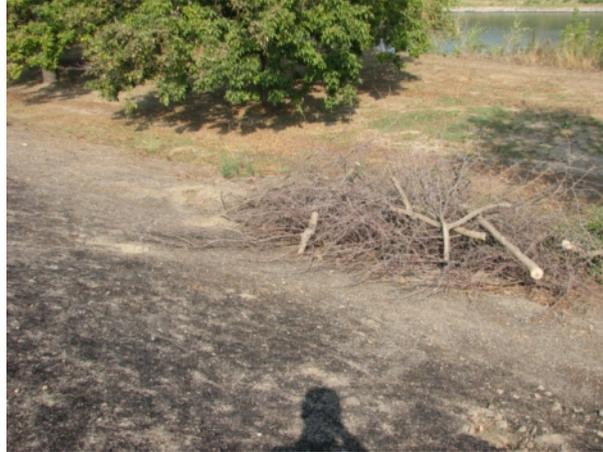
Levee Mile Report Line	42
Start Levee Mile	23.94
End Levee Mile	23.94
Location	Water Side
Category	Earthen Levee
Item	Encroachments
Pruning pile ready to burn on the waterside of the levee.	
johngw_f_20101025_258.jpg

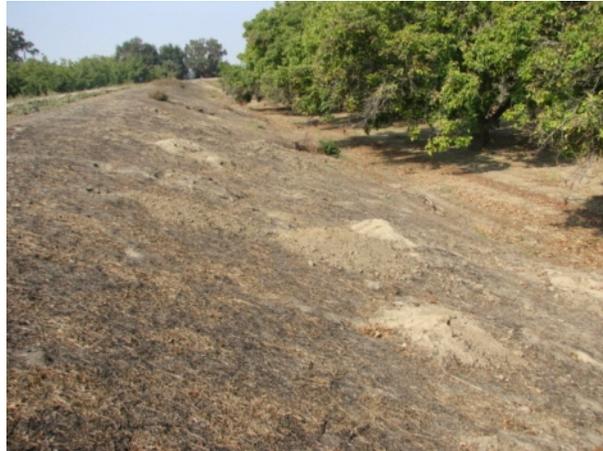
Levee Mile Report Line	43
Start Levee Mile	23.98
End Levee Mile	23.98
Location	Water Side
Category	Earthen Levee
Item	Animal Control
Many large rodent burrows along the waterside levee slope.	
johngw_f_20101025_259.jpg

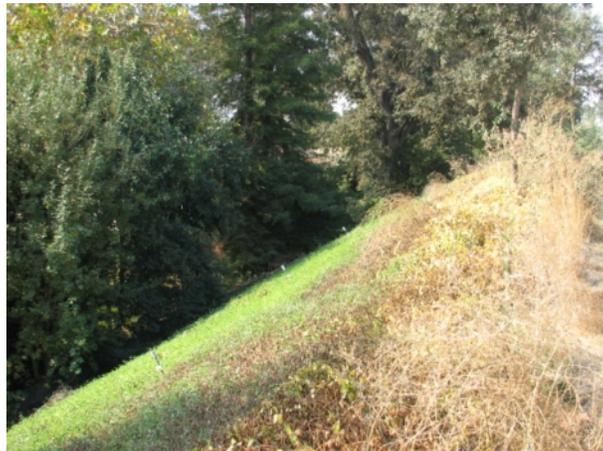
Levee Mile Report Line	46
Start Levee Mile	25.13
End Levee Mile	25.13
Location	Land Side
Category	Earthen Levee
Item	Encroachments
Groundcover and trees planted on the landside levee slope. The landscape is also irrigated.	
johngw_f_20101025_260.jpg

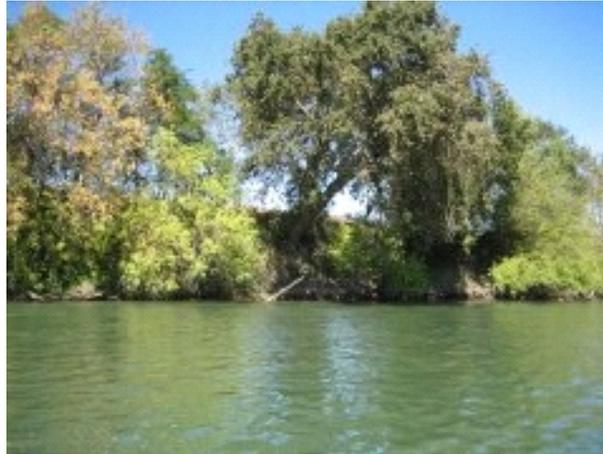
Levee Mile Report Line	48
Start Levee Mile	26.06
End Levee Mile	26.22
Location	Water Side
Category	Supplemental
Item	USACE Erosion Survey
2009: 10 ft berm, 1:1 slope, tree hazards and holes, clays and silts, 4.64 ft/s [2009 SiteID:SAC_118-0_R]	
johngw_f_20101012_072.JPG

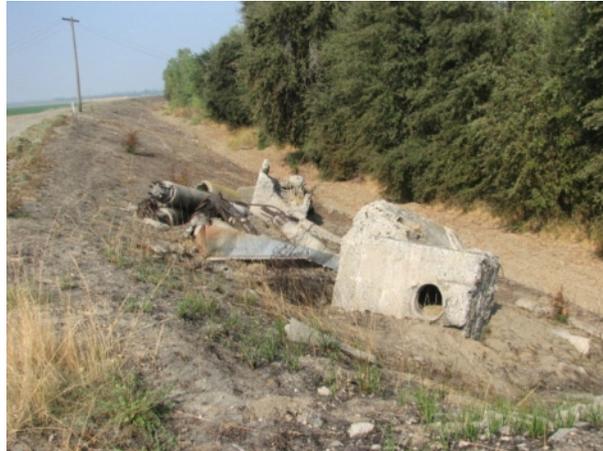
53	28.37	28.37	Earthen Levee	Encroachments	WS	M	Debris Inspector Comments: piles of concrete	39.040793 ° -121.835445 °	39.040793 ° -121.835445 °	59 Y

Levee Mile Report Line	53
Start Levee Mile	28.37
End Levee Mile	28.37
Location	Water Side
Category	Earthen Levee
Item	Encroachments
Concrete debris on waterside levee slope.	
johngw_f_20101025_261.jpg

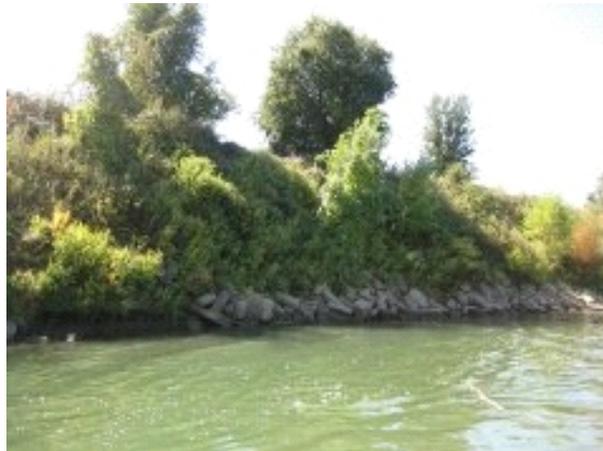
Levee Mile Report Line	54
Start Levee Mile	31.81
End Levee Mile	31.83
Location	Water Side
Category	Supplemental
Item	USACE Erosion Survey
2009: 15 ft berm, vertical slope, no stability issues, clays and silts, 5.3 ft/s [2009 SiteID:SAC_123-7_R]	
johngw_f_20101012_073.JPG

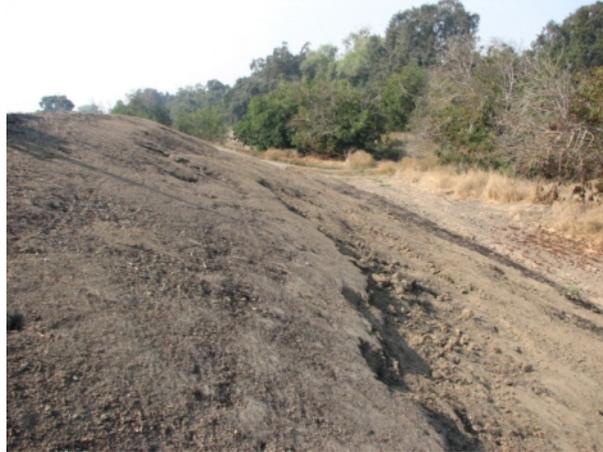
Levee Mile Report Line	63
Start Levee Mile	39.91
End Levee Mile	39.91
Location	Land Side
Category	Earthen Levee
Item	Erosion / Bank Caving
This erosion is caused by old rodent holes.	
johngw_f_20101025_262.jpg

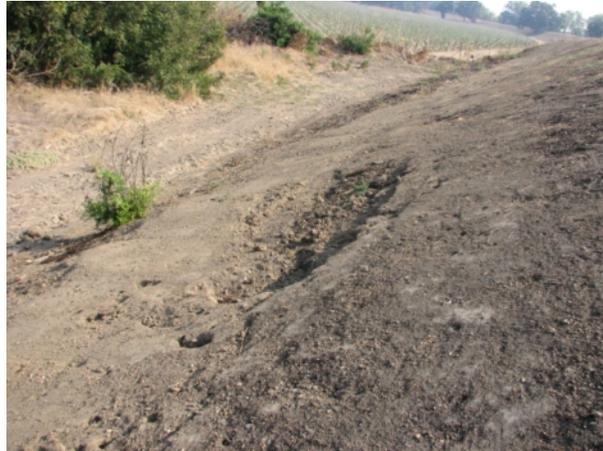
Levee Mile Report Line	63
Start Levee Mile	39.91
End Levee Mile	39.91
Location	Land Side
Category	Earthen Levee
Item	Erosion / Bank Caving
Levee slope caving in.	
johngw_f_20101025_263.jpg

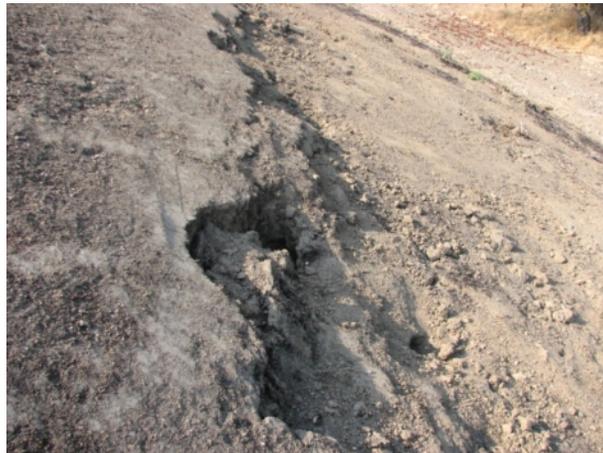
Levee Mile Report Line	63
Start Levee Mile	39.91
End Levee Mile	39.91
Location	Land Side
Category	Earthen Levee
Item	Erosion / Bank Caving
Close up of the damage to the slope.	
johngw_f_20101025_264.jpg

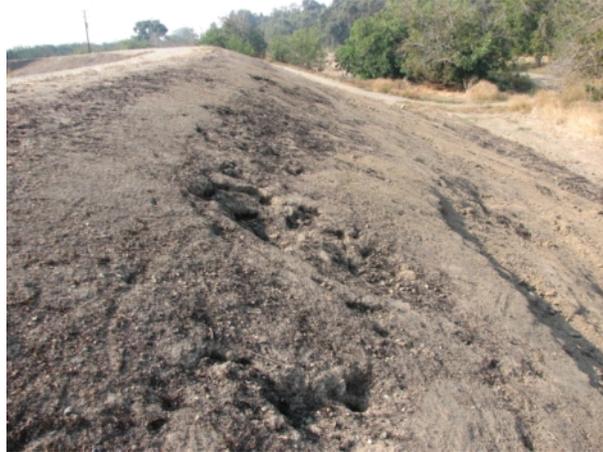
Levee Mile Report Line	63
Start Levee Mile	39.91
End Levee Mile	39.91
Location	Land Side
Category	Earthen Levee
Item	Erosion / Bank Caving
<p>Over view of the eroision needs to adressed as soon as possible.</p>	
<p>johngw_f_20101025_265.jpg</p>

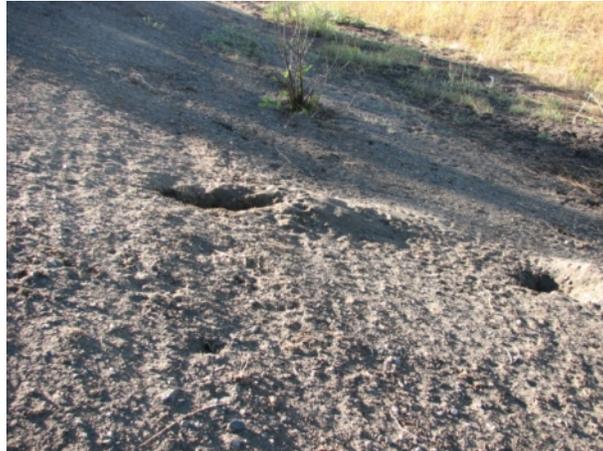
Levee Mile Report Line	65
Start Levee Mile	41.34
End Levee Mile	41.34
Location	Land Side
Category	Earthen Levee
Item	Animal Control
<p>A large rodent hole on the landside.</p>	
<p>johngw_f_20101101_266.jpg</p>

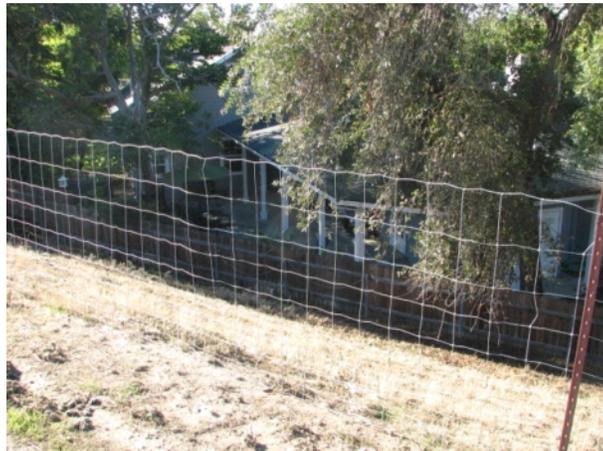
Levee Mile Report Line	71
Start Levee Mile	43.68
End Levee Mile	43.68
Location	Water Side
Category	Earthen Levee
Item	Encroachments
<p>Fence is along the landside shoulder to prevent animals from entering the landscape.</p>	
<p>johngw_f_20101101_267.jpg</p>

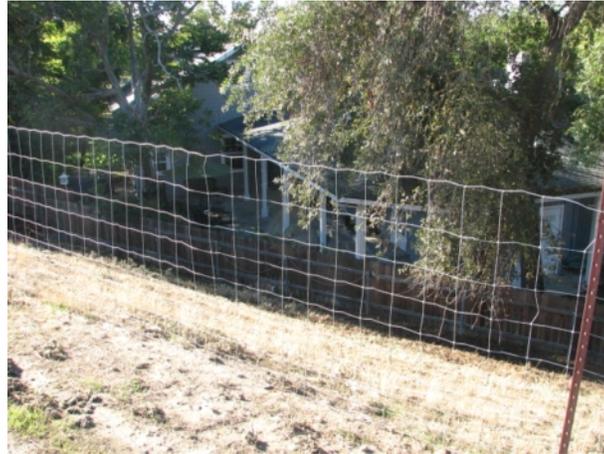
johngw_f_20101101_268.jpg

The corner of the house in the photo is encroaching into the easement.

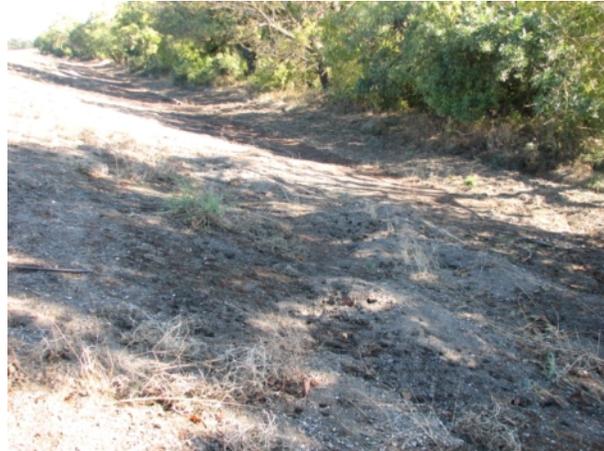
Levee Mile Report Line	76
Start Levee Mile	44.29
End Levee Mile	44.29
Location	Water Side
Category	Earthen Levee
Item	Animal Control

Large mounds of soil from rodents on the waterside. There are many holes in the area.

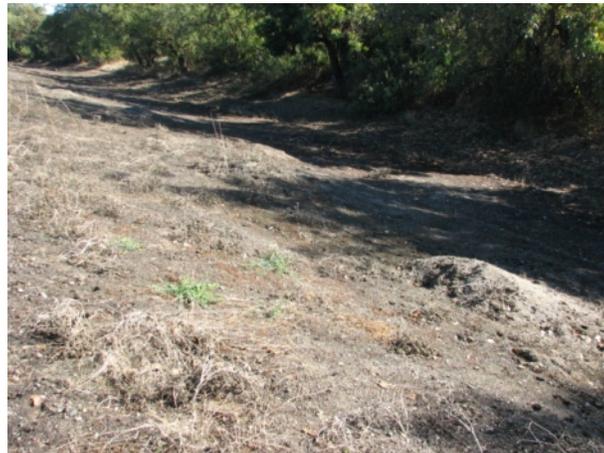
Levee Mile Report Line	76
Start Levee Mile	44.29
End Levee Mile	44.29
Location	Water Side
Category	Earthen Levee
Item	Animal Control

Here is another photo of the mounds.

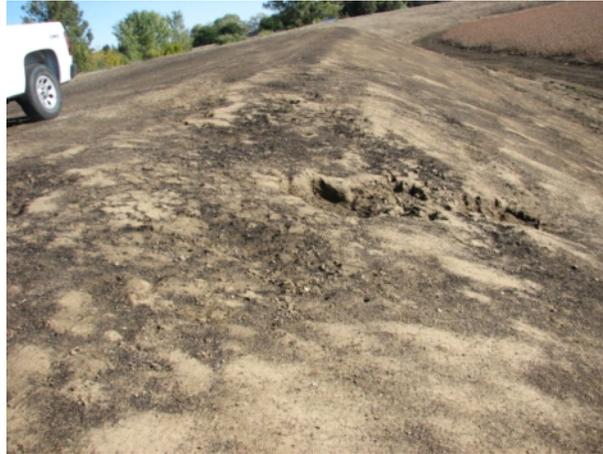
Levee Mile Report Line	78
Start Levee Mile	45.61
End Levee Mile	45.61
Location	Land Side
Category	Earthen Levee
Item	Erosion / Bank Caving
<p>This is eroision from old rodent holes the area needs to be dug up and recompacted.</p>	
<p>johngw_f_20101101_270.jpg</p>

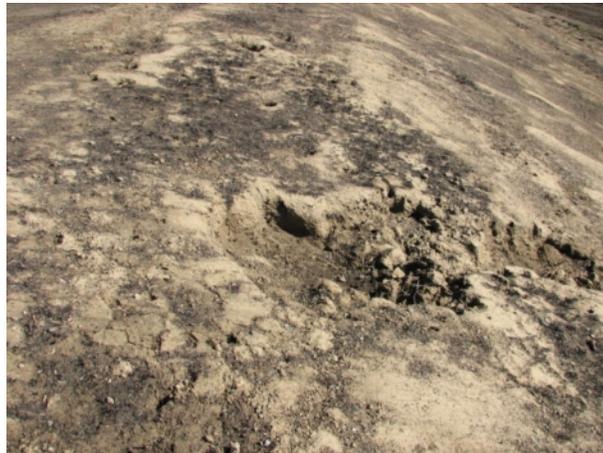
Levee Mile Report Line	78
Start Levee Mile	45.61
End Levee Mile	45.61
Location	Land Side
Category	Earthen Levee
Item	Erosion / Bank Caving
<p>A close up view of the eroision to show the depth of the eroision.</p>	
<p>johngw_f_20101101_271.jpg</p>

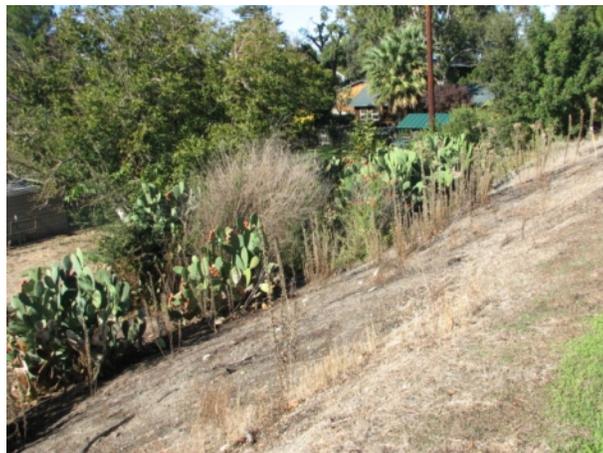
Levee Mile Report Line	80
Start Levee Mile	47.57
End Levee Mile	47.57
Location	Land Side
Category	Earthen Levee
Item	Encroachments
<p>Cactus is planted on the landside slope of the levee.</p>	
<p>johngw_f_20101101_273.jpg</p>

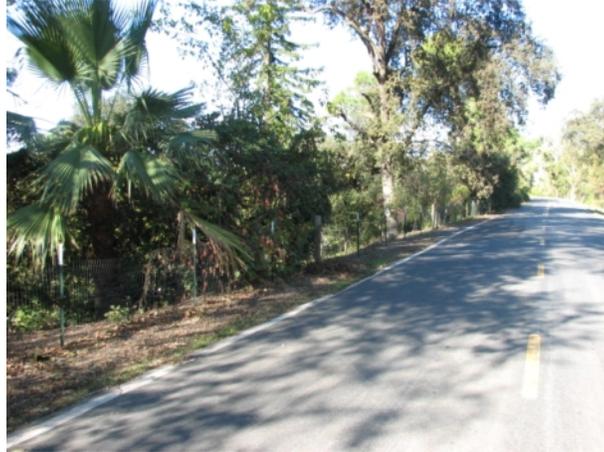
Levee Mile Report Line	80
Start Levee Mile	47.57
End Levee Mile	47.57
Location	Land Side
Category	Earthen Levee
Item	Encroachments
Landscaping along the shoulder and landside levee slope.	
johngw_f_20101101_274.jpg

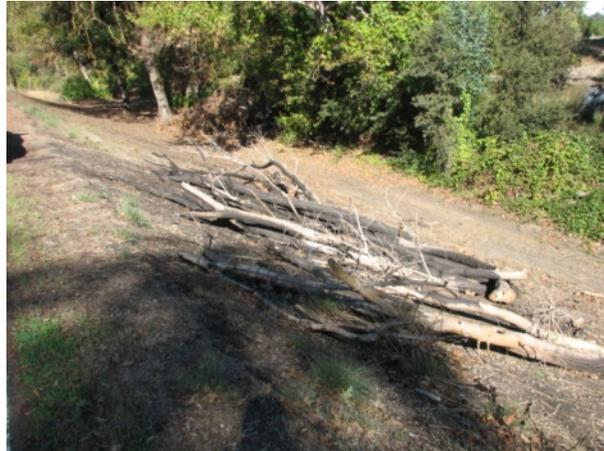
83	49.64	49.64	Earthen Levee	Encroachments	WS M	Prunings		39.211080 ° -121.991378 °	39.211080 ° -121.991378 °	77 Y
84	49.79	49.79	Earthen Levee	Animal Control	LS M	Exterminate rodents and backfill and compact or grout burrows.		39.212560 ° -121.993522 °	39.212560 ° -121.993522 °	980
85	50.11	50.11	Earthen Levee	Encroachments	LS PO	Landscaping Inspector Comments: Agave plants at toe of levee		39.213613 ° -121.998997 °	39.213613 ° -121.998997 °	58

Levee Mile Report Line	83
Start Levee Mile	49.64
End Levee Mile	49.64
Location	Water Side
Category	Earthen Levee
Item	Encroachments
Prunings that did not completely burn and are on the waterside slope.	
johngw_f_20101101_275.jpg
