**Flood Control Project Maintenance  
Levee Inspections  
LMA District Cover Sheet  
Spring 2011 Levee Inspection Results**

**Sacramento River West Side Levee District**

**Spring 2011 Levee Inspection Results**

Waterway	Bank	Unit Miles
Unit No. 01 Sacramento River	Right	50.21

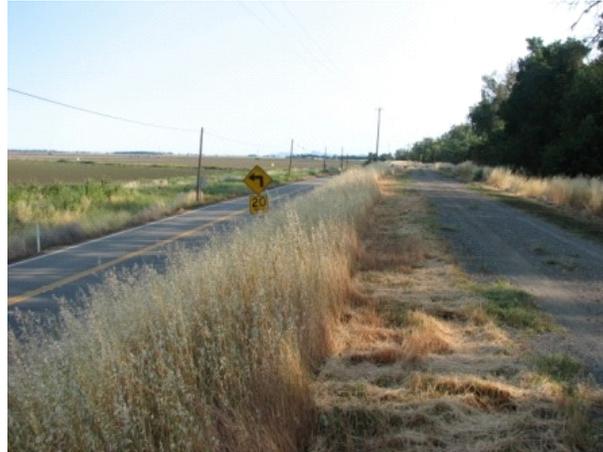
Levee Mile Report Line	1
Start Levee Mile	0.29
End Levee Mile	50.15
Location	Land Side
Category	Earthen Levee
Item	Vegetation
<p>The photo shows the height of the vegetation throughout the district.</p>	
<p>johngw_s_20110520_511.jpg</p>

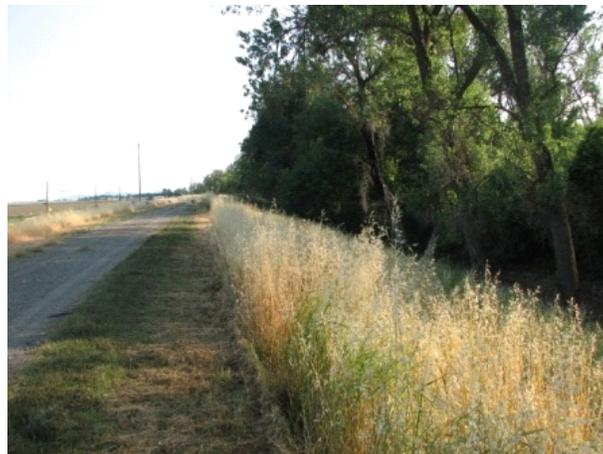
Levee Mile Report Line	2
Start Levee Mile	0.29
End Levee Mile	50.15
Location	Water Side
Category	Earthen Levee
Item	Vegetation
<p>The height of the vegetation on the water side is about the same throughout the district.</p>	
<p>johngw_s_20110520_512.jpg</p>

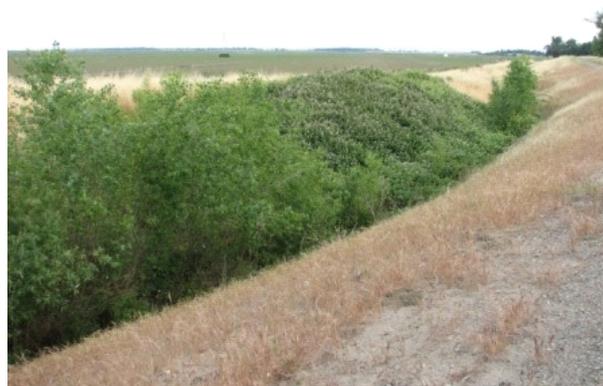
Levee Mile Report Line	3
Start Levee Mile	0.98
End Levee Mile	0.98
Location	Land Side
Category	Earthen Levee
Item	Vegetation
<p>The photo shows vegetation at the toe of the levee. The willows have been cut.</p>	
<p>johngw_s_20110228_111.jpg</p>

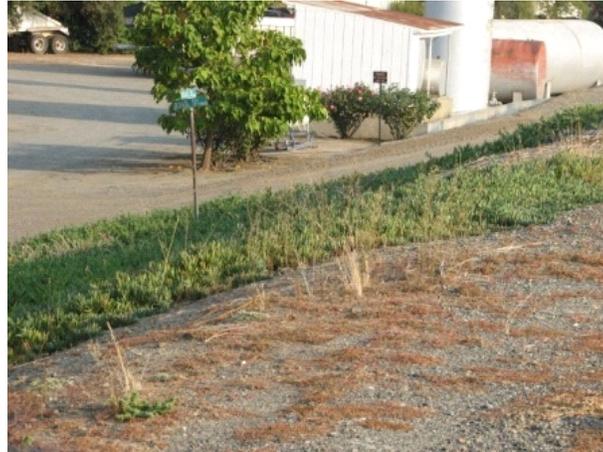
Levee Mile Report Line	5
Start Levee Mile	2.83
End Levee Mile	2.83
Location	Land Side
Category	Earthen Levee
Item	Encroachments
Landscape at River Garden Farms with irrigation.	
johngw_s_20110228_109.jpg

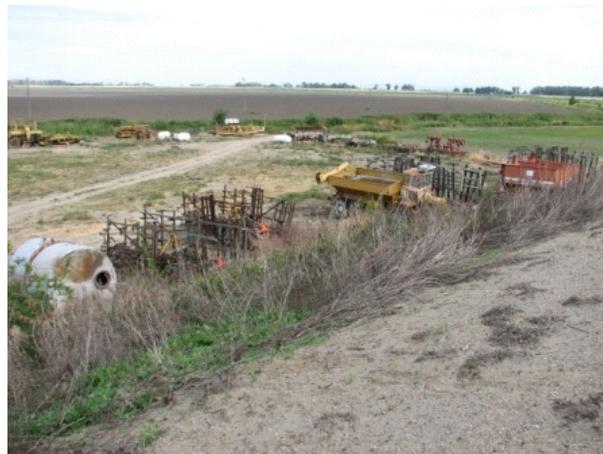
Levee Mile Report Line	6
Start Levee Mile	3.02
End Levee Mile	3.02
Location	Land Side
Category	Earthen Levee
Item	Encroachments
The equipment at the toe have been moved except for a couple of pieces.	
johngw_s_20110228_110.jpg

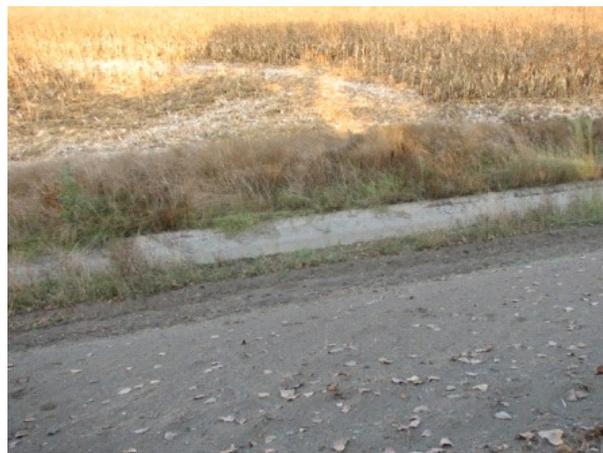
Levee Mile Report Line	7
Start Levee Mile	3.59
End Levee Mile	3.97
Location	Land Side
Category	Earthen Levee
Item	Encroachments
A concrete lined agricultural ditch along toe of levee.	
johngw_s_20110228_113.jpg

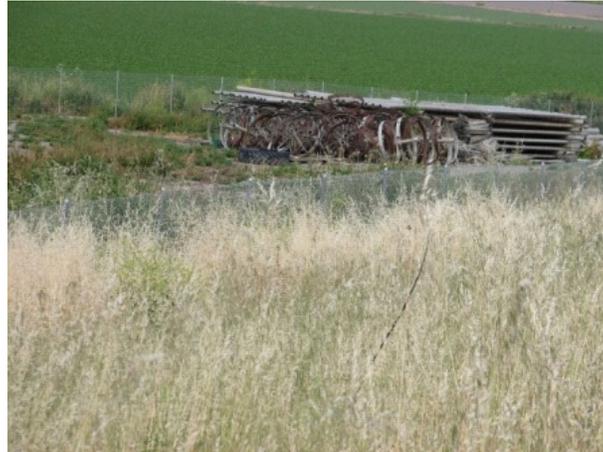
Levee Mile Report Line	9
Start Levee Mile	4.85
End Levee Mile	4.85
Location	Land Side
Category	Earthen Levee
Item	Encroachments
The chain link fence runs along the toe.	
johngw_s_20110228_114.jpg

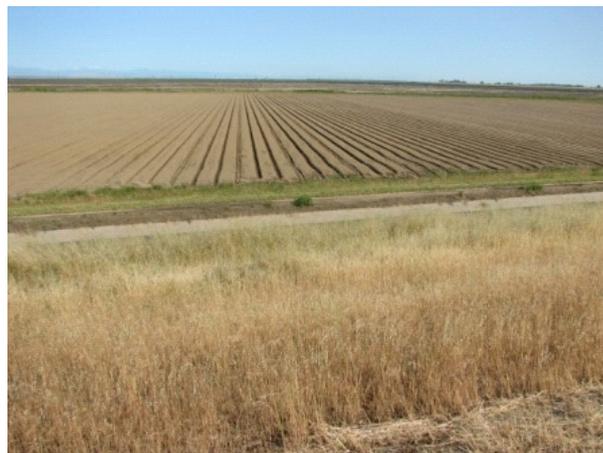
Levee Mile Report Line	19
Start Levee Mile	18.41
End Levee Mile	18.66
Location	Land Side
Category	Earthen Levee
Item	Encroachments
This is a concrete lined ditch for the district to distribute water in the area.	
johngw_s_20110520_513.jpg

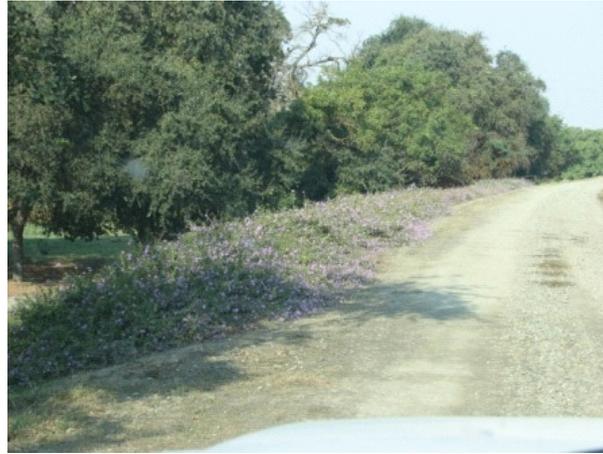
Levee Mile Report Line	22
Start Levee Mile	18.89
End Levee Mile	18.89
Location	Land Side
Category	Earthen Levee
Item	Encroachments
Groundcover and trees planted on landside levee slope with irrigation.	
johngw_s_20110228_116.jpg

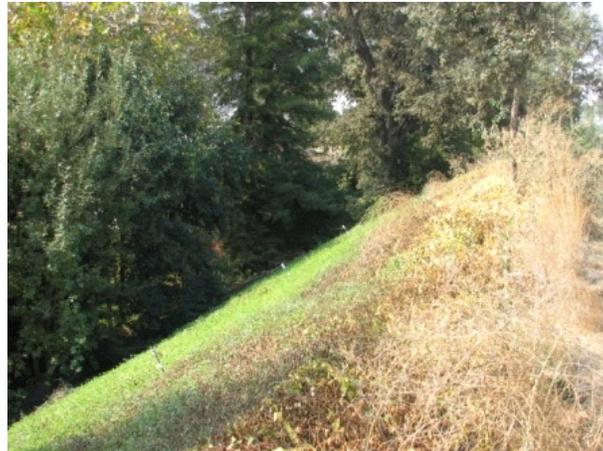
Levee Mile Report Line	43
Start Levee Mile	25.13
End Levee Mile	25.13
Location	Land Side
Category	Earthen Levee
Item	Encroachments
Groundcover and trees planted on the landside levee slope. The landscape is also irrigated.	
johngw_s_20110228_118.jpg

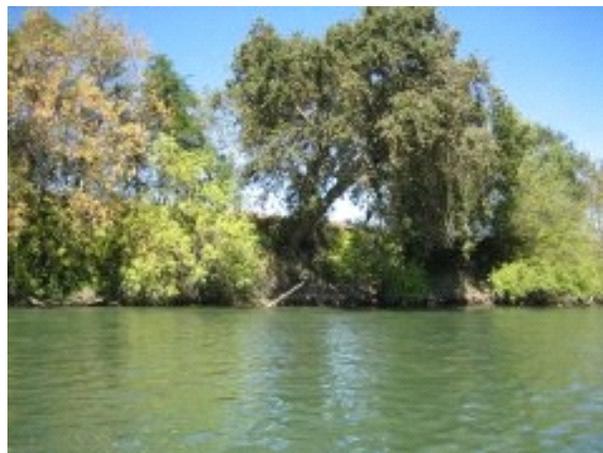
Levee Mile Report Line	45
Start Levee Mile	26.06
End Levee Mile	26.22
Location	Water Side
Category	Supplemental
Item	USACE Erosion Survey
2009: 10 ft berm, 1:1 slope, tree hazards and holes, clays and silts, 4.64 ft/s [2009 SiteID:SAC_118-0_R]	
johngw_s_20110228_120.JPG

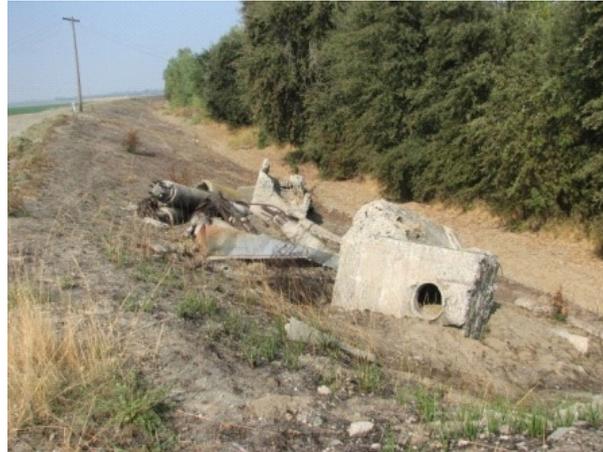
47	27.85	27.85	Earthen Levee	Animal Control	LS	M	Exterminate rodents and backfill and compact or grout burrows.	39.034620 ° -121.833378 °	39.034620 ° -121.833378 °	37
48	28.37	28.37	Earthen Levee	Encroachments	WS	M	Debris Inspector Comments: piles of concrete	39.040793 ° -121.835445 °	39.040793 ° -121.835445 °	59 Y
49	31.81	31.83	Supplemental Survey	USACE Erosion Survey	WS	M	Inspector Comments: 2009: 15 ft berm, vertical slope, no stability issues, clays and silts, 5.3 ft/s [2009 SiteID:SAC_123-7_R]	39.066900 ° -121.867322 °	39.067003 ° -121.866914 °	50 Y
50	32.01	32.01	Earthen Levee	Encroachments	WS	PO	Buildings Inspector Comments: Old concrete pumphouse on shoulder open needs to be sealed up.	39.066147 ° -121.870425 °	39.066147 ° -121.870425 °	60
51	32.42	32.42	Earthen Levee	Vegetation	WS	M	Elderberries are blocking visibility and flood fight capability.	39.069130 ° -121.876638 °	39.069130 ° -121.876638 °	41

Levee Mile Report Line	48
Start Levee Mile	28.37
End Levee Mile	28.37
Location	Water Side
Category	Earthen Levee
Item	Encroachments
Concrete debris is on the waterside levee slope.	
johngw_s_20110228_128.jpg

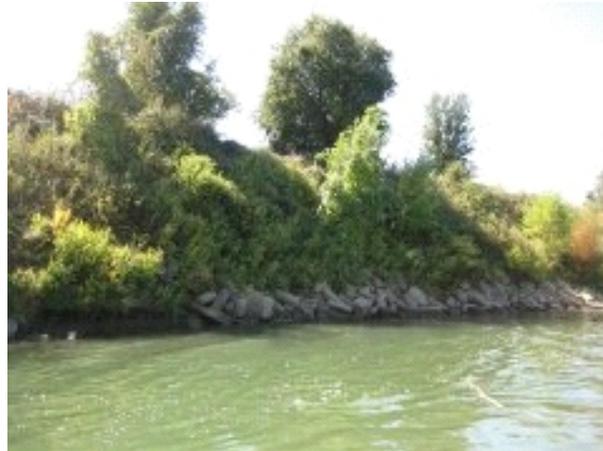
Levee Mile Report Line	49
Start Levee Mile	31.81
End Levee Mile	31.83
Location	Water Side
Category	Supplemental
Item	USACE Erosion Survey
2009: 15 ft berm, vertical slope, no stability issues, clays and silts, 5.3 ft/s [2009 SiteID:SAC_123-7_R]	
johngw_s_20110228_121.JPG

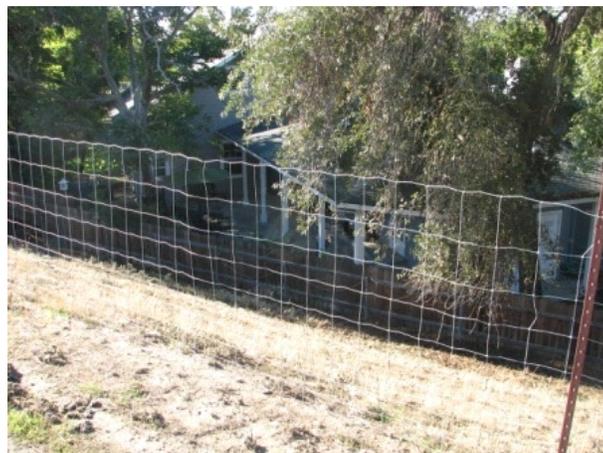
Levee Mile Report Line	65
Start Levee Mile	43.68
End Levee Mile	43.68
Location	Water Side
Category	Earthen Levee
Item	Encroachments
A solid board fence is along the landside toe to prevent animals from entering the landscape.	
johngw_s_20110228_122.jpg

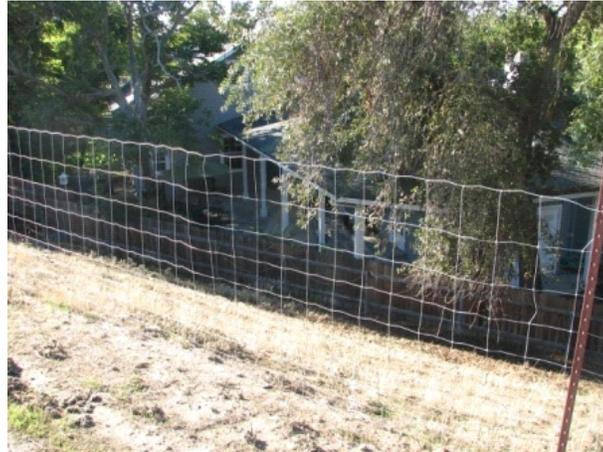
Levee Mile Report Line	66
Start Levee Mile	43.76
End Levee Mile	43.76
Location	Land Side
Category	Earthen Levee
Item	Encroachments
<p>The corner of the house in the photo is encroaching into the easement.</p>	
<p>johngw_s_20110228_119.jpg</p>

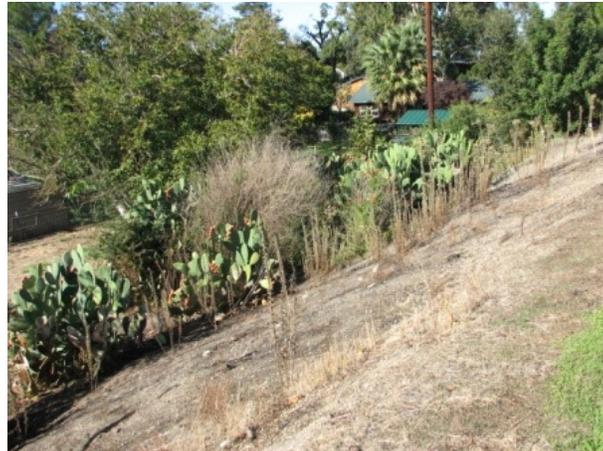
LMR No.	Levee Mile		Category	Item	* Location	** Rating	Action/Comment	GPS Latitude/Longitude		Issue No. Photo
	Start	End						Start	End	
71	47.57	47.57	Earthen Levee	Encroachments	LS	CO	Landscaping Inspector Comments: cactus on slope and toe of levee, landscape continues along roadway with fence and stairs	39.188577 ° -121.979388 °	39.188577 ° -121.979388 °	54 Y
72	47.64	47.64	Earthen Levee	Encroachments	WS	C	Prunings	39.189247 ° -121.980483 °	39.189247 ° -121.980483 °	75
73	49.61	49.61	Earthen Levee	Animal Control	LS	C	No rodents visible, but rodent burrows visible; need to backfill and compact or grout burrows.	39.210690 ° -121.990995 °	39.210690 ° -121.990995 °	76
74	49.64	49.64	Earthen Levee	Encroachments	WS	C	Prunings	39.211080 ° -121.991378 °	39.211080 ° -121.991378 °	77
75	49.79	49.79	Earthen Levee	Animal Control	LS	C	Exterminate rodents and backfill and compact or grout burrows.	39.212560 ° -121.993522 °	39.212560 ° -121.993522 °	980

Levee Mile Report Line	71
Start Levee Mile	47.57
End Levee Mile	47.57
Location	Land Side
Category	Earthen Levee
Item	Encroachments
<p>Cactus is planted on the landside slope of the levee.</p>	
<p>johngw_s_20110228_124.jpg</p>

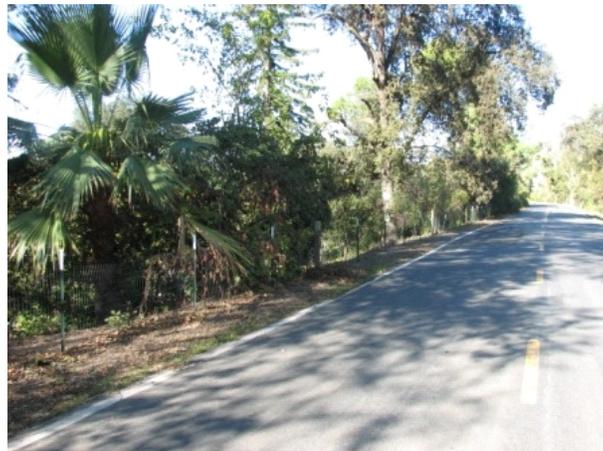
Levee Mile Report Line	71
Start Levee Mile	47.57
End Levee Mile	47.57
Location	Land Side
Category	Earthen Levee
Item	Encroachments
<p>Landscapng along the shoulder and landside levee slope.</p>	
<p>johngw_s_20110228_125.jpg</p>
