**Flood Control Project Maintenance
Levee Inspections**

2009 Channel Summary Report

San Joaquin County Flood Control and Water Conservation District

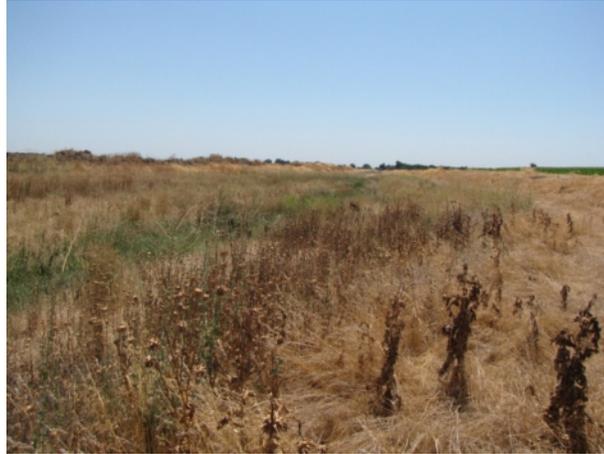
Levee Mile Report Line	1
Start Levee Mile	0.00
End Levee Mile	0.00
Location	
Category	Channels
Item	Vegetation & Obstructions
View of channel just downstream for the diversion structure looking downstream.	
dpesaven_c_20090731_003.jpg

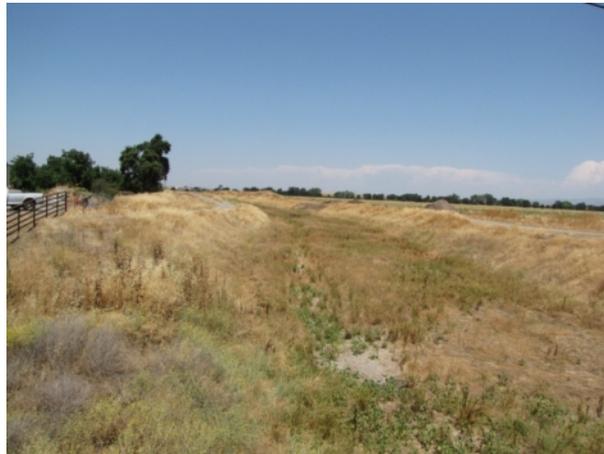
Levee Mile Report Line	6
Start Levee Mile	0.00
End Levee Mile	0.00
Location	
Category	Channels
Item	Vegetation & Obstructions
View from the Farmington Road bridge looking upstream.	
dpesaven_c_20090731_002.jpg

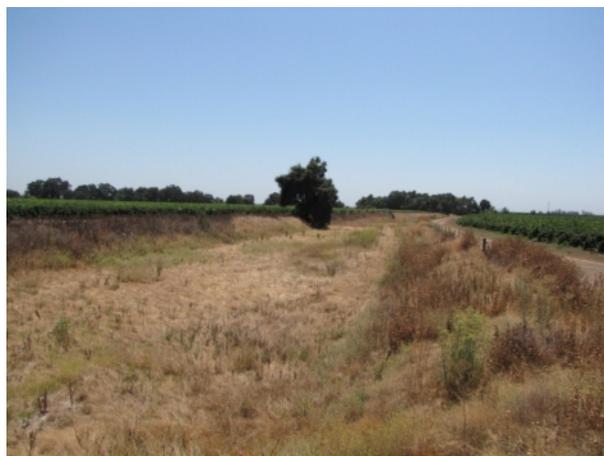
Levee Mile Report Line	11
Start Levee Mile	0.00
End Levee Mile	0.00
Location	
Category	Channels
Item	Vegetation & Obstructions
View looking downstream from the Farmington Road bridge.	
dpesaven_c_20090731_004.jpg

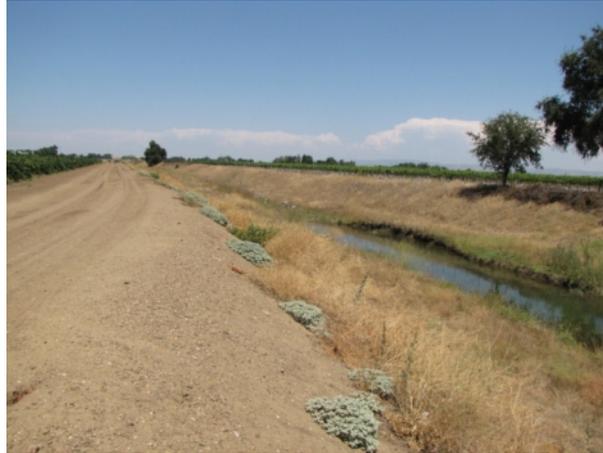
Levee Mile Report Line	16
Start Levee Mile	0.00
End Levee Mile	0.00
Location	
Category	Channels
Item	Vegetation & Obstructions
Confluence with South Little John looking upstream.	
dpesaven_c_20090731_005.jpg

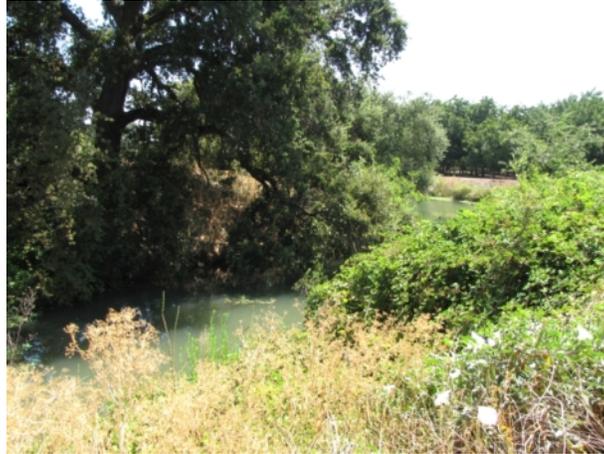
Levee Mile Report Line	1
Start Levee Mile	0.00
End Levee Mile	0.00
Location	
Category	Channels
Item	Vegetation & Obstructions
View of the creek at the diversion with South Little John Creek. Note the vegetation.	
dpesaven_c_20090731_022.jpg

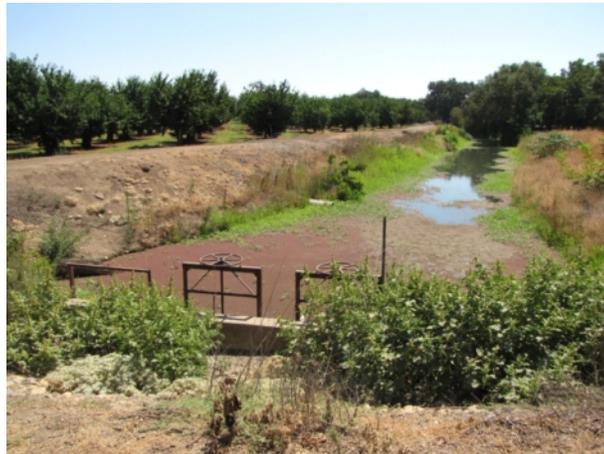
Levee Mile Report Line	6
Start Levee Mile	0.00
End Levee Mile	0.00
Location	
Category	Channels
Item	Vegetation & Obstructions
Upstream view of the creek from the extension of Hewit Lane.	
dpesaven_c_20090731_023.jpg

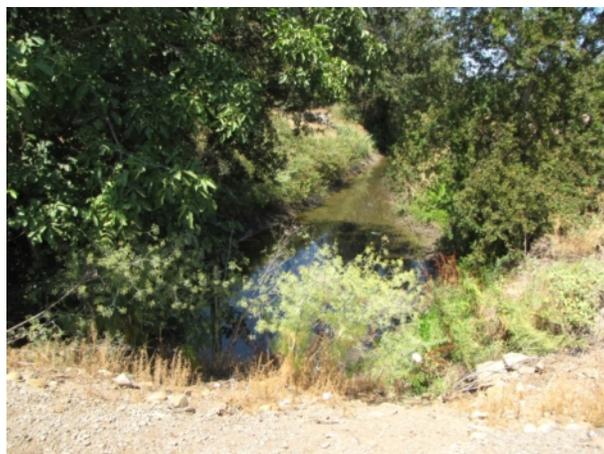
Levee Mile Report Line	11
Start Levee Mile	0.00
End Levee Mile	0.00
Location	
Category	Channels
Item	Vegetation & Obstructions
Downstream view from the extension of Hewit Lane. Note the trees.	
dpesaven_c_20090731_024.jpg

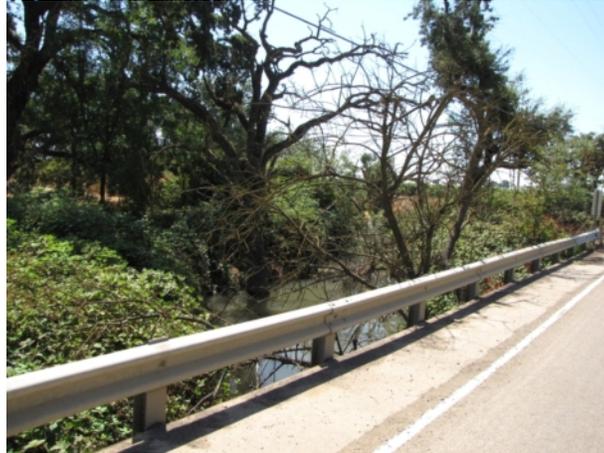
Levee Mile Report Line	16
Start Levee Mile	0.00
End Levee Mile	0.00
Location	
Category	Channels
Item	Vegetation & Obstructions
View looking upstream from Van Allen Road.	
dpesaven_c_20090731_020.jpg

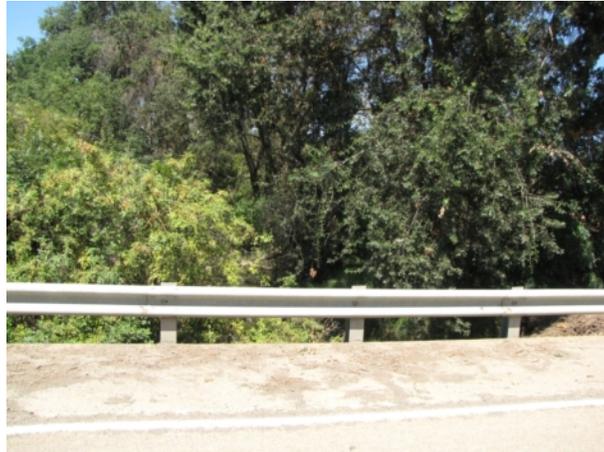
Levee Mile Report Line	21
Start Levee Mile	0.00
End Levee Mile	0.00
Location	
Category	Channels
Item	Vegetation & Obstructions
View looking downstream from Van Allen Road.	
dpesaven_c_20090731_021.jpg

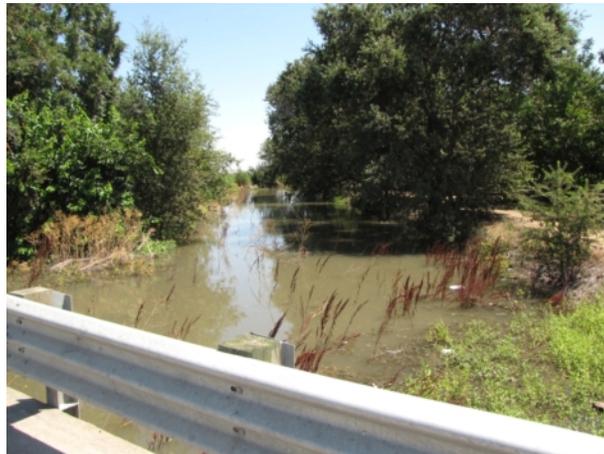
Levee Mile Report Line	26
Start Levee Mile	0.00
End Levee Mile	0.00
Location	
Category	Channels
Item	Vegetation & Obstructions
Upstream view from Jack Tone Road.	
dpesaven_c_20090731_025.jpg

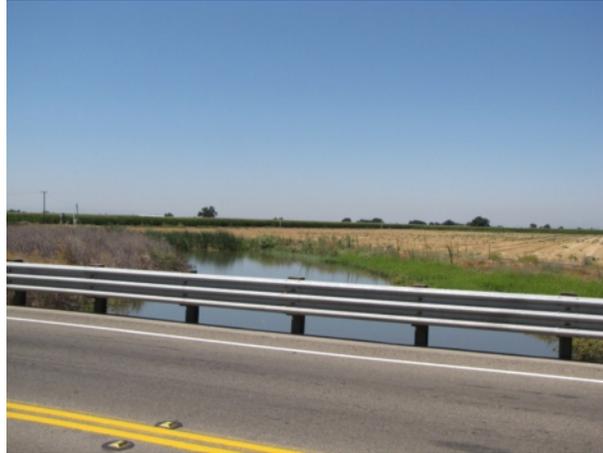
Levee Mile Report Line	31
Start Levee Mile	0.00
End Levee Mile	0.00
Location	
Category	Channels
Item	Vegetation & Obstructions
Downstream view from Jack Tone Road.	
dpesaven_c_20090731_026.jpg

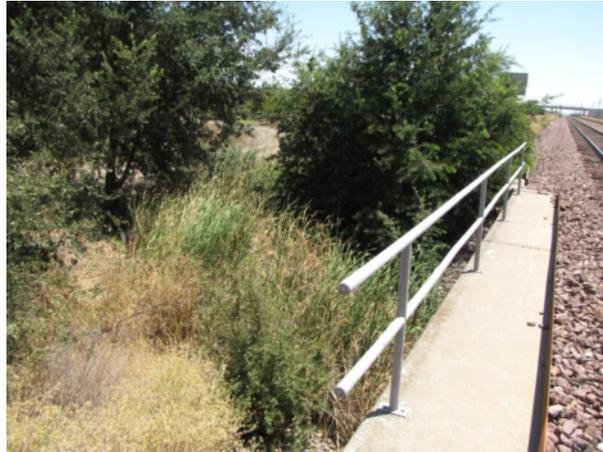
Levee Mile Report Line	36
Start Levee Mile	0.00
End Levee Mile	0.00
Location	
Category	Channels
Item	Vegetation & Obstructions
Upstream view from railroad adjacent to Mariposa Road. Note the excessive vegetation.	
dpesaven_c_20090731_027.jpg

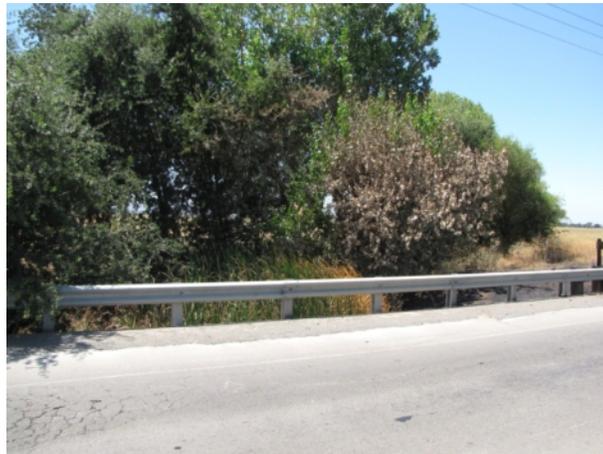
Levee Mile Report Line	41
Start Levee Mile	0.00
End Levee Mile	0.00
Location	
Category	Channels
Item	Vegetation & Obstructions
Downstream view from Mariposa Road. Note the excessive vegetation.	
dpesaven_c_20090731_028.jpg

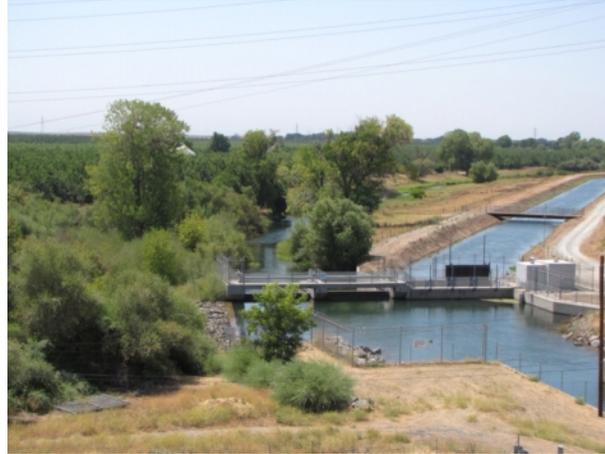
Levee Mile Report Line	1
Start Levee Mile	0.00
End Levee Mile	0.00
Location	
Category	Channels
Item	Vegetation & Obstructions
View of diversion structures & start of channel at north part of Farmington Dam looking downstream.	
dpesaven_c_20090731_006.jpg

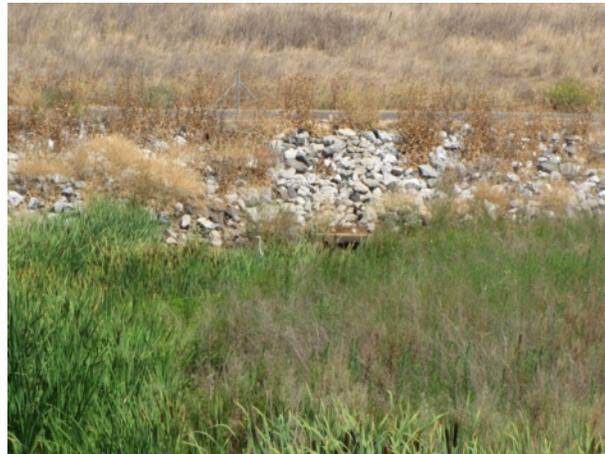
Levee Mile Report Line	1
Start Levee Mile	0.00
End Levee Mile	0.00
Location	
Category	Channels
Item	Vegetation & Obstructions
View of the outlet of creek under the south part of Farmington Dam.	
dpesaven_c_20090731_007.jpg

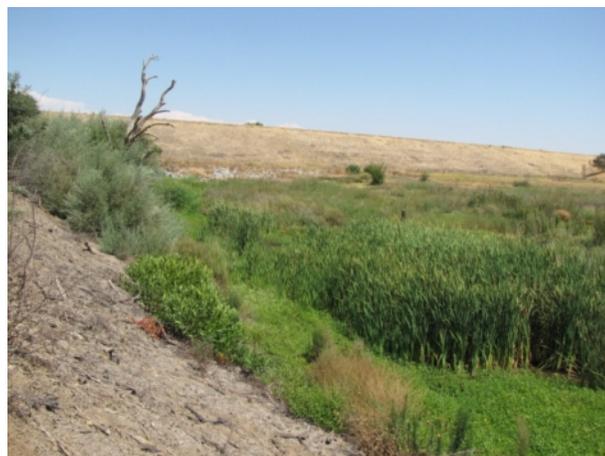
Levee Mile Report Line	1
Start Levee Mile	0.00
End Levee Mile	0.00
Location	
Category	Channels
Item	Vegetation & Obstructions
Larger view of the outlet of the creek under the south part of Farmington Dam.	
dpesaven_c_20090731_008.jpg

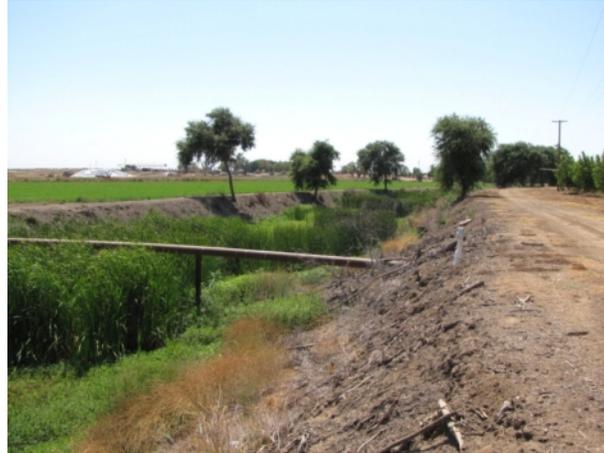
Levee Mile Report Line	1
Start Levee Mile	0.00
End Levee Mile	0.00
Location	
Category	Channels
Item	Vegetation & Obstructions
View looking downstream from creek at the south part of Farmington Dam.	
dpesaven_c_20090731_011.jpg

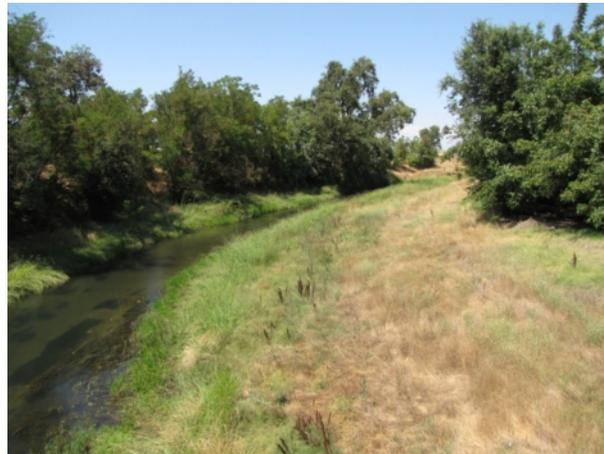
Levee Mile Report Line	6
Start Levee Mile	0.00
End Levee Mile	0.00
Location	
Category	Channels
Item	Vegetation & Obstructions
View looking upstream at Sonora Road.	
dpesaven_c_20090731_009.jpg

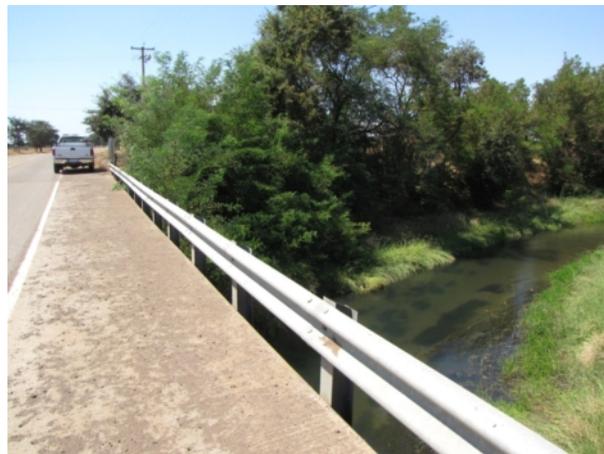
Levee Mile Report Line	6
Start Levee Mile	0.00
End Levee Mile	0.00
Location	
Category	Channels
Item	Vegetation & Obstructions
Additional view looking upstream from Sonora Road.	
dpesaven_c_20090731_010.jpg

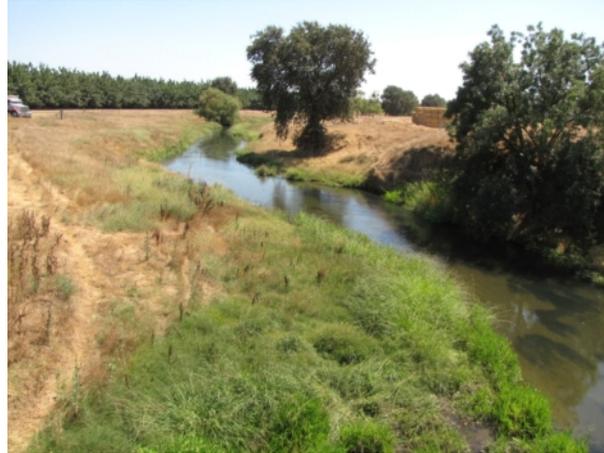
Levee Mile Report Line	11
Start Levee Mile	0.00
End Levee Mile	0.00
Location	
Category	Channels
Item	Vegetation & Obstructions
View looking downstream at Sonora Road.	
dpesaven_c_20090731_012.jpg

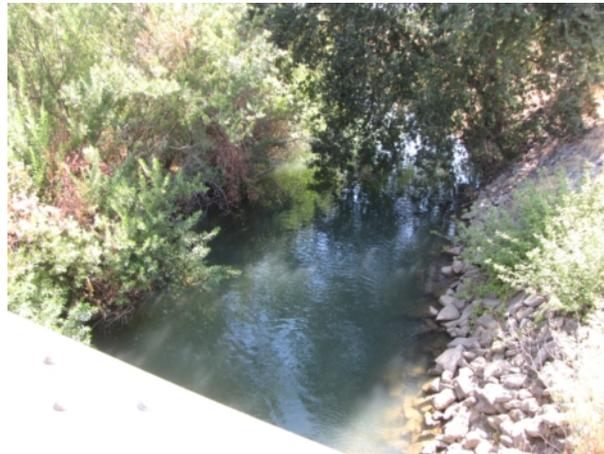
14		Down	Revetments		A		37.918260 ° -120.959360 °		19
15		Down	Encroachments		A		37.918260 ° -120.959360 °		20
16	Escalon Bellota Rd	Up	Vegetation & Obstructions		M	Inspector Comments: Trees in the channel may cause debris to become trapped and adversely affect the capacity of the channel.	37.925330 ° -121.000120 °	Y	21
17		Up	Shoaling / Sedimentation		A		37.925330 ° -121.000120 °		22

Levee Mile Report Line	16
Start Levee Mile	0.00
End Levee Mile	0.00
Location	
Category	Channels
Item	Vegetation & Obstructions
View looking upstream from Escalong Bellota Road; note the trees in the channel.	
dpesaven_c_20090731_013.jpg

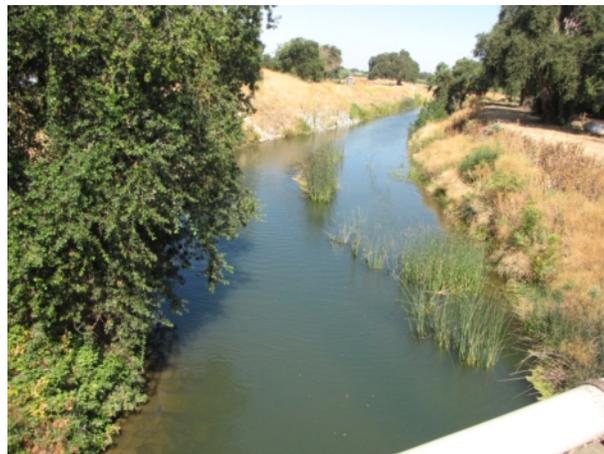
Levee Mile Report Line	21
Start Levee Mile	0.00
End Levee Mile	0.00
Location	
Category	Channels
Item	Vegetation & Obstructions
View looking downstream from Escalon Bellota Road.	
dpesaven_c_20090731_014.jpg

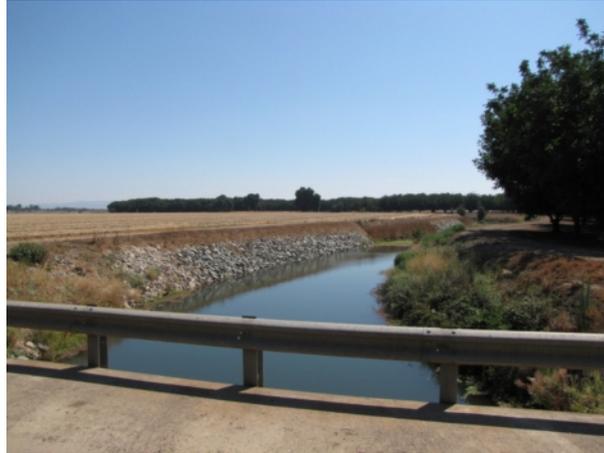
Levee Mile Report Line	26
Start Levee Mile	0.00
End Levee Mile	0.00
Location	
Category	Channels
Item	Vegetation & Obstructions
View looking upstream from Stanley Road.	
dpesaven_c_20090731_015.jpg

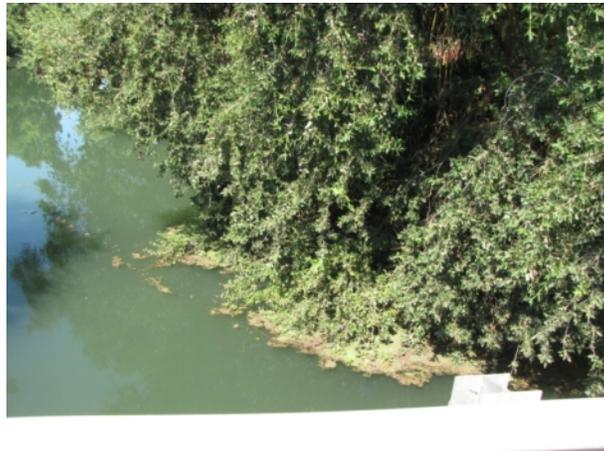
Levee Mile Report Line	31
Start Levee Mile	0.00
End Levee Mile	0.00
Location	
Category	Channels
Item	Vegetation & Obstructions
View looking downstream from Stanley Road.	
dpesaven_c_20090731_016.jpg

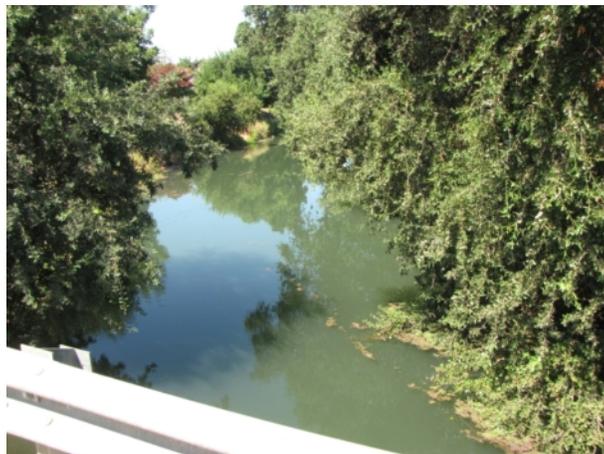
Levee Mile Report Line	31
Start Levee Mile	0.00
End Levee Mile	0.00
Location	
Category	Channels
Item	Vegetation & Obstructions
Additional view looking downstream from Stanley Road.	
dpesaven_c_20090731_017.jpg

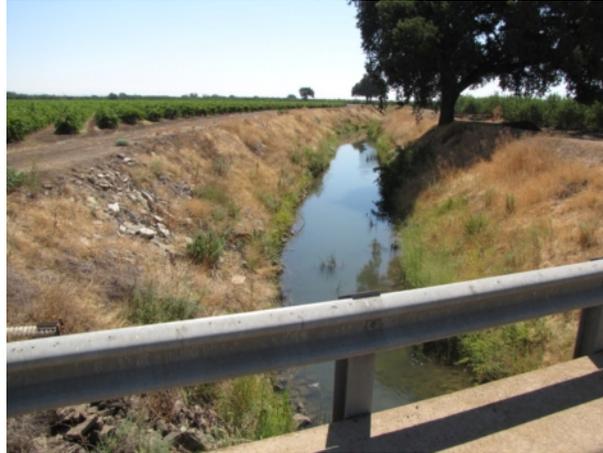
Levee Mile Report Line	36
Start Levee Mile	0.00
End Levee Mile	0.00
Location	
Category	Channels
Item	Vegetation & Obstructions
View looking upstream from Van Allen Road.	
dpesaven_c_20090731_018.jpg

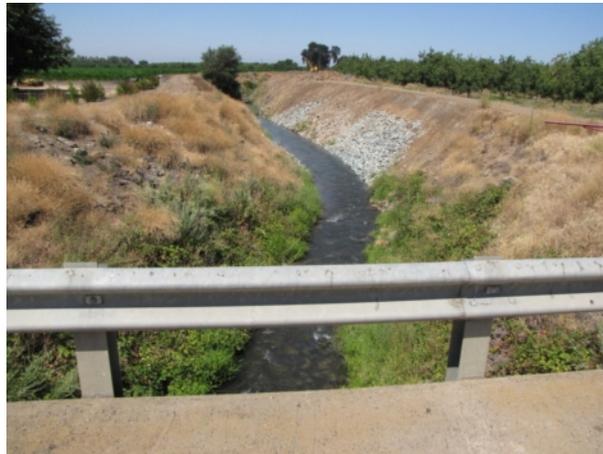
Levee Mile Report Line	41
Start Levee Mile	0.00
End Levee Mile	0.00
Location	
Category	Channels
Item	Vegetation & Obstructions
View looking upstream from Stanley Road.	
dpesaven_c_20090731_019.jpg

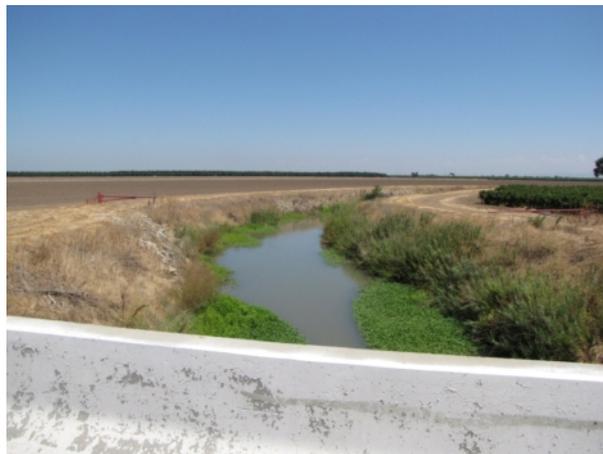
Levee Mile Report Line	46
Start Levee Mile	0.00
End Levee Mile	0.00
Location	
Category	Channels
Item	Vegetation & Obstructions
Upstream view from Mariposa Road.	
dpesaven_c_20090731_029.jpg

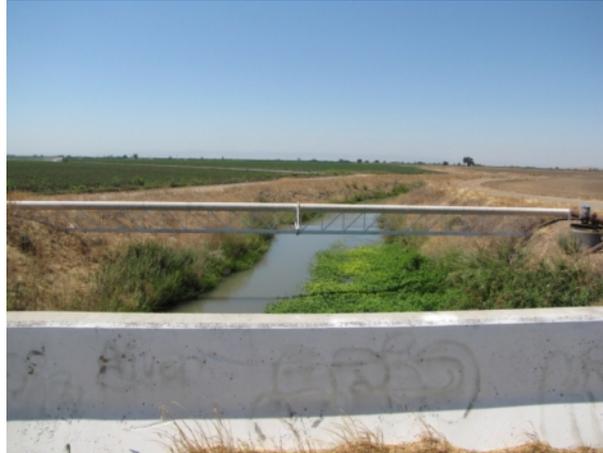
Levee Mile Report Line	51
Start Levee Mile	0.00
End Levee Mile	0.00
Location	
Category	Channels
Item	Vegetation & Obstructions
Downstream view from Mariposa Road.	
dpesaven_c_20090731_030.jpg

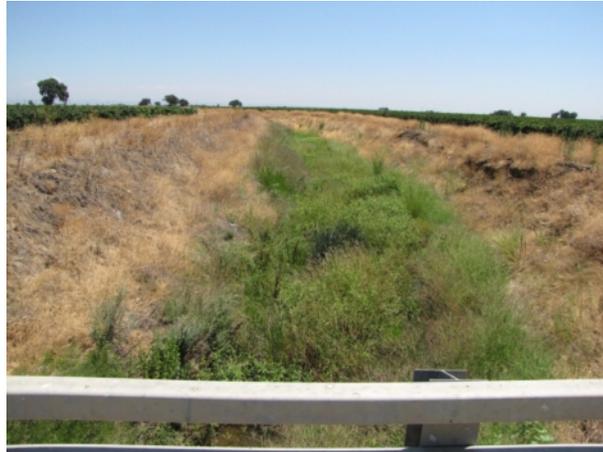
Levee Mile Report Line	56
Start Levee Mile	0.00
End Levee Mile	0.00
Location	
Category	Channels
Item	Vegetation & Obstructions
Upstream view from Jack Tone Road.	
dpesaven_c_20090731_034.jpg

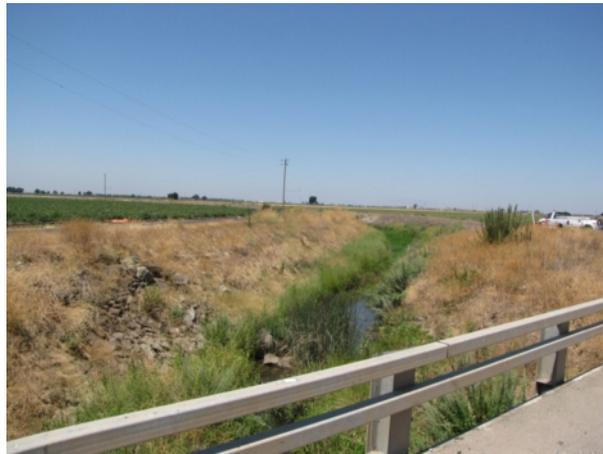
Levee Mile Report Line	61
Start Levee Mile	0.00
End Levee Mile	0.00
Location	
Category	Channels
Item	Vegetation & Obstructions
Downstream view from Jack Tone Road.	
dpesaven_c_20090731_035.jpg

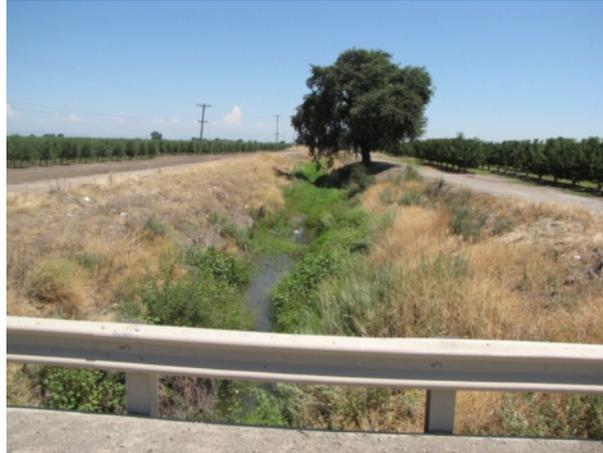
Levee Mile Report Line	66
Start Levee Mile	0.00
End Levee Mile	0.00
Location	
Category	Channels
Item	Vegetation & Obstructions
Upstream view from Austin Road.	
dpesaven_c_20090731_039.jpg

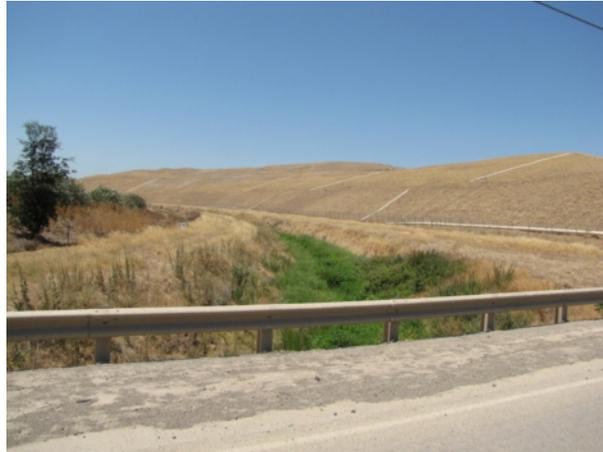
Levee Mile Report Line	71
Start Levee Mile	0.00
End Levee Mile	0.00
Location	
Category	Channels
Item	Vegetation & Obstructions
Downstream view from Austin Road.	
dpesaven_c_20090731_040.jpg

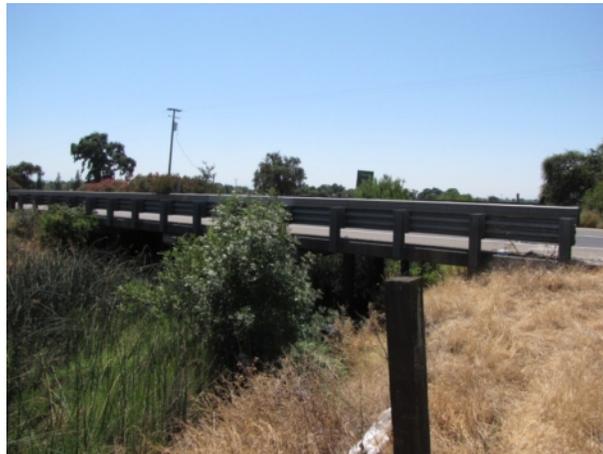
Levee Mile Report Line	80
Start Levee Mile	
End Levee Mile	
Location	
Category	Channels
Item	Vegetation & Obstructions
View of the creek at Highway 99. Note the excessive vegetation under and between the bridges.	
dpesaven_c_20090731_041.jpg

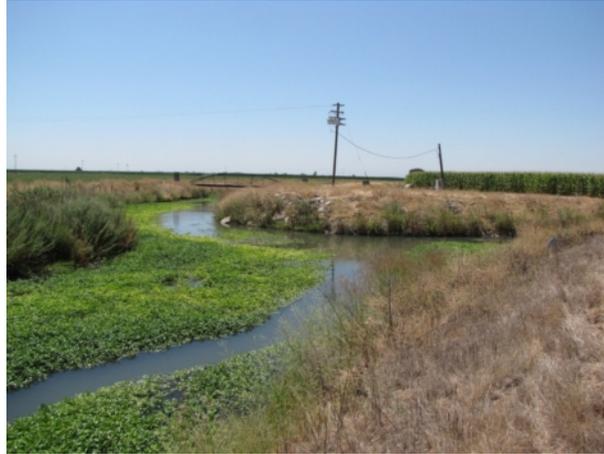
Levee Mile Report Line	1
Start Levee Mile	0.00
End Levee Mile	0.00
Location	
Category	Channels
Item	Vegetation & Obstructions
Downstream view at the diversion of South Little John and South Little John North Branch. Note some excessive vegetation along the left that could affect the flow of the water in the channels.	
dpesaven_c_20090731_031.jpg

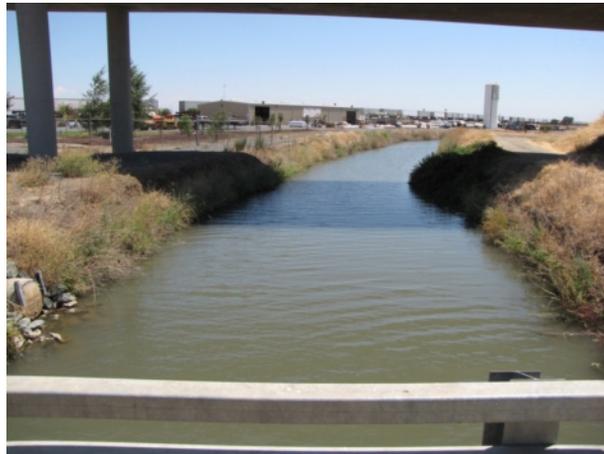
Levee Mile Report Line	6
Start Levee Mile	0.00
End Levee Mile	0.00
Location	
Category	Channels
Item	Vegetation & Obstructions
Upstream view from South Access Road under Jack Tone Road.	
dpesaven_c_20090731_032.jpg

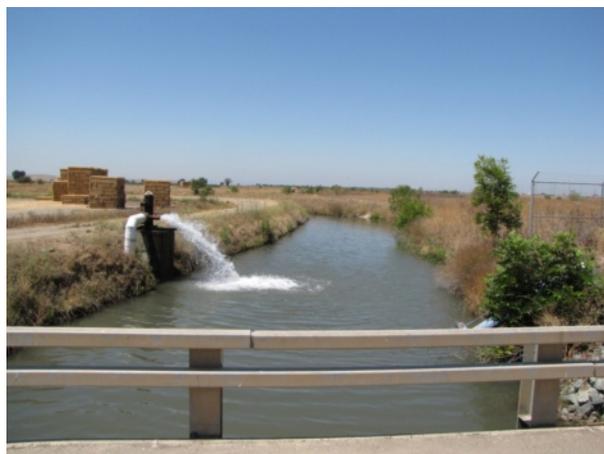
Levee Mile Report Line	11
Start Levee Mile	0.00
End Levee Mile	0.00
Location	
Category	Channels
Item	Vegetation & Obstructions
Downstream view from South Access Road under Jack Tone Road.	
dpesaven_c_20090731_033.jpg

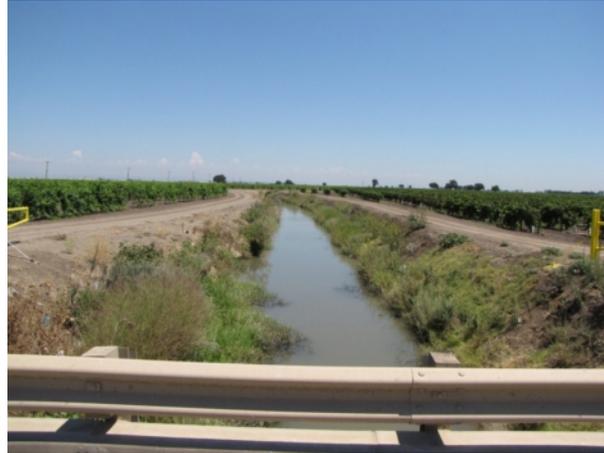
Levee Mile Report Line	16
Start Levee Mile	0.00
End Levee Mile	0.00
Location	
Category	Channels
Item	Vegetation & Obstructions
Upstream view from Austin Road.	
dpesaven_c_20090731_036.jpg

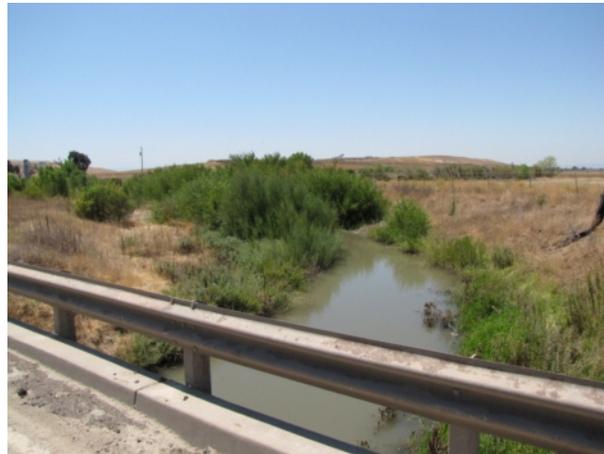
Levee Mile Report Line	21
Start Levee Mile	0.00
End Levee Mile	0.00
Location	
Category	Channels
Item	Vegetation & Obstructions
Downstream view from Austin Road.	
dpesaven_c_20090731_037.jpg

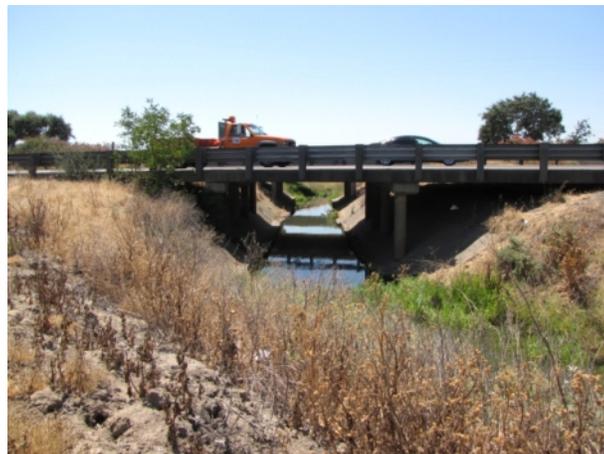
Levee Mile Report Line	26
Start Levee Mile	
End Levee Mile	
Location	
Category	Channels
Item	Vegetation & Obstructions
View of the creek as it passes under Highway 99.	
dpesaven_c_20090731_038.jpg
