**Flood Control Project Maintenance
Levee Inspections
2012 Channel Summary Report
Overall Unit and Item Ratings**

San Joaquin County Flood Control and Water Conservation District

Flood Control Project Maintenance**Unit Cover Sheet****2012 Channel Inspection Results****San Joaquin County Flood Control and Water Conservation District**

Channel Inspection Report By Check Point and View Direction - 2012

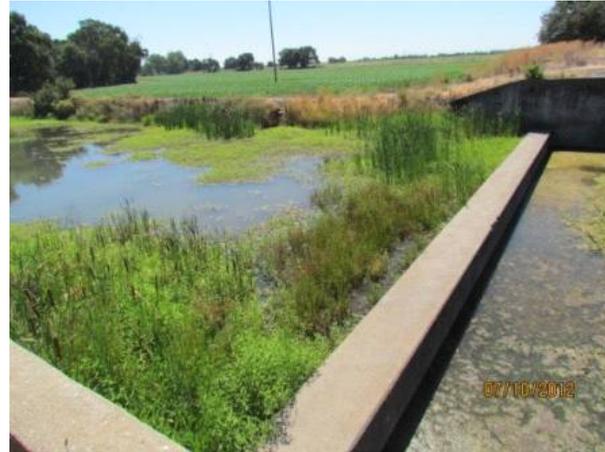
Levee Mile Report Line	1
Start Levee Mile	
End Levee Mile	
Location	
Category	Channels
Item	Vegetation & Obstructions
View of the vegetation in the channel downstream of the diversion channel.	
pkazi_c_20120720_133.jpg

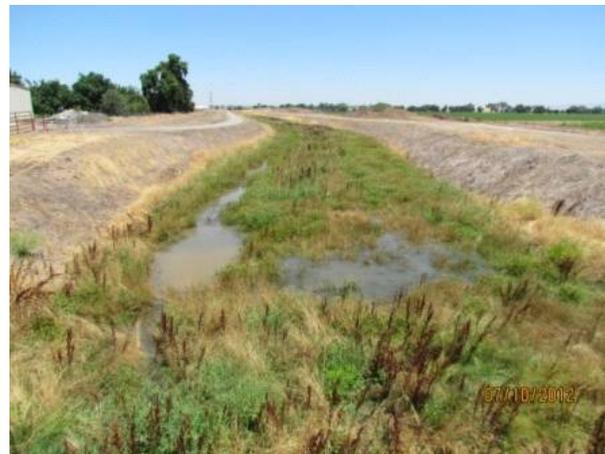
Levee Mile Report Line	6
Start Levee Mile	0.00
End Levee Mile	0.00
Location	
Category	Channels
Item	Vegetation & Obstructions
View of the vegetation on the channel looking upstream.	
pkazi_c_20120720_134.jpg

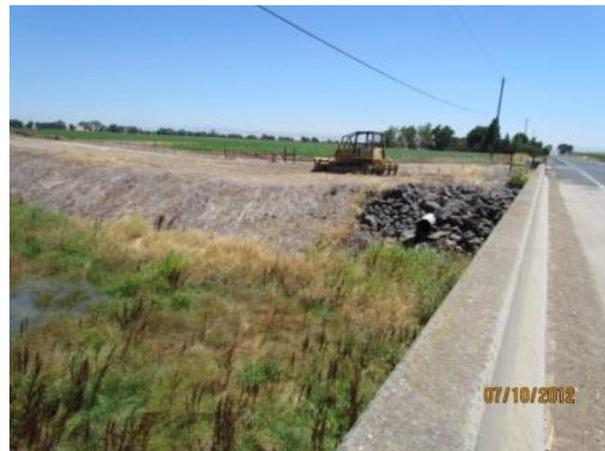
Levee Mile Report Line	9
Start Levee Mile	0.00
End Levee Mile	0.00
Location	
Category	Channels
Item	Revetments
View of the revetments on the upstream end of the channel.	
pkazi_c_20120720_135.jpg

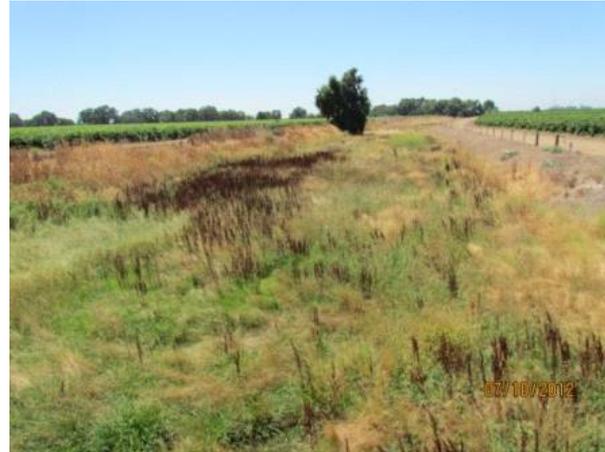
Levee Mile Report Line	11
Start Levee Mile	0.00
End Levee Mile	0.00
Location	
Category	Channels
Item	Vegetation & Obstructions
View of the vegetation growth on downstream of the channel.	
pkazi_c_20120720_136.jpg

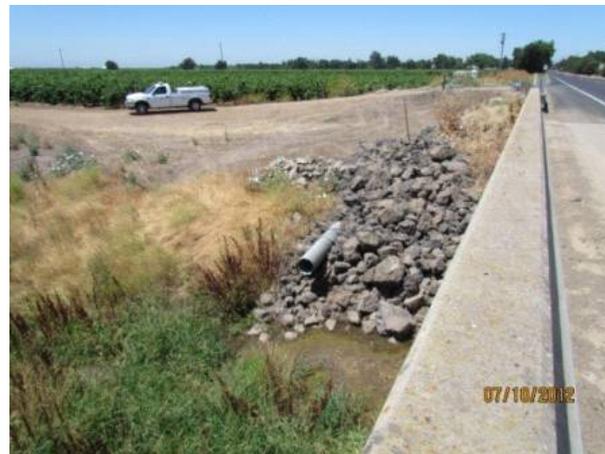
Levee Mile Report Line	14
Start Levee Mile	0.00
End Levee Mile	0.00
Location	
Category	Channels
Item	Revetments
View of the revetments on the downstream of the channel.	
pkazi_c_20120720_137.jpg

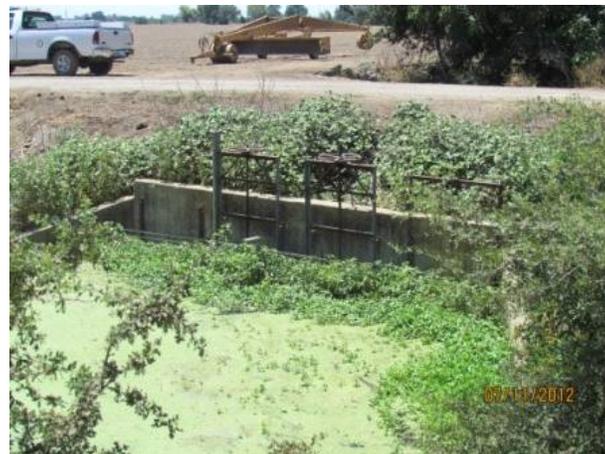
Levee Mile Report Line	10
Start Levee Mile	
End Levee Mile	
Location	
Category	Channels
Item	Concrete Surfaces
View of the concrete surface of the culvert looking from the upstream end of the channel.	
pkazi_c_20120718_104.jpg

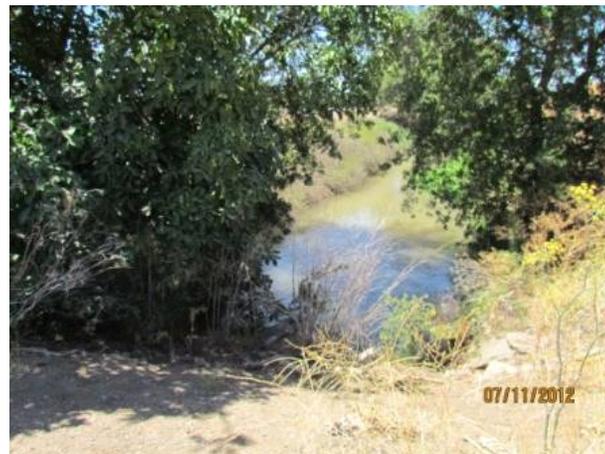
Levee Mile Report Line	12
Start Levee Mile	0.00
End Levee Mile	0.00
Location	
Category	Channels
Item	Vegetation & Obstructions
The picture was taken looking downstream of the channel.	
pkazi_c_20120718_105.jpg

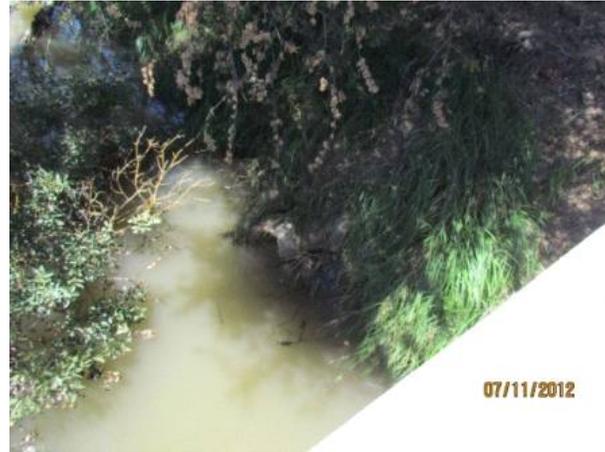
Levee Mile Report Line	26
Start Levee Mile	0.00
End Levee Mile	0.00
Location	
Category	Channels
Item	Encroachments
View of the broken pipe on the downstream end of the channel.	
pkazi_c_20120718_109.jpg

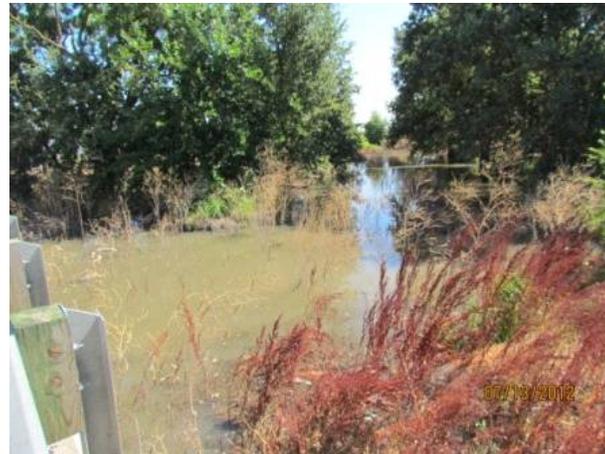
Levee Mile Report Line	27
Start Levee Mile	0.00
End Levee Mile	0.00
Location	
Category	Channels
Item	Vegetation & Obstructions
The picture was taken from upstream end of the channel.	
pkazi_c_20120718_110.jpg

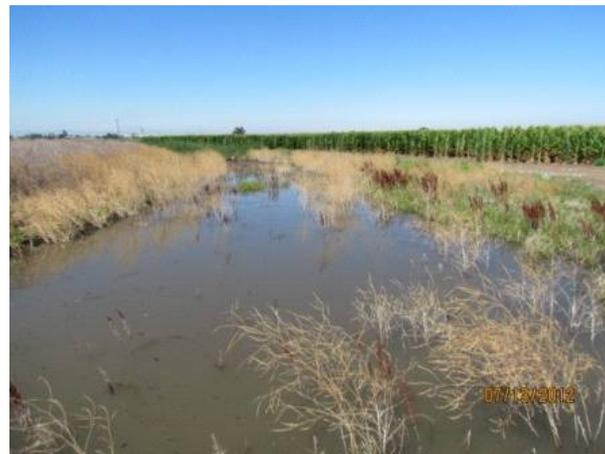
Levee Mile Report Line	32
Start Levee Mile	0.00
End Levee Mile	0.00
Location	
Category	Channels
Item	Vegetation & Obstructions
View of the channel looking downstream.	
pkazi_c_20120718_111.jpg

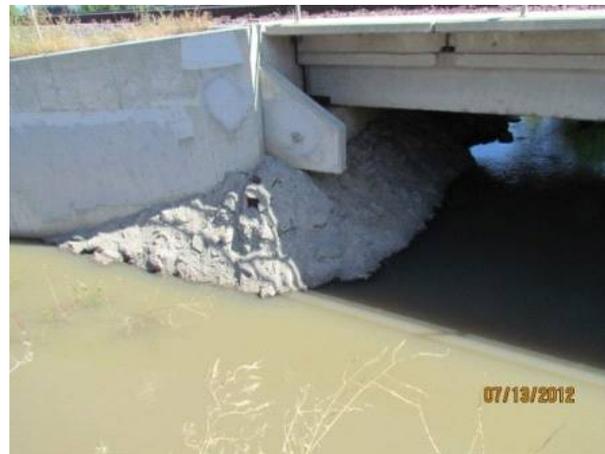
Levee Mile Report Line	40
Start Levee Mile	0.00
End Levee Mile	0.00
Location	
Category	Channels
Item	Revetments
View of the revetments looking upstream of the channel.	
pkazi_c_20120718_113.jpg

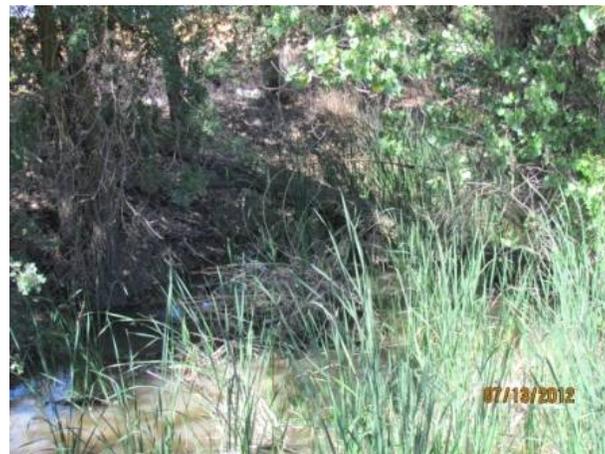
Levee Mile Report Line	42
Start Levee Mile	0.00
End Levee Mile	0.00
Location	
Category	Channels
Item	Vegetation & Obstructions
View of the vegetation growth on the downstream end of the channel.	
pkazi_c_20120718_114.jpg

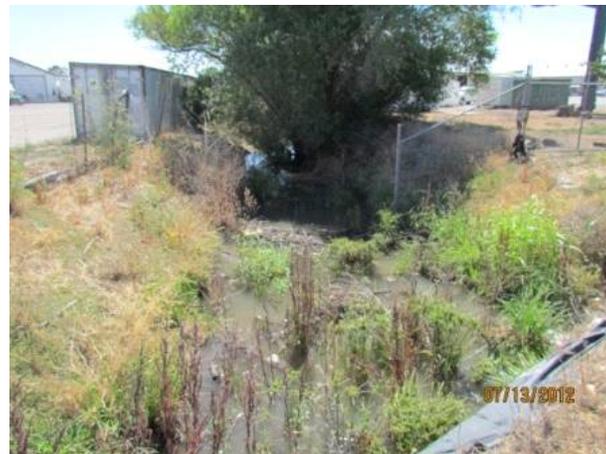
Levee Mile Report Line	47
Start Levee Mile	0.00
End Levee Mile	0.00
Location	
Category	Channels
Item	Vegetation & Obstructions
View of vegetation growth on the channel looking upstream.	
pkazi_c_20120720_116.jpg

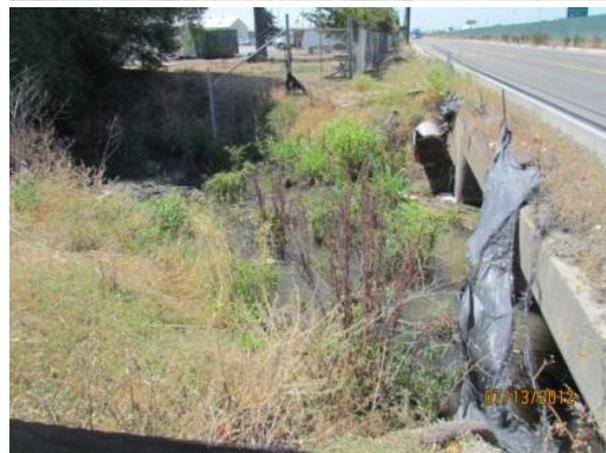
Levee Mile Report Line	51
Start Levee Mile	0.00
End Levee Mile	0.00
Location	
Category	Channels
Item	Encroachments
View of the encroachments on the channel and the picture was taken from the upstream end of the channel.	
pkazi_c_20120720_117.jpg

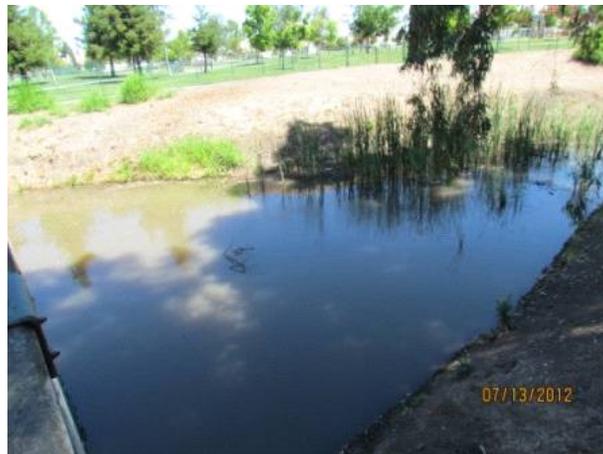
Levee Mile Report Line	57
Start Levee Mile	0.00
End Levee Mile	0.00
Location	
Category	Channels
Item	Vegetation & Obstructions
View of the channel looking upstream.	
pkazi_c_20120720_119.jpg

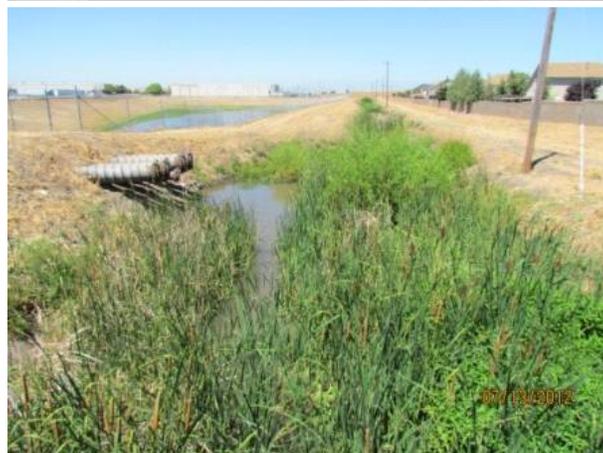
Levee Mile Report Line	62
Start Levee Mile	0.00
End Levee Mile	0.00
Location	
Category	Channels
Item	Vegetation & Obstructions
View of the vegetation on the channel looking downstream.	
pkazi_c_20120720_120.jpg

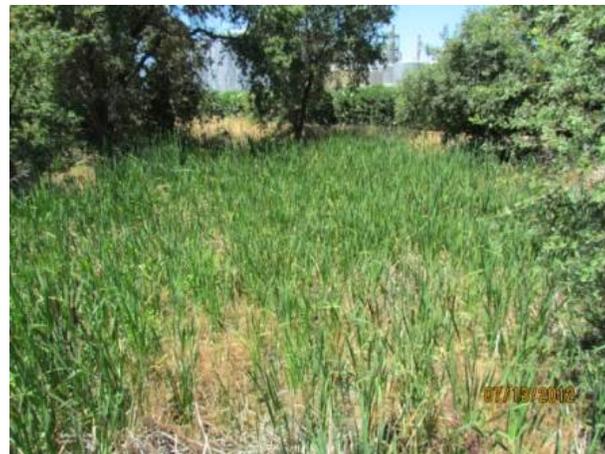
Levee Mile Report Line	82
Start Levee Mile	0.00
End Levee Mile	0.00
Location	
Category	Channels
Item	Vegetation & Obstructions
View of the vegetation growth on the channel looking downstream.	
pkazi_c_20120720_125.jpg

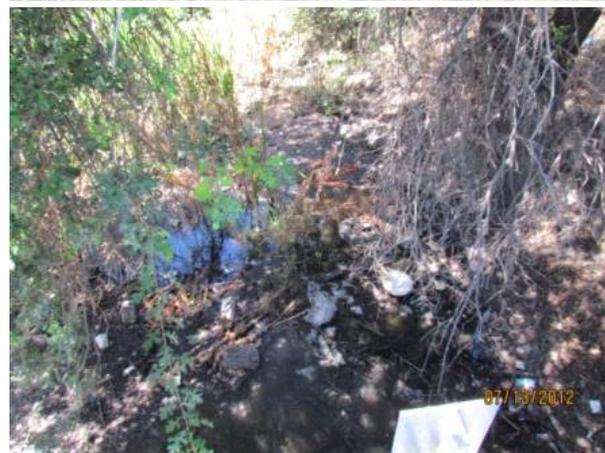
Levee Mile Report Line	86
Start Levee Mile	0.00
End Levee Mile	0.00
Location	
Category	Channels
Item	Encroachments
View of the encroachments on the downstream end of the channel.	
pkazi_c_20120720_126.jpg

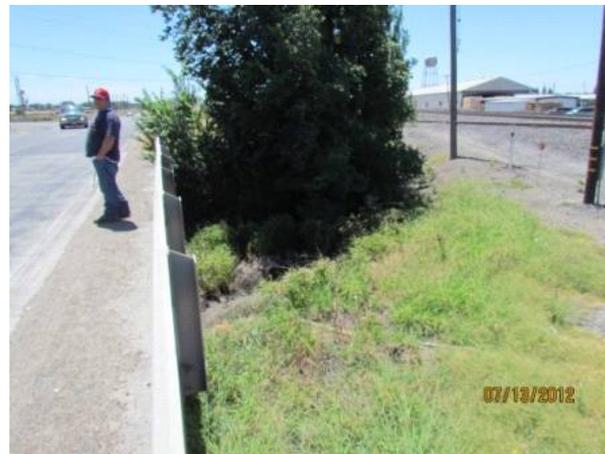
Levee Mile Report Line	102
Start Levee Mile	0.00
End Levee Mile	0.00
Location	
Category	Channels
Item	Vegetation & Obstructions
View of the vegetation growth on the downstream end of the channel.	
pkazi_c_20120720_131.jpg

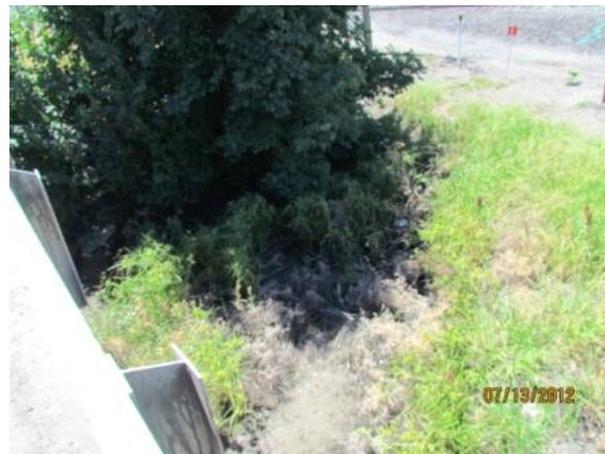
Levee Mile Report Line	106
Start Levee Mile	0.00
End Levee Mile	0.00
Location	
Category	Channels
Item	Encroachments
View of the encroachments on the channel looking downstream.	
pkazi_c_20120720_132.jpg

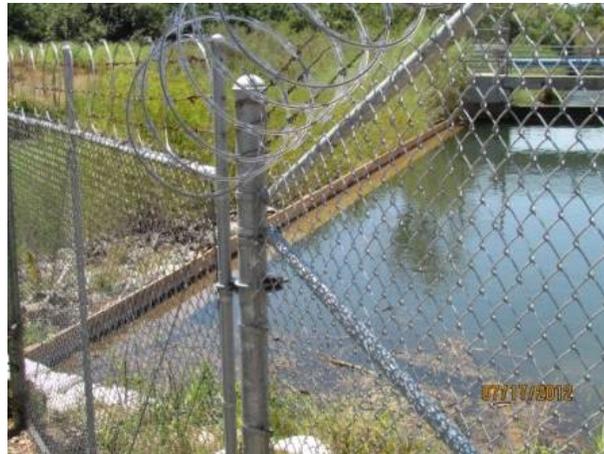
Levee Mile Report Line	5
Start Levee Mile	0.00
End Levee Mile	0.00
Location	
Category	Channels
Item	Encroachments
Debris were found on the channel and the height of the weir was increased using wood planks. The picture was taken looking downstream of the channel.	
pkazi_c_20120718_078.jpg

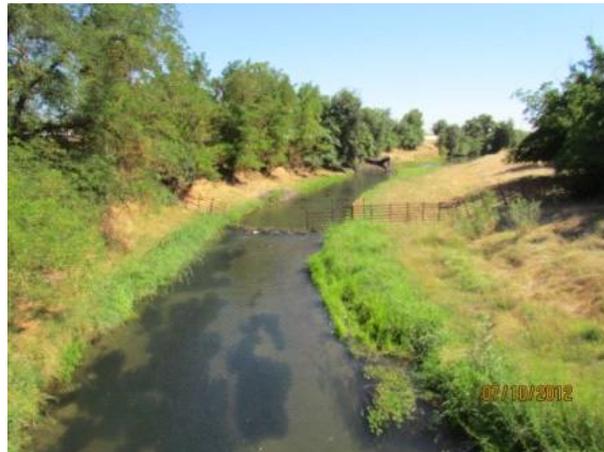
Levee Mile Report Line	6
Start Levee Mile	0.00
End Levee Mile	0.00
Location	
Category	Channels
Item	Vegetation & Obstructions
This picture shows a log and some debris is obstructing the flow of the channel. This picture was taken looking upstream.	
pkazi_c_20120716_067.jpg

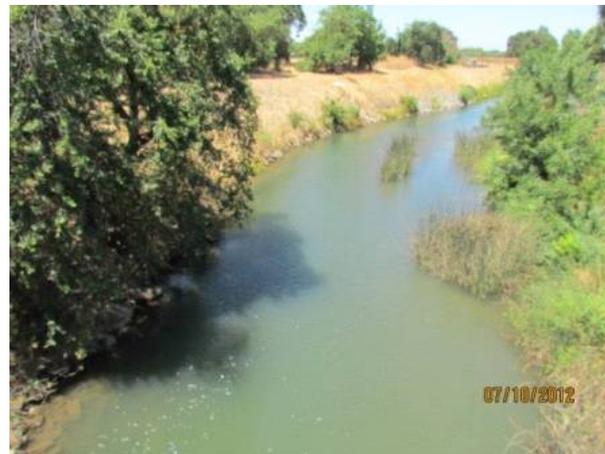
Levee Mile Report Line	21
Start Levee Mile	0.00
End Levee Mile	0.00
Location	
Category	Channels
Item	Vegetation & Obstructions
View of the channel looking downstream.	
pkazi_c_20120716_072.jpg

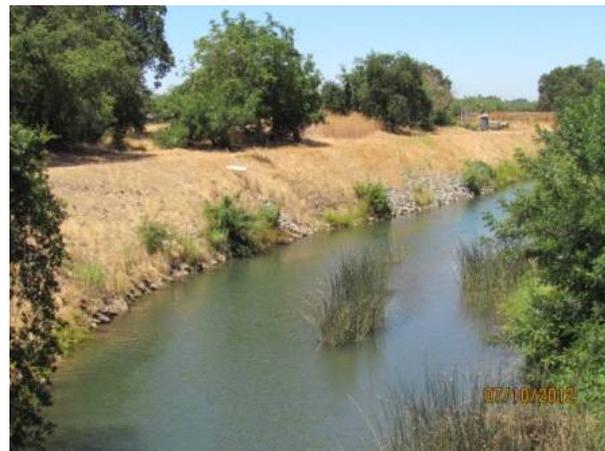
Levee Mile Report Line	24
Start Levee Mile	0.00
End Levee Mile	0.00
Location	
Category	Channels
Item	Revetments
View of the revetments looking downstream of the channel.	
pkazi_c_20120716_073.jpg

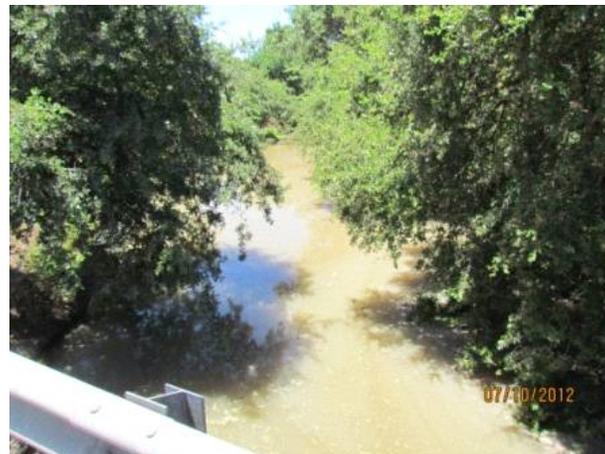
Levee Mile Report Line	31
Start Levee Mile	0.00
End Levee Mile	0.00
Location	
Category	Channels
Item	Vegetation & Obstructions
<p>Minimal vegetation growth and tree branches might obstruct the flow of the channel looking downstream.</p>	
<p>pkazi_c_20120716_075.jpg</p>

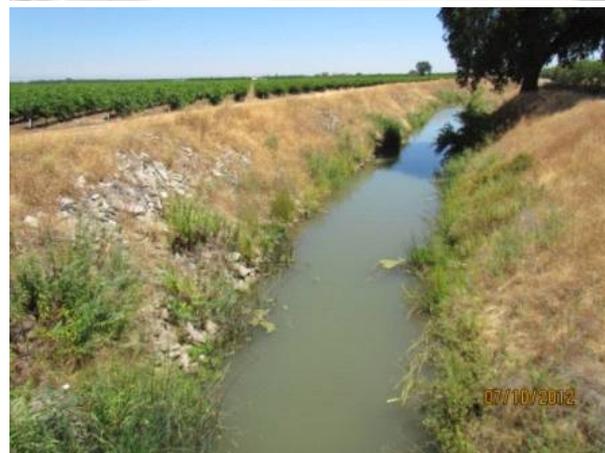
Levee Mile Report Line	36
Start Levee Mile	0.00
End Levee Mile	0.00
Location	
Category	Channels
Item	Vegetation & Obstructions
<p>View of the channel looking upstream.</p>	
<p>pkazi_c_20120716_076.jpg</p>

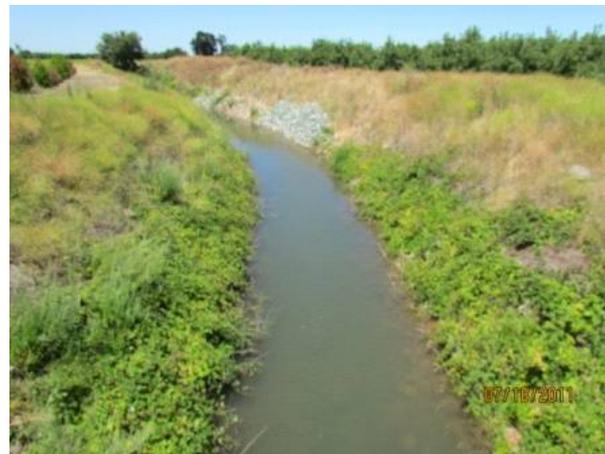
Levee Mile Report Line	41
Start Levee Mile	0.00
End Levee Mile	0.00
Location	
Category	Channels
Item	Vegetation & Obstructions
View of then channel looking downstream.	
pkazi_c_20120611_046.jpg

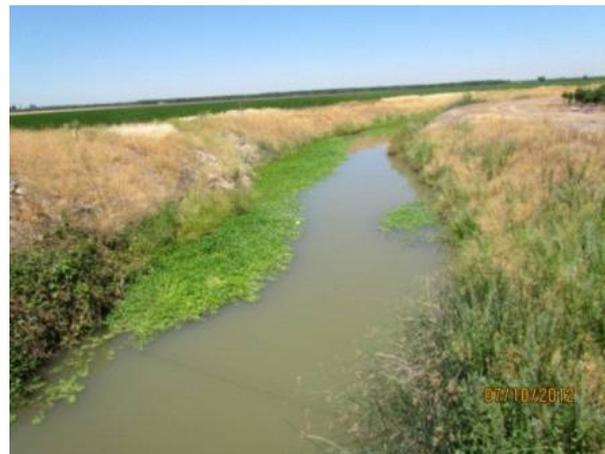
Levee Mile Report Line	46
Start Levee Mile	0.00
End Levee Mile	0.00
Location	
Category	Channels
Item	Vegetation & Obstructions
View of the channel looking upstream.	
pkazi_c_20120718_079.jpg

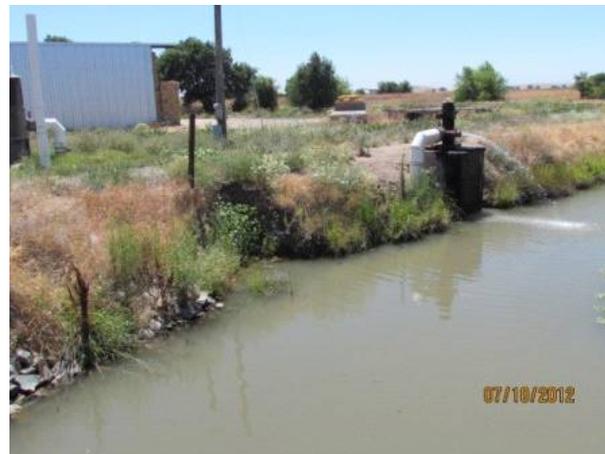
Levee Mile Report Line	63
Start Levee Mile	0.00
End Levee Mile	0.00
Location	
Category	Channels
Item	Erosion / Bank Caving
View of the erosion on the bank of the channel looking downstream.	
pkazi_c_20120718_084.jpg

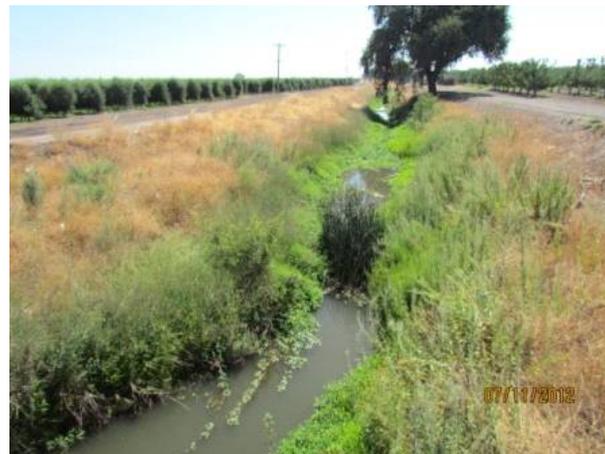
Levee Mile Report Line	66
Start Levee Mile	0.00
End Levee Mile	0.00
Location	
Category	Channels
Item	Vegetation & Obstructions
View of the upstream channel.	
pkazi_c_20120718_085.jpg
