**Flood Control Project Maintenance
Levee Inspections
2014 Channel Summary Report
Overall Unit and Item Ratings**

San Joaquin County Flood Control and Water Conservation District

Flood Control Project Maintenance**Unit Cover Sheet****2014 Channel Inspection Results****San Joaquin County Flood Control and Water Conservation District**

Levee Inspection Report By Mile - Channel 2014

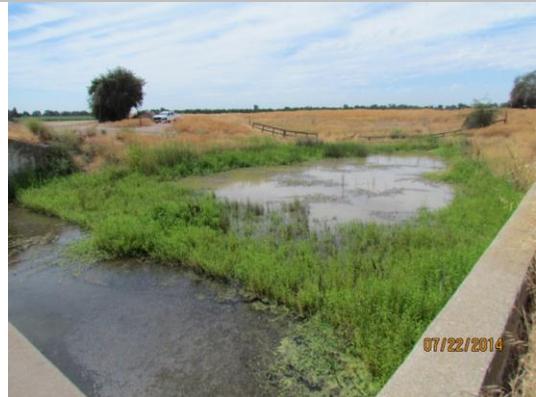
Photo 1 of 2 : CH_2014_NA0017_43_31_20140805_00009.jpg

Check Point / View				
Diversion Structure / Down				
Rating **	A	Issue No.	31	GPS Lat/Long
Issue Type +	Ma	Location *		37.938270 °
Category	Rivers, Channels & Designated Flood			-120.990130 °
Item	Vegetation & Obstructions			
DWR ID	DWR_NA0017_43_c_2012_31			
Action/Comments				
Inspector Comments: Minimal vegetation in the channel should not impede the flow.

View of the vegetation in the diversion channel looking downstream during 2014 inspection.

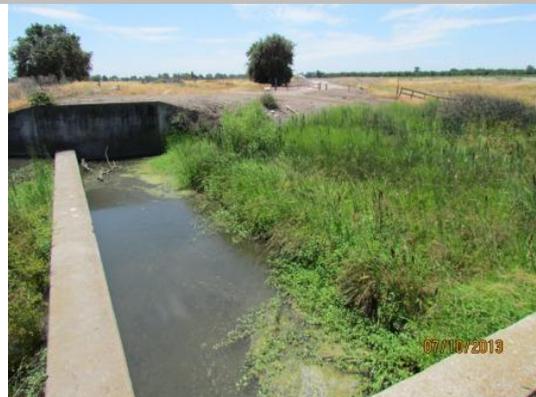
Photo 2 of 2 : CH_2014_NA0017_43_31_20140709_00008.jpg

View of the vegetation in the channel downstream of the diversion channel.

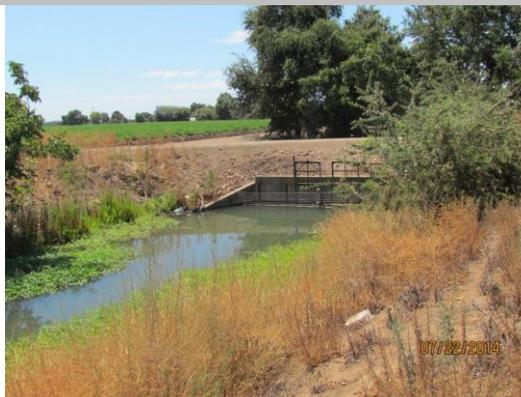
Photo 1 of 2 : CH_2014_NA0017_42_113_20140808_00034.jpg

Rating **	A	Issue No.	113	GPS Lat/Long
Issue Type +	Ma	Location *		37.920600 °
Category	Rivers, Channels & Designated Flood			-121.037920 °
Item	Gates			
DWR ID	DWR_NA0017_42_c_2012_113			
Action/Comments				
Inspector Comments: Slide gates appeared to be in good operational condition.

View of the gate looking upstream during 2014 inspection.

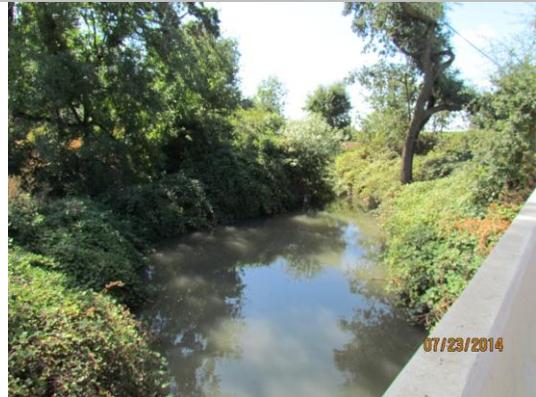
Photo 1 of 1 : CH_2014_NA0017_42_21_20140808_00037.jpg

Check Point / View				
Van Allen Rd / Up				
Rating **	M	Issue No.	21	GPS Lat/Long
Issue Type +	Ma	Location *		37.918960 °
Category	Rivers, Channels & Designated Flood			-121.056260 °
Item	Vegetation & Obstructions			
DWR ID	DWR_NA0017_42_c_2012_21			
Action/Comments				
Inspector Comments: Tree branches in the channel may cause an obstruction in the flow.

View of the tree branches that may impede the flow of the channel looking upstream.

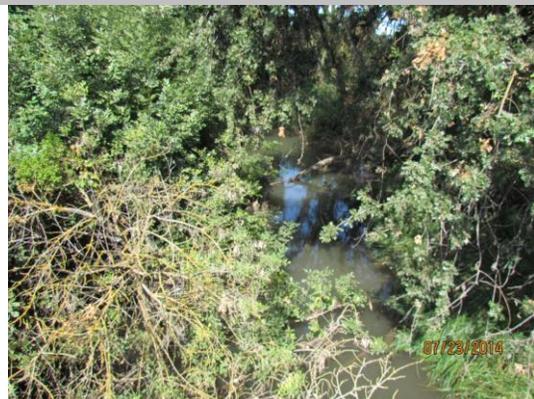
Photo 1 of 1 : CH_2014_NA0017_42_26_20140808_00038.jpg

View of heavy vegetation looking downstream of the channel.

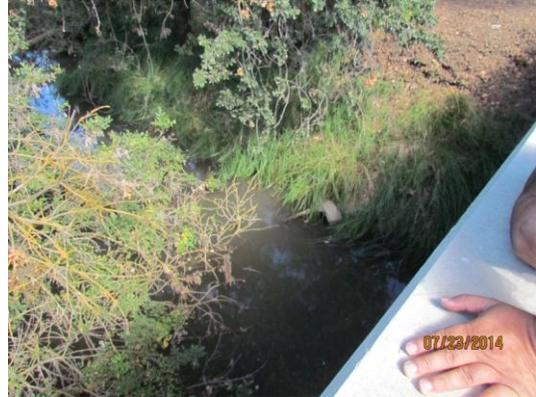
Photo 1 of 1 : CH_2014_NA0017_42_30_20140808_00039.jpg

Check Point / View			
Van Allen Rd / Down (cont)			
Rating **	A	Issue No.	30
Issue Type +	Ma	Location *	GPS Lat/Long
Category	Rivers, Channels & Designated Flood		-121.056260 °
Item	Encroachments		
DWR ID	DWR_NA0017_42_c_2012_30		
Action/Comments			
Inspector Comments: A broken pipe was found on the bank of the channel during inspection.

View of the broken pipe on the downstream of the channel.

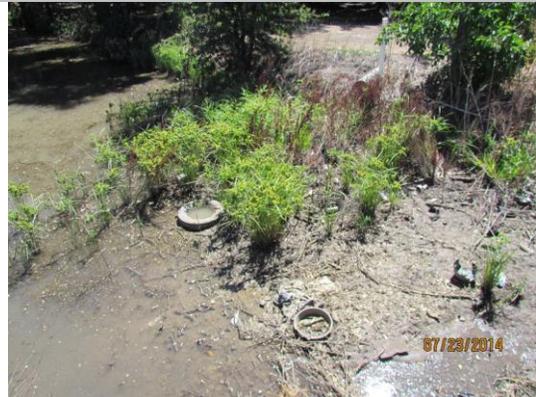
Photo 1 of 2 : CH_2014_NA0017_42_35_20140808_00041.jpg

Debris was found on the upstream end of the channel during 2014 inspection.

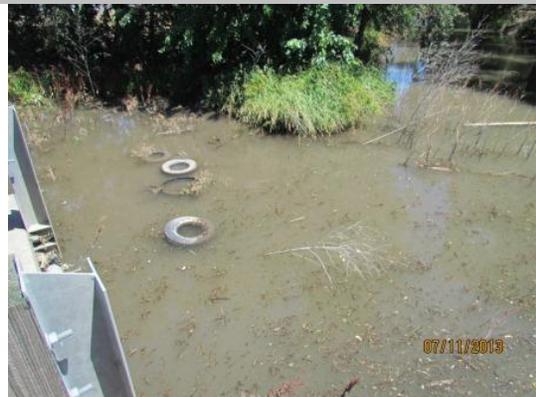
Photo 2 of 2 : CH_2014_NA0017_42_35_20140709_00008.jpg

View of the debris in the channel looking upstream.

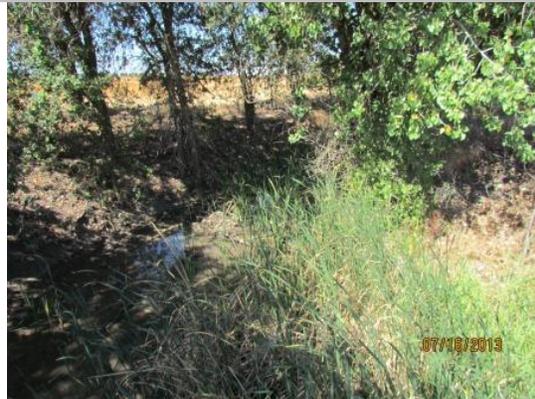
Photo 1 of 1 : CH_2014_NA0017_42_50_20140709_00012.jpg

View of debris in the downstream end of the channel.

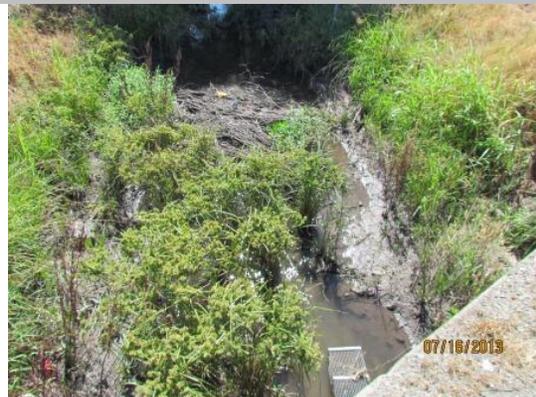
Photo 1 of 1 : CH_2014_NA0017_42_52_20140709_00014.jpg

View of sedimentation on the upstream of the channel.

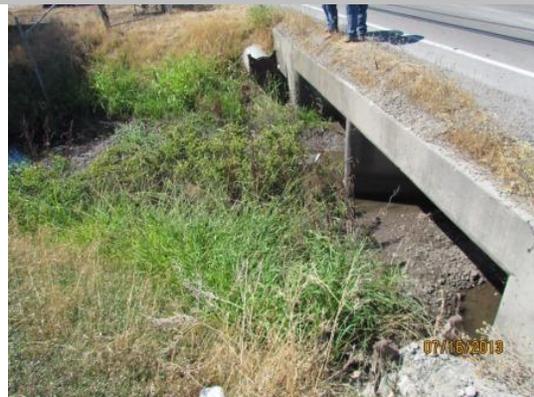
Photo 1 of 1 : CH_2014_NA0017_42_55_20140709_00015.jpg

View of the encroachments on the upstream of the channel.

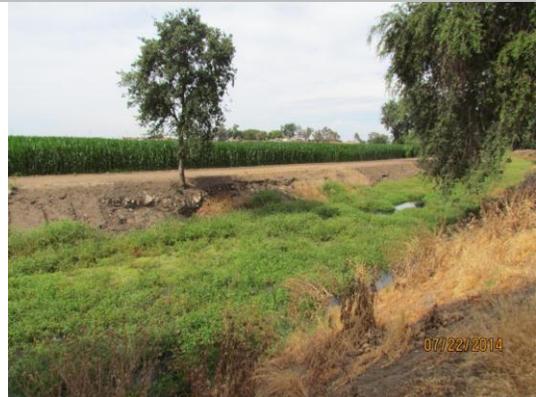
Photo 1 of 2 : CH_2014_NA0017_44_8_20140806_00035.jpg

Erosion was found on the channel bank looking downstream during 2014 inspection.

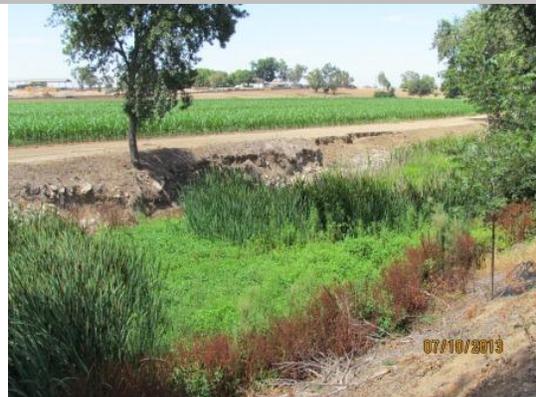
Photo 2 of 2 : CH_2014_NA0017_44_8_20140709_00002.jpg

Erosion was found on the channel banks looking downstream.

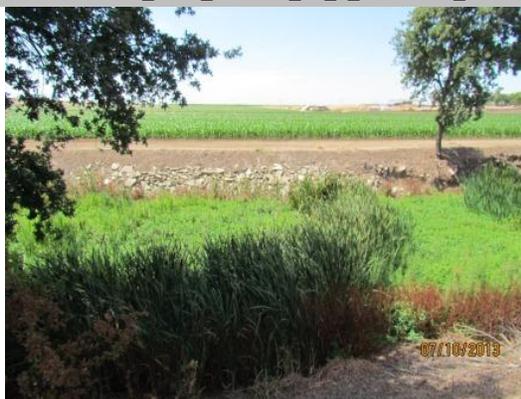
Photo 2 of 2 : CH_2014_NA0017_44_9_20140709_00003.jpg

Existing revetments are not properly maintained and appeared to be damaged. The picture was taken looking downstream of the channel.

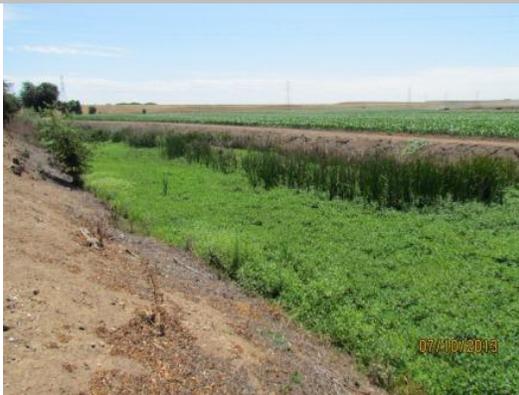
Photo 2 of 2 : CH_2014_NA0017_44_99_20140709_00028.jpg

View of the vegetation that may impede the flow of the channel. The picture was taken looking upstream.

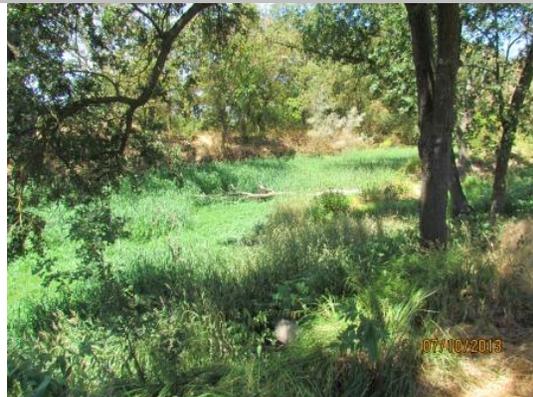
Photo 2 of 2 : CH_2014_NA0017_44_107_20140709_00030.jpg

View of tree trunks on the channel looking downstream.

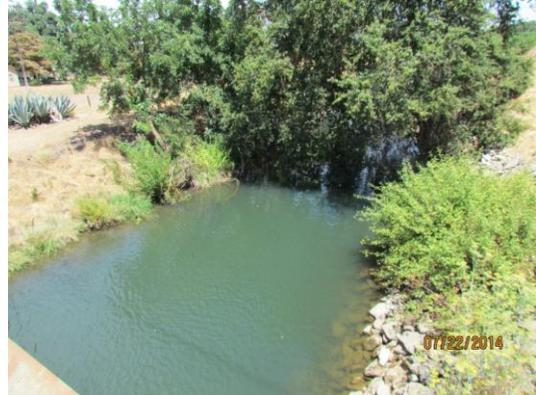
Photo 1 of 2 : CH_2014_NA0017_44_21_20140806_00041.jpg

Tree branches may cause obstruction on the channel. The picture was taken looking upstream.

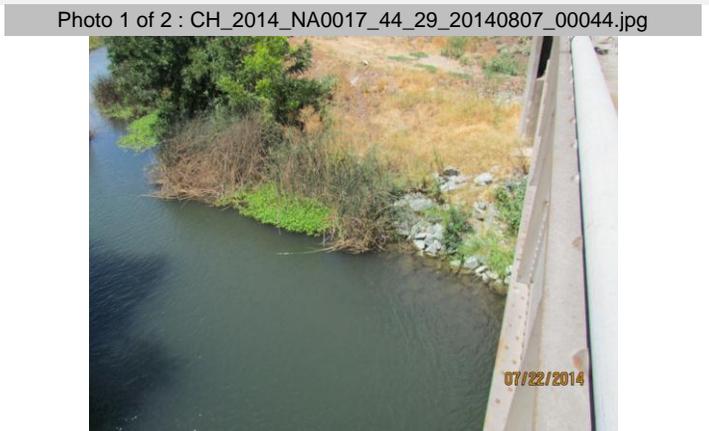
Check Point / View			
Escalon Bellota Rd / Down (cont)			
Rating **	A	Issue No.	29
Issue Type +	Ma	Location *	GPS Lat/Long
Category	Rivers, Channels & Designated Flood		37.925330 °
Item	Revetments		-121.000120 °
DWR ID	DWR_NA0017_44_c_2012_29		
Action/Comments			
Inspector Comments: Existing riprap is properly maintained.

View of the revetments on the channel bank looking downstream.

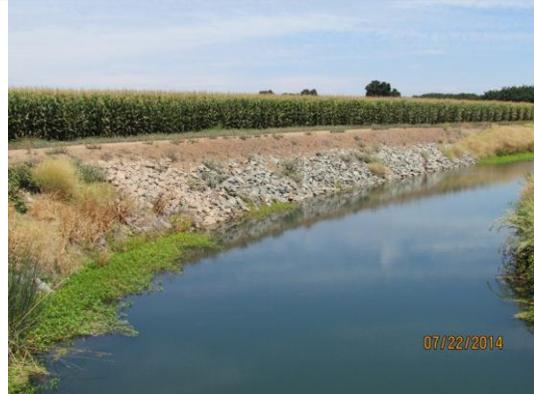
Photo 1 of 1 : CH_2014_NA0017_44_34_20140807_00047.jpg

The revetments on the channel bank were properly maintained. The picture was taken looking upstream.

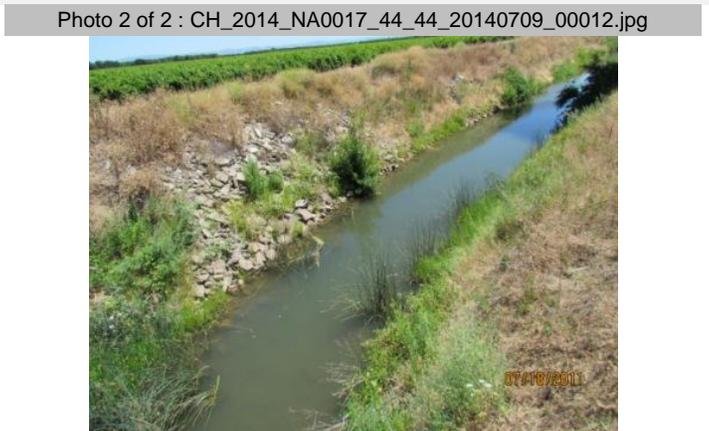
Check Point / View			
Van Allen Rd / Up (cont)			
Rating **	A	Issue No.	44 (cont)
Issue Type +	Ma	Location *	GPS Lat/Long
Category	Rivers, Channels & Designated Flood		37.913060 °
Item	Revetments		-121.056230 °
DWR ID	DWR_NA0017_44_c_2012_44		
Action/Comments			
Inspector Comments: Existing riprap protection is properly maintained.

The picture shows the revetments looking upstream of the channel.

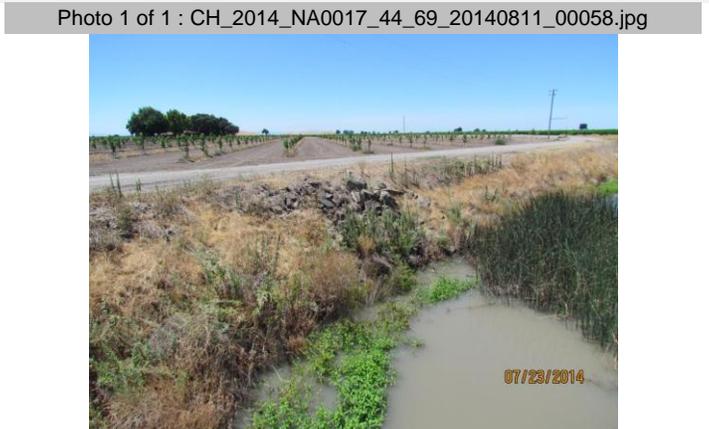
Check Point / View			
Jack Tone Rd / Down (cont)			
Rating **	A	Issue No.	69
Issue Type +	Ma	Location *	GPS Lat/Long
Category	Rivers, Channels & Designated Flood		37.880726 °
Item	Revetments		-121.146929 °
DWR ID	DWR_NA0017_44_c_2012_69		
Action/Comments			
Inspector Comments: Existing riprap protection is properly maintained.

View of the existing riprap on the channel bank looking downstream.

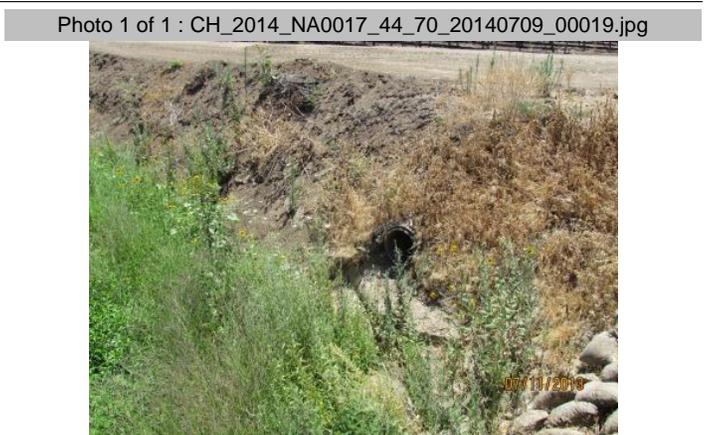
Check Point / View			
Rating **	M	Issue No.	70
Issue Type +	Ma	Location *	GPS Lat/Long
Category	Rivers, Channels & Designated Flood		37.880726 °
Item	Encroachments		-121.146929 °
DWR ID	DWR_NA0017_44_c_2012_70		
Action/Comments			
Inspector Comments: A flap gate is missing and the pipe broken was found on the channel.

View of broken pipe and other debris on the downstream of the channel.

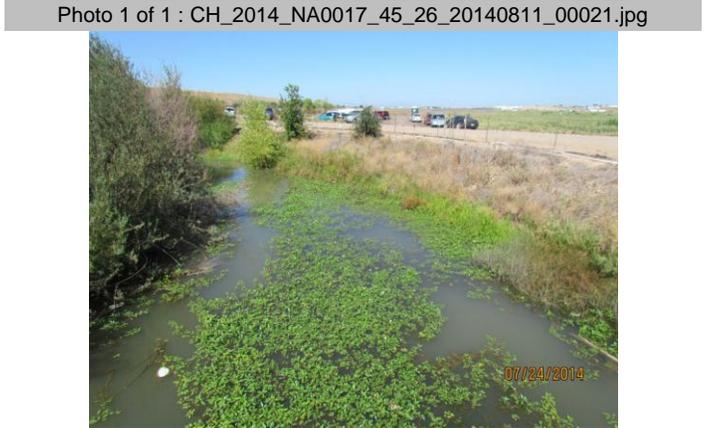
Check Point / View			
Austin Rd / Down			
Rating **	A	Issue No. 26	GPS Lat/Long
Issue Type +	Ma	Location *	37.886060 °
Category	Rivers, Channels & Designated Flood		-121.183760 °
Item	Vegetation & Obstructions		
DWR ID	DWR_NA0017_45_c_2012_26		
Action/Comments			
Inspector Comments: Minimal vegetation was found during the inspection, but the flow was not impeded.

View of downstream of the channel.
