**Flood Control Project Maintenance
Levee Inspections**

Fall 2008 Levee Maintenance Deficiency Summary Report

San Joaquin River Basin

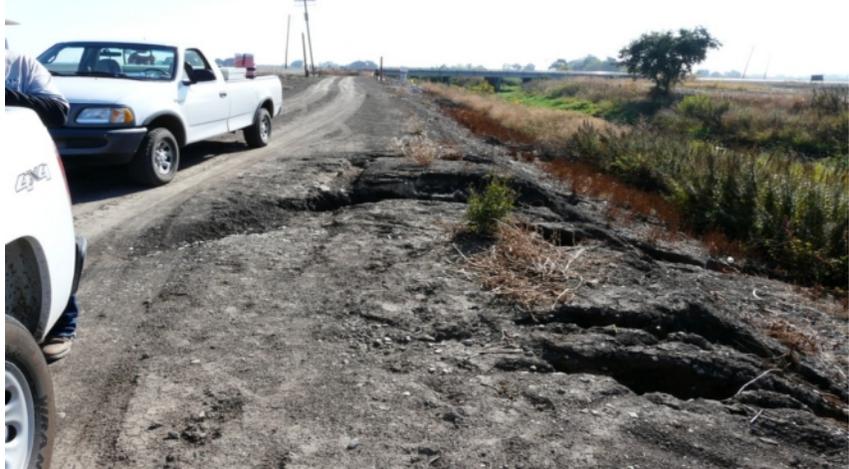
Levee Mile Report Line	3
Start Levee Mile	1.90
End Levee Mile	1.90
Location	
Category	Earthen Levee
Item	Erosion / Bank Caving
Repair & compact errosion caused by farmer on waterward slope at LM 1.90.

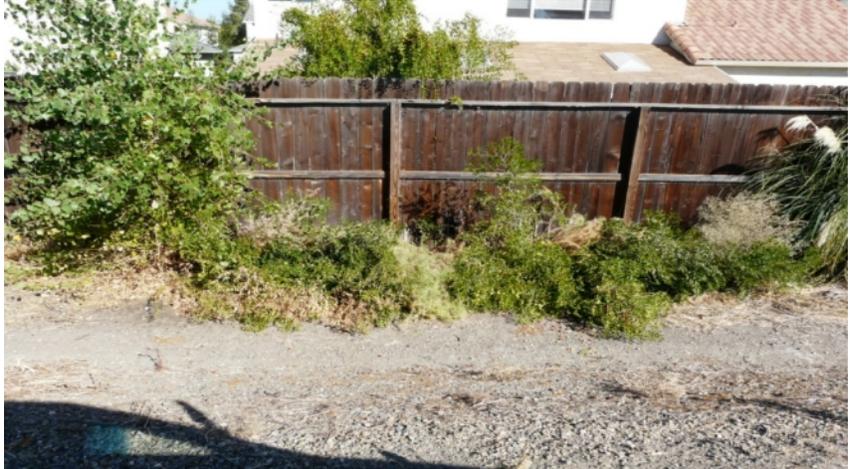
Levee Mile Report Line	3
Start Levee Mile	1.45
End Levee Mile	1.45
Location	
Category	Earthen Levee
Item	Encroachments
<p>Landscaping located within 10' from landside toe of levee at LM 1.45.</p>

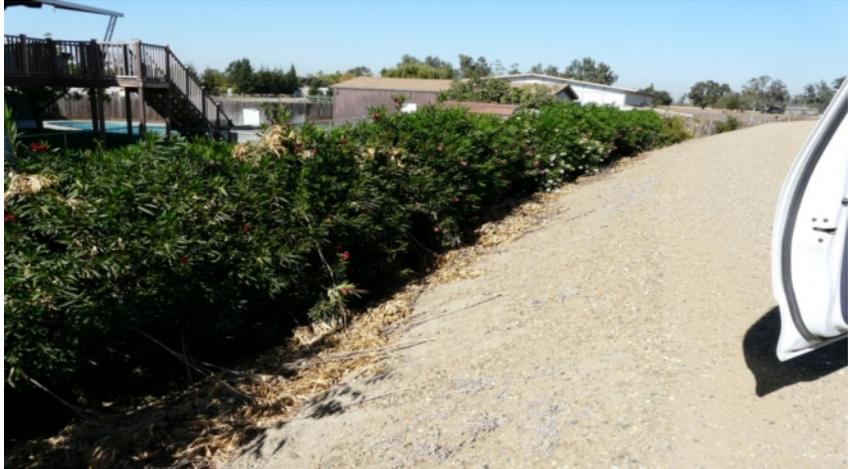
Levee Mile Report Line	18
Start Levee Mile	10.95
End Levee Mile	10.96
Location	
Category	Earthen Levee
Item	Encroachments
Debris located along landside toe of levee from LM 10.95 to LM 10.96.

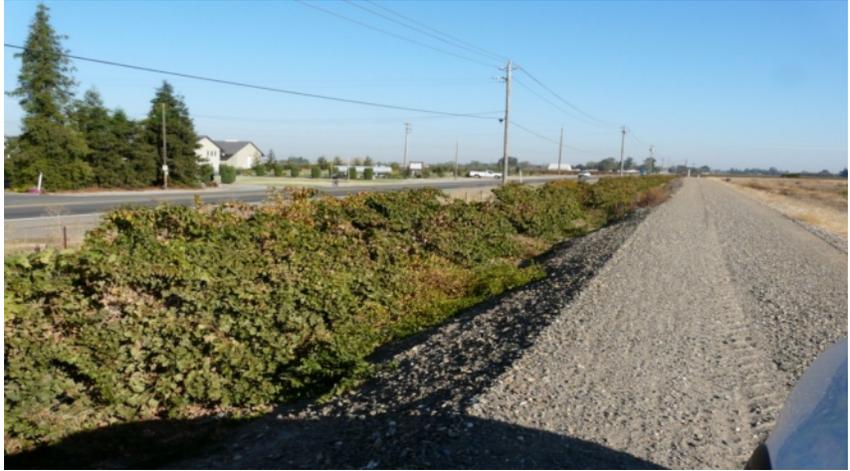
Levee Mile Report Line	24
Start Levee Mile	14.08
End Levee Mile	14.08
Location	
Category	Earthen Levee
Item	Encroachments
Move firewood to outside of 10' from landside toe of levee at LM 14.08.

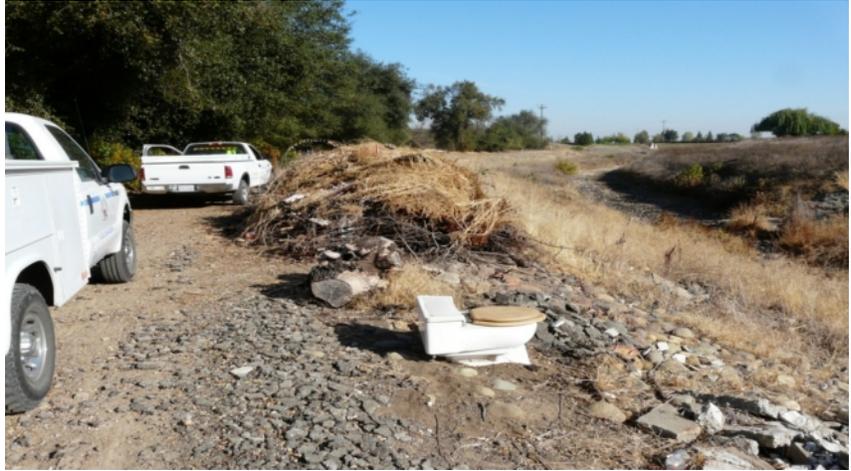
Levee Mile Report Line	27
Start Levee Mile	15.58
End Levee Mile	15.63
Location	
Category	Earthen Levee
Item	Encroachments
Debris located on waterside shoulder of access road next to golf course maintenance yard from LM 15.58 to 15.63. Debris should be moved to allow for patrolling next to channel and for visibility.

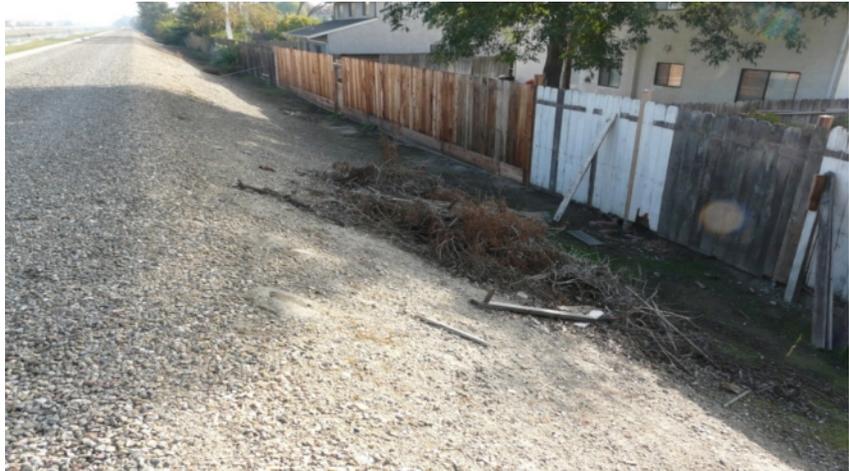
Levee Mile Report Line	2
Start Levee Mile	1.27
End Levee Mile	1.27
Location	
Category	Earthen Levee
Item	Encroachments
Landscaping along landside toe of levee at LM 1.27

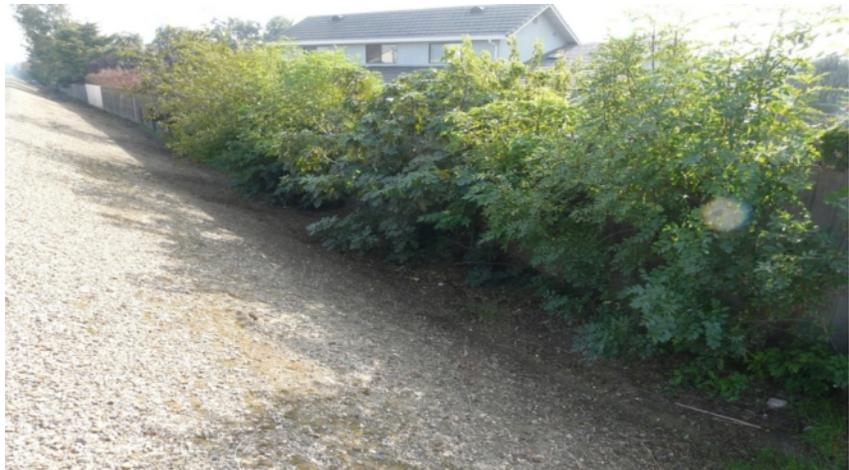
Levee Mile Report Line	3
Start Levee Mile	1.34
End Levee Mile	1.34
Location	
Category	Earthen Levee
Item	Encroachments
Remove prunings along toe of landside of levee at LM 1.34

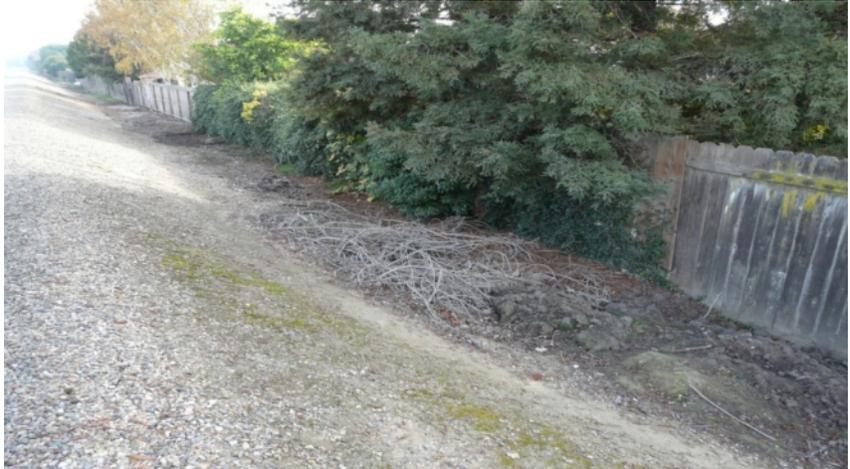
Levee Mile Report Line	5
Start Levee Mile	1.48
End Levee Mile	1.48
Location	
Category	Earthen Levee
Item	Encroachments
Landscaping along toe of landside of levee at LM 1.48

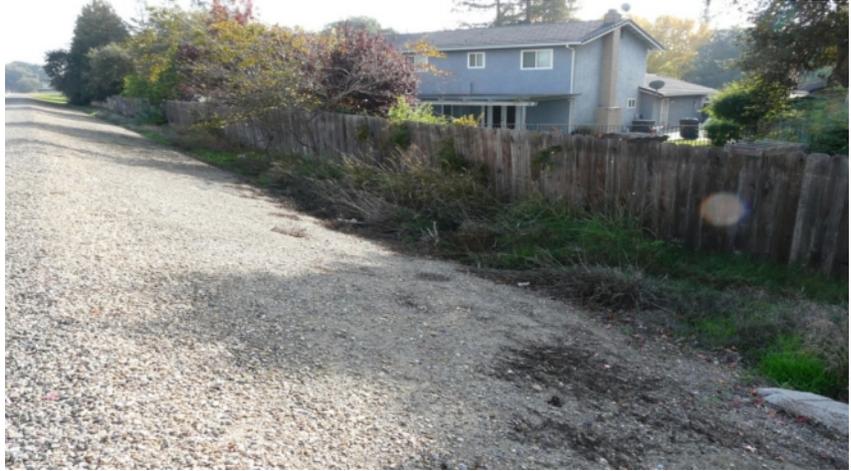
Levee Mile Report Line	8
Start Levee Mile	1.77
End Levee Mile	1.77
Location	
Category	Earthen Levee
Item	Encroachments
Landscaping along landside toe of levee at LM 1.77

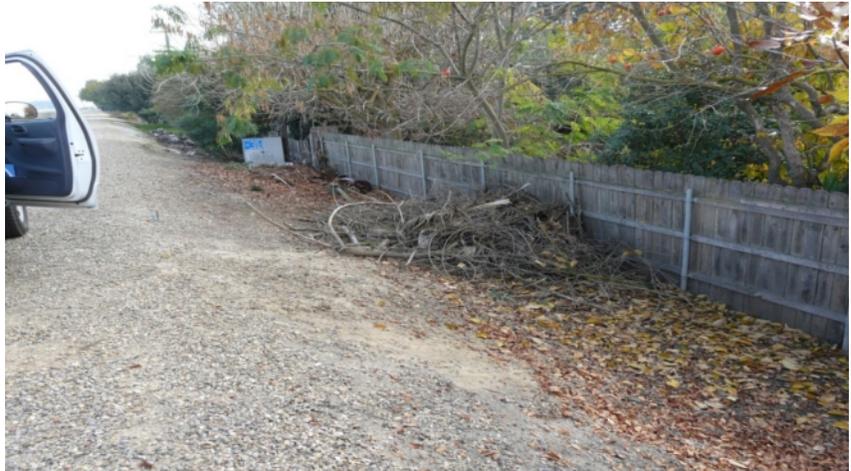
Levee Mile Report Line	11
Start Levee Mile	2.20
End Levee Mile	2.20
Location	
Category	Earthen Levee
Item	Encroachments
Remove prunings and logs from landside of levee at LM 2.20

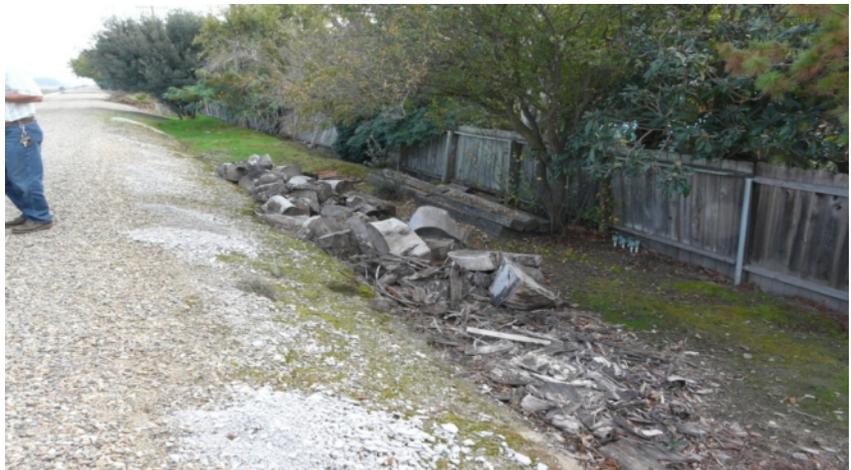
Levee Mile Report Line	12
Start Levee Mile	2.22
End Levee Mile	2.22
Location	
Category	Earthen Levee
Item	Encroachments
Remove prunings from landside of levee at LM 2.22

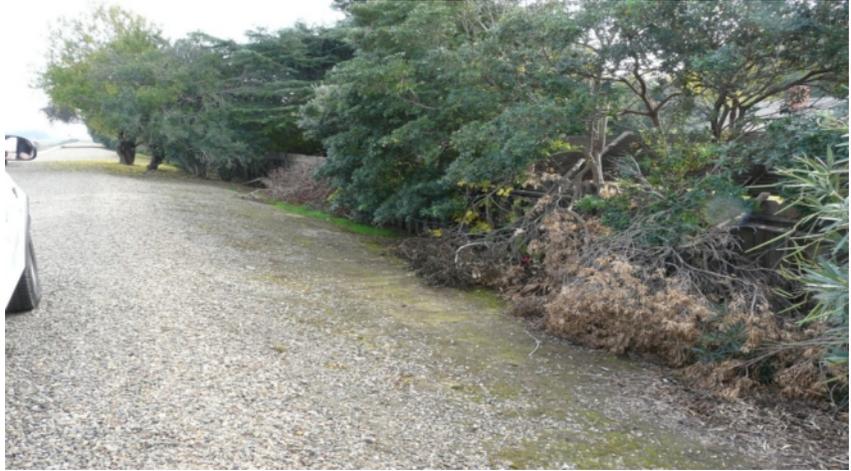
Levee Mile Report Line	14
Start Levee Mile	2.32
End Levee Mile	2.32
Location	
Category	Earthen Levee
Item	Trim / Thin Trees
Trim/thin trees on landside of levee to allow for visibility at LM 2.32

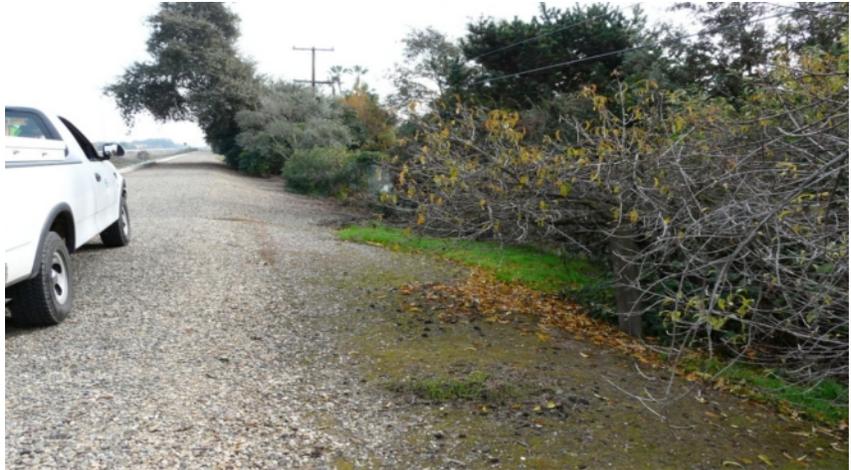
Levee Mile Report Line	15
Start Levee Mile	2.32
End Levee Mile	2.35
Location	
Category	Earthen Levee
Item	Encroachments
Garden located on landside slope of levee from LM 2.32 to LM 2.35

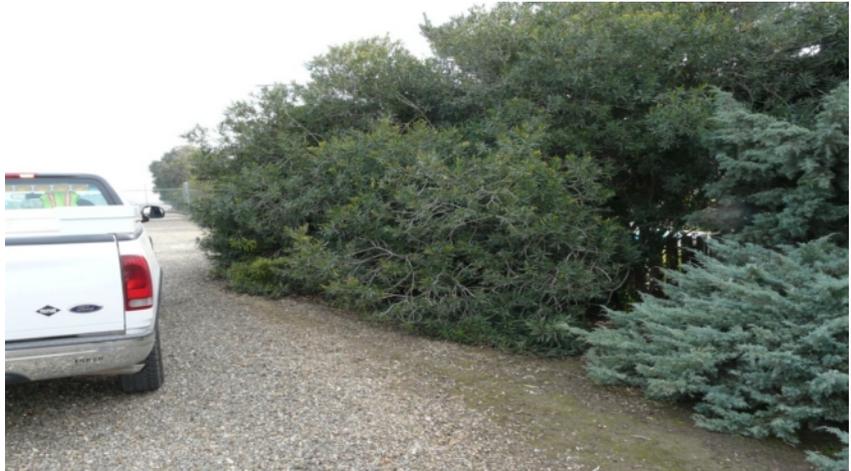
Levee Mile Report Line	17
Start Levee Mile	2.40
End Levee Mile	2.42
Location	
Category	Earthen Levee
Item	Trim / Thin Trees
Trim/thin trees along landside of levee from LM 2.40 to LM 2.42

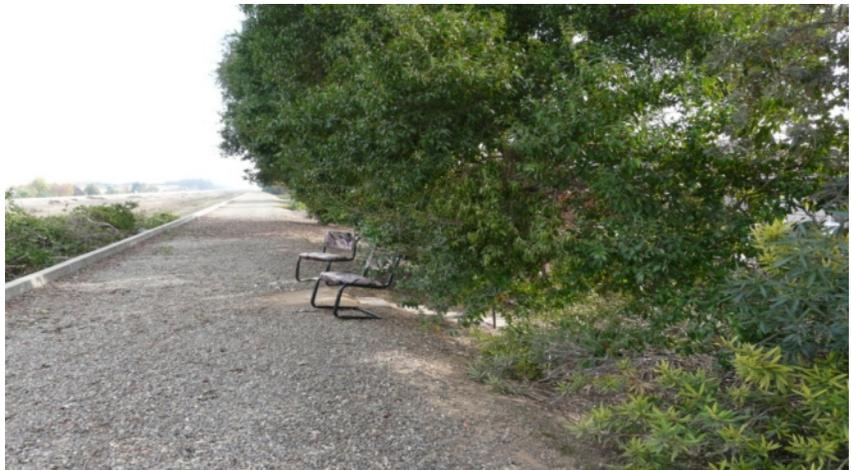
Levee Mile Report Line	18
Start Levee Mile	2.40
End Levee Mile	2.42
Location	
Category	Earthen Levee
Item	Encroachments
Remove prunings from waterside of levee from LM 2.40 to LM 2.42

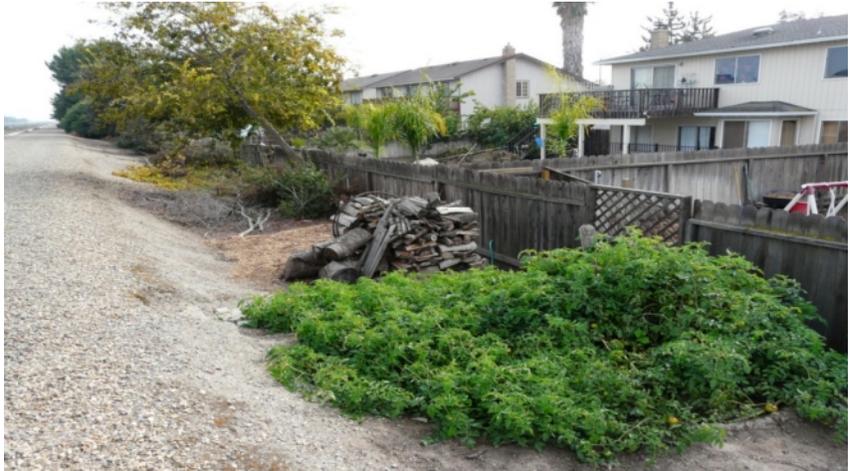
Levee Mile Report Line	20
Start Levee Mile	2.48
End Levee Mile	2.48
Location	
Category	Earthen Levee
Item	Encroachments
Remove prunings from landside of levee at LM 2.48

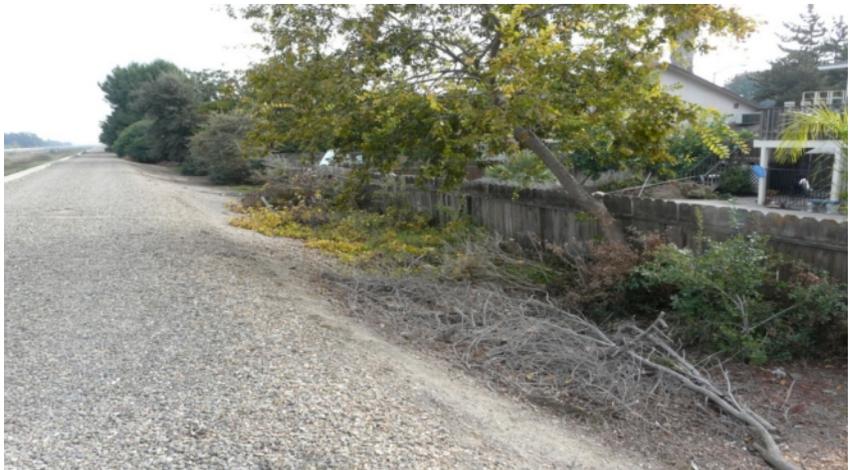
Levee Mile Report Line	21
Start Levee Mile	2.48
End Levee Mile	2.52
Location	
Category	Earthen Levee
Item	Trim / Thin Trees
Trim trees along landside of levee to allow for visibility from LM 2.48 to LM 2.52

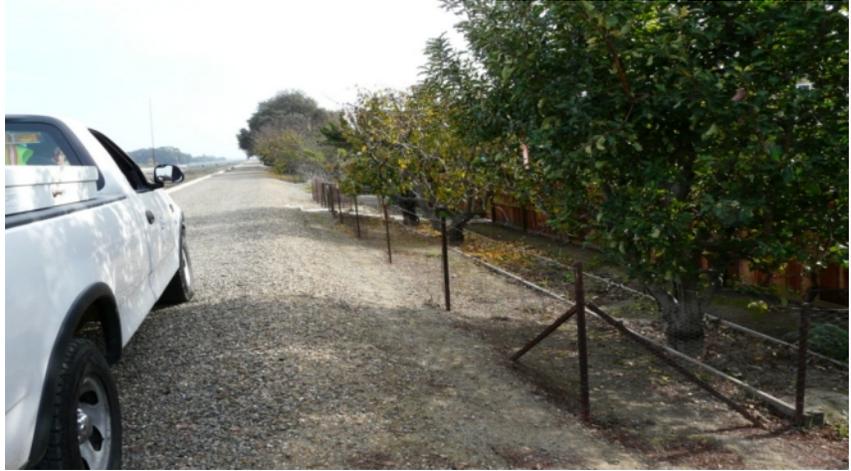
Levee Mile Report Line	23
Start Levee Mile	2.62
End Levee Mile	2.63
Location	
Category	Earthen Levee
Item	Encroachments
Landscaping on landside of levee slope from LM 2.62 to LM 2.63

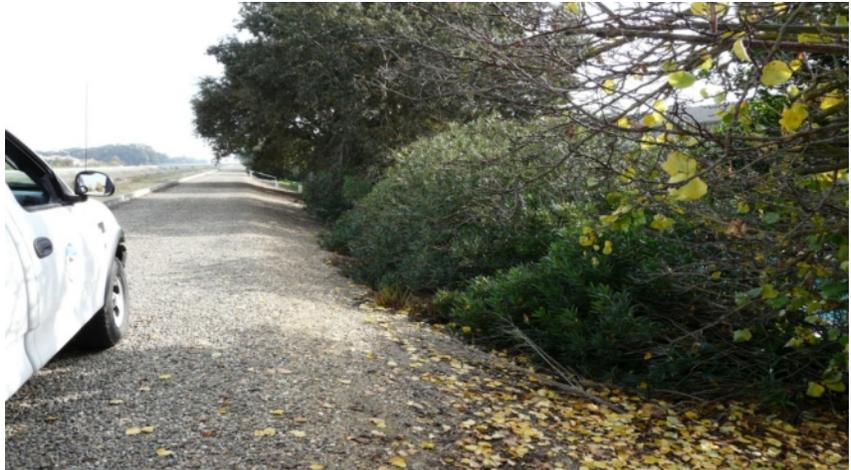
Levee Mile Report Line	24
Start Levee Mile	2.67
End Levee Mile	2.71
Location	
Category	Earthen Levee
Item	Trim / Thin Trees
Trim trees along landside of levee slope from LM 2.67 to LM 2.71

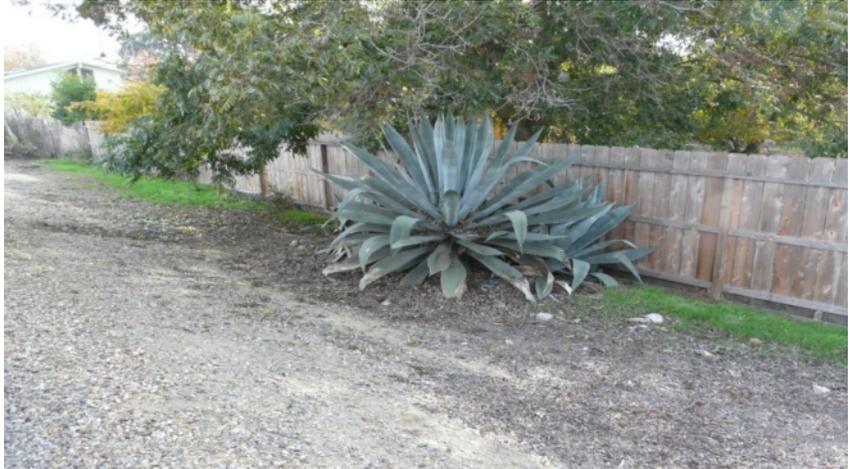
Levee Mile Report Line	26
Start Levee Mile	2.78
End Levee Mile	2.78
Location	
Category	Earthen Levee
Item	Encroachments
Landscaping along landside toe of levee at LM 2.78

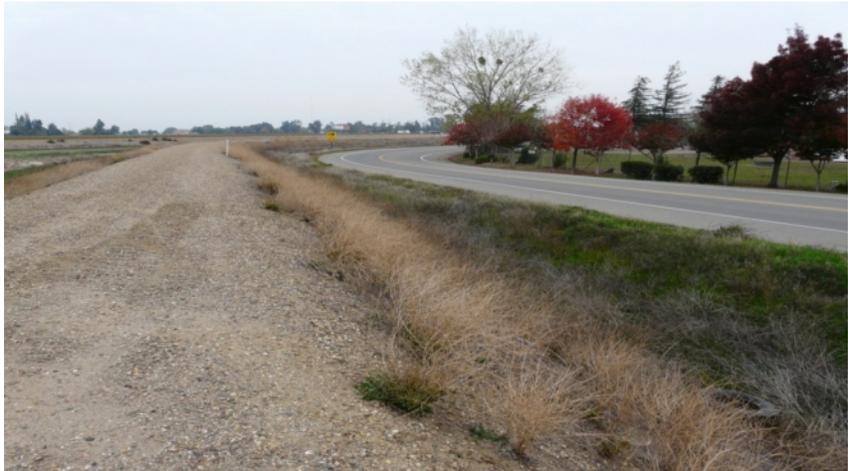
Levee Mile Report Line	38
Start Levee Mile	7.57
End Levee Mile	7.62
Location	
Category	Earthen Levee
Item	Encroachments
Landscaping along landside slope of levee at from LM 7.57 to 7.62

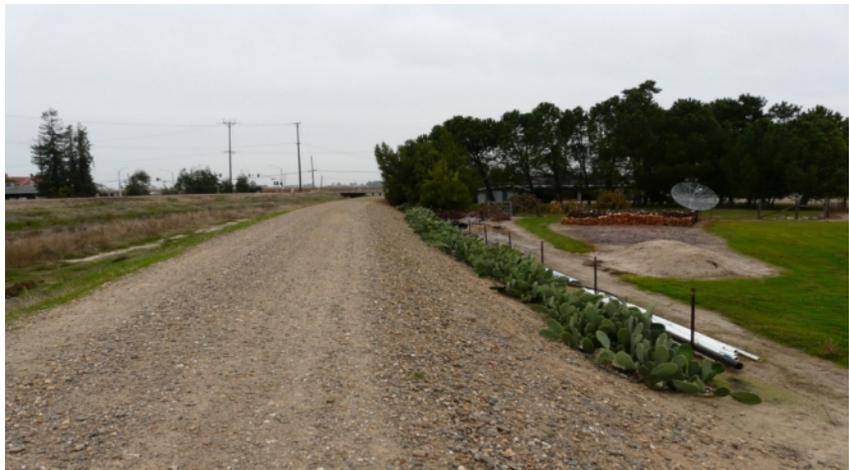
Levee Mile Report Line	44
Start Levee Mile	14.90
End Levee Mile	14.90
Location	
Category	Earthen Levee
Item	Encroachments
Remove prunings from waterside of levee at LM 14.90

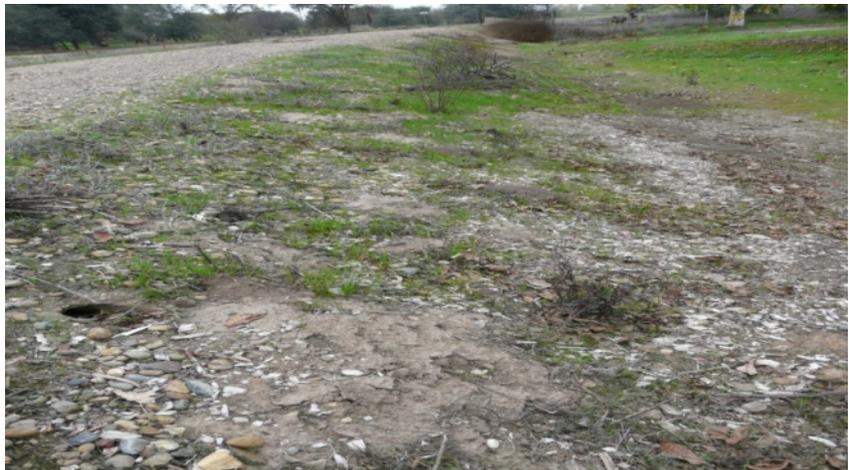
Levee Mile Report Line	47
Start Levee Mile	15.14
End Levee Mile	15.15
Location	
Category	Earthen Levee
Item	Animal Control
Example of rodent hole needing to be repaired along waterside of levee from LM 15.14 to LM 15.15

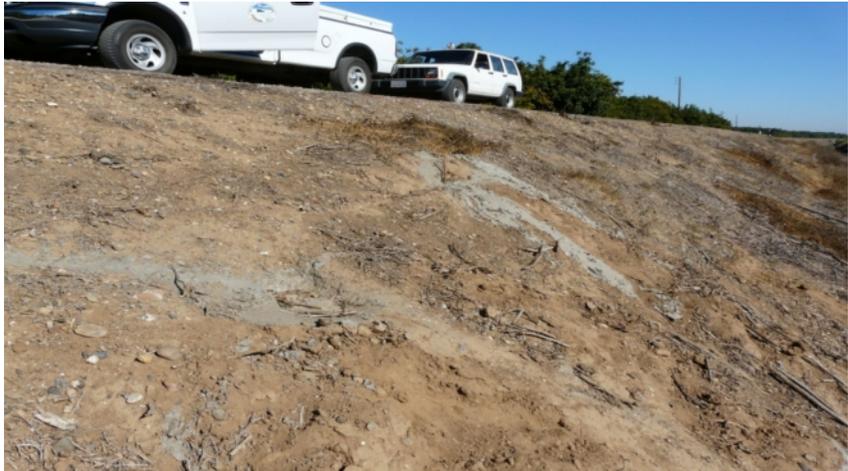
Levee Mile Report Line	22
Start Levee Mile	4.05
End Levee Mile	4.07
Location	
Category	Earthen Levee
Item	Animal Control
Good example of grouting rodent holes
