**Flood Control Project Maintenance
Levee Inspections**

Fall 2011 Levee Maintenance Deficiency Summary Report

San Joaquin River Basin

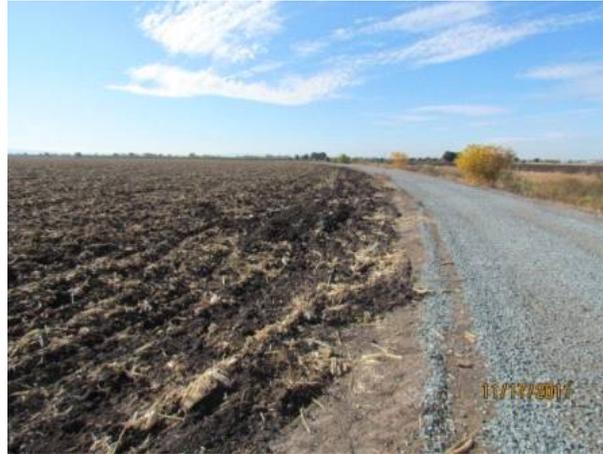
Levee Mile Report Line	3
Start Levee Mile	0.42
End Levee Mile	0.42
Location	Water Side
Category	Earthen Levee
Item	Encroachments
Pruning was found on the waterside of the levee looking downstream.	
pkazi_f_20111201_322.jpg

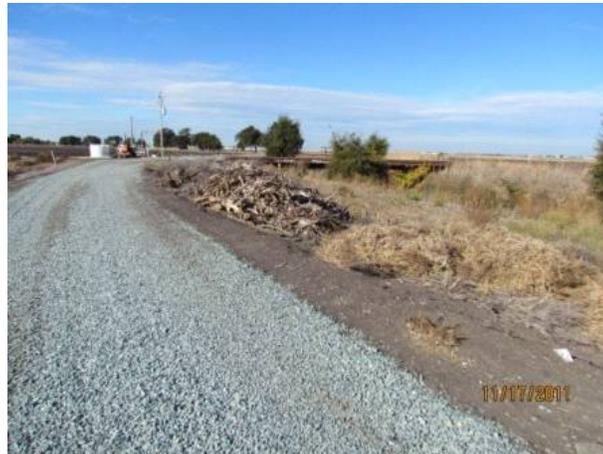
Levee Mile Report Line	6
Start Levee Mile	0.88
End Levee Mile	1.04
Location	Land Side
Category	Earthen Levee
Item	Encroachments
Tilling was repaired by the LMA on the landside of the levee looking downstream.	
pkazi_f_20111201_323.jpg

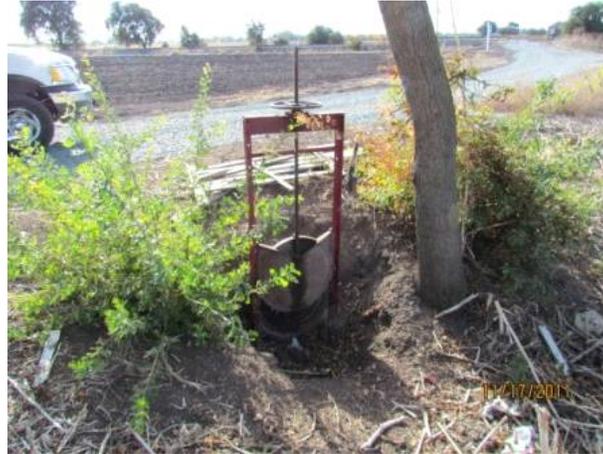
Levee Mile Report Line	10
Start Levee Mile	1.06
End Levee Mile	1.06
Location	Water Side
Category	Interior Drainage & Piping Systems
Item	Flap Gates

Flap gate appeared to be broken on the waterside of the levee looking downstream.

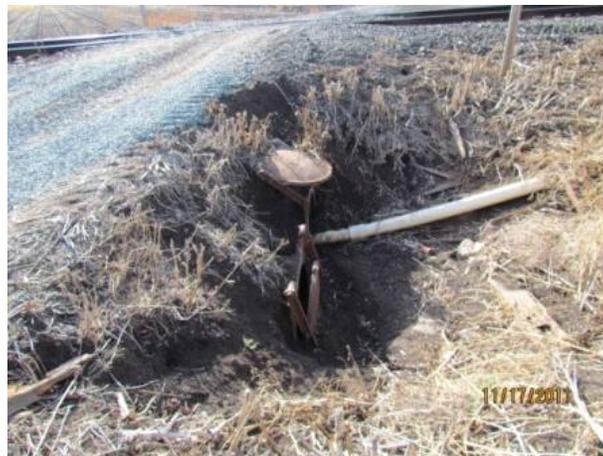
Levee Mile Report Line	11
Start Levee Mile	1.07
End Levee Mile	1.27
Location	Water Side
Category	Earthen Levee
Item	Encroachments

PVC Pipe was found on the waterside of the levee looking downstream.

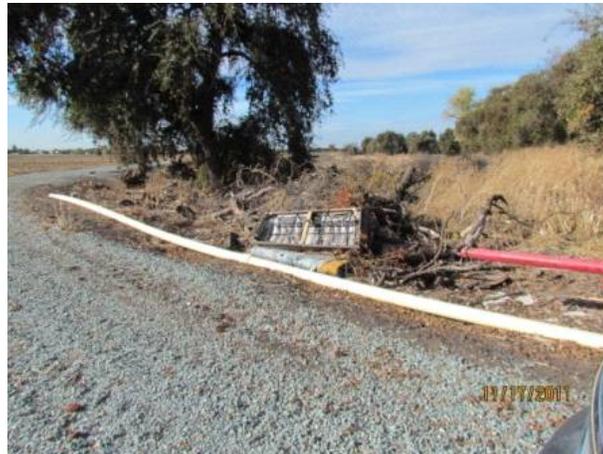
Levee Mile Report Line	16
Start Levee Mile	1.32
End Levee Mile	1.32
Location	Water Side
Category	Earthen Levee
Item	Encroachments
Prunings were found on the waterside of the levee looking upstream.	
pkazi_f_20111201_329.jpg

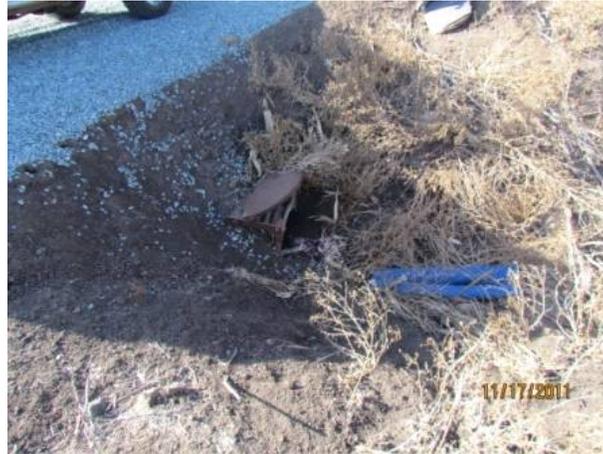
Levee Mile Report Line	18
Start Levee Mile	1.52
End Levee Mile	1.58
Location	Land Side
Category	Earthen Levee
Item	Encroachments

An agricultural ditch was found on the landside of the levee looking downstream.

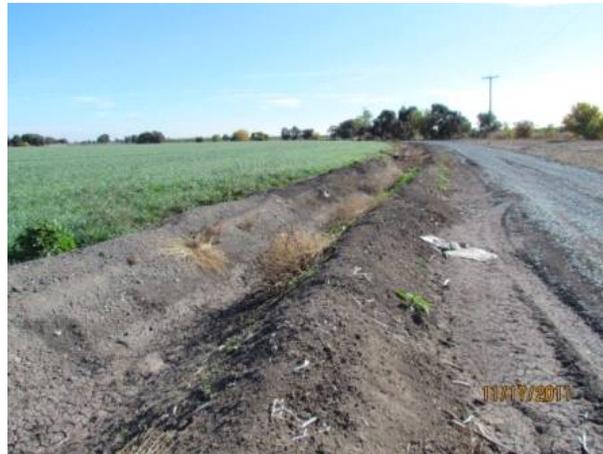
Levee Mile Report Line	4
Start Levee Mile	1.70
End Levee Mile	1.70
Location	Water Side
Category	Earthen Levee
Item	Encroachments
Tilling on the waterside of the levee has been fixed by the LMA. The picture was taken from the crown looking upstream.	
pkazi_f_20111128_320.jpg

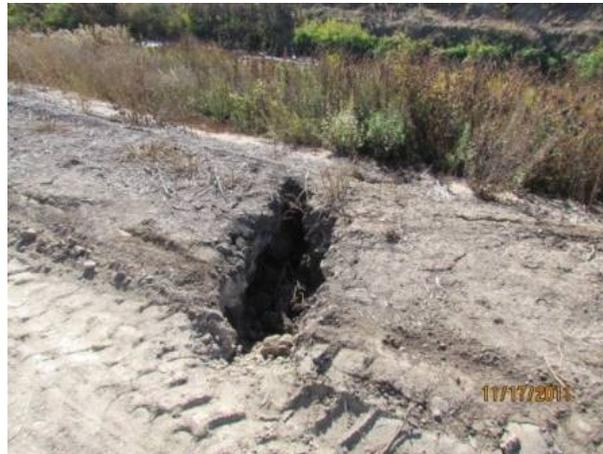
Levee Mile Report Line	8
Start Levee Mile	1.95
End Levee Mile	1.95
Location	Water Side
Category	Earthen Levee
Item	Encroachments
Pruning was found on the waterside shoulder of the levee looking downstream.	
pkazi_f_20111128_305.jpg

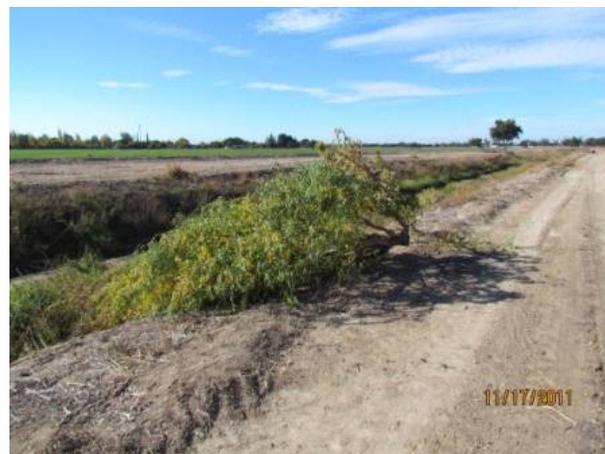
Levee Mile Report Line	11
Start Levee Mile	2.06
End Levee Mile	2.06
Location	Water Side
Category	Earthen Levee
Item	Encroachments
An abandoned pipe was found on the waterside of the levee looking downstream.	
pkazi_f_20111128_308.jpg

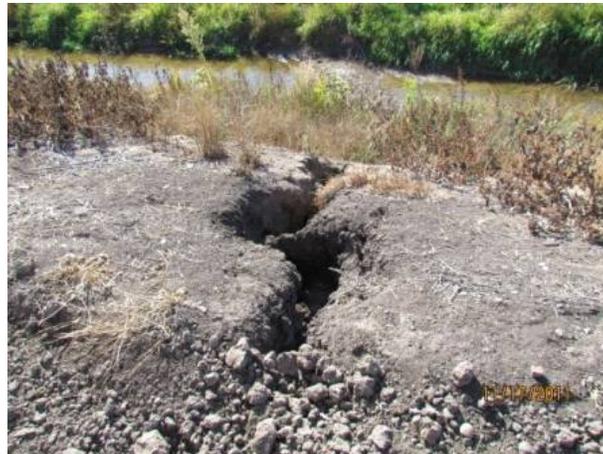
Levee Mile Report Line	14
Start Levee Mile	2.27
End Levee Mile	2.27
Location	Water Side
Category	Earthen Levee
Item	Erosion / Bank Caving
<p>Erosion was found on the waterside of the levee looking upstream.</p>	
<p>pkazi_f_20111128_311.jpg</p>

14	2.27	2.27	Earthen Levee	Erosion / Bank Caving	WS	M	Schedule repair of erosion site prior to the next inspection.	37.885182 ° -121.253971 °	37.885182 ° -121.253971 °	13 Y
15	2.27	2.27	Earthen Levee	Animal Control	WS	M	No rodents visible, but rodent burrows visible; need to backfill and compact or grout burrows.	37.885183 ° -121.253971 °	37.885183 ° -121.253971 °	14 Y
16	2.54	2.54	Earthen Levee	Erosion / Bank Caving	WS	M	Schedule repair of erosion site prior to the next inspection.	37.888239 ° -121.256586 °	37.888239 ° -121.256586 °	15 Y
17	2.65	2.65	Earthen Levee	Animal Control	CR	M	Exterminate rodents and backfill and compact or grout burrows.	37.888847 ° -121.258344 °	37.888847 ° -121.258344 °	10 Y
18	2.66	3.17	Earthen Levee	Encroachments	LS	PO	Agricultural Ditch	37.888885 ° -121.258519 °	37.888573 ° -121.267475 °	17 Y

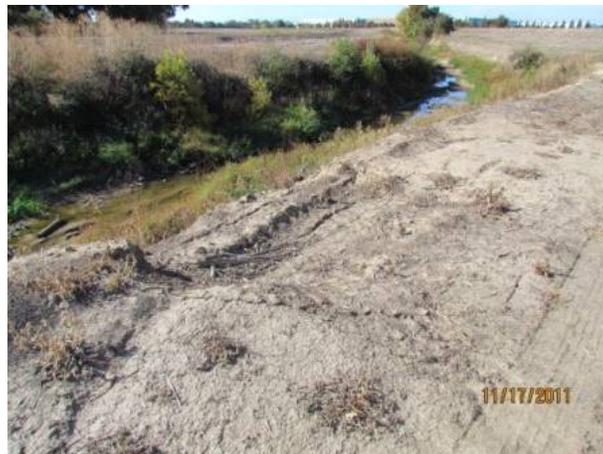
Levee Mile Report Line	17
Start Levee Mile	2.65
End Levee Mile	2.65
Location	Crown
Category	Earthen Levee
Item	Animal Control
Rodent hole was found on the crown of the levee looking downstream.	
pkazi_f_20111128_314.jpg

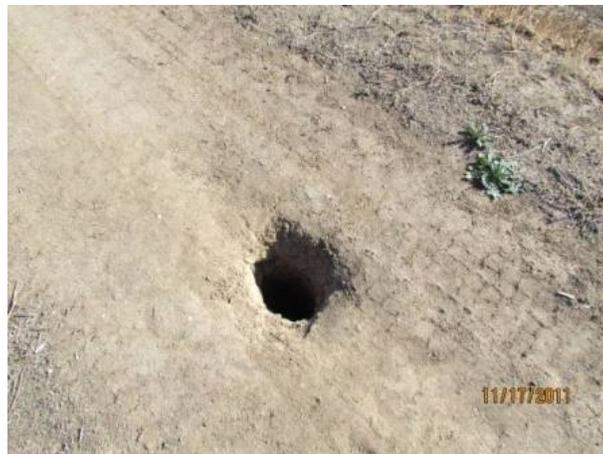
Levee Mile Report Line	21
Start Levee Mile	2.89
End Levee Mile	2.89
Location	Water Side
Category	Earthen Levee
Item	Animal Control
A rodent hole was found on the waterside slope of the levee looking downstream.	
pkazi_f_20111128_317.jpg

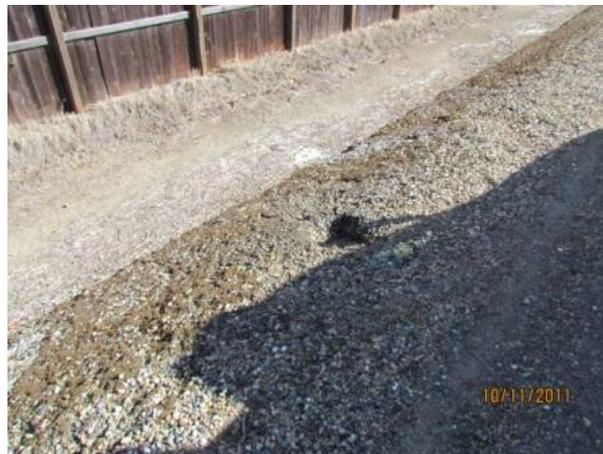
Levee Mile Report Line	9
Start Levee Mile	1.47
End Levee Mile	1.47
Location	Land Side
Category	Earthen Levee
Item	Encroachments
<p>Debris was found on the landside of the levee looking upstream.</p>	
<p>pkazi_f_20111117_200.jpg</p>

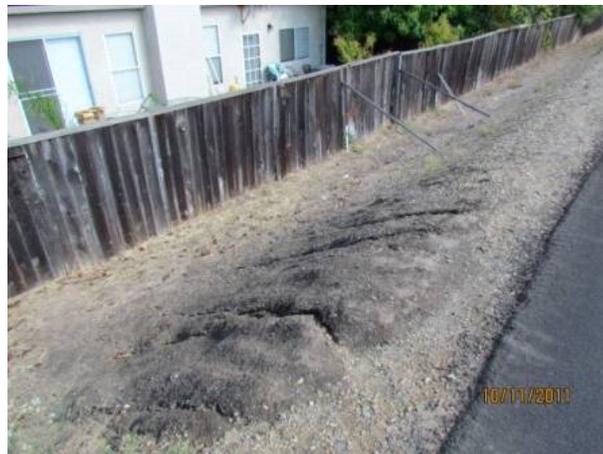
Levee Mile Report Line	19
Start Levee Mile	2.30
End Levee Mile	2.30
Location	Land Side
Category	Earthen Levee
Item	Encroachments
<p>View of landscaping coming through the fence and blocking visibility within 10' of the landward toe looking upstream.</p>	
<p>pkazi_f_20110923_585.jpg</p>

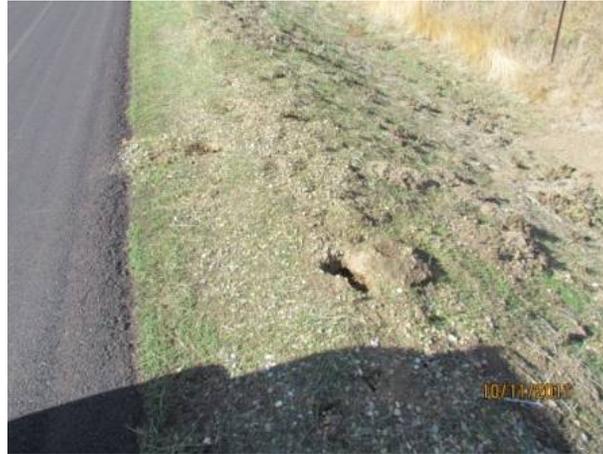
Levee Mile Report Line	26
Start Levee Mile	2.99
End Levee Mile	2.99
Location	Land Side
Category	Earthen Levee
Item	Animal Control
<p>Rodent holes were found on the landside of the levee looking downstream.</p>	
<p>pkazi_f_20111117_209.jpg</p>

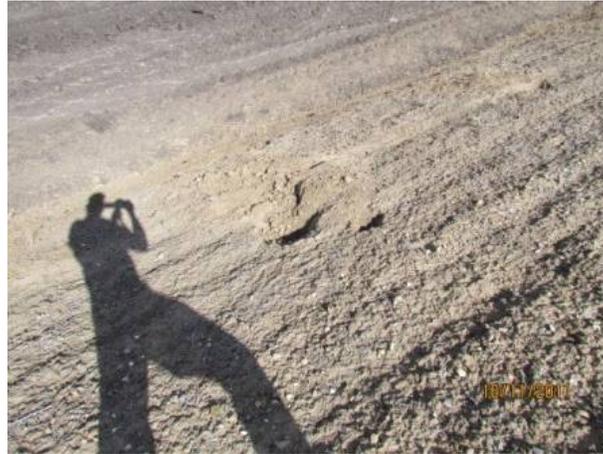
Levee Mile Report Line	33
Start Levee Mile	3.92
End Levee Mile	3.92
Location	Land Side
Category	Earthen Levee
Item	Slope Stability
Slope instability was created by foot traffic on the landside of the levee looking downstream.	
pkazi_f_20111117_215.jpg

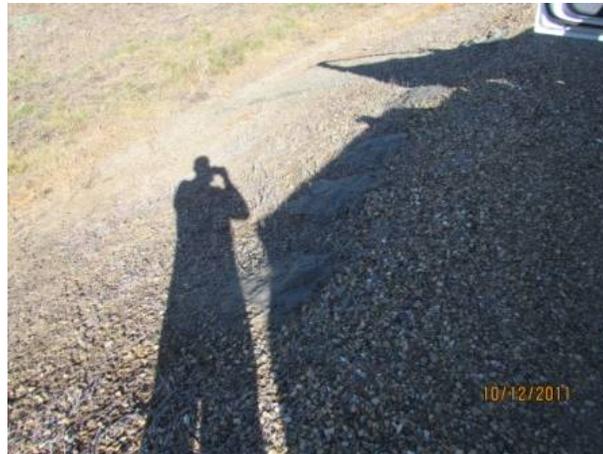
Levee Mile Report Line	45
Start Levee Mile	7.36
End Levee Mile	7.36
Location	Land Side
Category	Earthen Levee
Item	Animal Control
Rodent hole was found on the landside of the levee looking downstream.	
pkazi_f_20111117_222.jpg

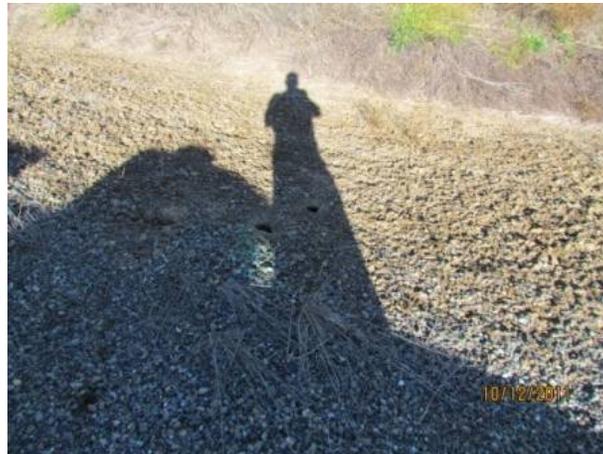
Levee Mile Report Line	49
Start Levee Mile	7.73
End Levee Mile	7.73
Location	Water Side
Category	Earthen Levee
Item	Encroachments
Pruning was found on the waterside of the levee looking upstream.	
pkazi_f_20111117_226.jpg

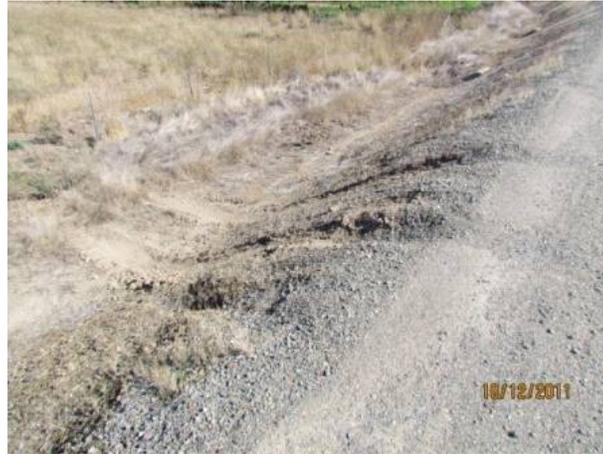
Levee Mile Report Line	52
Start Levee Mile	7.91
End Levee Mile	8.29
Location	Land Side
Category	Earthen Levee
Item	Vegetation
No vegetation was found on the landside of the levee looking upstream.	
pkazi_f_20111117_227.jpg

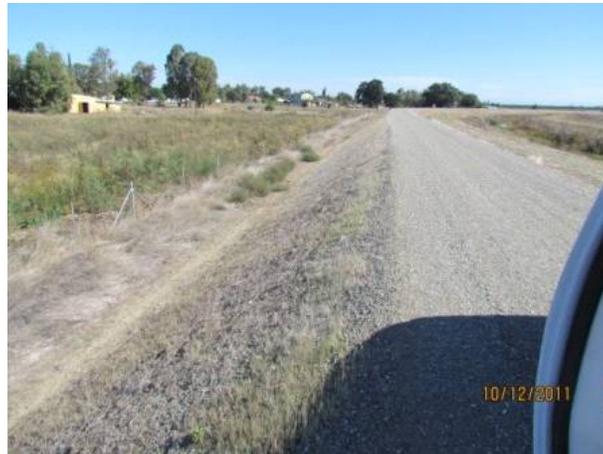
Levee Mile Report Line	53
Start Levee Mile	7.98
End Levee Mile	7.98
Location	Land Side
Category	Earthen Levee
Item	Slope Stability
Slope instability was found on the landside of the levee looking upstream.	
pkazi_f_20111117_228.jpg

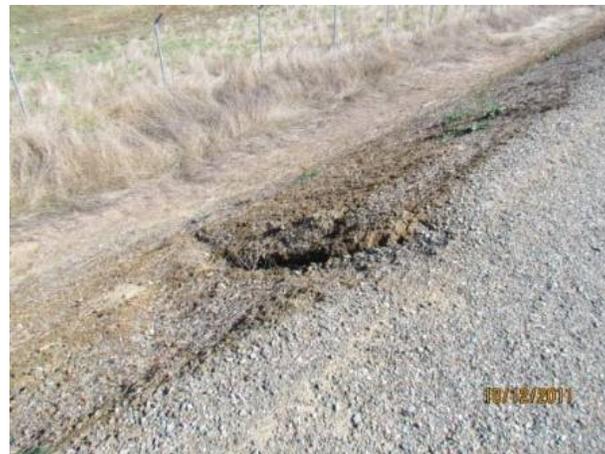
Levee Mile Report Line	56
Start Levee Mile	8.29
End Levee Mile	8.51
Location	Land Side
Category	Earthen Levee
Item	Slope Stability
Farmer is cutting at the toe of landside of the levee and in addition a slope instability issue exists on the slope. The picture was taken from the crown looking upstream.	
pkazi_f_20111117_232.jpg

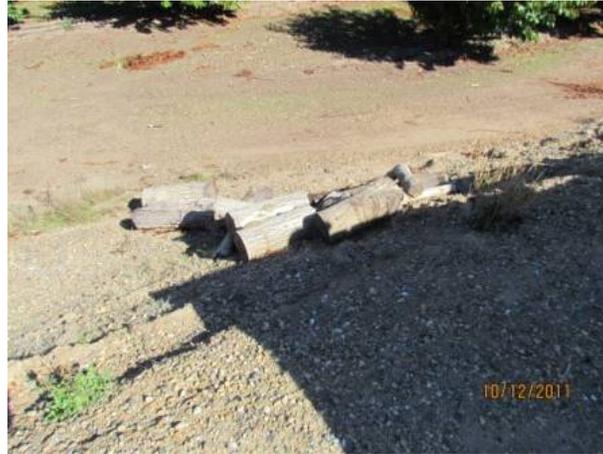
Levee Mile Report Line	58
Start Levee Mile	8.87
End Levee Mile	8.87
Location	Land Side
Category	Earthen Levee
Item	Encroachments
Pruning was found on the landside of the levee looking upstream.	
pkazi_f_20111117_233.jpg

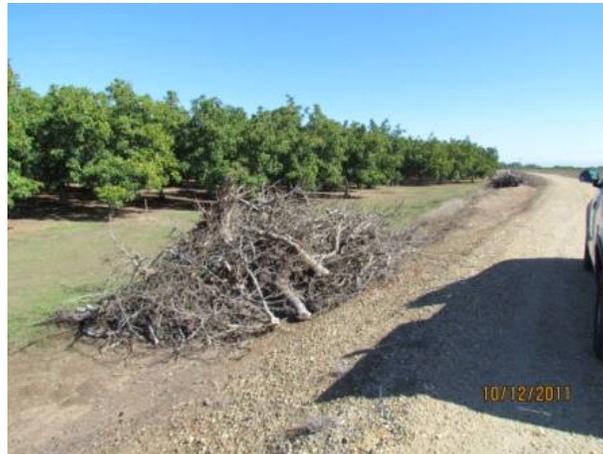
Levee Mile Report Line	60
Start Levee Mile	9.15
End Levee Mile	9.15
Location	Land Side
Category	Earthen Levee
Item	Encroachments
Ash pile was found on the landside of the levee looking upstream.	
pkazi_f_20111117_234.jpg

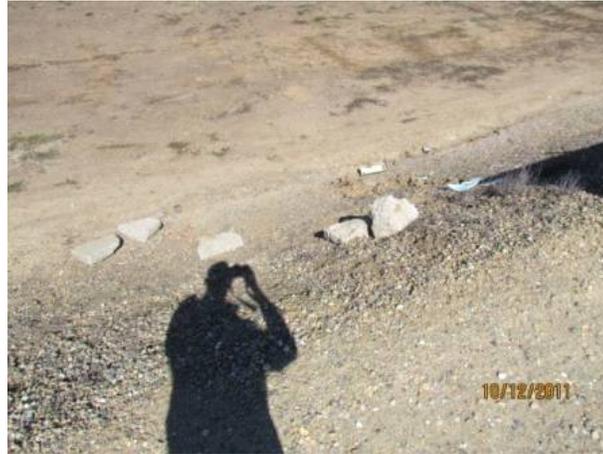
Levee Mile Report Line	69
Start Levee Mile	9.89
End Levee Mile	9.89
Location	Land Side
Category	Earthen Levee
Item	Slope Stability
Slope instability was found on the landside of the levee looking downstream.	
pkazi_f_20111117_237.jpg

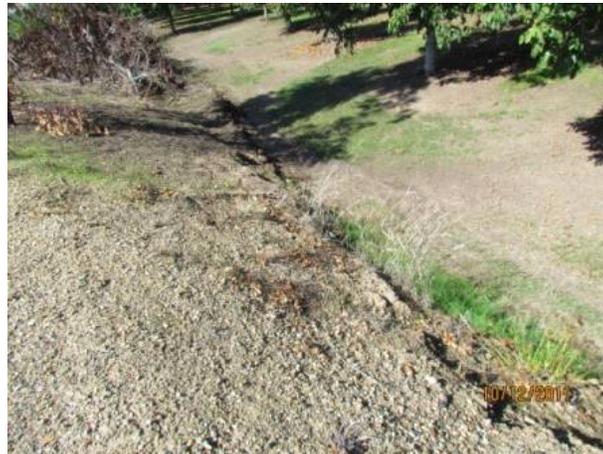
Levee Mile Report Line	71
Start Levee Mile	9.95
End Levee Mile	9.95
Location	Land Side
Category	Earthen Levee
Item	Erosion / Bank Caving
View of erosion occurring on a recent slope repair on the landward slope looking upstream.	
pkazi_f_20110923_606.jpg

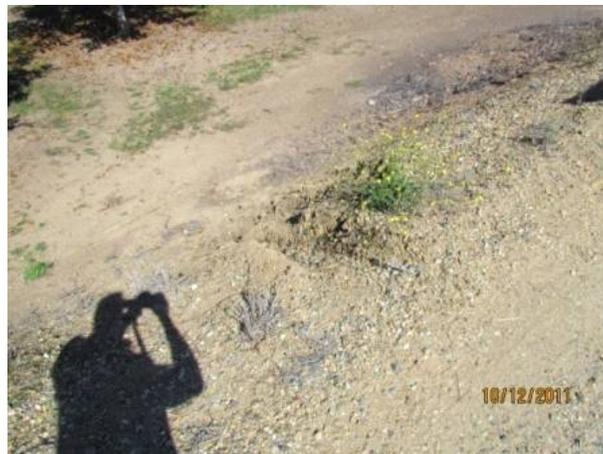
Levee Mile Report Line	78
Start Levee Mile	10.51
End Levee Mile	10.51
Location	Land Side
Category	Earthen Levee
Item	Animal Control
Rodent holes were found on the landside of the levee looking downstream.	
pkazi_f_20111117_240.jpg

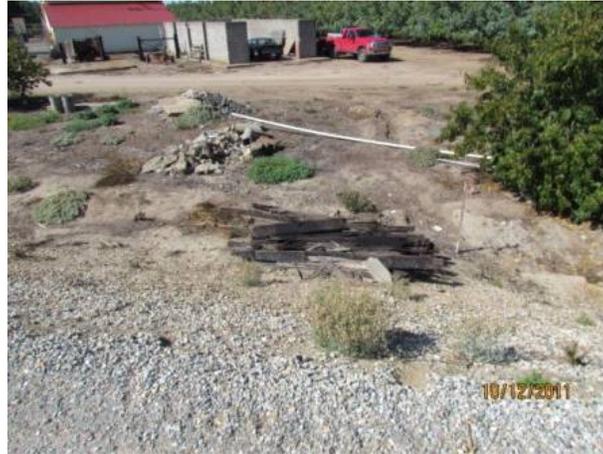
Levee Mile Report Line	81
Start Levee Mile	12.47
End Levee Mile	12.47
Location	Land Side
Category	Earthen Levee
Item	Animal Control
A rodent hole was found on the landside of the levee looking upstream.	
pkazi_f_20111117_242.jpg
