**Flood Control Project Maintenance  
Levee Inspections**

**Fall 2015 Levee Maintenance Deficiency Summary Report**

**San Joaquin River Basin**

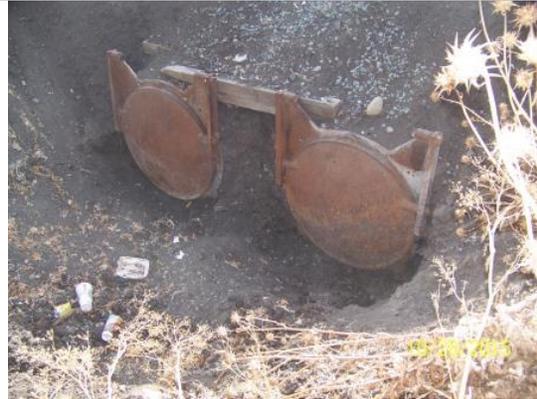
Photo 1 of 1 : FA\_2015\_NA0017\_148\_1\_20151116\_00008.jpg

LM Start	<b>0.79</b>	Rating **	A	Issue No.	<b>1</b>
LM End	<b>0.79</b>	Issue Type +	En	Location *	LS
Category	Earthen Levee			GPS Latitude/Longitude	
				Start	End
Item	Encroachments			37.878502 °	37.878502 °
				-121.242377 °	-121.242377 °
DWR ID	DWR_NA0017_01_f_2015_1				
Action/Comments					
Pipe Inspector Comments: LMA cleaned the flap gates area which UCIP noted on their inspection.

View of the cleaned flap gates.

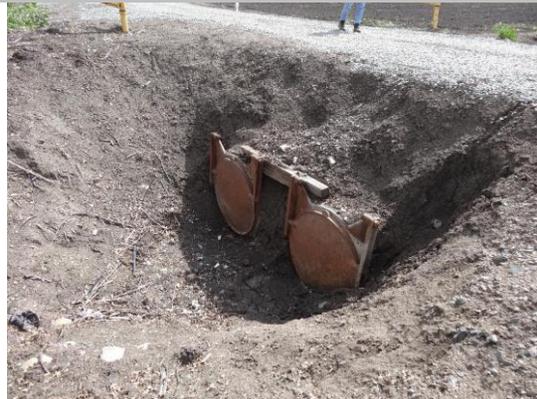
Photo 3 of 3 : UCIP\_FA\_2015\_3911.jpg

WS view: CMP drain pipes with flap gates on ditch.

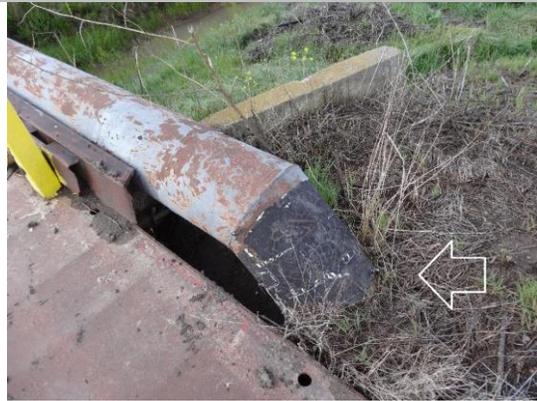
Photo 2 of 3 : UCIP\_FA\_2015\_3803.jpg

WS view: closer view of 14-inch steel pipe attached to the steel bridge.

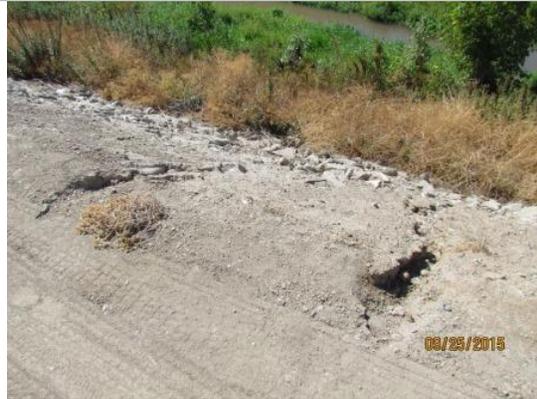
Photo 1 of 1 : FA\_2015\_NA0017\_149\_12\_20150928\_00009.jpg

View of erosion due to runoff on the waterside slope of the levee looking upstream.

LM Start	<b>2.11</b>	Rating **	M	Issue No.	<b>128</b>
LM End	<b>2.11</b>	Issue Type +	Ma	Location *	WS
Category	Earthen Levee		GPS Latitude/Longitude		
			Start	End	
Item	Erosion / Bank Caving		37.883599 °	37.883599 °	
			-121.252355 °	-121.252355 °	
DWR ID	DWR_NA0017_02_s_2015_128				
Action/Comments					
Schedule repair of erosion site prior to the next inspection. Inspector Comments: Runoff

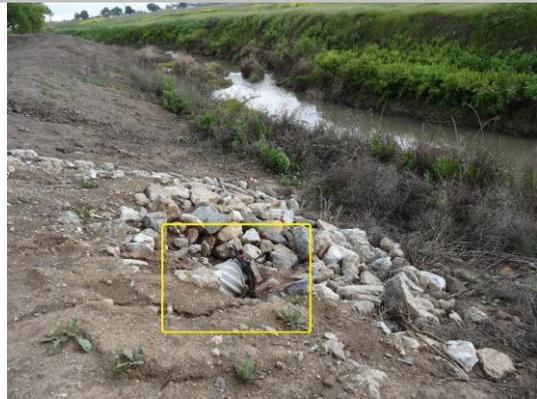
Photo 3 of 3 : UCIP\_FA\_2015\_3922.jpg

WS view: new CM drain pipe and flap gate on levee slope.

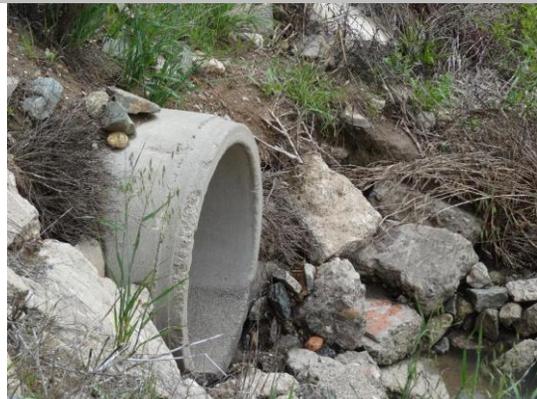
Photo 2 of 3 : UCIP\_FA\_2015\_4035.jpg

WS view: closer view of concrete drain pipe on levee slope.

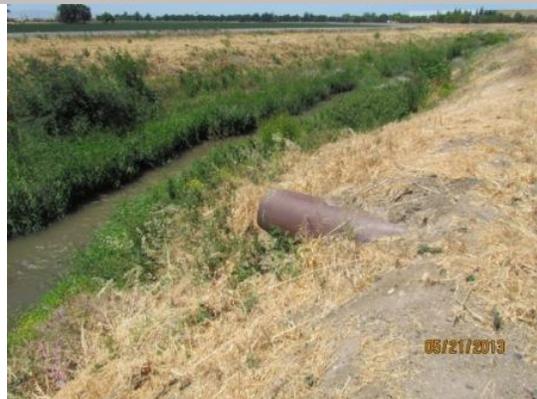
Photo 2 of 2 : FA\_2015\_NA0017\_149\_8\_20150911\_00005.jpg

A pipe was found without a flap gate on waterside slope of the levee looking downstream. This pipe may predate the project.

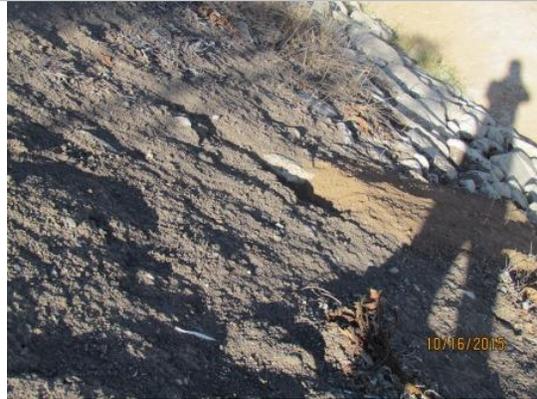
Photo 1 of 1 : FA\_2015\_NA0017\_150\_2\_20151023\_00002.jpg

A rodent hole was found on the waterside of the levee.

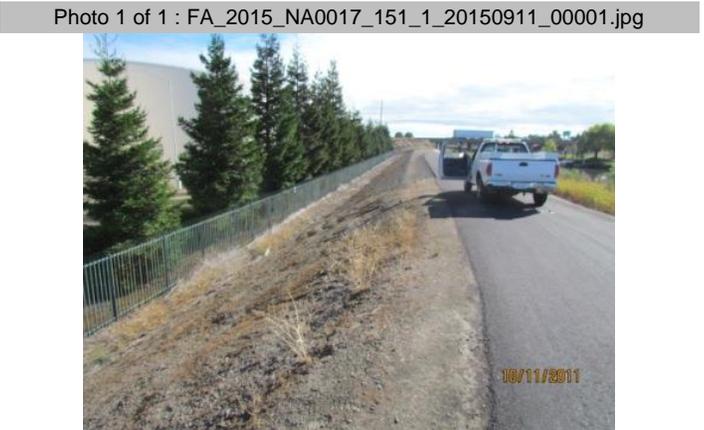
LM Start	<b>0.18</b>	Rating **	M	Issue No.	<b>1</b>
LM End	<b>0.28</b>	Issue Type +	En	Location *	LS
Category	Earthen Levee		GPS Latitude/Longitude		
			Start	End	
Item	Encroachments		38.043682 °	38.043511 °	
			-121.370390 °	-121.368500 °	
DWR ID	DWR_NA0017_07_s_2012_1				
Action/Comments					
Fence Inspector Comments: The fence is within the 10 feet of levee easement.

View of the fence along landside toe of the levee looking upstream.

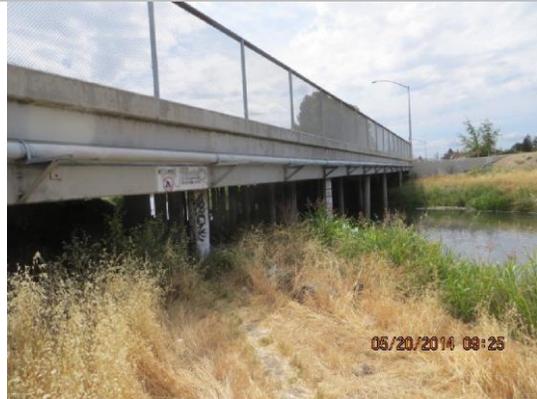
Photo 1 of 1 : UCIP\_FA\_2015\_4751.jpg

Gasline visible on bridge.

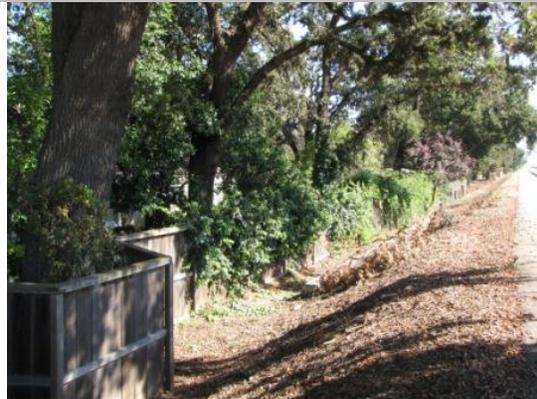
Photo 1 of 1 : FA\_2015\_NA0017\_151\_1033\_20150911\_00058.jpg

View of a wood fence adjacent to the landward toe looking upstream.

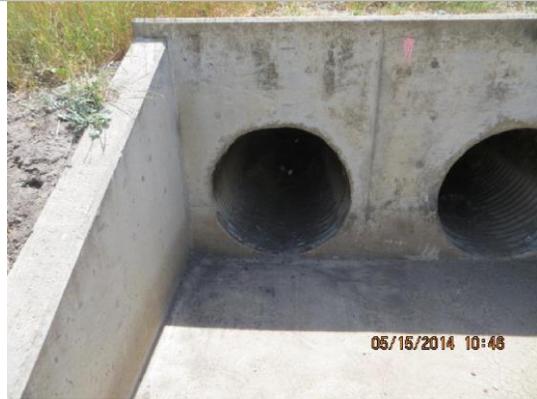
Photo 1 of 3 : UCIP\_FA\_2015\_4755.jpg

Headwall at LS toe.

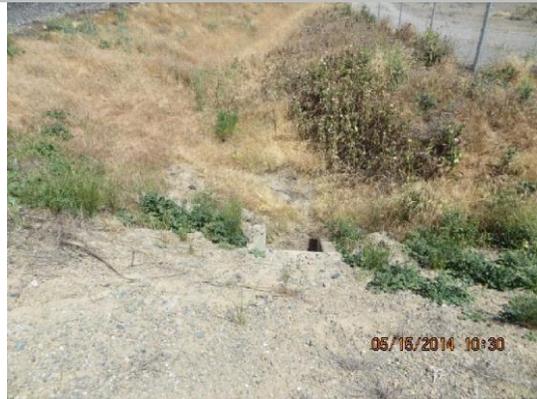
Photo 2 of 3 : UCIP\_FA\_2015\_6717.jpg

Headwall on LS toe.

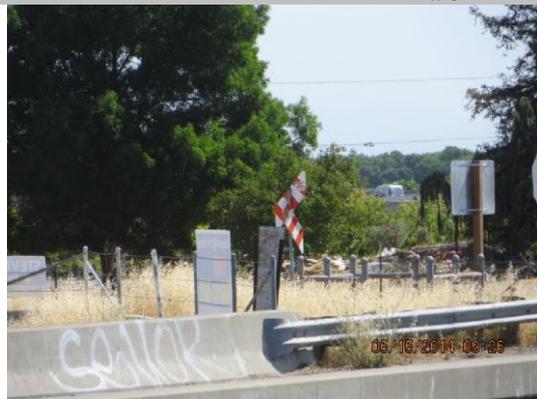
Photo 1 of 3 : UCIP\_FA\_2015\_2456.jpg

Signage on opposite levee may indicate a crossing at this point.

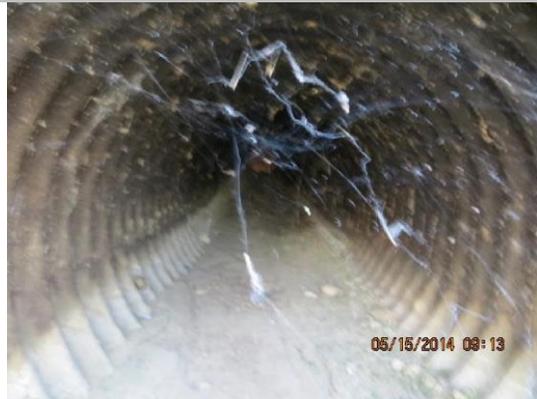
Photo 2 of 3 : UCIP\_FA\_2015\_6574.jpg

Inside pipe at LS toe. Note silt buildup inside pipe.

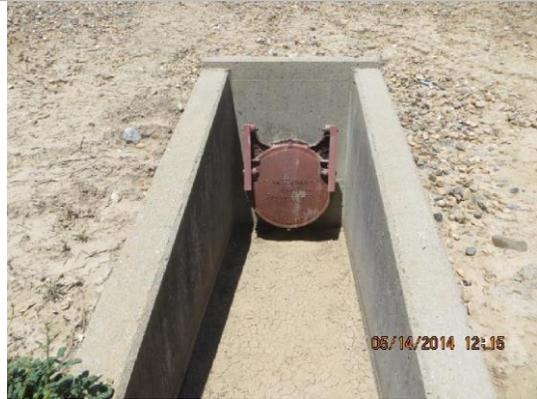
Photo 1 of 3 : UCIP\_FA\_2015\_6243.jpg

Pipe, headwall, and flapgate on WS toe.

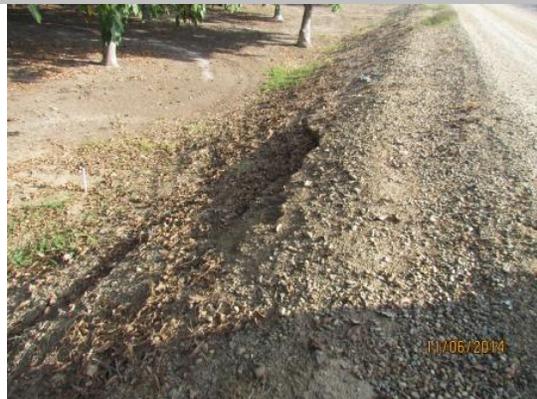
Photo 1 of 1 : FA\_2015\_NA0017\_151\_103\_20150911\_00049.jpg

View of a slope instability found on the landside of the levee looking upstream.

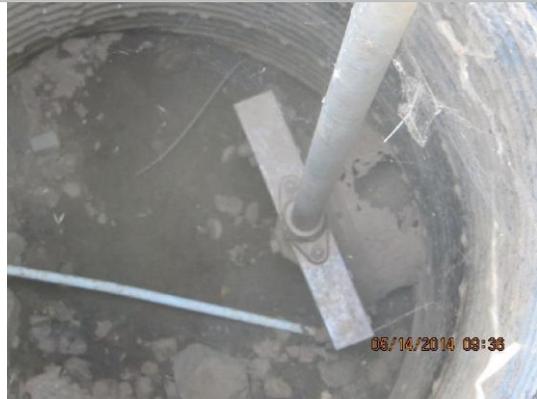
Photo 3 of 3 : UCIP\_FA\_2015\_6527.jpg

Pipe rusted through at connection to slide gate on WS slope.

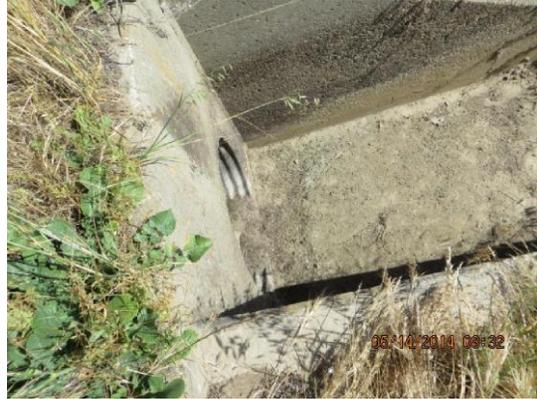
Photo 2 of 3 : UCIP\_FA\_2015\_6362.jpg

Pipe and headwall on WS slope.

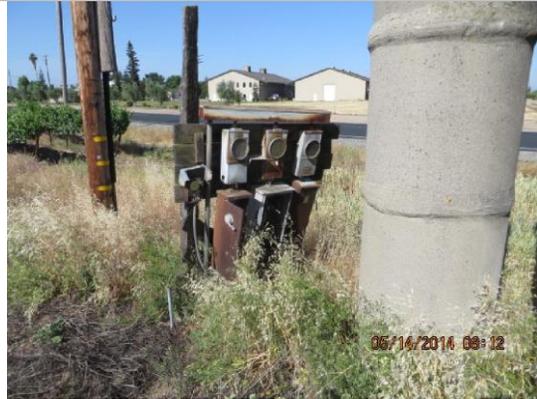
Photo 1 of 2 : UCIP\_FA\_2015\_5886.jpg

Conduits visible at base of meter panel on LS shoulder.

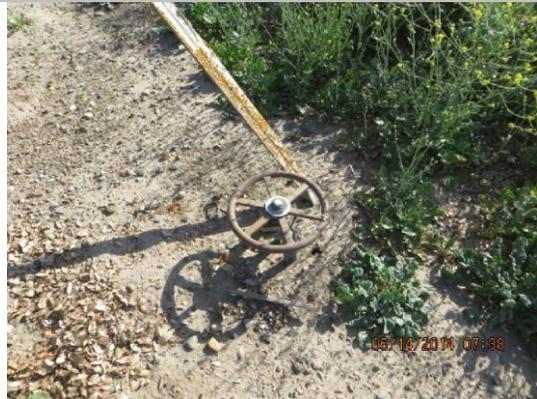
Photo 2 of 3 : UCIP\_FA\_2015\_6140.jpg

Gate valve on WS berm.

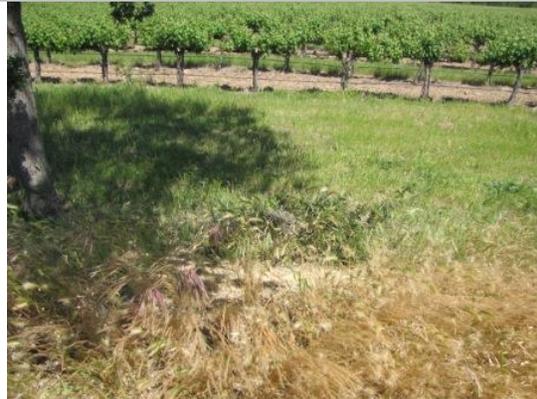
Photo 1 of 1 : FA\_2015\_NA0017\_151\_53\_20150911\_00025.jpg

View of a stump in the landward slope.

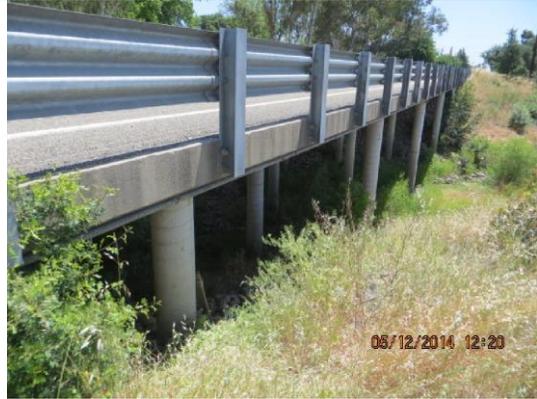
Photo 2 of 2 : UCIP\_FA\_2015\_5874.jpg

Communication conduit visible on downstream side of bridge at WS slope.

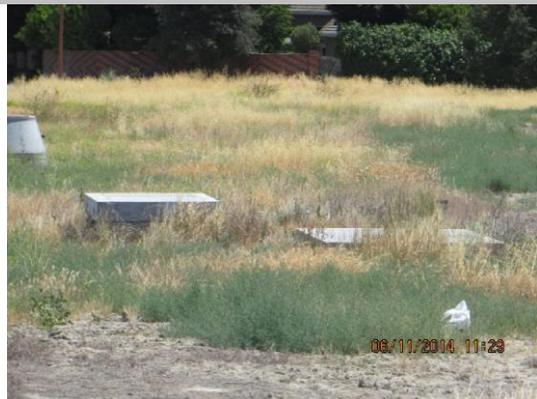
Photo 2 of 2 : UCIP\_FA\_2015\_6164.jpg

Concrete box/manhole off LS toe (at right).

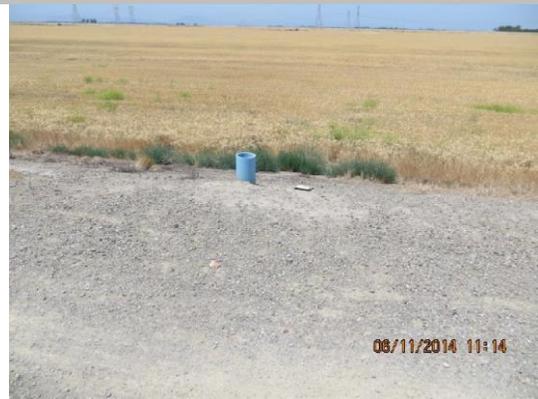
Photo 2 of 2 : UCIP\_FA\_2015\_6158.jpg

8-inch PVC riser on WS slope.

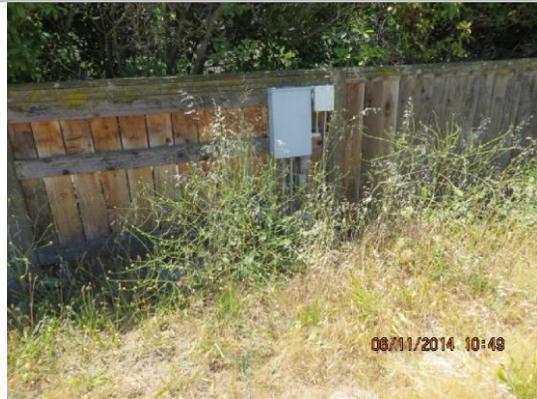
Photo 2 of 3 : UCIP\_FA\_2015\_6828.jpg

Pipe found at base of electrical control panel on LS shoulder.

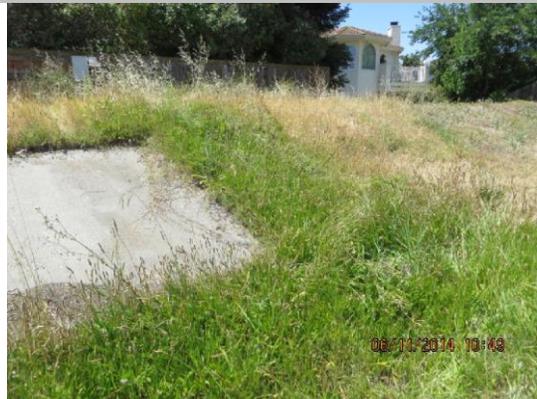
Photo 3 of 3 : UCIP\_FA\_2015\_6829.jpg

Green grass on WS slope may indicate a break in the irrigation line as there were no sprinklers found on WS slope.

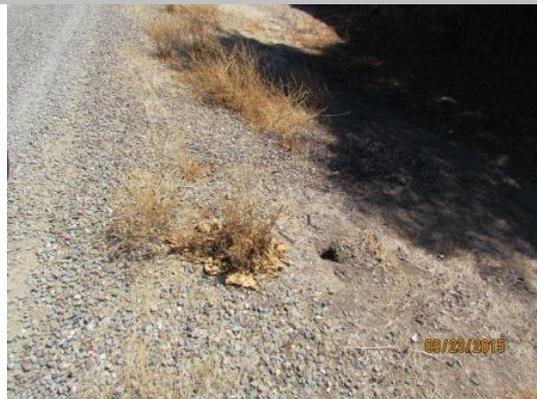
Photo 1 of 1 : FA\_2015\_NA0017\_152\_58\_20150928\_00096.jpg

An animal hole was found on the landside of the levee looking upstream.

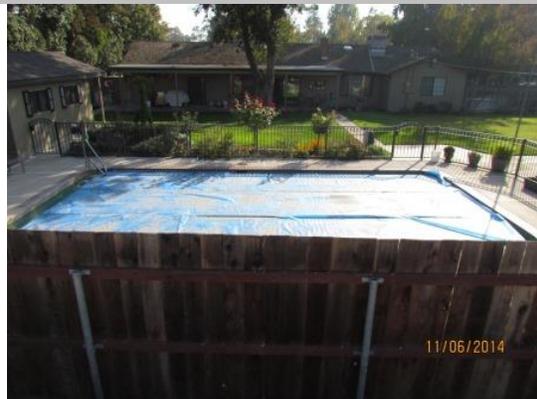
Photo 1 of 1 : FA\_2015\_NA0017\_152\_101\_20150911\_00032.jpg

A pool was found on the landside toe of the levee. The picture was taken from the crown looking towards the toe.

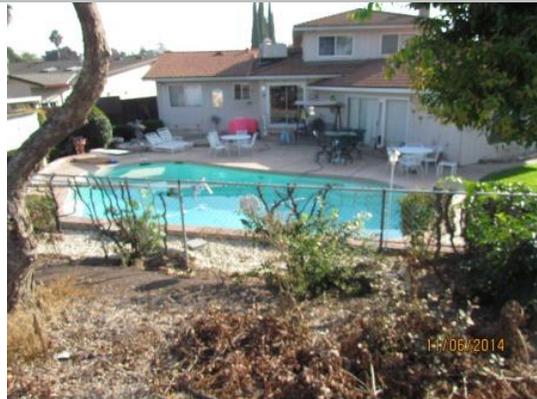
Photo 1 of 1 : FA\_2015\_NA0017\_152\_106\_20150911\_00033.jpg

A pool was found within 10 feet away from the landside toe of the levee.

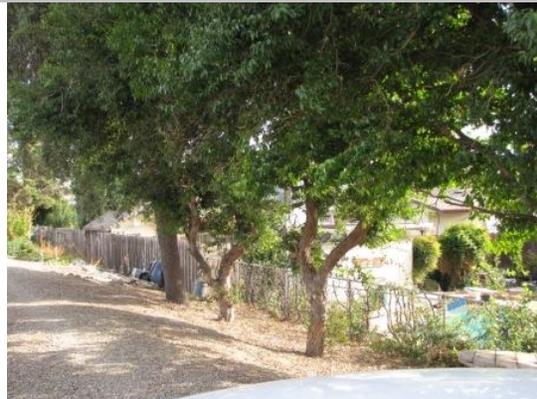
Photo 1 of 1 : FA\_2015\_NA0017\_152\_1024\_20150911\_00053.jpg

View of a fence at the landward toe.

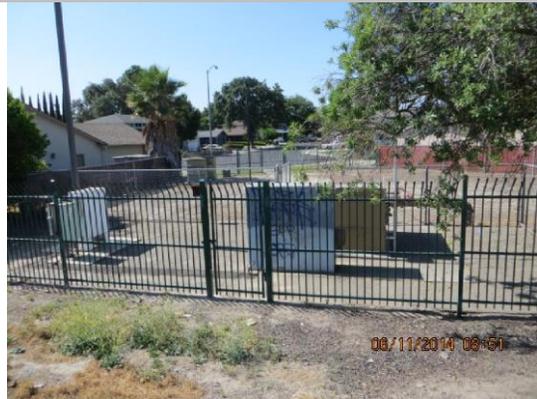
Photo 2 of 2 : UCIP\_FA\_2015\_4719.jpg

Pump station on LS toe.

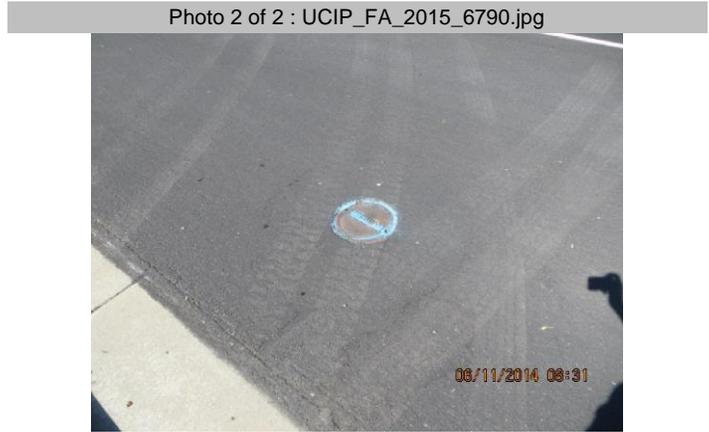
Valve for waterline in roadway at crown.

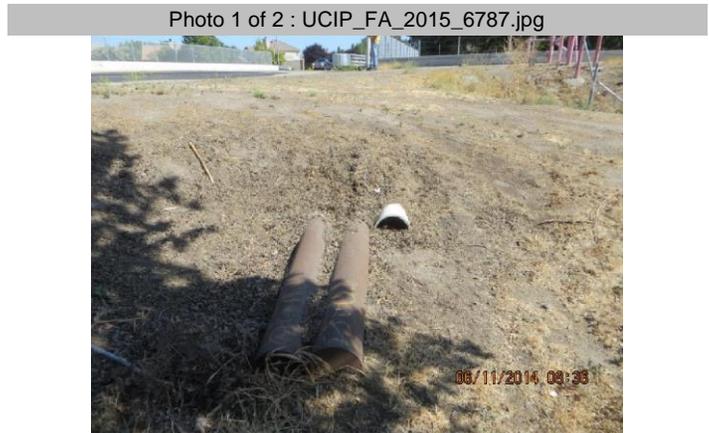
LM Start	2.86	Rating **	M	Issue No.	1121	
LM End	2.86	Issue Type +	En	Location *	LS	
Category	Supplemental			GPS Latitude/Longitude		
			Start	End		
Item	DWR UCIP Field Study			38.042677 °	38.042677 °	
				-121.331765 °	-121.331765 °	
DWR ID						
Action/Comments						
Inspector Comments: FS_ID:41364 DS_ID:25029 EP_NO: N/A FS_HLM: 2.915 Repair Type: Non-Urgent Crossing Status: Found UCIP Comments: No permit identified for this crossing. FIELD_STRUCT_DESC: 10-inch steel pipe apparently through the levee 4.5-feet below the crown. Unclear what the purpose of this pipe is. Pipe open on LS toe. FS Date: 06/11/2014

Open steel pipe visible on LS of levee (left most pipe in photo).

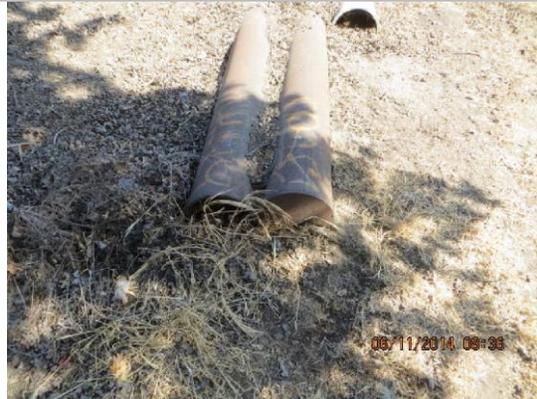
Photo 1 of 2 : UCIP\_FA\_2015\_6791.jpg

Pipe with welded steel cover visible on LS toe.

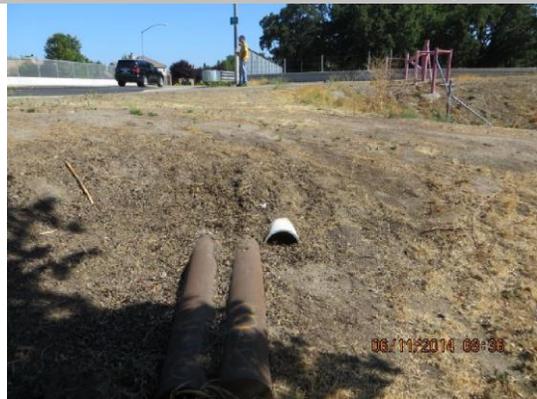
Photo 1 of 1 : UCIP\_FA\_2015\_6788.jpg

Open PVC pipe visible on LS slope.

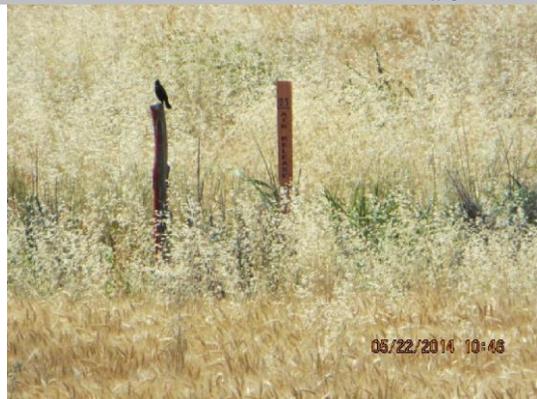
Photo 2 of 2 : UCIP\_FA\_2015\_6657.jpg

Air valve marker off LS toe.

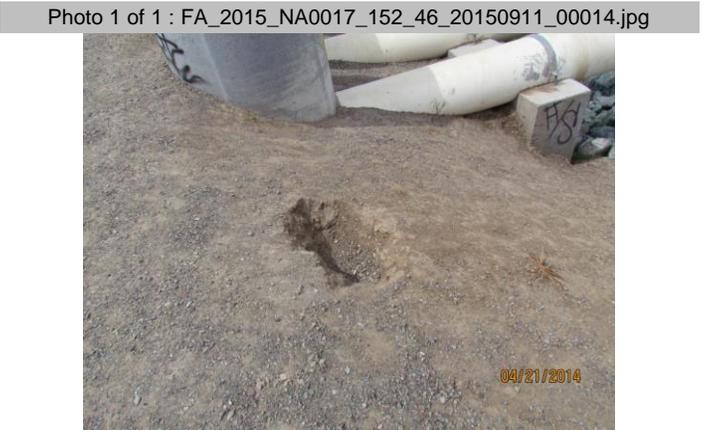
LM Start	<b>4.60</b>	Rating **	M	Issue No.	<b>46</b>
LM End	<b>4.60</b>	Issue Type +	Ma	Location *	WS
Category	Earthen Levee		GPS Latitude/Longitude		
			Start	End	
Item	Slope Stability		38.043093 °	38.043093 °	
			-121.300166 °	-121.300166 °	
DWR ID	DWR_NA0017_08_s_2014_46				
Action/Comments					
Repair slope instability.

A slope instability was found on the waterside of the levee looking downstream.

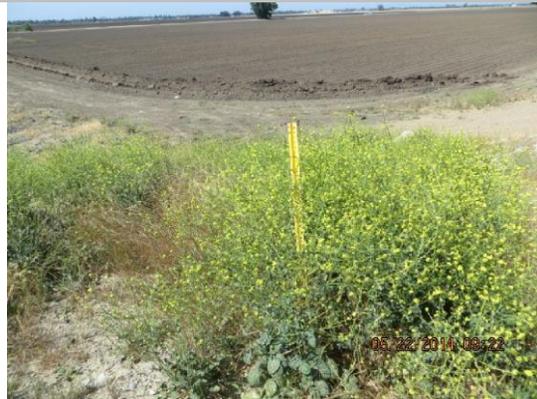
Photo 2 of 2 : UCIP\_FA\_2015\_6652.jpg

Kinder Morgan gasline marker on LS shoulder.

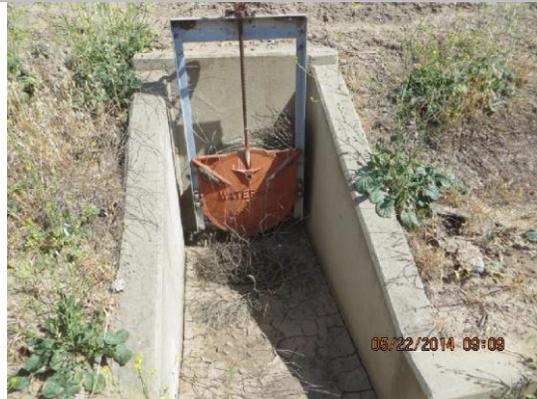
Photo 1 of 3 : UCIP\_FA\_2015\_6292.jpg

Slide gate on headwall at LS toe.

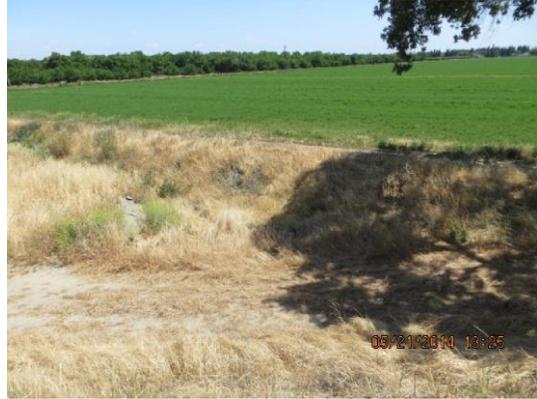
Photo 2 of 3 : UCIP\_FA\_2015\_6643.jpg

Headwall at drainage channel on LS toe.

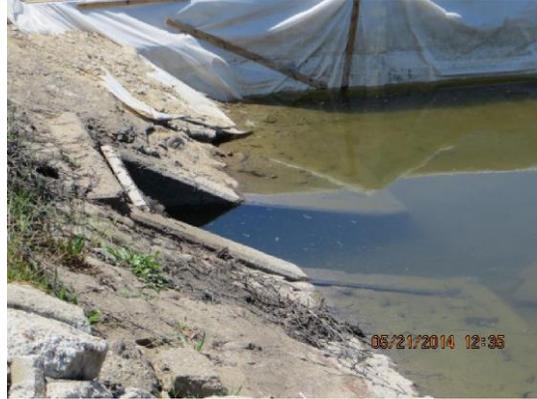
Photo 3 of 3 : UCIP\_FA\_2015\_6608.jpg

Concrete U-shaped headwall at waters edge-inlet for 24-inch CMP pump over sump on WS toe.

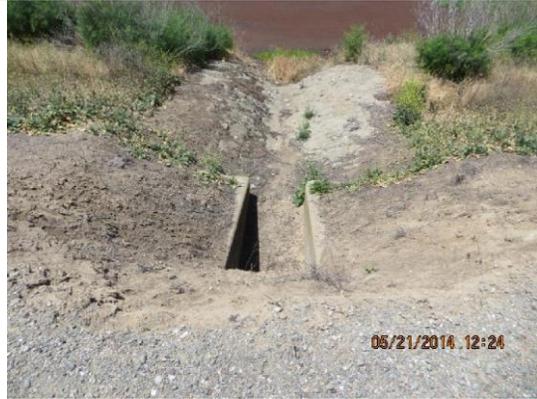
Photo 2 of 3 : UCIP\_FA\_2015\_6459.jpg

Headwall, flapgate, and grouted spillway on WS slope.

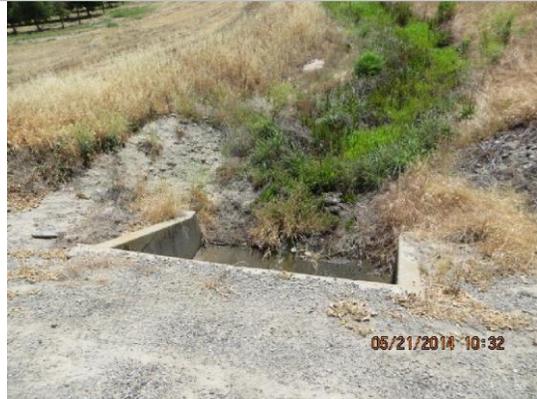
Photo 1 of 3 : UCIP\_FA\_2015\_6245.jpg

Headwall on LS toe.

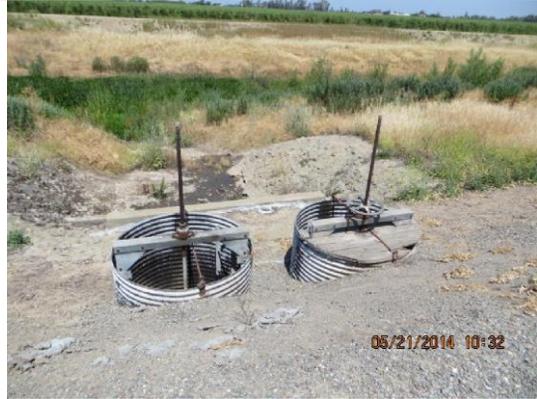
Photo 3 of 3 : UCIP\_FA\_2015\_6817.jpg

Slide gate in CMP riser on WS slope missing cover.

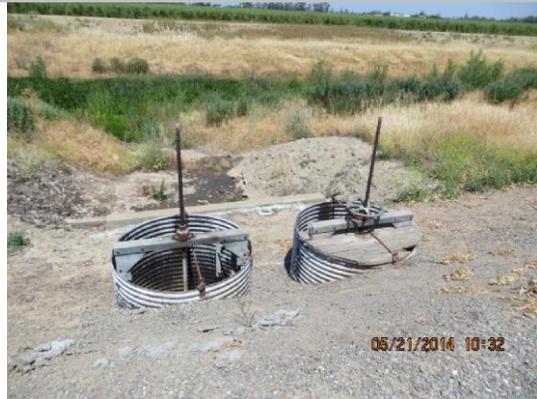
Photo 2 of 3 : UCIP\_FA\_2015\_6814.jpg

Slidegate on WS shoulder.

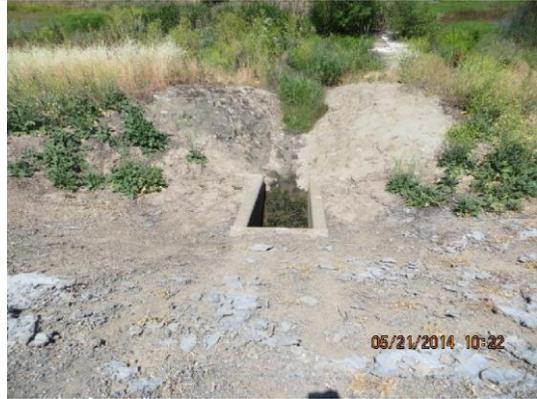
Photo 2 of 3 : UCIP\_FA\_2015\_6763.jpg

Headwall, flapgate, and grouted spillway on WS slope.

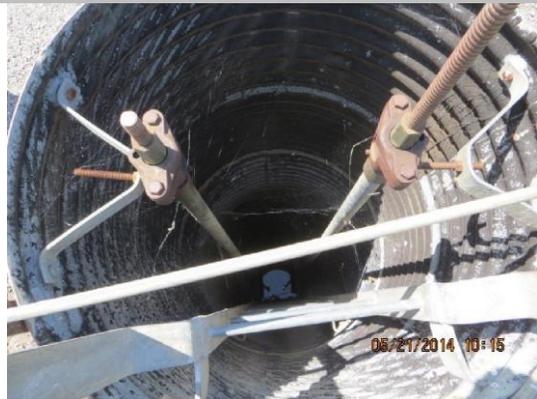
Photo 1 of 3 : UCIP\_FA\_2015\_6759.jpg

Two slidegates in 36-inch CMP riser on WS slope.

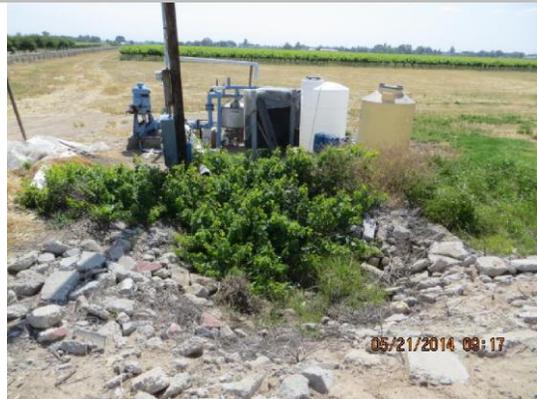
Photo 2 of 3 : UCIP\_FA\_2015\_6616.jpg

Pump station on LS toe not connected, but may have been.

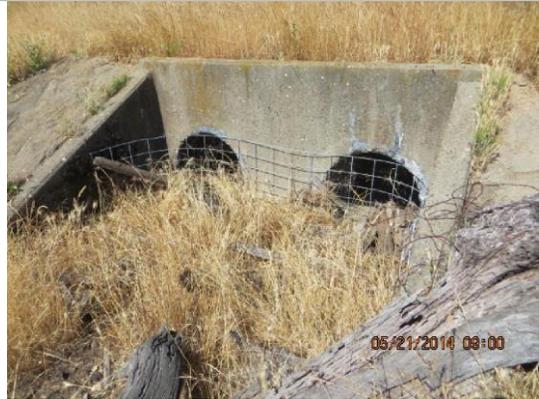
Photo 1 of 3 : UCIP\_FA\_2015\_4378.jpg

Headwall on LS toe. Note debris buildup.

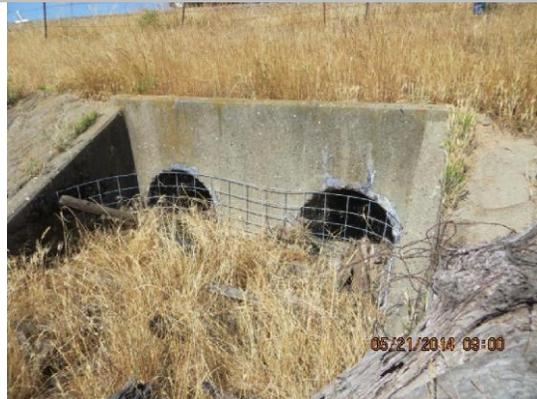
Photo 2 of 3 : UCIP\_FA\_2015\_5197.jpg

Headwall on LS toe. Note debris buildup.

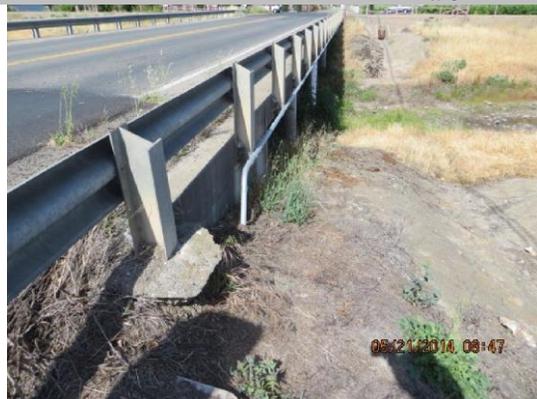
Photo 2 of 3 : UCIP\_FA\_2015\_6782.jpg

Pipe visible on upstream side of bridge.

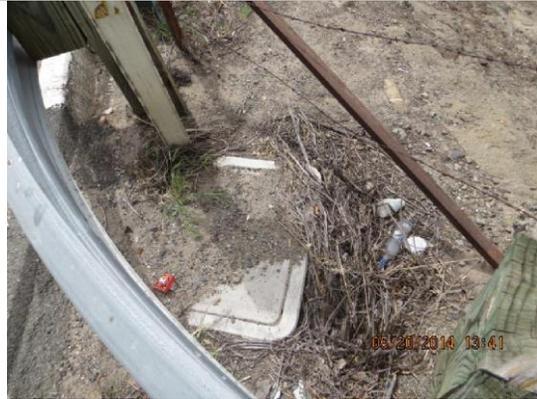
Photo 3 of 3 : UCIP\_FA\_2015\_6780.jpg

Christy box on WS shoulder.

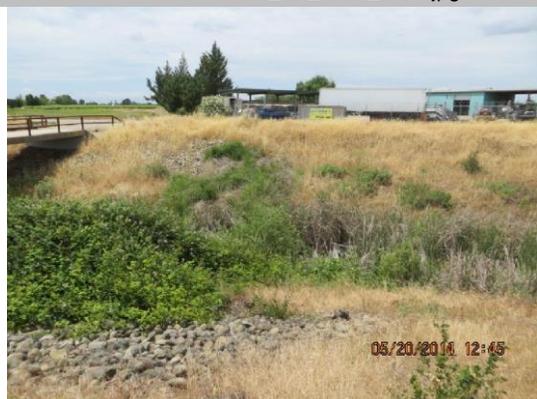
Photo 3 of 3 : UCIP\_FA\_2015\_4370.jpg

Pipe visible in center of channel at WS toe from bridge.

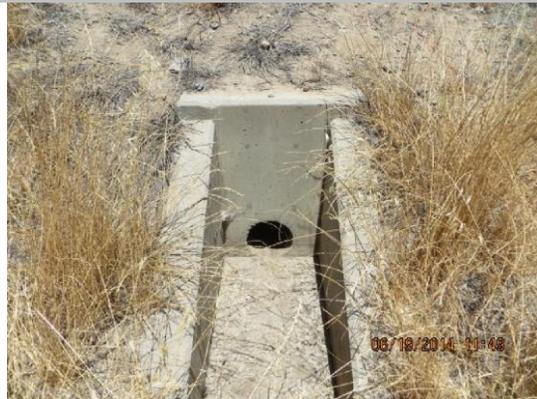
Photo 2 of 3 : UCIP\_FA\_2015\_5966.jpg

Pipe and headwall on LS toe.

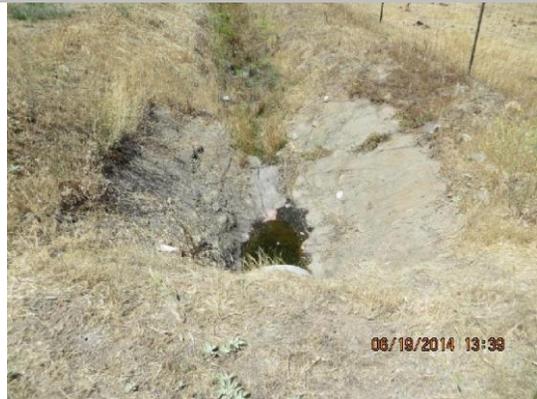
Photo 2 of 3 : UCIP\_FA\_2015\_6438.jpg

Pipe on LS toe.

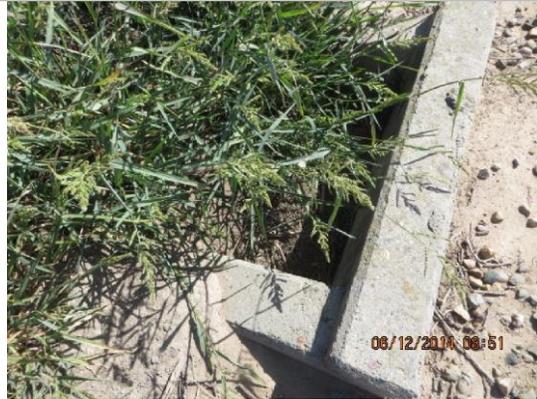
Photo 1 of 3 : UCIP\_FA\_2015\_5146.jpg

Headwall at LS toe has been filled in with soil.

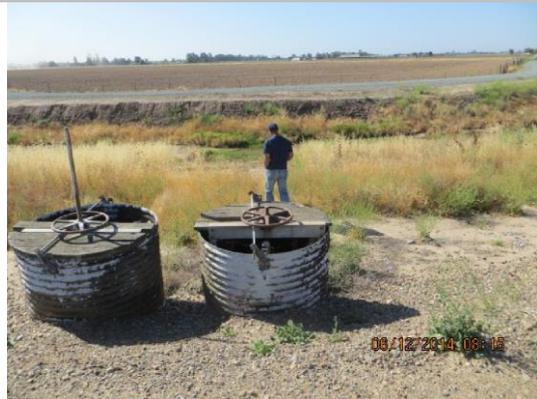
Photo 2 of 3 : UCIP\_FA\_2015\_5141.jpg

Slidegate inside CMP riser on WS shoulder. Lid needs repair.

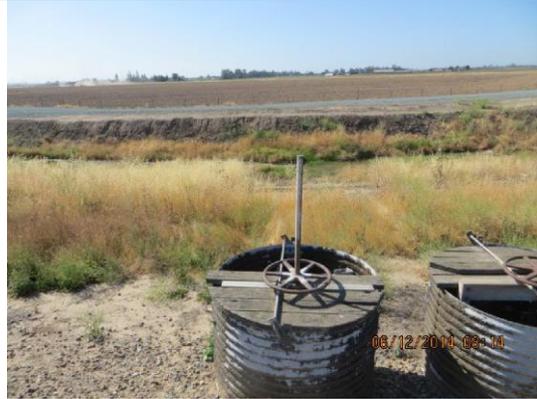
Photo 3 of 3 : UCIP\_FA\_2015\_5139.jpg

Slidegate in CMP riser on WS shoulder. No lid and gateavle does not work.

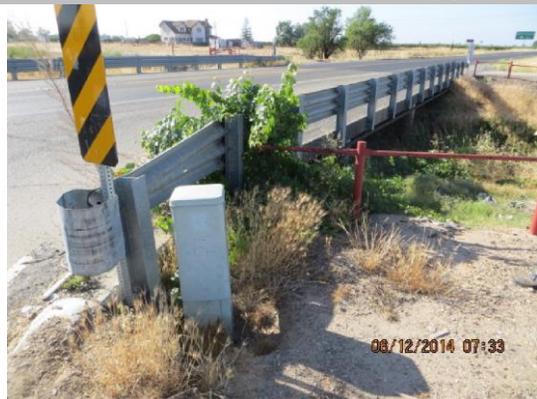
Photo 2 of 2 : UCIP\_FA\_2015\_4970.jpg

Communication junction box next to WS shoulder.

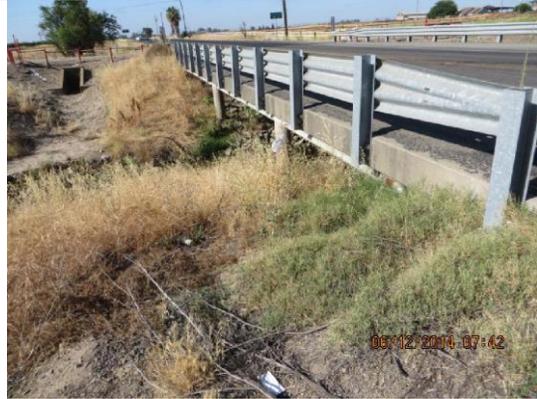
Photo 1 of 2 : UCIP\_FA\_2015\_5944.jpg

Gasline visible on upstream side of bridge

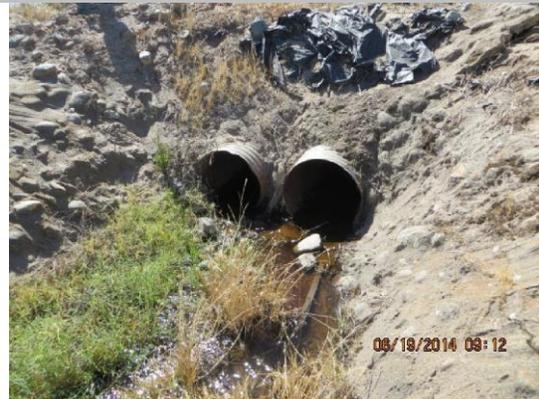
Photo 3 of 3 : UCIP\_FA\_2015\_6287.jpg

Pipe visible on WS slope at grouted spillway.

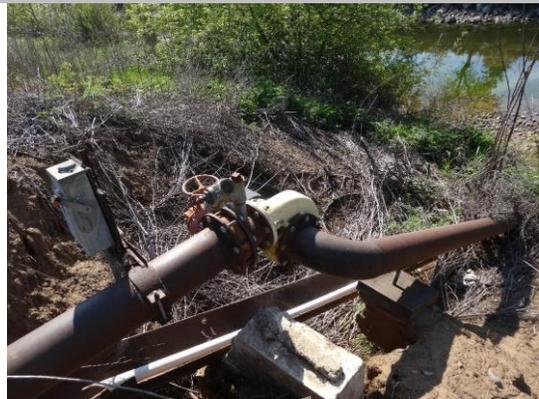
Photo 1 of 3 : UCIP\_FA\_2015\_5450.jpg

WS view: steel pipe, pump, and appurtenances.

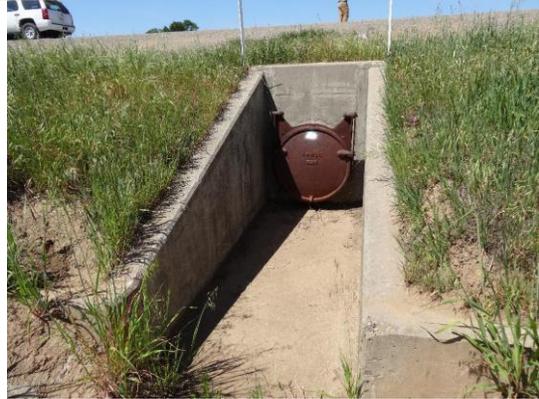
Photo 2 of 3 : UCIP\_FA\_2015\_5668.jpg

WS view: U type concrete headwall, CM pipe with flapgate, and concrete spillway on levee slope.

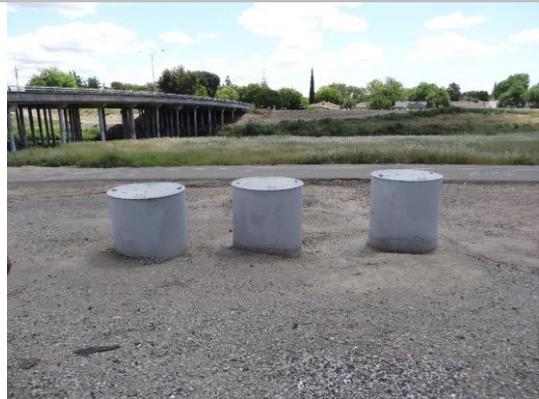
Photo 2 of 2 : UCIP\_FA\_2015\_5546.jpg

WS view: siphon breakers in concrete pipe risers on levee slope.

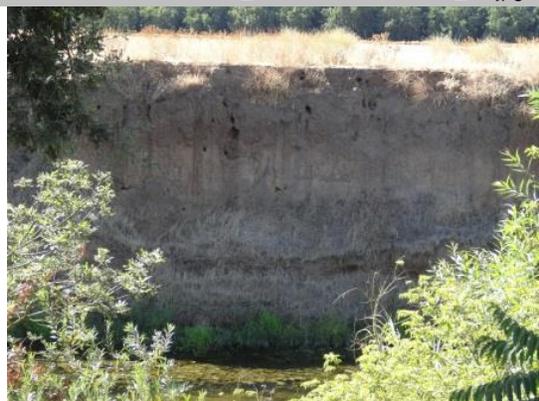
Photo 1 of 3 : SJR2015\_NA0017U16RM23.35\_10.jpg

Close view of the erosion.

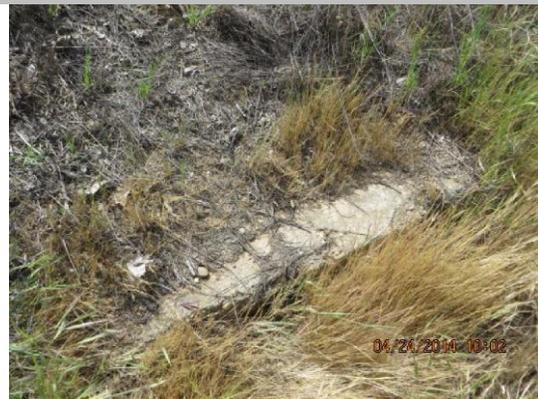
Photo 2 of 3 : UCIP\_FA\_2015\_5479.jpg

Concrete headwall visible on WS slope.

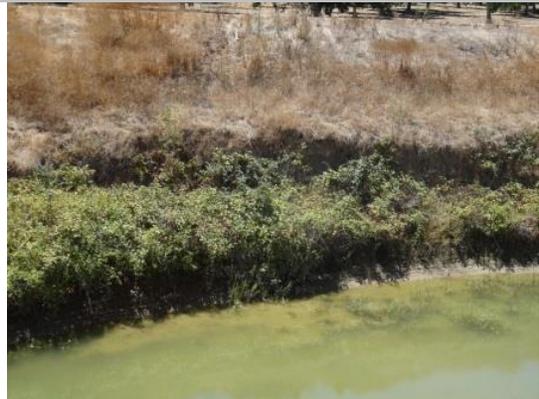
Photo 2 of 2 : SJR2015\_NA0017U16RM12.95\_5.jpg

Closer view of the erosion.

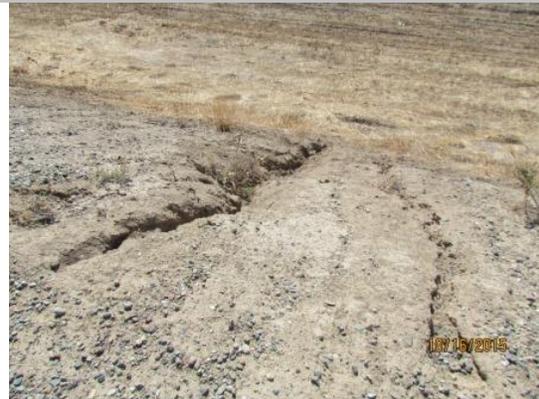
Photo 1 of 1 : FA\_2015\_NA0017\_160\_249\_20151023\_00167.jpg

View of the erosion caused by surface runoff on the landside of the levee.
