**Flood Control Project Maintenance
Levee Inspections**

Maintenance Issue Types Only, Levee Inspection Report By Mile - Fall 2014

San Joaquin County Flood Control and Water Conservation District

Waterway	Bank	Unit Miles	Inspection Start/End	Inspector
Unit No. 01 Littlejohn Creek	Left	2.59	11/24/2014 11/24/2014	Pavel Kazi

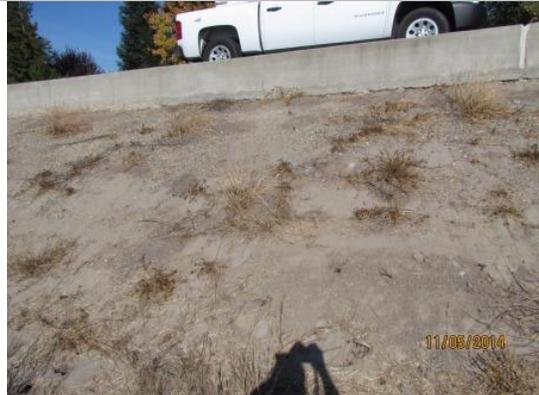
Photo 1 of 1 : FA_2014_NA0017_151_69_20141109_00061.jpg

An animal hole was found on the waterside of the levee looking downstream.

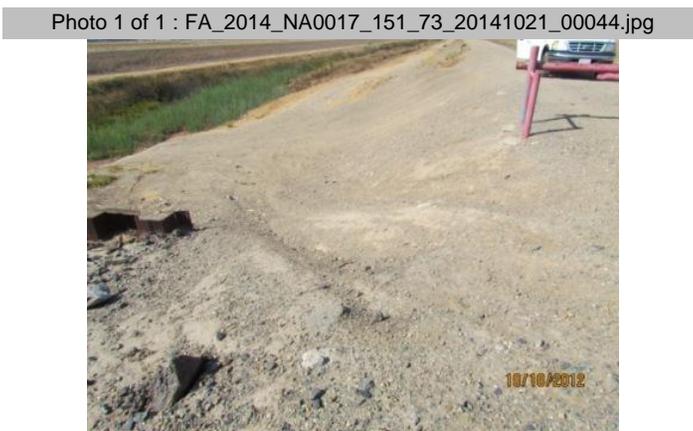
LM Start	5.85	Rating **	M	Issue No.	73
LM End	5.85	Issue Type +	Ma	Location *	WS
Category	Earthen Levee		GPS Latitude/Longitude		
			Start	End	
Item	Slope Stability		38.052753 °	38.052753 °	
			-121.277680 °	-121.277680 °	
DWR ID	DWR_NA0017_07_f_2012_73				
Action/Comments					
Repair the levee slope damaged by vehicle traffic and prevent access where possible.

Slope instability was found on the landside of the levee looking upstream.

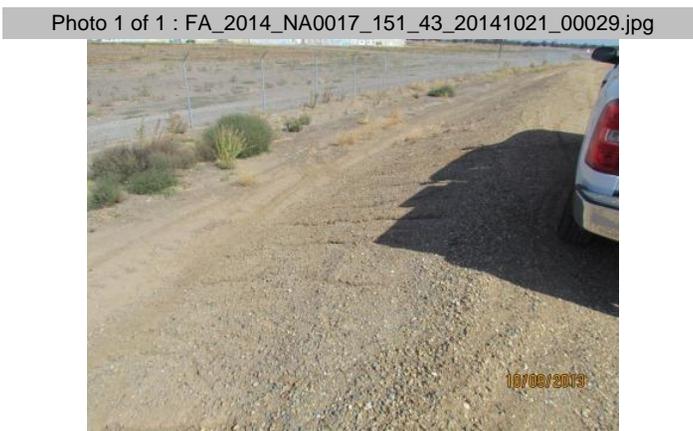
LM Start	5.89	Rating **	M	Issue No.	43
LM End	5.89	Issue Type +	Ma	Location *	LS
Category	Earthen Levee		GPS Latitude/Longitude		
			Start	End	
Item	Erosion / Bank Caving		38.052794 °	38.052794 °	
			-121.277035 °	-121.277035 °	
DWR ID	DWR_NA0017_07_f_2013_43				
Action/Comments					
Schedule repair of erosion site prior to the next inspection. Inspector Comments: Runoff on the landside.

Runoff was found on the landside slope of the levee looking upstream.

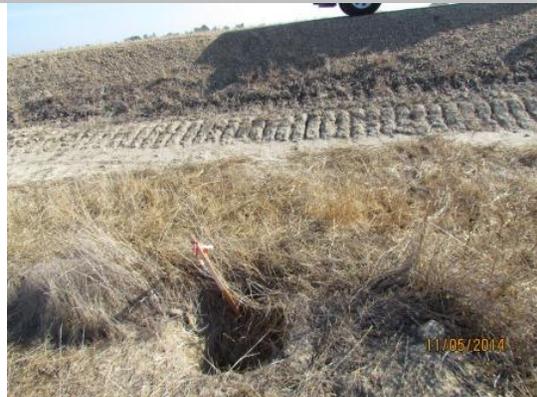
Photo 1 of 1 : FA_2014_NA0017_151_93_20141109_00068.jpg

A hole was found on the landside toe of the levee.

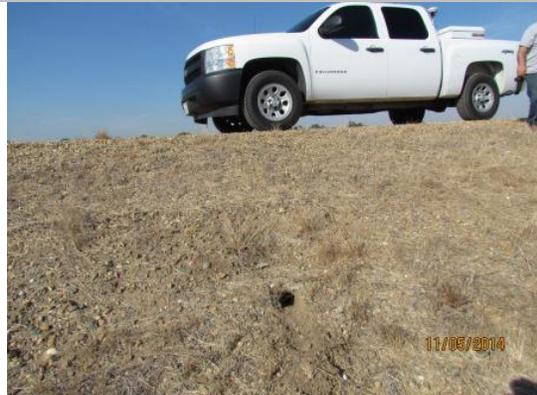
Photo 1 of 1 : FA_2014_NA0017_151_87_20141109_00066.jpg

An animal hole was on the waterside of the levee looking upstream.

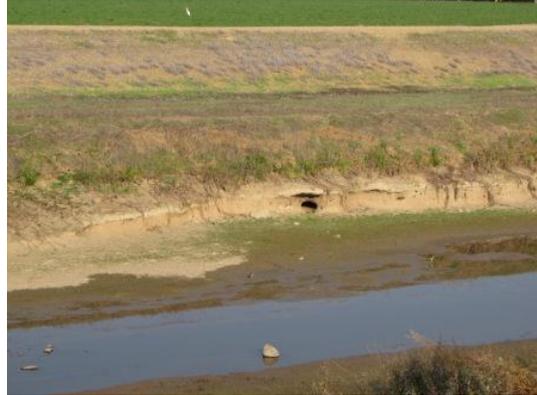
Photo 1 of 1 : FA_2014_NA0017_151_80_20141021_00045.jpg

View of a large hole and several smaller holes from across the channel.

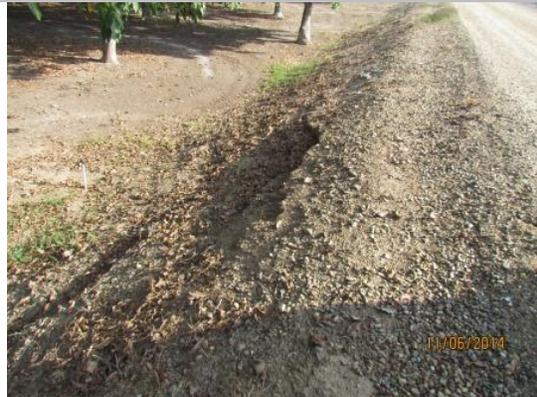
Photo 1 of 1 : FA_2014_NA0017_151_103_20141109_00073.jpg

View of a slope instability found on the landside of the levee looking upstream.

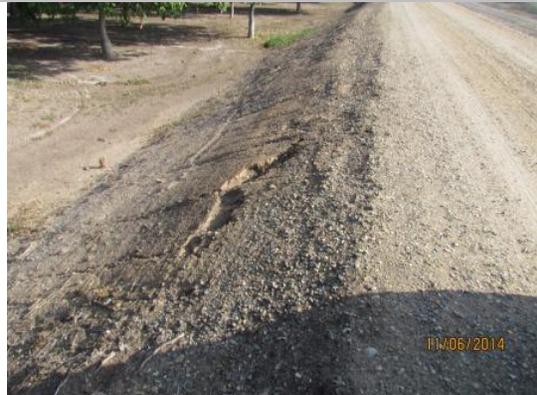
Photo 1 of 1 : FA_2014_NA0017_151_104_20141109_00074.jpg

View of erosion caused by surface runoff found on the landside slope of the levee looking upstream.

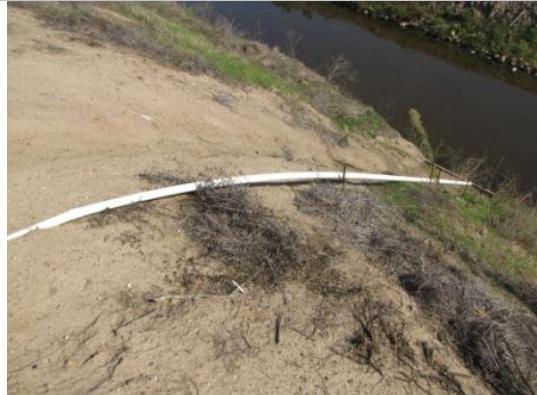
Photo 1 of 1 : FA_2014_NA0017_151_1054_20141021_00060.jpg

View of a pipe a landowner placed in the access road and watershed slope to pump water from the channel to irrigate their garden.

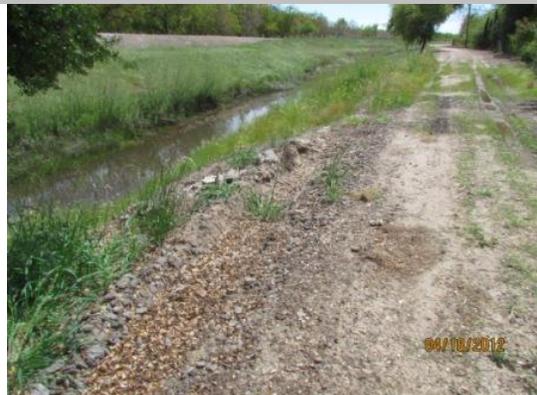
Photo 1 of 1 : FA_2014_NA0017_151_60_20141021_00039.jpg

Crown depression was found on the waterside shoulder of the levee looking downstream.

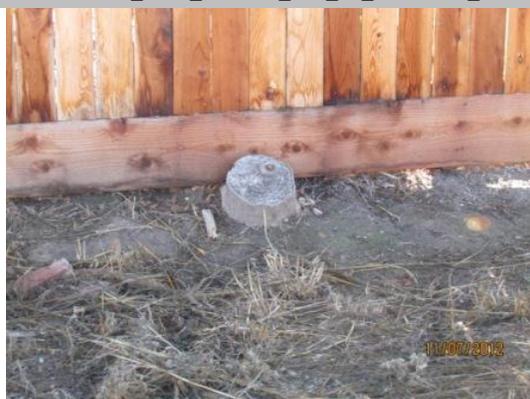
Photo 1 of 1 : FA_2014_NA0017_152_18_20141021_00008.jpg

View of a tree stump that was found on the landside toe of the levee. The picture was taken from the crown looking towards the toe.

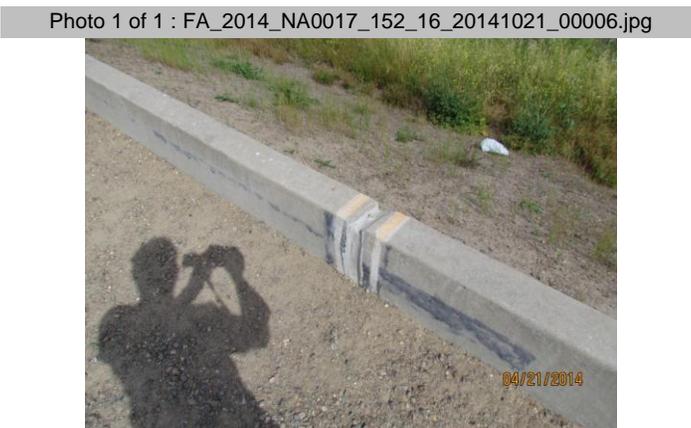
LM Start	1.83	Rating **	A	Issue No.	16
LM End	1.83	Issue Type +	Ma	Location *	WS
Category	Concrete Floodwalls		GPS Latitude/Longitude		
			Start	End	
Item	Monolith Joints		38.042713 °	38.042713 °	
			-121.351122 °	-121.351122 °	
DWR ID	DWR_NA0017_08_s_2014_16				
Action/Comments					
Inspector Comments: The LMA has repaired the monolith joint at this location.

Monolith Joints at this location was repaired by the LMA. The picture was taken from the crown looking downstream.

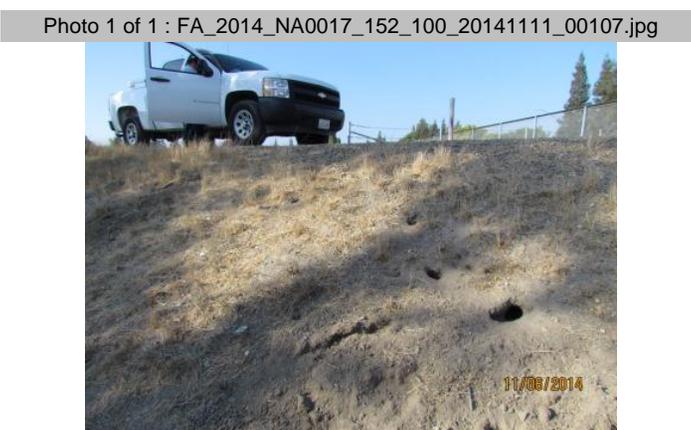
LM Start	1.99	Rating **	M	Issue No.	100
LM End	1.99	Issue Type +	Ma	Location *	LS
Category	Earthen Levee		GPS Latitude/Longitude		
			Start	End	
Item	Animal Control		38.042795 °	38.042795 °	
			-121.348274 °	-121.348274 °	
DWR ID	DWR_NA0017_08_f_2014_100				
Action/Comments					
No rodents visible, but rodent burrows visible; need to backfill and compact or grout burrows.

Rodent holes were found on the landside slope of the levee.

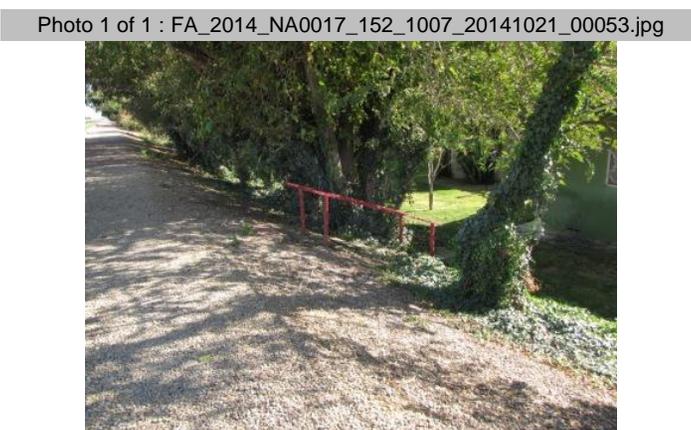
LM Start	2.06	Rating **	M	Issue No.	1007
LM End	2.06	Issue Type +	Ma	Location *	LS
Category	Earthen Levee		GPS Latitude/Longitude		
			Start	End	
Item	Encroachments		38.042805 °	38.042805 °	
			-121.347071 °	-121.347071 °	
DWR ID	DWR_NA0017_08_s_2012_1007				
Action/Comments					
Stairway Inspector Comments: Steps were removed but the hand rails still exists at the location.

View of steps dug into the landward slope looking upstream.

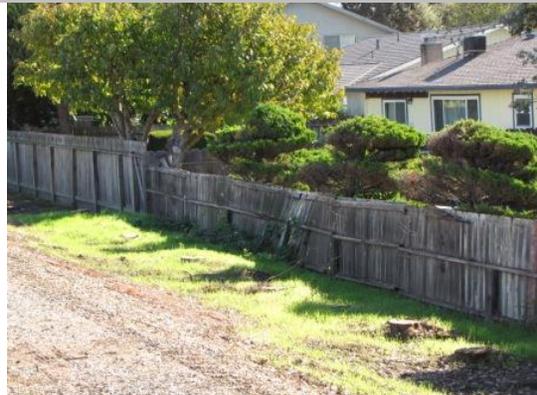
Photo 1 of 1 : FA_2014_NA0017_152_12_20141021_00003.jpg

View of stumps along the landward toe looking upstream.

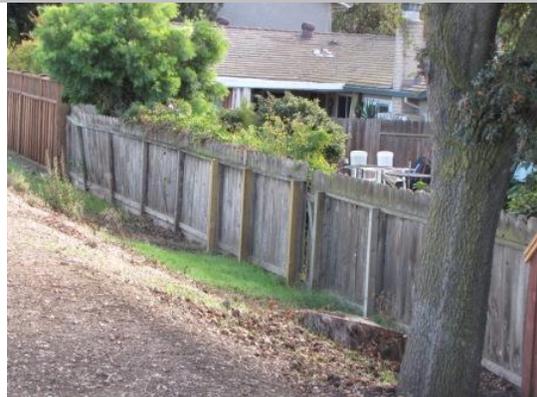
Photo 1 of 1 : FA_2014_NA0017_152_13_20141021_00004.jpg

View of a stump on the landward slope looking upstream.

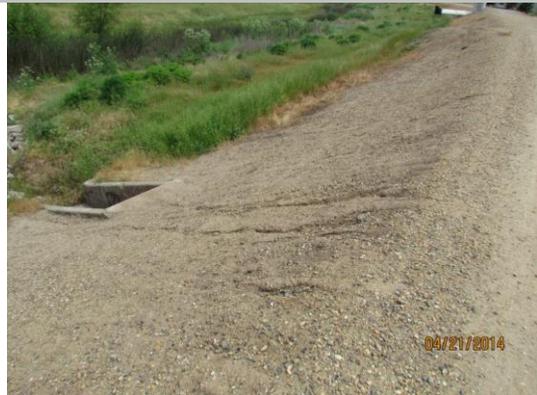
Photo 1 of 1 : FA_2014_NA0017_152_27_20141021_00011.jpg

Erosion caused by runoffs on the waterside slope of the levee looking upstream.

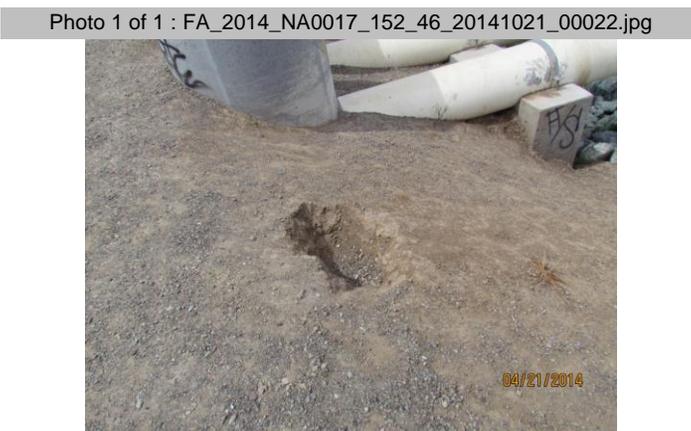
LM Start	4.68	Rating **	M	Issue No.	46
LM End	4.68	Issue Type +	Ma	Location *	WS
Category	Earthen Levee		GPS Latitude/Longitude		
			Start	End	
Item	Slope Stability		38.043078 °	38.043078 °	
			-121.300166 °	-121.300166 °	
DWR ID	DWR_NA0017_08_s_2014_46				
Action/Comments					
Repair slope instability.

A slope instability was found on the waterside of the levee looking downstream.

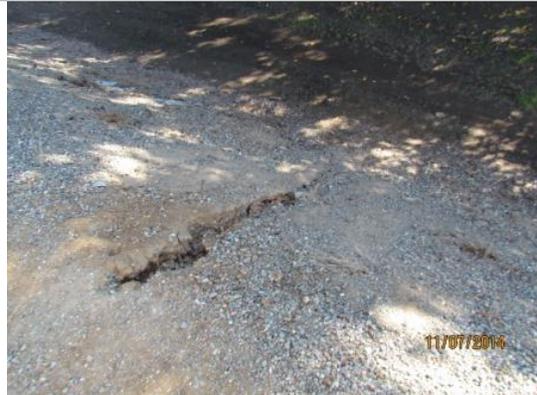
Photo 1 of 1 : FA_2014_NA0017_152_124_20141111_00115.jpg

Rodent holes were found on the landside of the levee looking upstream.

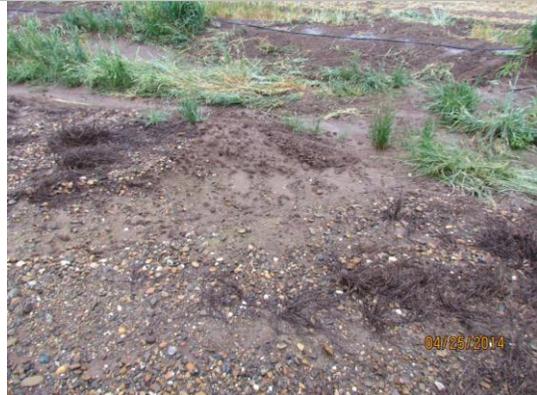
Photo 1 of 1 : FA_2014_NA0017_152_83_20141021_00038.jpg

A slope instability was found on the landside of the levee looking upstream.

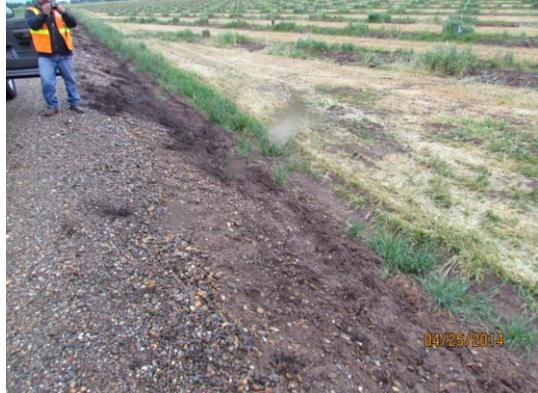
Photo 1 of 1 : FA_2014_NA0017_152_84_20141021_00039.jpg

Tilling along the landside toe was found at this location. The picture was taken from the crown looking upstream.

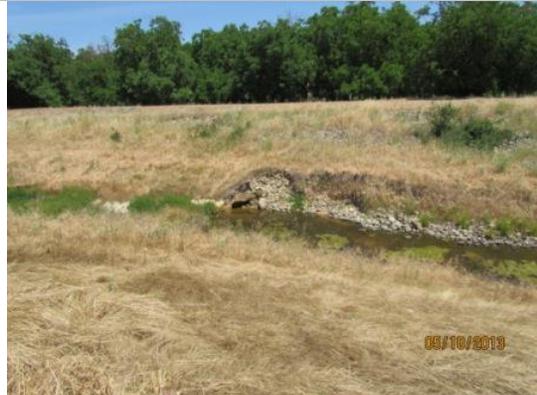
Photo 1 of 1 : FA_2014_NA0017_152_89_20141021_00042.jpg

Erosion was found on the waterside toe of the levee. The picture was taken from the opposite side of the levee.

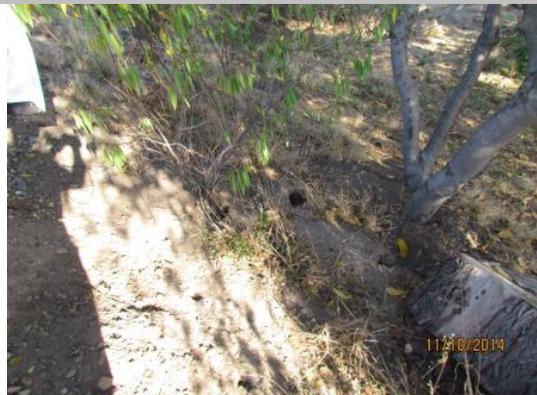
Photo 1 of 1 : FA_2014_NA0017_152_132_20141111_00123.jpg

Rodent holes were found on the landside of the levee looking upstream.

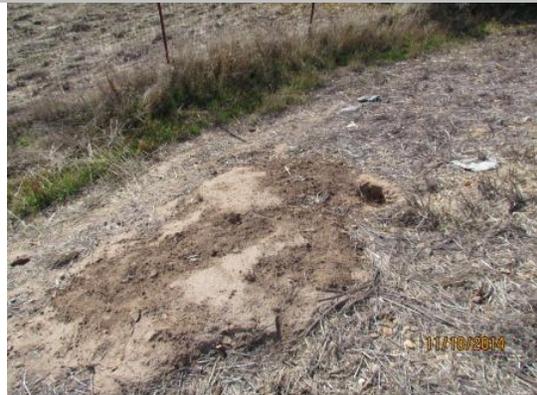
Photo 1 of 2 : FA_2014_NA0017_156_9_20141111_00024.jpg

Updated picture of the rodent holes on the landside of the levee looking downstream.

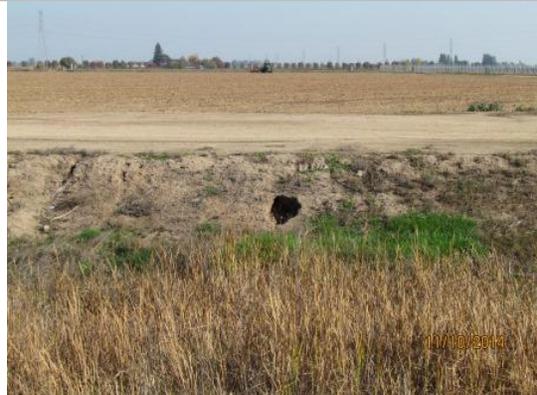
Photo 1 of 2 : FA_2014_NA0017_156_16_20141111_00028.jpg

Updated picture of a rodent hole on the waterside of the levee. The picture was taken from the opposite side of the levee during fall 2014 inspection.

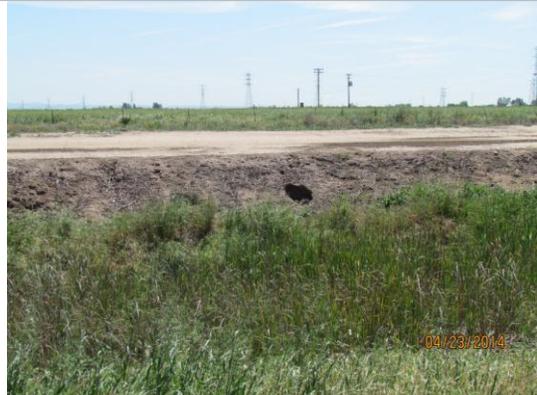
Photo 2 of 2 : FA_2014_NA0017_156_16_20141021_00013.jpg

View of a rodent hole on the waterside slope of the levee. The picture was taken from the opposite side of the levee.

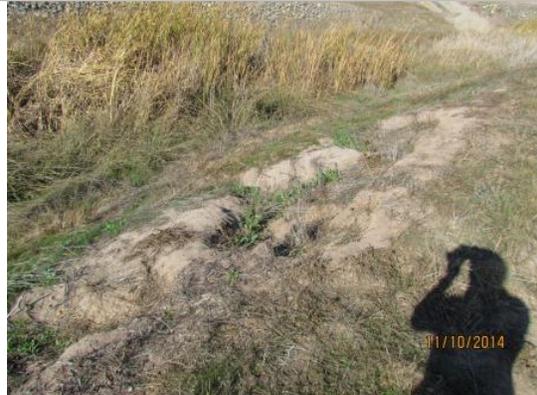
Photo 1 of 1 : FA_2014_NA0017_156_32_20141111_00026.jpg

View of a slope instability that was found on the waterside of the levee looking upstream.

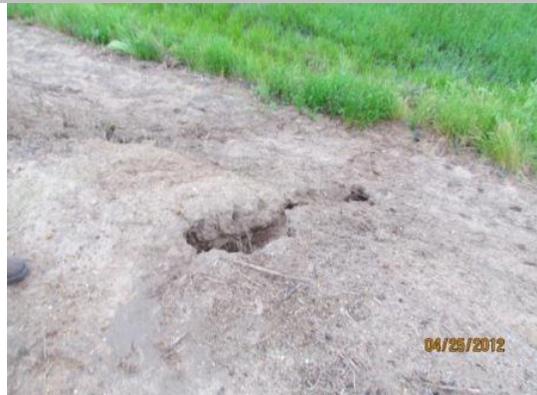
Photo 1 of 1 : FA_2014_NA0017_156_12_20141021_00011.jpg

View of erosion that was found on the waterside of the levee looking downstream.

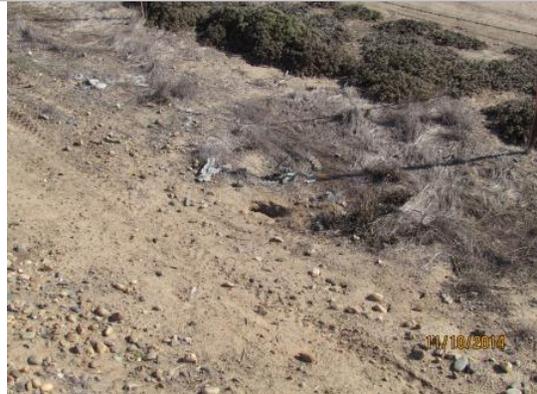
Photo 1 of 1 : FA_2014_NA0017_157_8_20141111_00005.jpg

View of an animal hole that was found on the landside of the levee looking upstream.

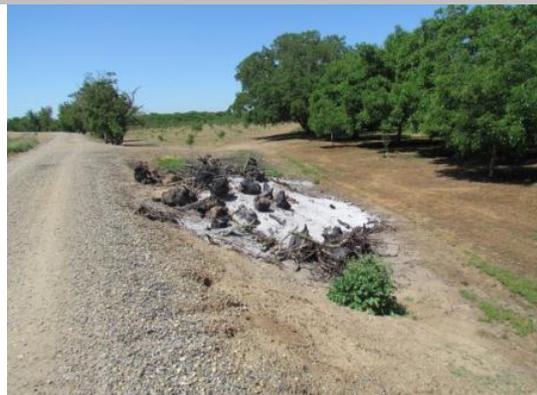
Photo 1 of 1 : FA_2014_NA0017_159_12_20141021_00006.jpg

New material was placed at the toe of the landside of the levee. The picture was taken from the crown looking downstream.

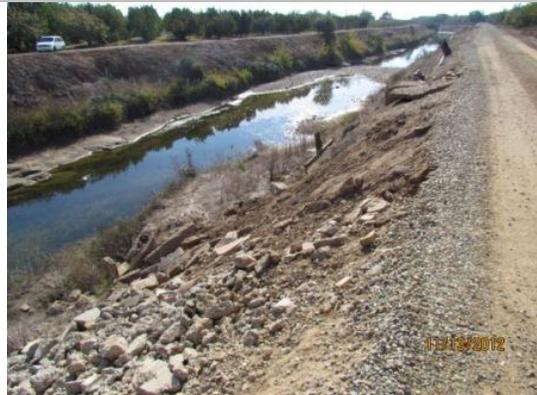
Photo 2 of 2 : FA_2014_NA0017_159_43_20141021_00033.jpg

Slope instability was found on the landside slope of the levee looking downstream.

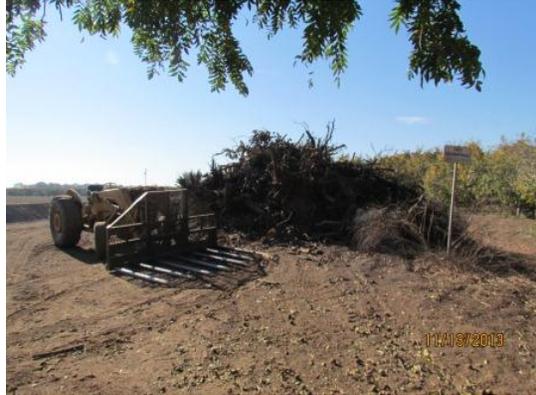
Photo 1 of 2 : FA_2014_NA0017_159_19_20141021_00012.jpg

Updated picture of the prunings pile on the landside of the levee looking downstream during fall 2013 inspection.

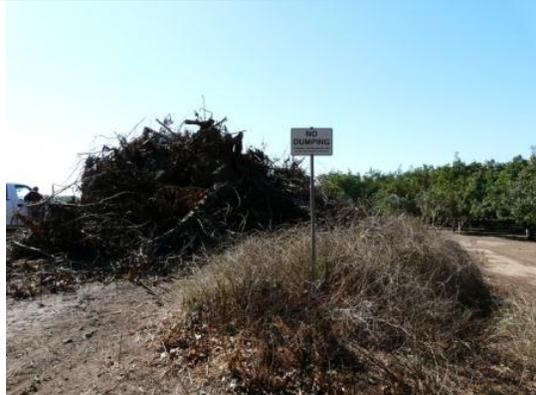
Photo 2 of 2 : FA_2014_NA0017_159_19_20141021_00013.jpg

Example of a prunings pile immediately adjacent to access road at LM 4.29. Evidence of habitual burnings at this site.

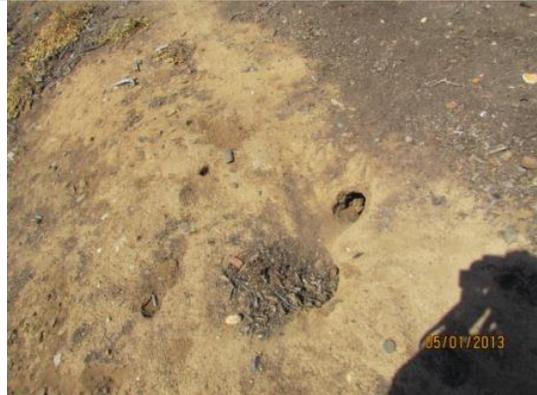
Photo 2 of 2 : FA_2014_NA0017_159_30_20141021_00022.jpg

Animal holes were found on the waterside slope of the levee looking downstream.

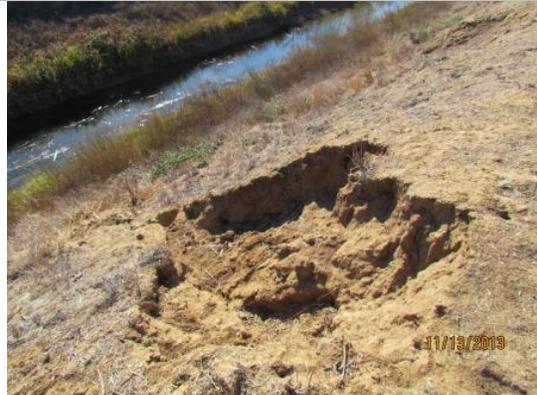
Photo 1 of 3 : FA_2014_NA0017_159_65_20141021_00049.jpg

Updated picture of the slope instability on the waterside of the levee looking downstream during fall 2013 inspection.

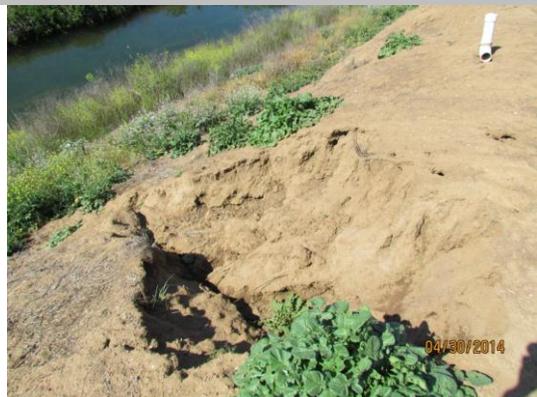
Photo 2 of 3 : FA_2014_NA0017_159_65_20141021_00050.jpg

Updated picture of the slope instability on the waterside of the levee looking downstream during spring 2014 inspection.

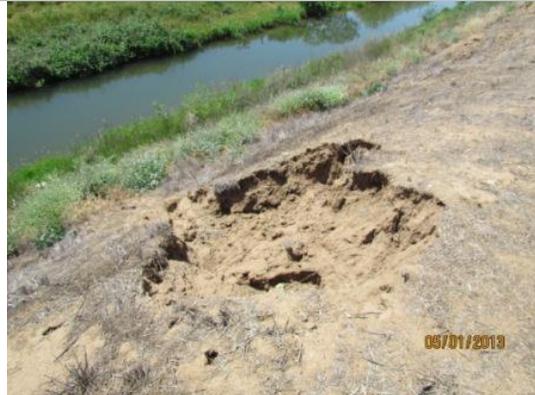
Photo 3 of 3 : FA_2014_NA0017_159_65_20141021_00051.jpg

A slope instability was found on the waterside slope of the levee looking downstream.

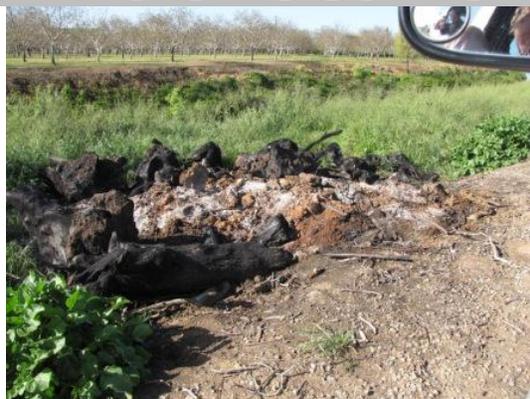
Photo 2 of 2 : FA_2014_NA0017_159_78_20141021_00060.jpg

View of the prunings pile on the waterward slope looking downstream.

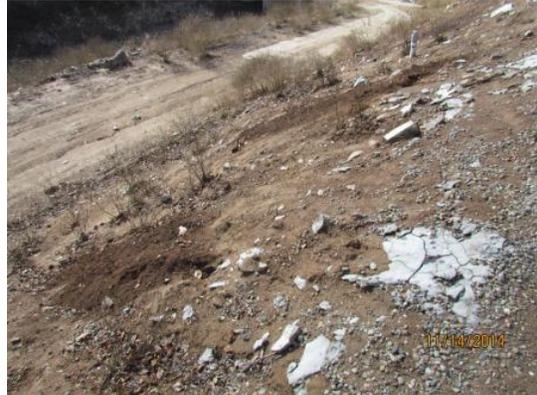
Photo 1 of 1 : FA_2014_NA0017_159_175_20141118_00136.jpg

Rodent holes were found on the waterside of the levee looking downstream.

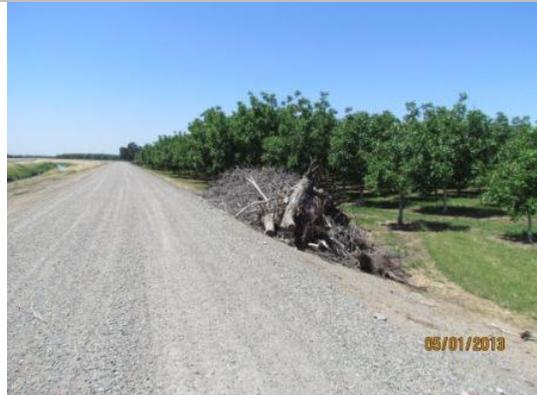
Photo 1 of 1 : FA_2014_NA0017_159_989_20141021_00115.jpg

Prunings were found on the landside slope of the levee looking downstream.

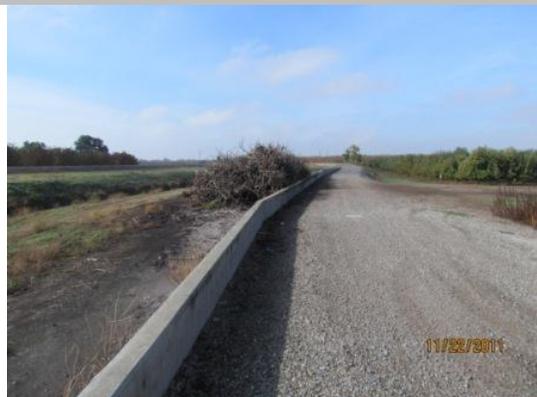
Photo 1 of 1 : FA_2014_NA0017_159_46_20141021_00039.jpg

Prunings were found on the waterside of the levee looking downstream.

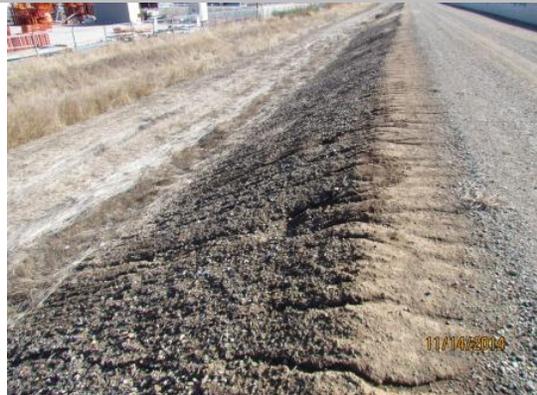
Photo 1 of 1 : FA_2014_NA0017_159_184_20141118_00141.jpg

Erosion caused by surface runoff was found on the landside of the levee looking upstream.

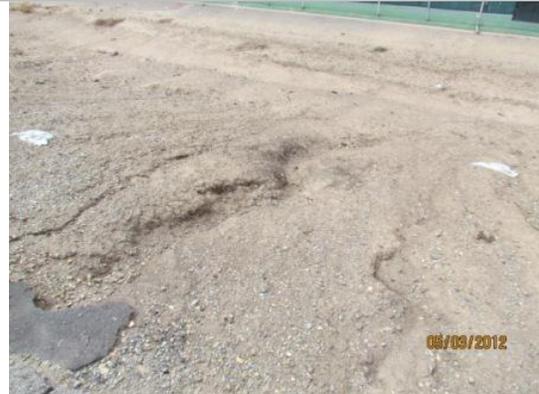
Photo 1 of 3 : FA_2014_NA0017_159_173_20141021_00106.jpg

Erosion was found due to runoff on the landside of the levee looking downstream.

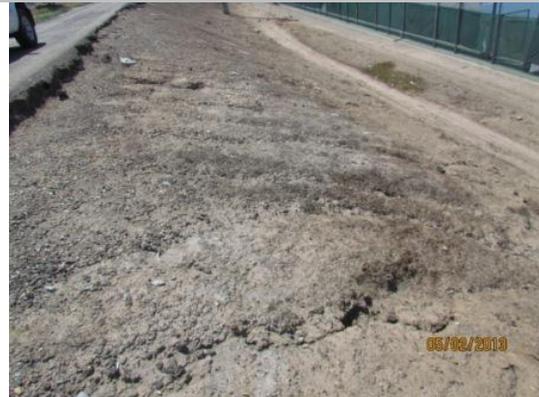
Photo 2 of 3 : FA_2014_NA0017_159_173_20141021_00107.jpg

Updated picture of the erosion caused by run off on the landside slope of the levee looking downstream during spring 2013 inspection.

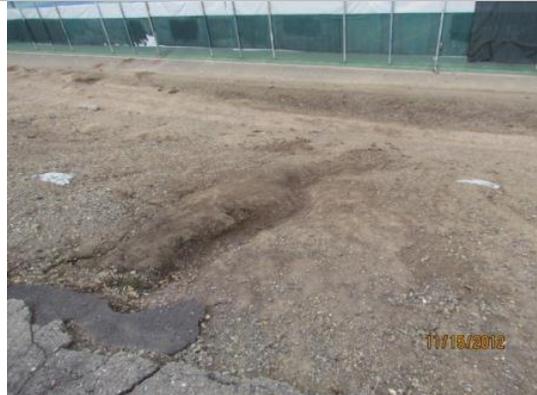
Photo 3 of 3 : FA_2014_NA0017_159_173_20141021_00108.jpg

Updated picture of the erosion located on the landside of the levee looking downstream.

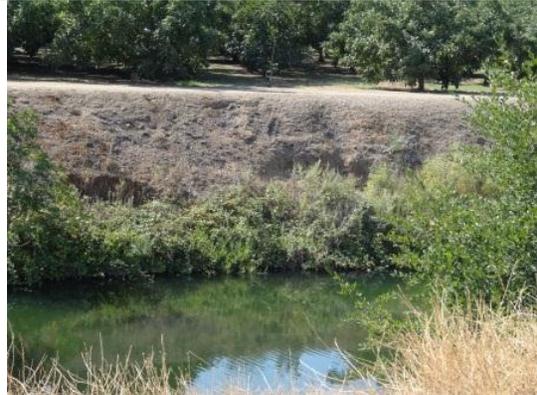
Photo 1 of 1 : SJR2014_NA0017U16RM22.01_1.jpg

Close view of the pocket erosion.

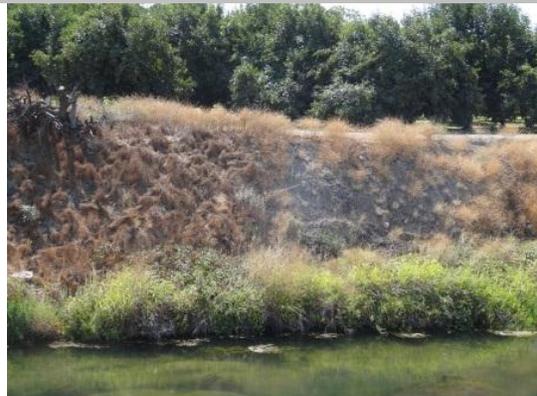
Photo 1 of 1 : SJR2014_NA0017U16RM19.28_1.jpg

Front view of the repaired erosion.

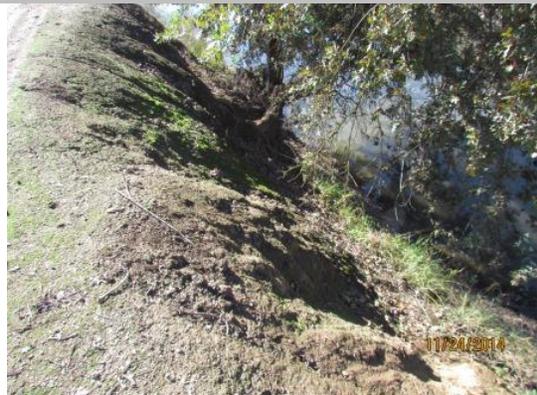
Photo 1 of 2 : FA_2014_NA0017_160_228_20141125_00174.jpg

Updated picture of the slope instability on the waterside of the levee looking downstream.

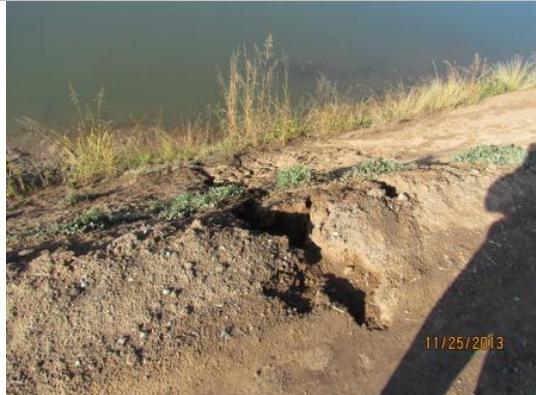
Photo 1 of 2 : FA_2014_NA0017_160_73_20141021_00041.jpg

Updated picture of the erosion on the waterside of the levee looking upstream.

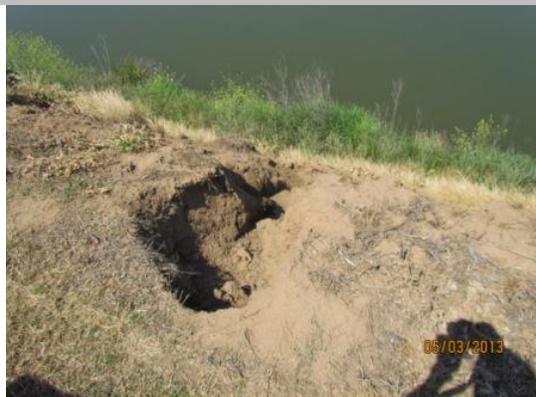
Photo 2 of 2 : FA_2014_NA0017_160_73_20141021_00042.jpg

Erosion was found on the waterside shoulder of the levee looking downstream.

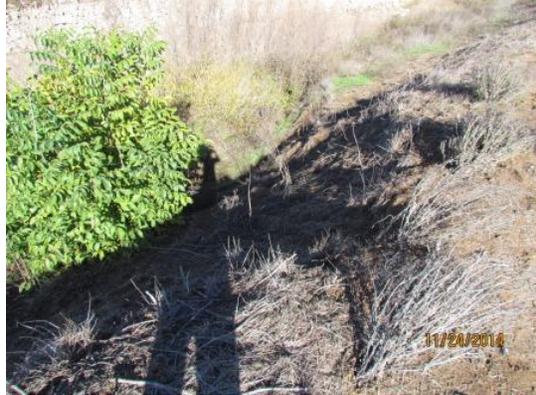
Photo 1 of 1 : FA_2014_NA0017_160_265_20141125_00173.jpg

A slope instability was found on the waterside slope of the levee looking upstream.

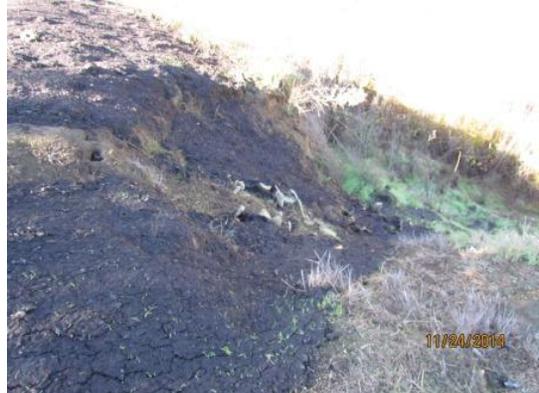
Photo 1 of 2 : FA_2014_NA0017_160_120_20141125_00170.jpg

Updated picture of the slope instability on the waterside of the levee looking downstream.

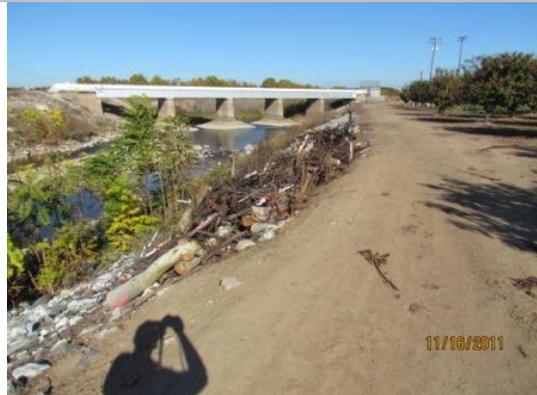
Photo 1 of 1 : FA_2014_NA0017_160_61_20141021_00033.jpg

Debris and prunings were found on the waterside of the levee looking upstream.

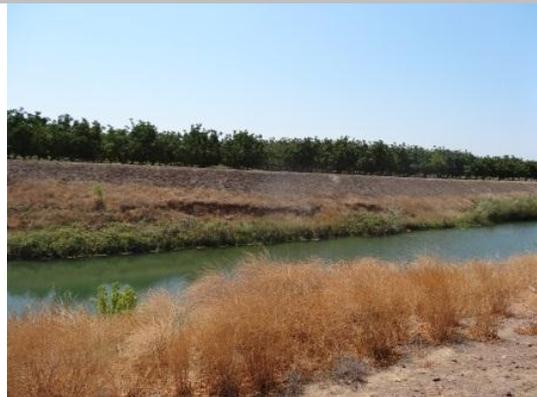
Photo 1 of 1 : SJR2014_NA0017U16RM13.72_1.jpg

Upstream view of the erosion.

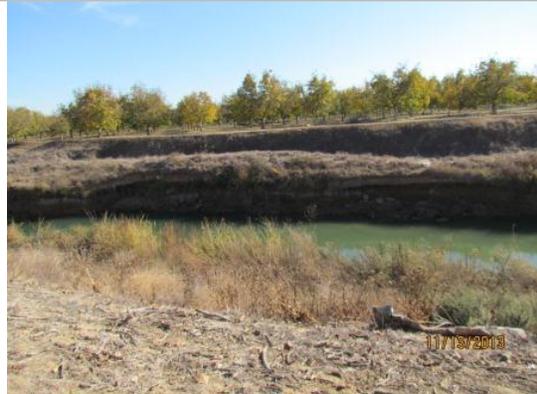
Photo 1 of 1 : FA_2014_NA0017_160_28_20141021_00012.jpg

View of the erosion on the waterside toe of the levee looking from the opposite side of the levee.

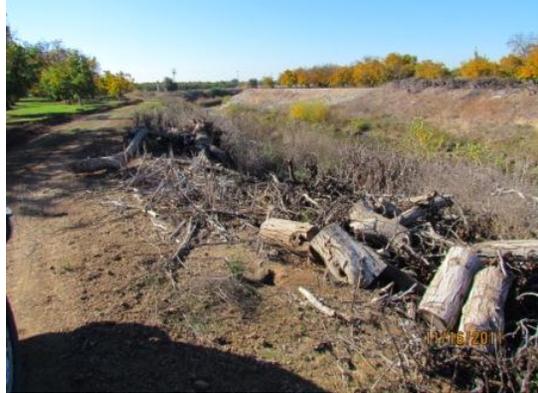
Photo 2 of 2 : FA_2014_NA0017_160_90_20141021_00054.jpg

Prunings were found on the waterside of the levee looking downstream.

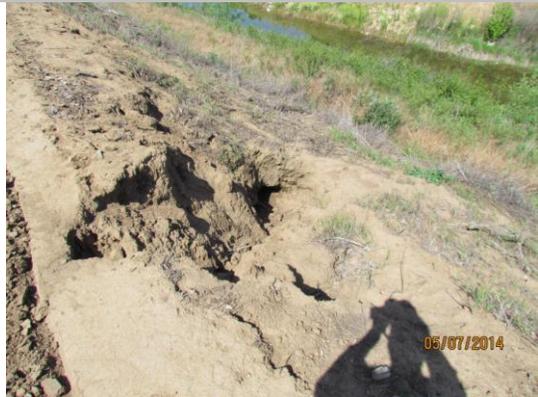
Photo 1 of 2 : FA_2014_NA0017_160_139_20141021_00090.jpg

Updated picture of the erosion on the waterside shoulder of the levee looking downstream.

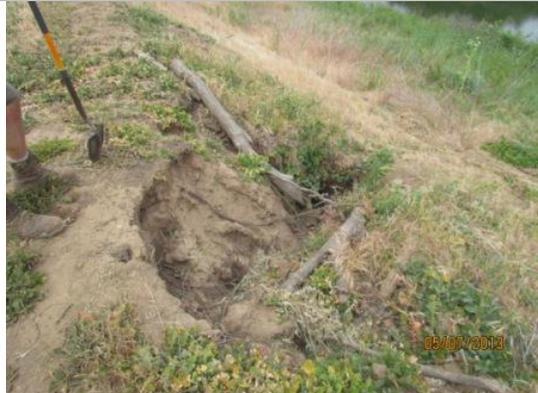
Photo 2 of 2 : FA_2014_NA0017_160_139_20141021_00091.jpg

Erosion was found on the waterside of the levee looking downstream.

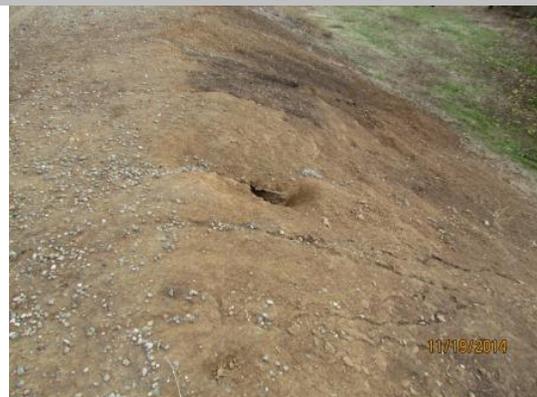
Photo 1 of 1 : FA_2014_NA0017_160_260_20141125_00167.jpg

Rodent holes were found on the landside slope of the levee looking upstream.

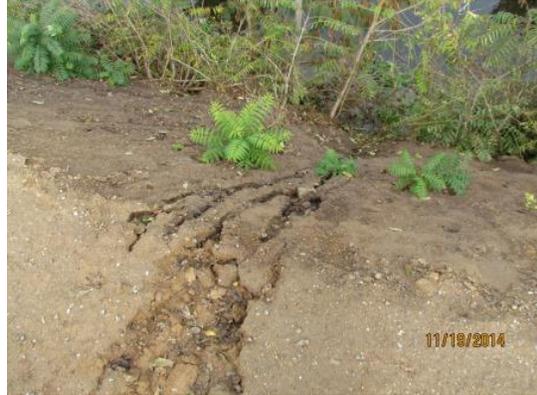
Photo 1 of 2 : FA_2014_NA0017_160_175_20141125_00162.jpg

Updated picture of the slope instability on the waterside slope of the levee looking upstream during fall 2014 inspection.

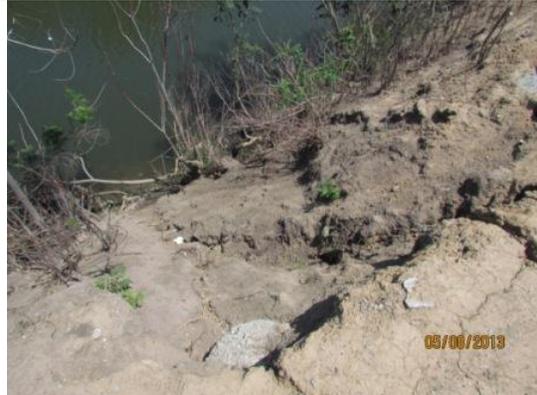
Photo 2 of 2 : FA_2014_NA0017_160_175_20141021_00122.jpg

Slope instability was found on the waterside slope of the levee looking upstream.

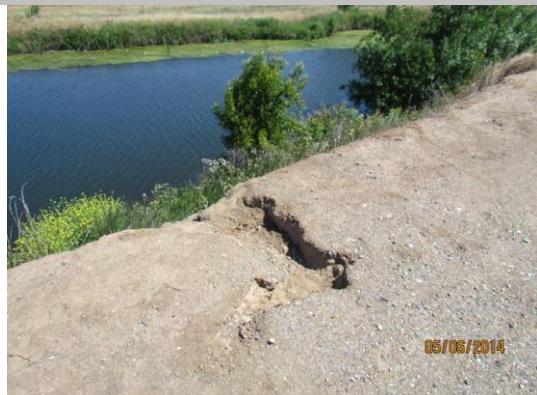
updated picture of the erosion on the waterside of the levee looking upstream during spring 2014 inspection.

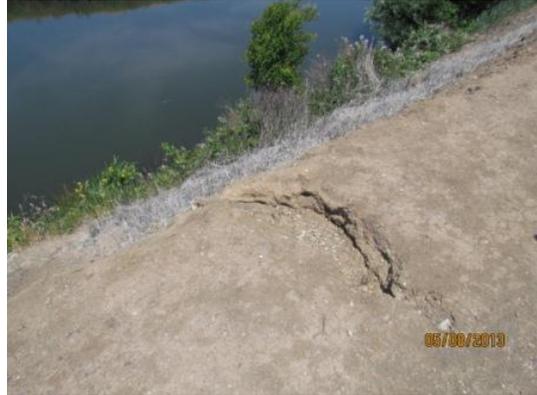
Erosion was found on the waterside slope of the levee looking upstream.

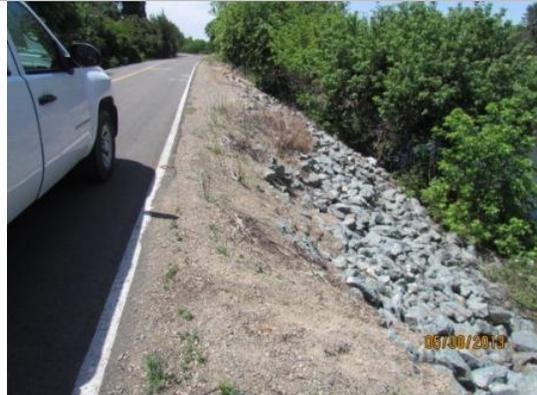
Slope instability was found on the waterside slope of the levee looking downstream.

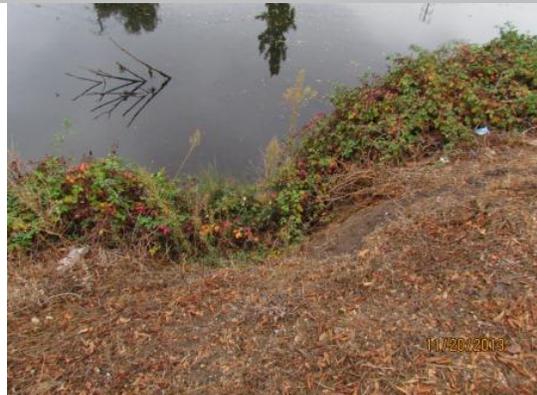
Erosion was found on the waterside slope of the levee looking upstream.

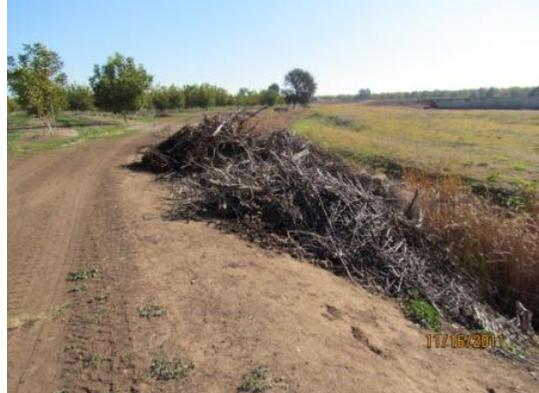
Prunings were found on the waterside of the levee looking upstream.
