**Flood Control Project Maintenance
Levee Inspections**

Maintenance Issue Types Only, Levee Inspection Report By Mile - Fall 2015

San Joaquin County Flood Control and Water Conservation District

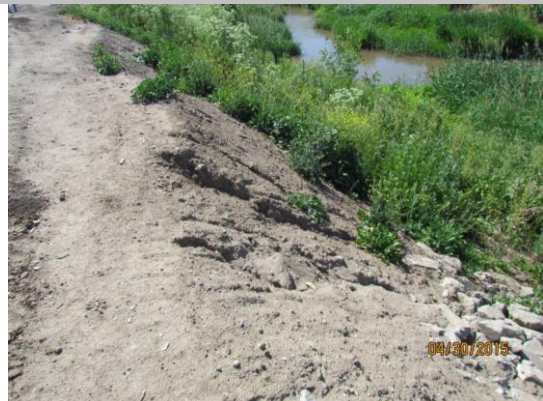
Photo 1 of 1 : FA_2015_NA0017_149_127_20150911_00007.jpg

Erosion was found on the waterside slope of the levee looking upstream.

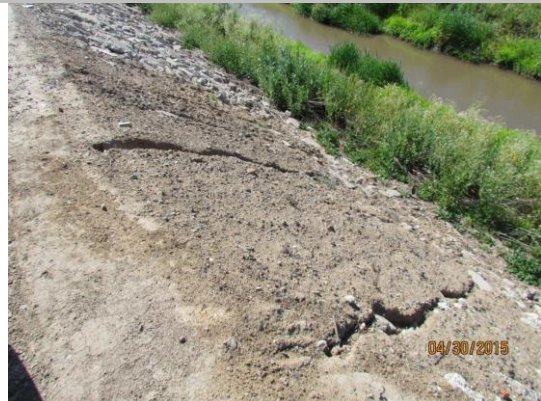
Photo 1 of 1 : FA_2015_NA0017_149_128_20150911_00008.jpg

LM Start	2.11	Rating **	M	Issue No.	128
LM End	2.11	Issue Type +	Ma	Location *	WS
Category	Earthen Levee			GPS Latitude/Longitude	
				Start	End
Item	Erosion / Bank Caving			37.883599 °	37.883599 °
				-121.252355 °	-121.252355 °
DWR ID	DWR_NA0017_02_s_2015_128				
Action/Comments					
Schedule repair of erosion site prior to the next inspection.					
Inspector Comments: Runoff

Erosion caused by runoff on the waterside looking upstream.

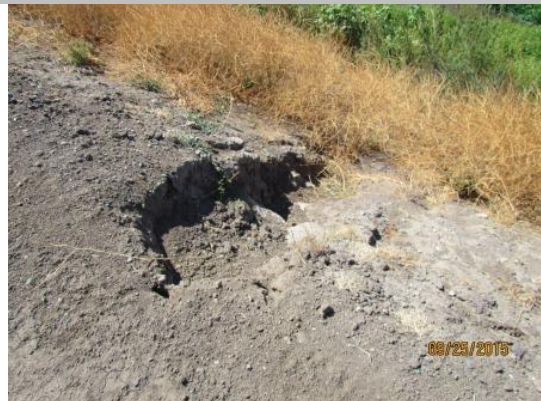
Photo 1 of 2 : FA_2015_NA0017_149_4_20150928_00010.jpg

LM Start	2.22	Rating **	M	Issue No.	4
LM End	2.22	Issue Type +	Ma	Location *	WS
Category	Earthen Levee			GPS Latitude/Longitude	
				Start	End
Item	Erosion / Bank Caving			37.884741 °	37.884741 °
				-121.253808 °	-121.253808 °
DWR ID	DWR_NA0017_02_s_2014_4				
Action/Comments					
Schedule repair of erosion site prior to the next inspection.

Updated picture of the erosion on the waterside of the levee during fall 2015 inspection.

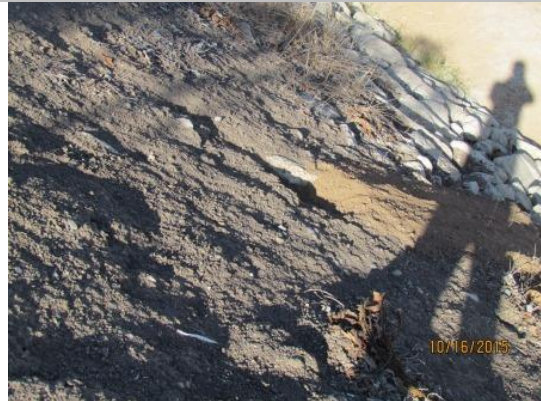
Photo 1 of 1 : FA_2015_NA0017_150_2_20151023_00002.jpg

A rodent hole was found on the waterside of the levee.

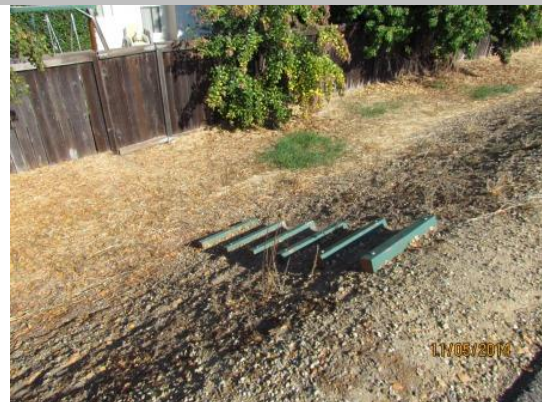
Photo 1 of 1 : FA_2015_NA0017_151_76_20150911_00034.jpg

A stairway was found on the landside of the levee looking upstream.

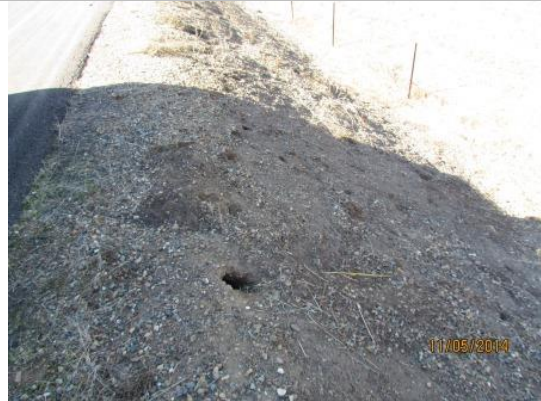
Photo 1 of 1 : FA_2015_NA0017_151_83_20150911_00037.jpg

Rodent holes were found on the landside of the levee looking downstream.

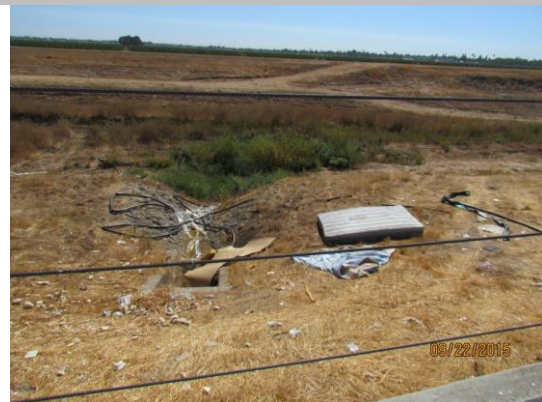
Photo 1 of 1 : FA_2015_NA0017_151_37_20150928_00063.jpg

Debris was found on the waterside toe of the levee looking downstream.

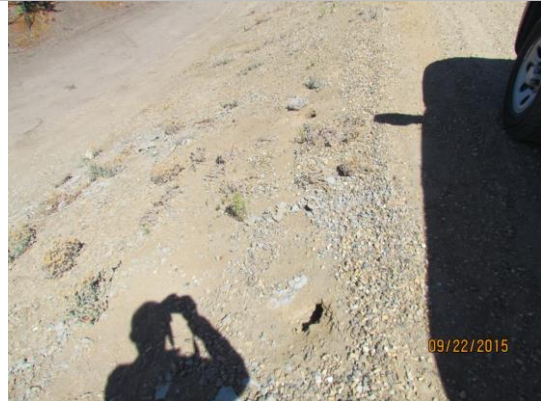
Photo 1 of 1 : FA_2015_NA0017_151_40_20150928_00064.jpg

Rodent holes were found on the landside slope of the levee looking upstream.

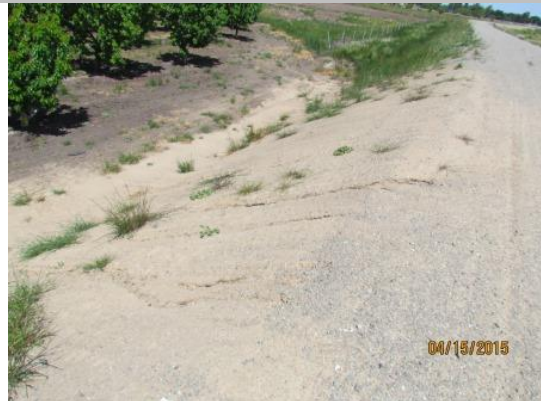
Photo 1 of 1 : FA_2015_NA0017_151_63_20150911_00030.jpg

LM Start	7.09	Rating **	M	Issue No.	63
LM End	7.09	Issue Type +	Ma	Location *	LS
Category	Earthen Levee			GPS Latitude/Longitude	
				Start	End
Item	Slope Stability			38.063929 °	38.063929 °
				-121.254950 °	-121.254950 °
DWR ID	DWR_NA0017_07_s_2015_63				
Action/Comments					
Repair slope instability.					
Inspector Comments: Runoff

Slope instability was found on the landside of the levee looking upstream.

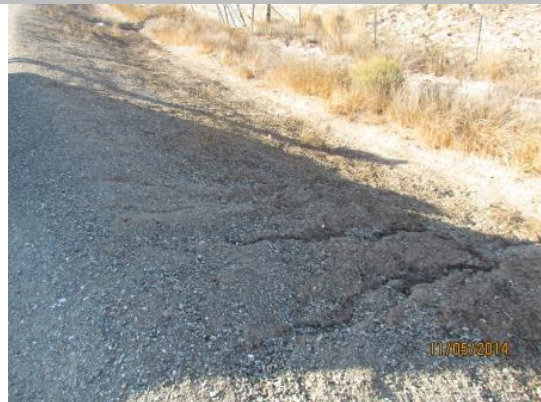
Photo 1 of 1 : FA_2015_NA0017_151_102_20150911_00048.jpg

LM Start	7.33	Rating **	M	Issue No.	102
LM End	7.33	Issue Type +	Ma	Location *	LS
Category	Earthen Levee			GPS Latitude/Longitude	
				Start	End
Item	Erosion / Bank Caving			38.064983 °	38.064983
				-121.251043 °	-121.251043
DWR ID	DWR_NA0017_07_f_2014_102				
Action/Comments					
Schedule repair of erosion site prior to the next inspection.					
Inspector Comments: Runoff

View of erosion caused by runoff found on the landside of the levee looking downstream.

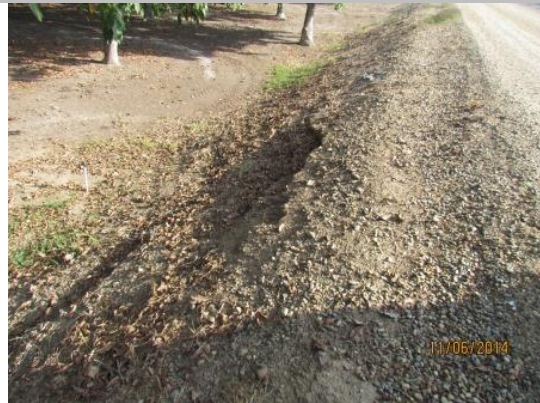
Photo 1 of 1 : FA_2015_NA0017_151_103_20150911_00049.jpg

LM Start	9.52	Rating **	M	Issue No.	103
LM End	9.52	Issue Type +	Ma	Location *	LS
Category	Earthen Levee			GPS Latitude/Longitude	
				Start	End
Item	Slope Stability			38.073712 °	38.073712 °
				-121.214236 °	-121.214236 °
DWR ID	DWR_NA0017_07_f_2014_103				
Action/Comments					
Repair slope instability.

View of a slope instability found on the landside of the levee looking upstream.

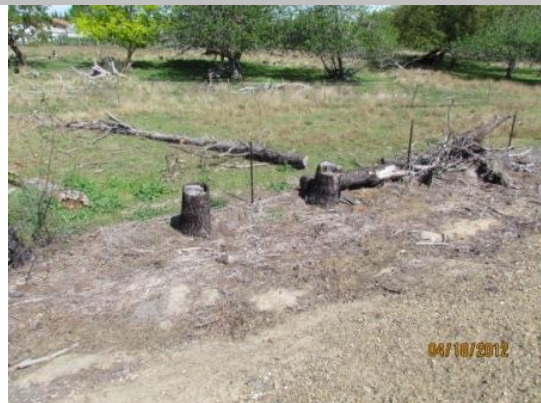
Photo 1 of 1 : FA_2015_NA0017_151_46_20150911_00019.jpg

View of tree stumps found on the landside of the levee looking upstream.

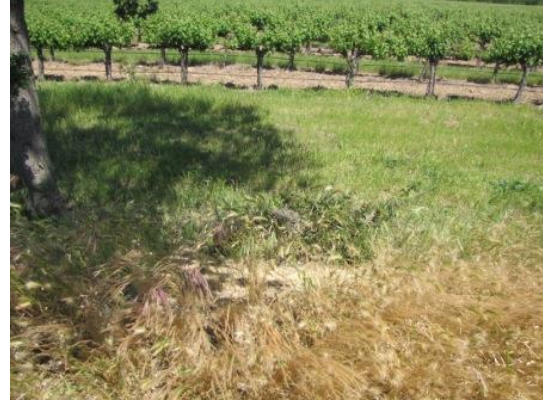
Photo 1 of 1 : FA_2015_NA0017_151_53_20150911_00025.jpg

View of a stump in the landward slope.

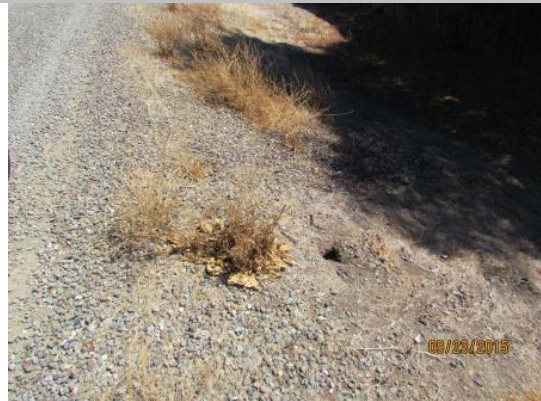
Photo 1 of 1 : FA_2015_NA0017_152_58_20150928_00096.jpg

An animal hole was found on the landside of the levee looking upstream.

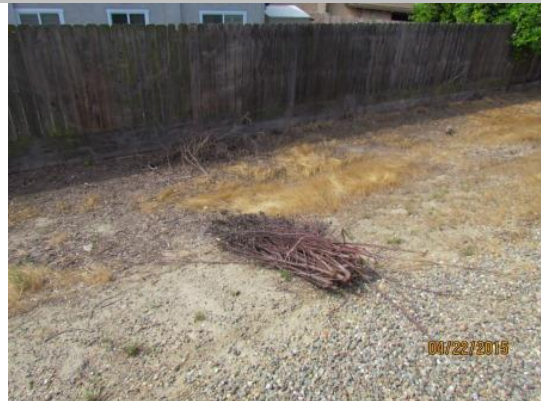
Photo 1 of 1 : FA_2015_NA0017_152_81_20150911_00022.jpg

Prunings were found on the landside slope of the levee looking downstream.

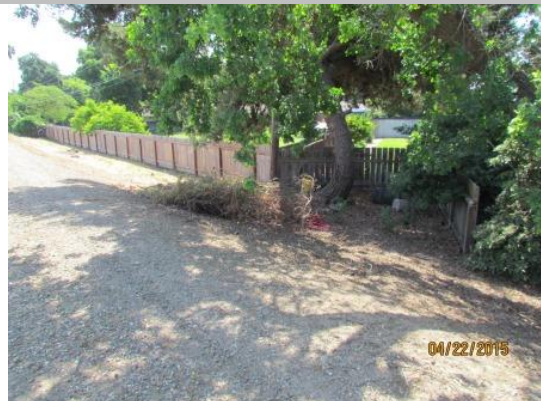
Photo 1 of 1 : FA_2015_NA0017_152_92_20150911_00029.jpg

Prunings were found on the landside of the levee looking upstream.

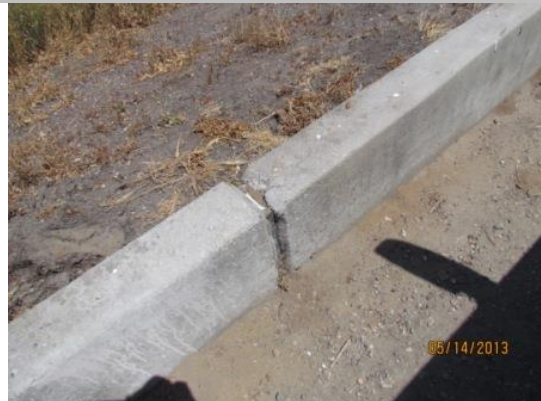
Photo 1 of 1 : FA_2015_NA0017_152_37_20150911_00011.jpg

The monolith joint material is deteriorating at this location of the flood wall. The picture was taken from the crown looking upstream.

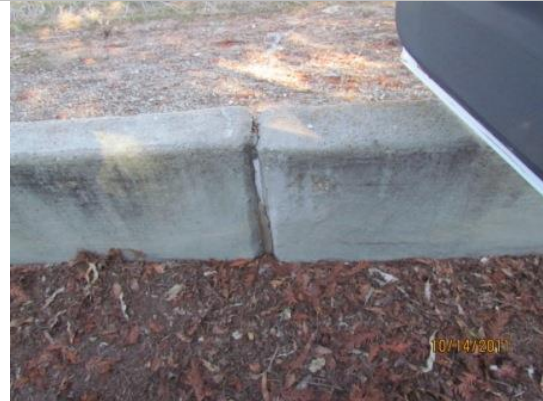
Photo 1 of 1 : FA_2015_NA0017_152_940_20150911_00041.jpg

Monolith joint material is deteriorating at the joint of the flood wall. The picture was taken from the crown looking upstream.

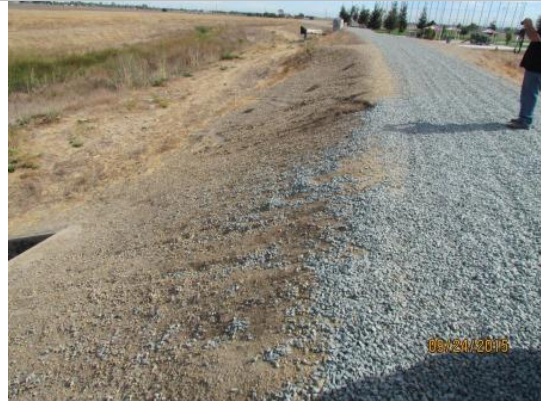
Photo 1 of 1 : FA_2015_NA0017_152_27_20150928_00099.jpg

Erosion caused by runoffs on the waterside slope of the levee looking upstream.

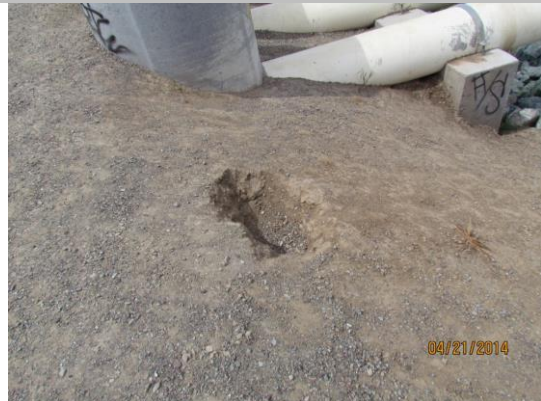
Photo 1 of 1 : FA_2015_NA0017_152_46_20150911_00014.jpg

A slope instability was found on the waterside of the levee looking downstream.

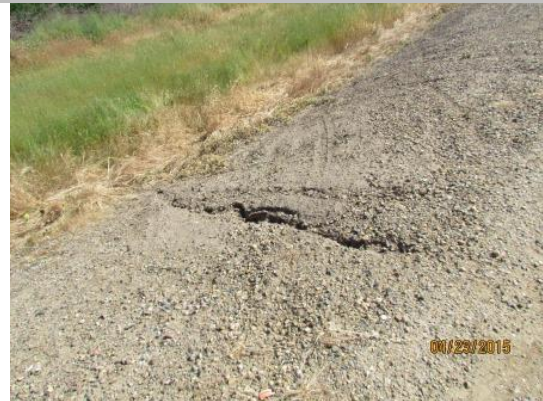
Photo 1 of 1 : FA_2015_NA0017_152_6_20150911_00004.jpg

View of a slope instability due to runoff on the waterside of the levee looking upstream.

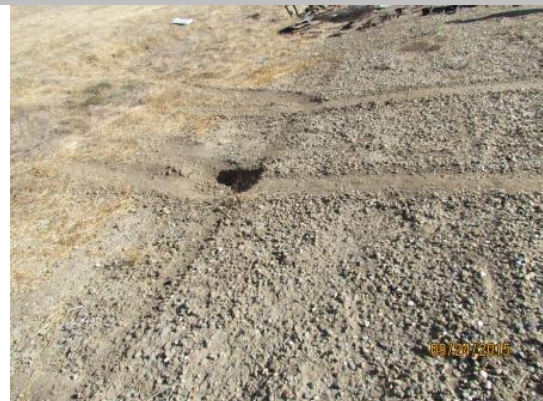
Photo 1 of 1 : FA_2015_NA0017_152_69_20150928_00100.jpg

Slope instability was found on the waterside toe of the levee upstream.

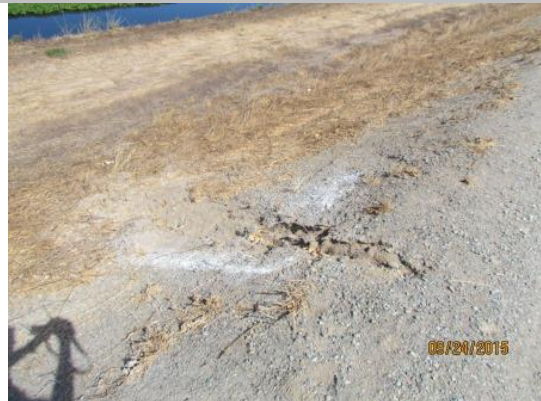
Photo 1 of 1 : FA_2015_NA0017_152_76_20150928_00106.jpg

A slope instability was found on the waterside of the levee looking upstream.

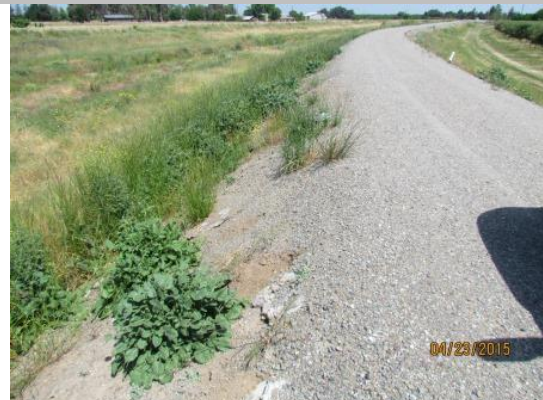
Photo 2 of 2 : FA_2015_NA0017_152_94_20150911_00030.jpg

Rodent holes were found on the waterside of the levee looking upstream.

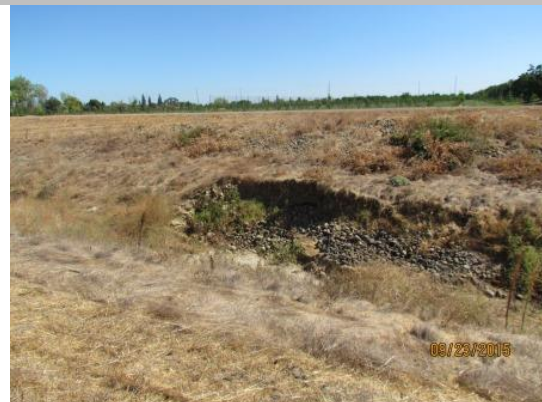
Photo 1 of 1 : FA_2015_NA0017_152_57_20150928_00095.jpg

Erosion was found on the waterside toe of the levee. The picture was taken from the right bank of the levee.

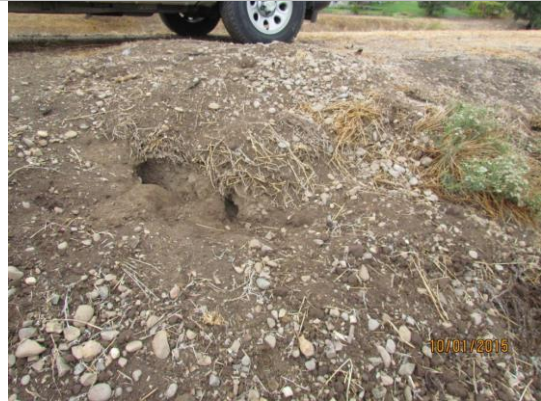
Photo 1 of 1 : FA_2015_NA0017_152_96_20151009_00112.jpg

Rodent holes were found on the landside slope of the levee looking upstream.

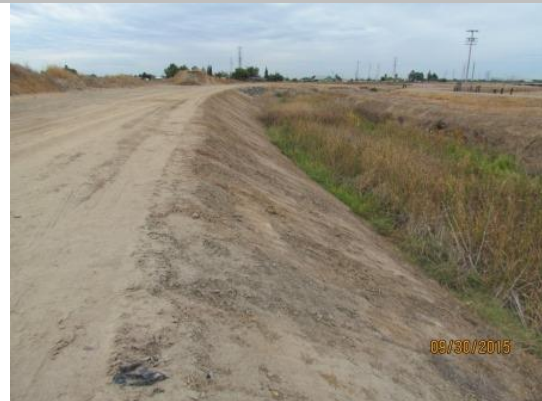
Photo 1 of 1 : FA_2015_NA0017_156_27_20151005_00029.jpg

LMA has repaired rodent holes on the waterside of the levee looking downstream.

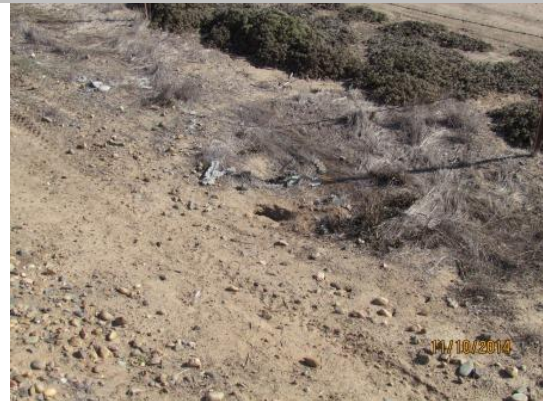
Photo 1 of 1 : FA_2015_NA0017_157_8_20150911_00006.jpg

View of an animal hole that was found on the landside of the levee looking upstream.

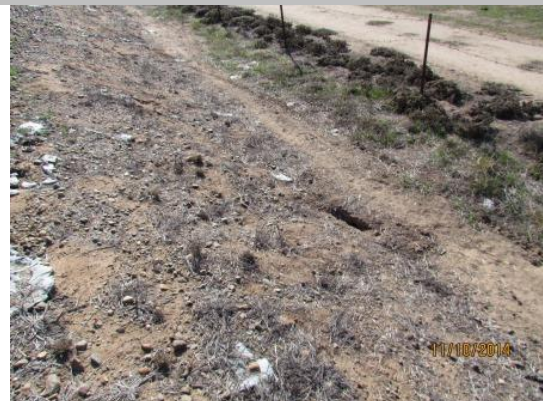
Photo 1 of 1 : FA_2015_NA0017_157_7_20150911_00005.jpg

View of an animal hole that was found on the landside toe of the levee looking upstream.

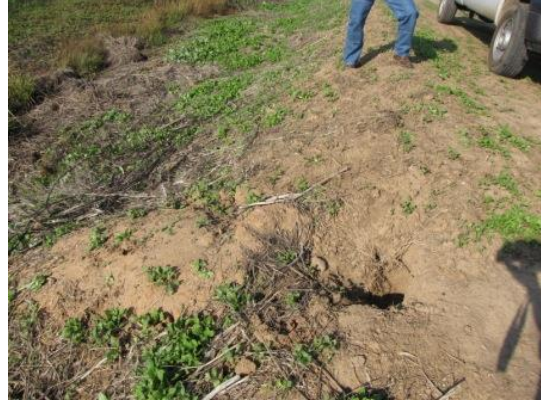
Photo 1 of 1 : FA_2015_NA0017_158_2_20150911_00002.jpg

View of a large diameter rodent hole in the waterward berm looking downstream.

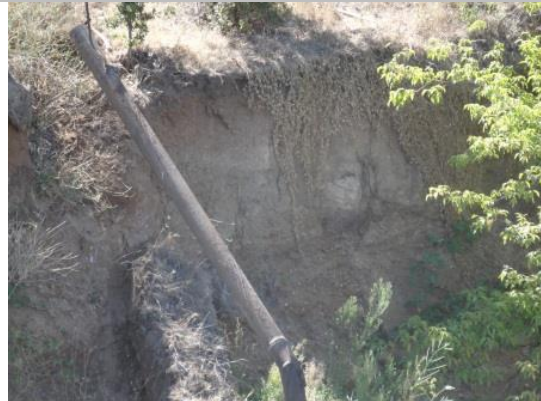
Photo 1 of 2 : SJR2015_NA0017U16RM22.74_2.jpg

Close view of the erosion.

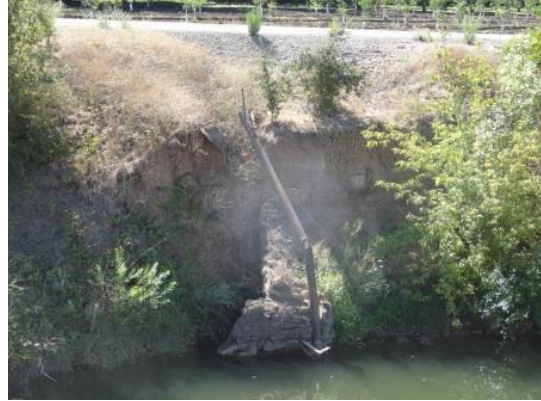
Photo 2 of 2 : SJR2015_NA0017U16RM22.74_3.jpg

Close view of the erosion. Note the drainage pipe at the site.

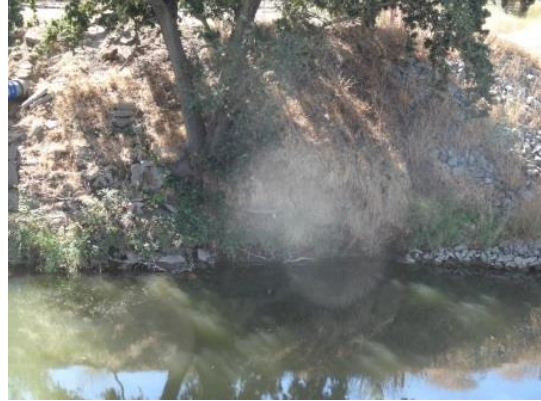
Photo 2 of 3 : SJR2015_NA0017U16RM22.58_3.jpg

Closer view of the erosion.

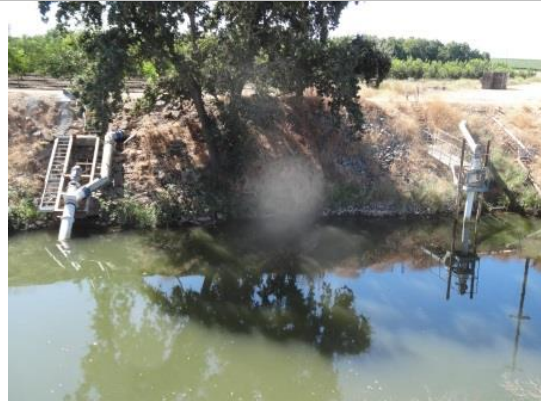
Photo 3 of 3 : SJR2015_NA0017U16RM22.58_5.jpg

Front view of the erosion and broken concrete protection on the levee slope.

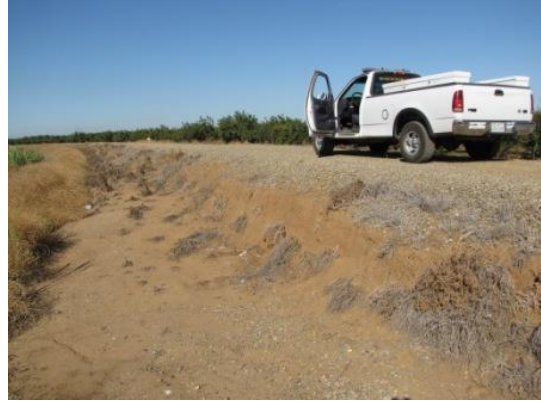
Photo 1 of 1 : FA_2015_NA0017_159_995_20150911_00119.jpg

View of erosion of waterward levee slope looking upstream.

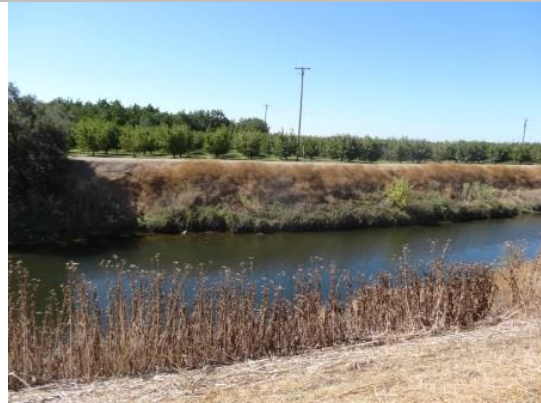
Photo 1 of 3 : SJR2015_NA0017U16RM22.15_1.jpg

Front view of the erosion.

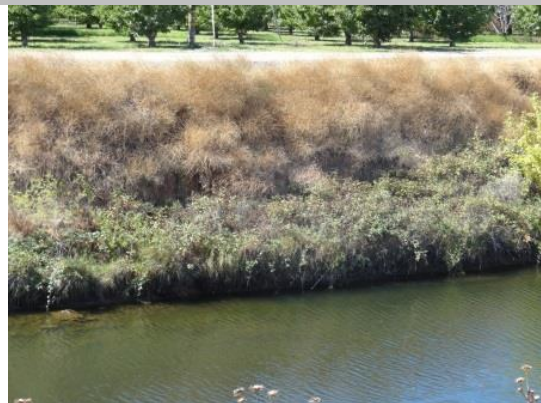
Photo 2 of 3 : SJR2015_NA0017U16RM22.15_2.jpg

Close view of the erosion.

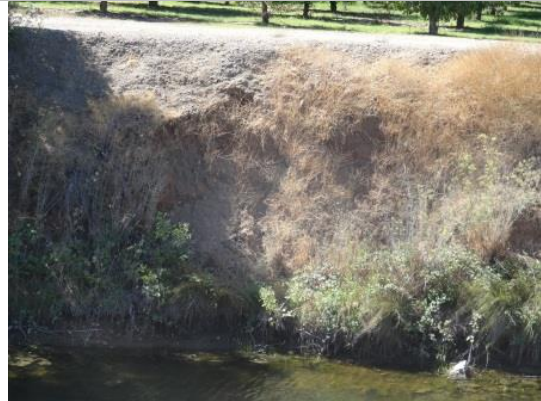
Photo 3 of 3 : SJR2015_NA0017U16RM22.15_4.jpg

Close view of the erosion.

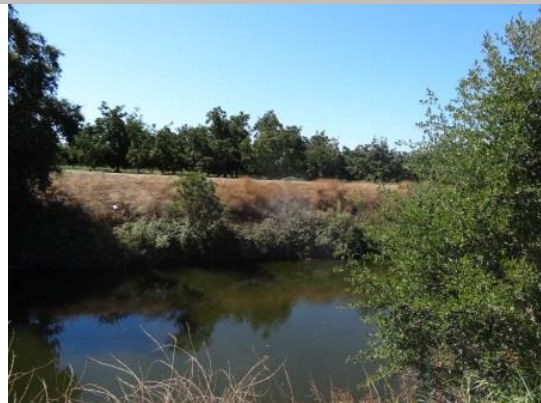
Photo 1 of 3 : SJR2015_NA0017U16RM22.01_1.jpg

Front view of the erosion site from the left river bank.

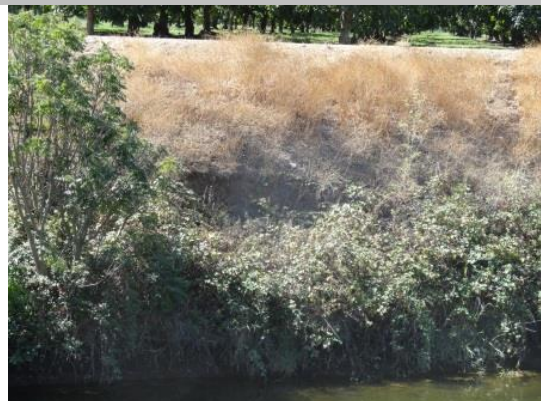
Photo 2 of 3 : SJR2015_NA0017U16RM22.01_2.jpg

Front view of the pocket erosion.

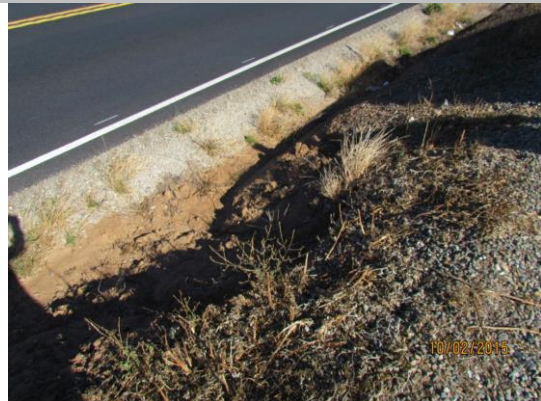
Photo 1 of 1 : FA_2015_NA0017_159_120_20151009_00138.jpg

A slope instability possible cause by runoff on the landside of the levee looking upstream.

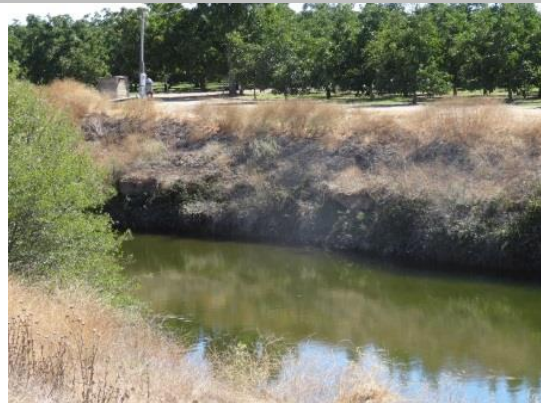
Photo 3 of 3 : SJR2015_NA0017U16RM21.05_5.jpg

Close view of the erosion.

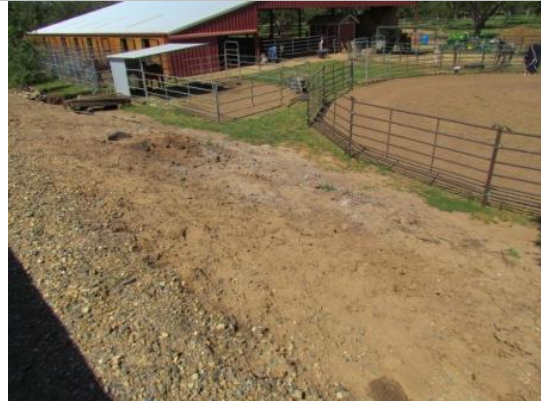
Photo 1 of 1 : FA_2015_NA0017_159_27_20150911_00019.jpg

Slope instability was found on the landside of the levee. The picture was taken from the crown looking downstream.

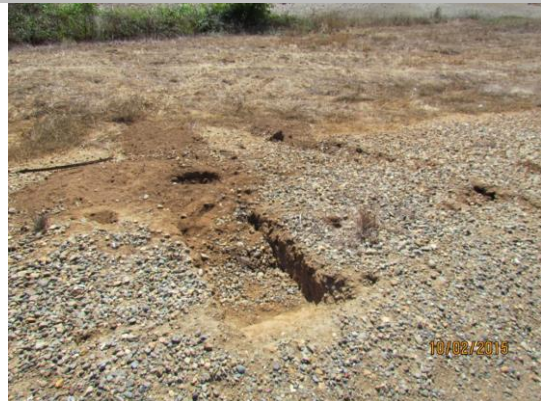
Photo 1 of 1 : FA_2015_NA0017_159_127_20151009_00139.jpg

Slope instability caused by vehicle on the waterside of the levee looking downstream.

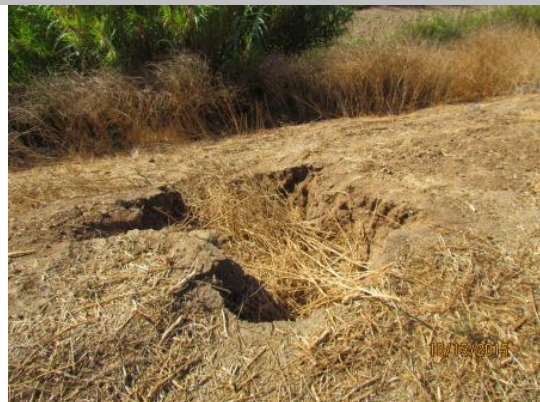
Photo 1 of 1 : FA_2015_NA0017_159_146_20151019_00148.jpg

Erosion was found on the waterside of the levee looking downstream.

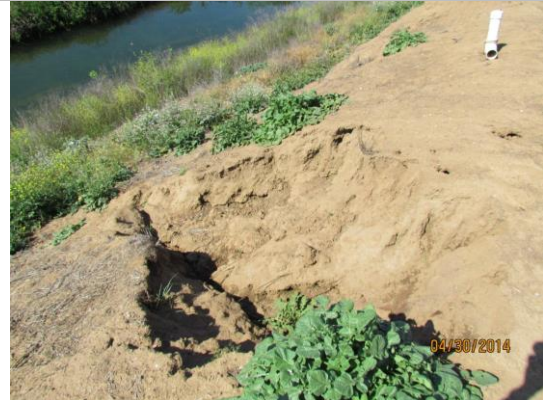
Photo 2 of 2 : FA_2015_NA0017_159_65_20150911_00048.jpg

View of the slope instability on the waterside of the levee looking downstream during spring 2014 inspection.

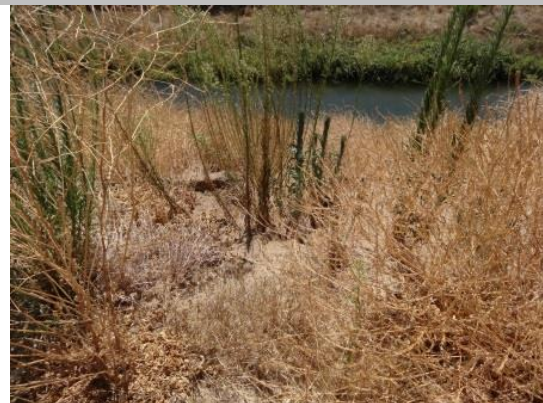
Photo 1 of 3 : SJR2015_NA0017U15RM14.49_1.JPG

Looking down at the erosion from the levee crest.

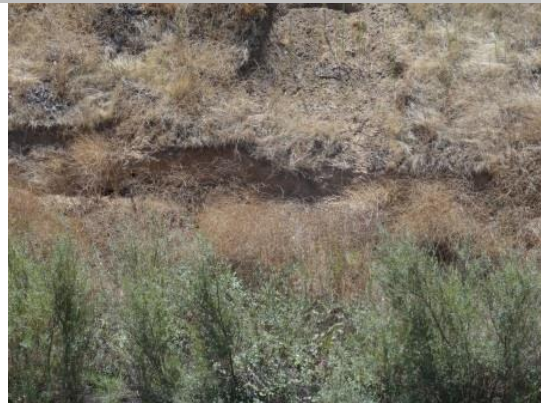
Photo 2 of 2 : SJR2015_NA0017U16RM13.85_3.JPG

Close view of the erosion.

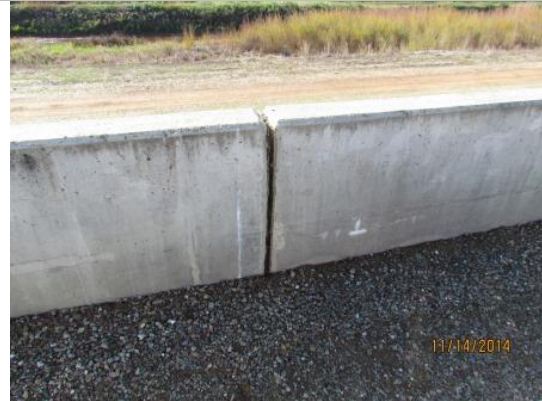
Photo 1 of 1 : FA_2015_NA0017_159_180_20150911_00102.jpg

The monolith joint is deteriorating on the waterside shoulder of the levee.

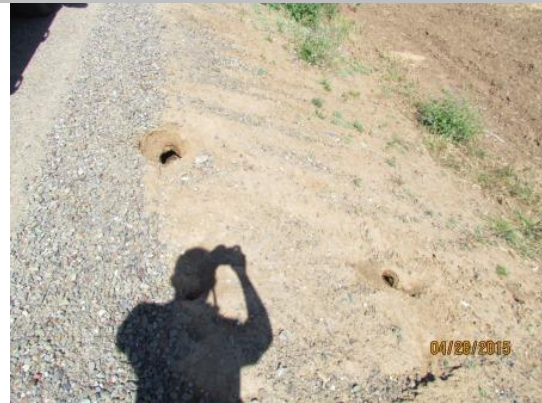
Photo 1 of 1 : FA_2015_NA0017_159_194_20150911_00108.jpg

Rodent holes were found on the landside of the levee looking downstream.

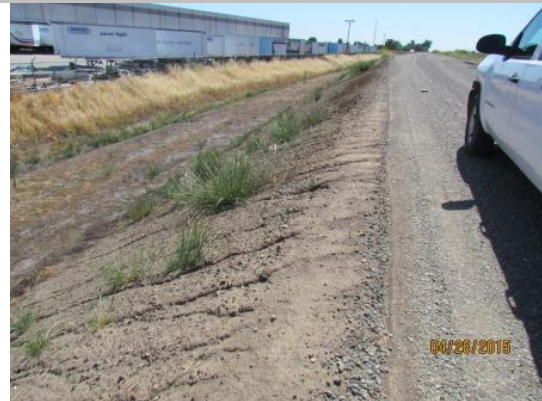
Photo 1 of 1 : FA_2015_NA0017_159_198_20150911_00109.jpg

View of slope instability due to runoff on the landside of the levee looking upstream.

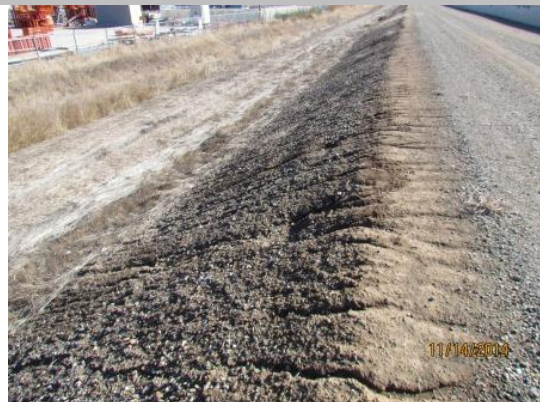
Photo 1 of 1 : FA_2015_NA0017_159_184_20150911_00103.jpg

Erosion caused by surface runoff was found on the landside of the levee looking upstream.

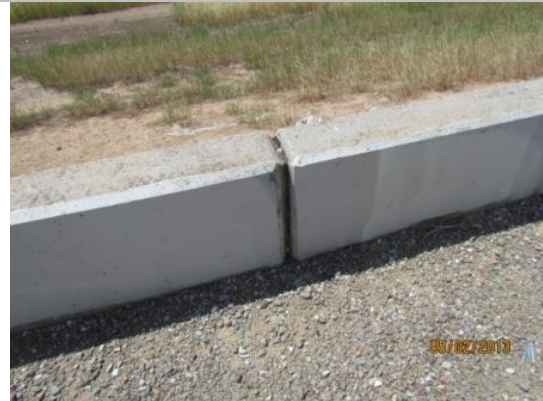
Photo 1 of 1 : FA_2015_NA0017_159_93_20150911_00062.jpg

The monolith joint material is deteriorating at the waterside shoulder of the levee looking downstream.

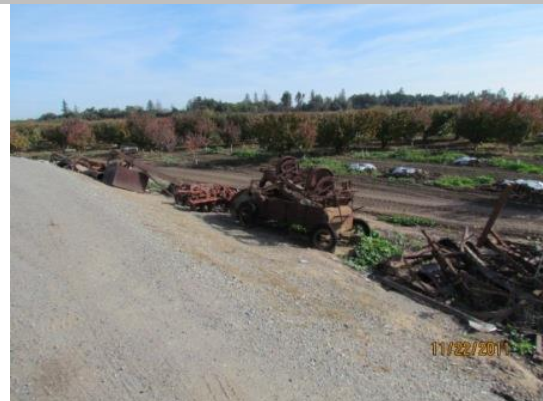
Photo 1 of 1 : FA_2015_NA0017_159_567_20150911_00115.jpg

Equipment was found on the landside of the levee looking downstream.

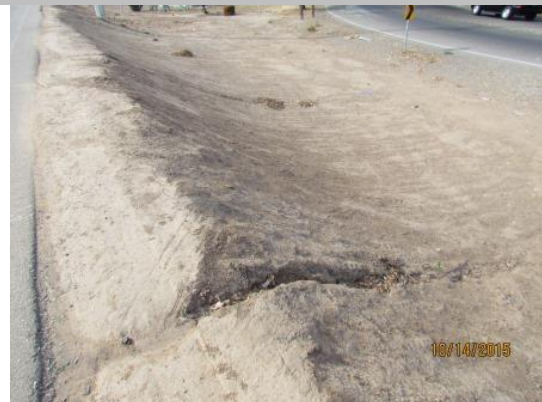
Photo 1 of 1 : FA_2015_NA0017_159_172_20151019_00155.jpg

Erosion was found on the landside of the levee looking downstream.

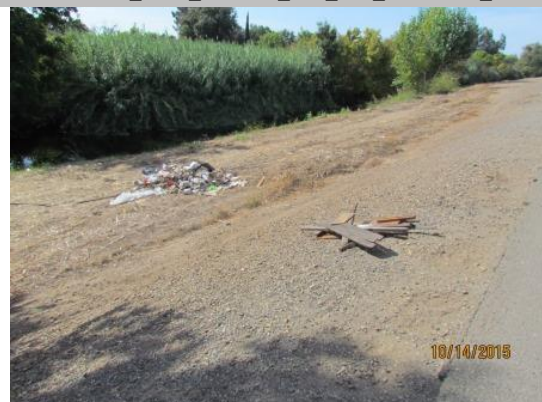
Photo 1 of 1 : FA_2015_NA0017_159_175_20151019_00157.jpg

Debris was found on the waterside of the levee.

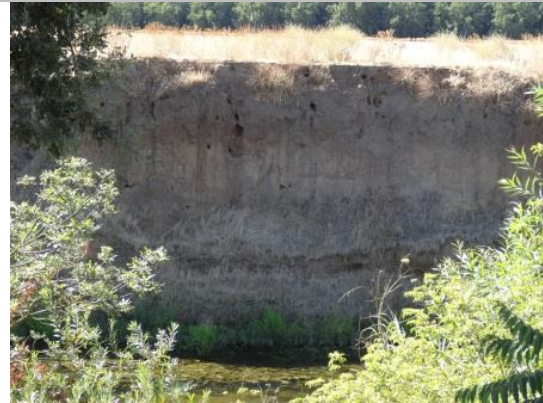
Photo 1 of 3 : SJR2015_NA0017U16RM23.35_10.jpg

Close view of the erosion.

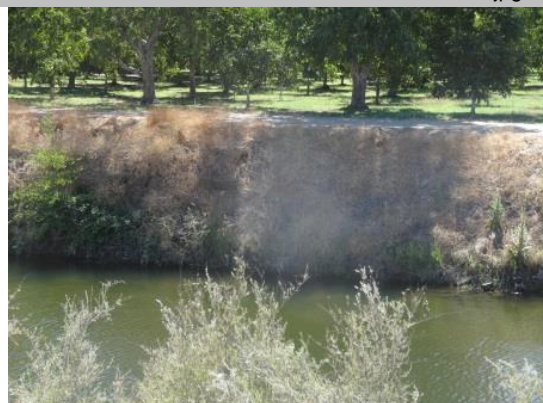
Photo 3 of 3 : SJR2015_NA0017U16RM20.62_5.jpg

Close view of the site.

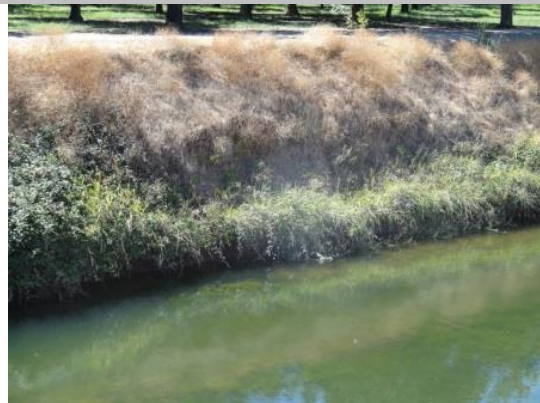
Photo 1 of 2 : SJR2015_NA0017U16RM19.29_2.JPG

Close view of the erosion.

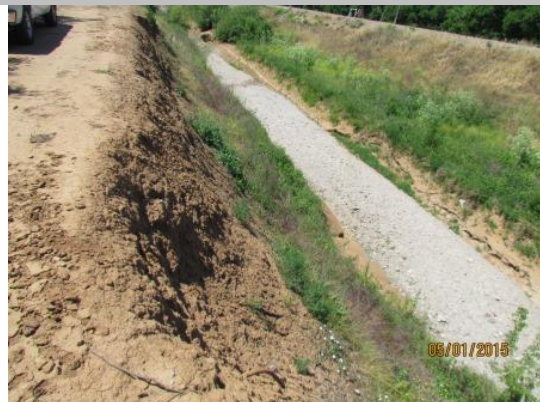
Photo 1 of 1 : FA_2015_NA0017_160_245_20150911_00142.jpg

View of erosion on the waterside slope of the levee looking downstream.

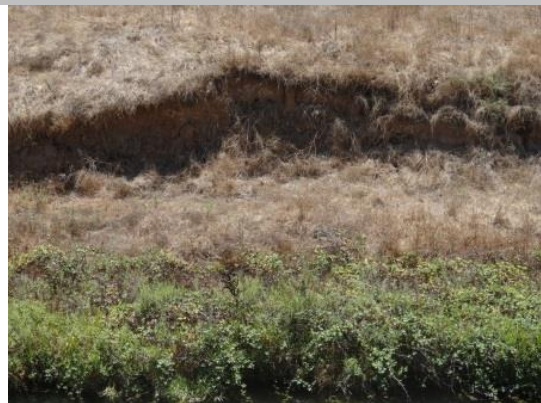
Photo 2 of 2 : SJR2015_NA0017U16RM14.48_4.jpg

Close view of the erosion.

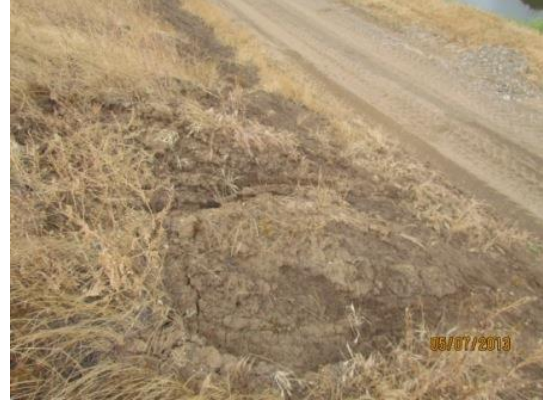
Photo 2 of 2 : FA_2015_NA0017_160_128_20150911_00070.jpg

Slope instability was found on the waterside slope of the levee looking downstream.

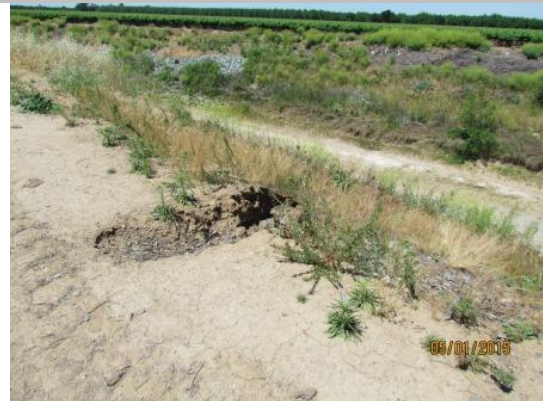
Photo 1 of 1 : FA_2015_NA0017_160_248_20150911_00144.jpg

Erosion was found on the waterside looking downstream.

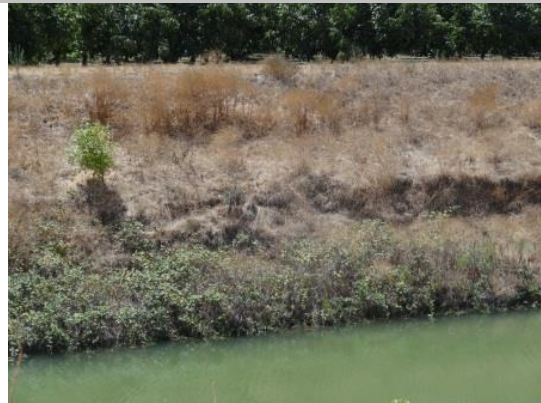
Photo 3 of 3 : SJR2015_NA0017U16RM13.72_5.jpg

Front view of the erosion.

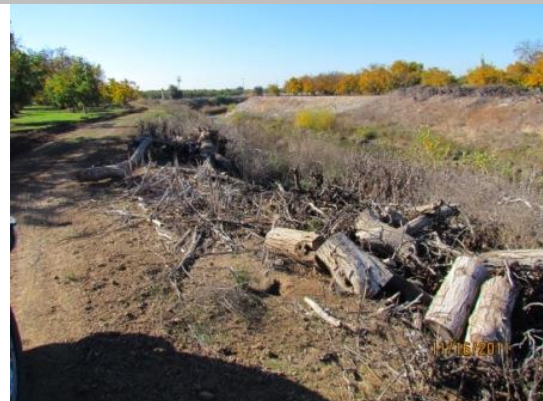
Photo 2 of 2 : FA_2015_NA0017_160_90_20150911_00047.jpg

Prunings were found on the waterside of the levee looking downstream.

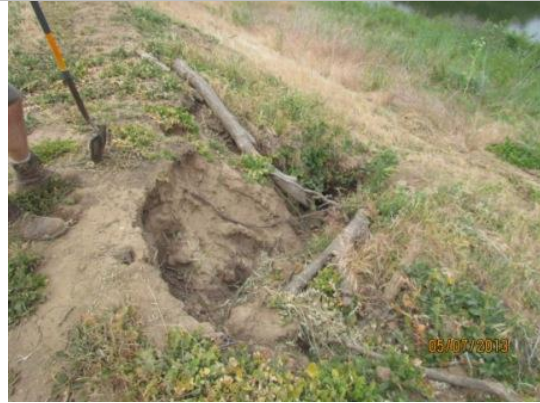
Photo 2 of 2 : FA_2015_NA0017_160_139_20150911_00079.jpg

Erosion was found on the waterside of the levee looking downstream.

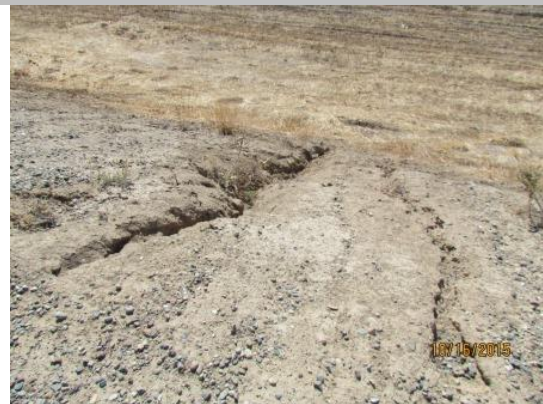
Photo 1 of 1 : FA_2015_NA0017_160_249_20151023_00167.jpg

View of the erosion caused by surface runoff on the landside of the levee.

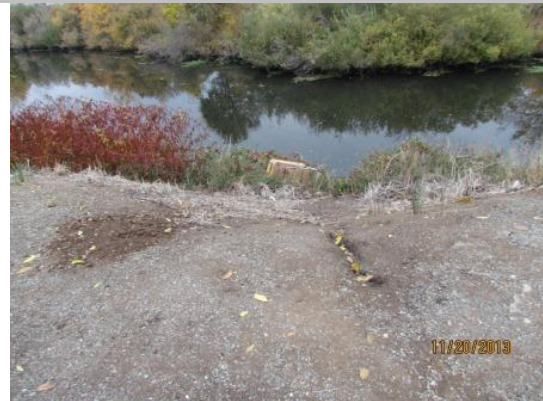
Photo 1 of 1 : FA_2015_NA0017_160_74_20150911_00040.jpg

Erosion due to runoff was found on the waterside of the levee looking upstream.

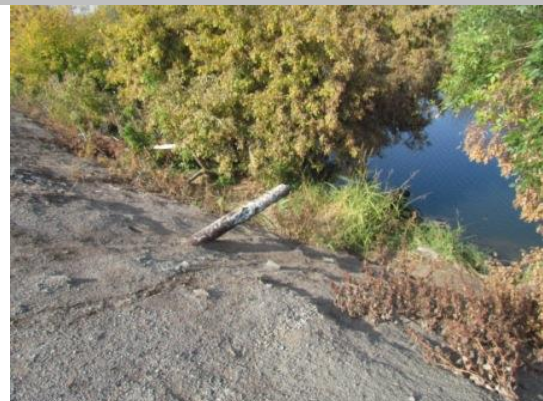
Photo 1 of 1 : FA_2015_NA0017_160_761_20150911_00161.jpg

An abandoned pipe was found on the waterside of the levee looking downstream.

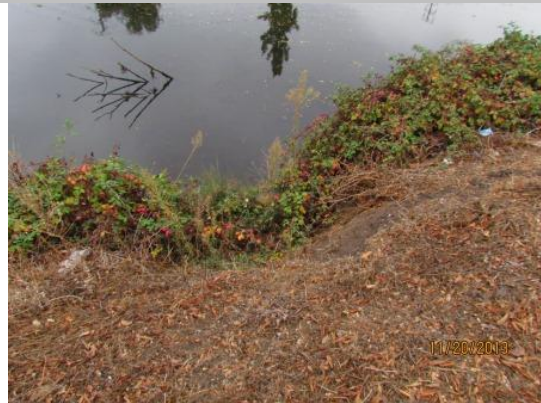
Photo 1 of 1 : FA_2015_NA0017_160_62_20150911_00032.jpg

Erosion was found on the waterside slope of the levee looking upstream.
