**Flood Control Project Maintenance  
Levee Inspections**

**Maintenance Issue Types Only, Levee Inspection Report By Mile - Fall 2016**

**San Joaquin County Flood Control and Water Conservation District**

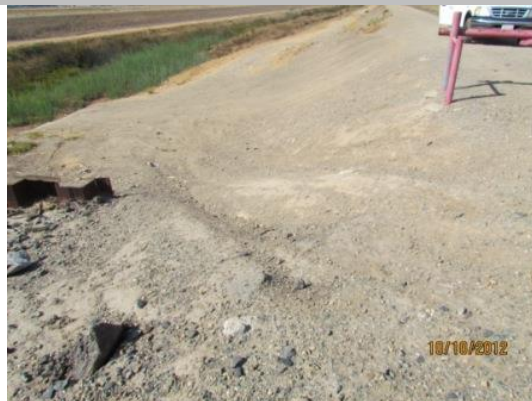
Photo 1 of 1 : FA\_2016\_NA0017\_151\_73\_20160823\_00029.jpg

Slope instability was found on the landside of the levee looking upstream.

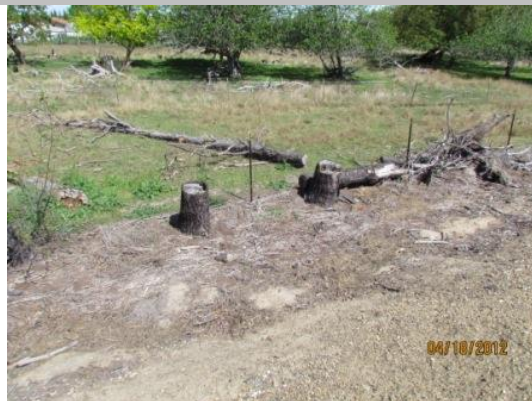
Photo 1 of 1 : FA\_2016\_NA0017\_151\_46\_20160823\_00017.jpg

View of tree stumps found on the landside of the levee looking upstream.

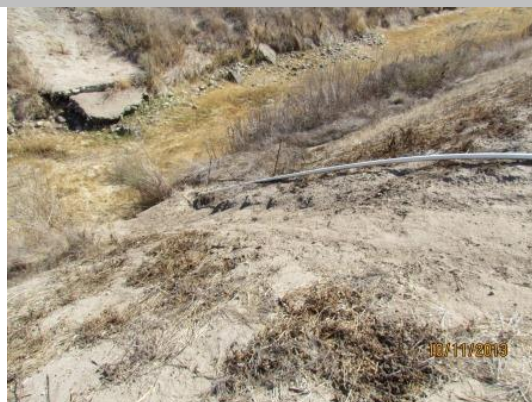
Photo 1 of 1 : FA\_2016\_NA0017\_151\_61\_20160823\_00026.jpg

Steps were found on the waterside slope of the levee looking downstream.

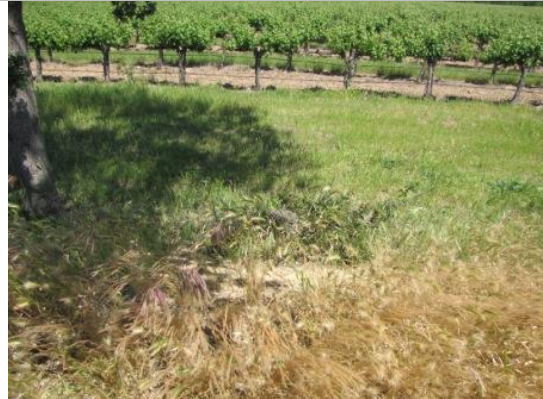
Photo 1 of 1 : FA\_2016\_NA0017\_151\_53\_20160823\_00023.jpg

View of a stump in the landward slope.

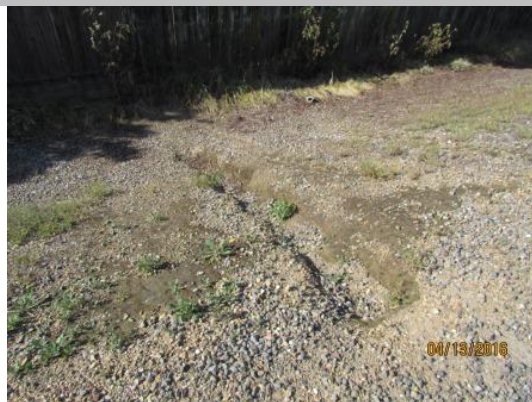
Photo 1 of 1 : FA\_2016\_NA0017\_152\_130\_20160823\_00036.jpg

View of the steps dug into the landside slope of the levee.

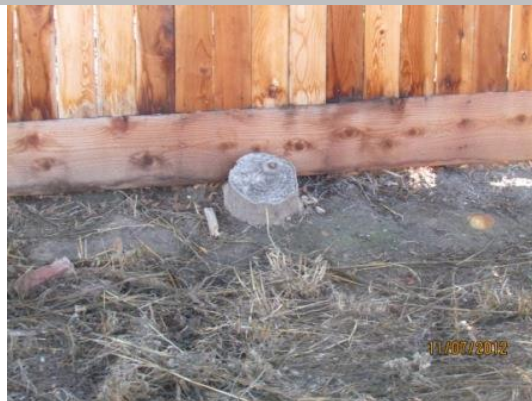
Photo 1 of 1 : FA\_2016\_NA0017\_152\_18\_20160823\_00005.jpg

View of a tree stump that was found on the landside toe of the levee.  
The picture was taken from the crown looking towards the toe.

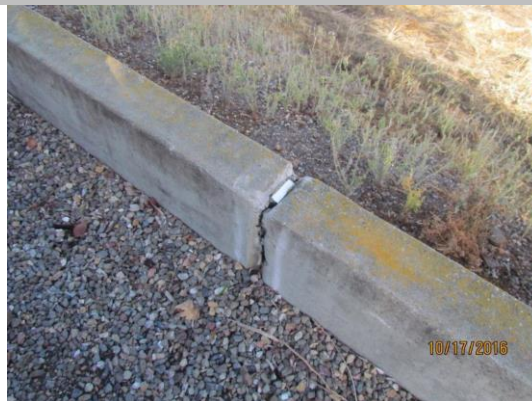
Photo 1 of 1 : FA\_2016\_NA0017\_152\_116\_20161021\_00198.jpg

View of deteriorated monolith joint on the waterside shoulder of the levee. Fall 2016.

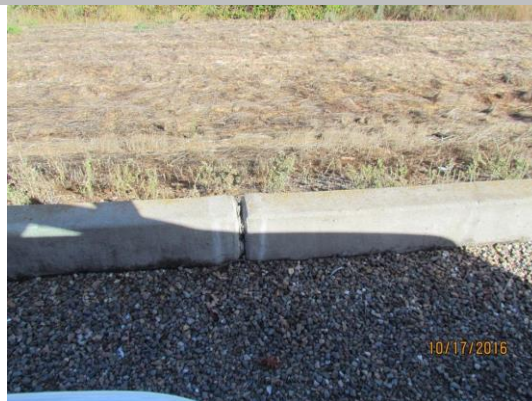
Photo 1 of 1 : FA\_2016\_NA0017\_152\_117\_20161021\_00199.jpg

View of deteriorated monolith joint on the waterside shoulder of the levee. Fall 2016.

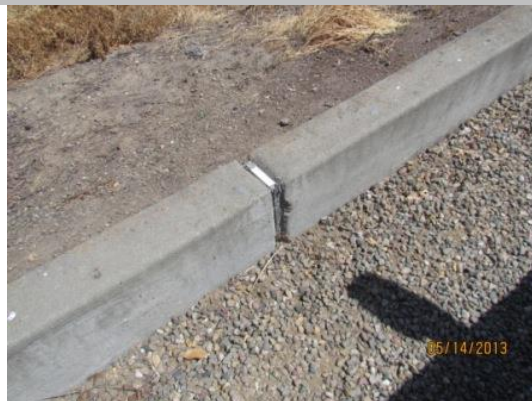
Photo 1 of 1 : FA\_2016\_NA0017\_152\_29\_20160823\_00010.jpg

The monolith joint material is deteriorating at this location of the flood wall. The picture was taken from the crown looking upstream.

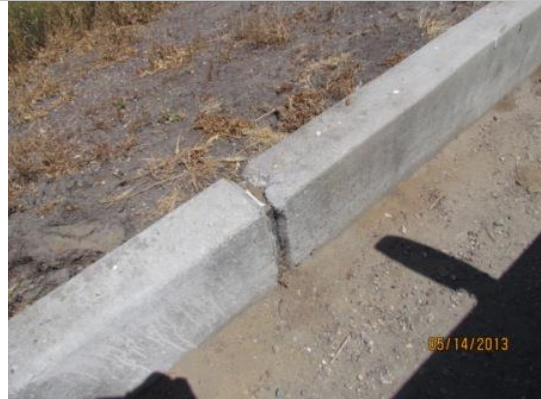
Photo 1 of 1 : FA\_2016\_NA0017\_152\_37\_20160823\_00011.jpg

The monolith joint material is deteriorating at this location of the flood wall. The picture was taken from the crown looking upstream.

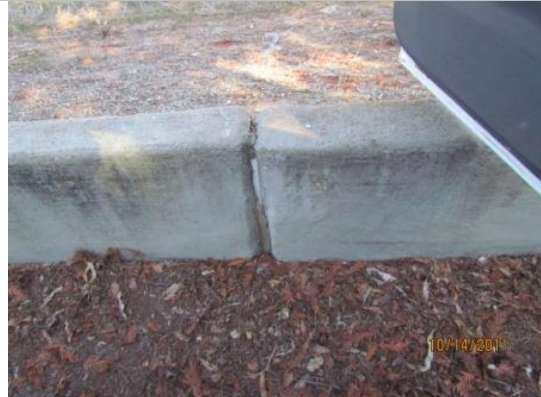
Photo 1 of 1 : FA\_2016\_NA0017\_152\_940\_20160823\_00041.jpg

Monolith joint material is deteriorating at the joint of the flood wall. The picture was taken from the crown looking upstream.

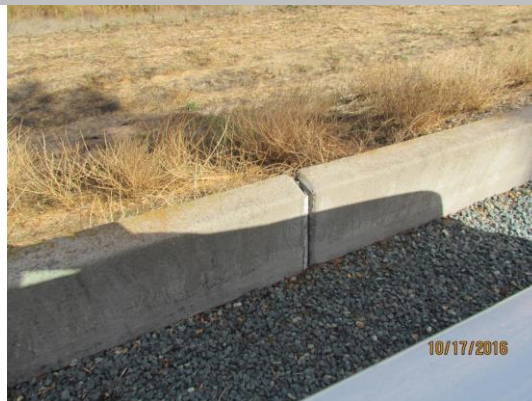
Photo 1 of 1 : FA\_2016\_NA0017\_152\_119\_20161021\_00203.jpg

View of deteriorated monolith joint on the waterside shoulder of the levee. Fall 2016.

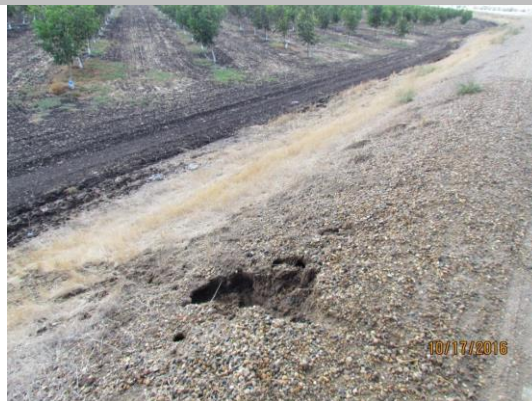
Photo 1 of 1 : FA\_2016\_NA0017\_152\_68\_20161021\_00206.jpg

View of the slope instability on landside of the levee looking downstream.

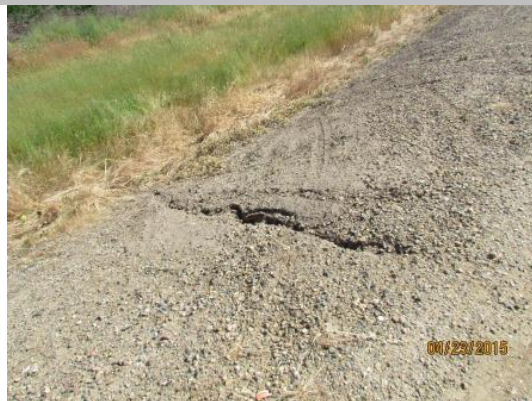
Photo 1 of 1 : FA\_2016\_NA0017\_152\_6\_20160823\_00002.jpg

View of a slope instability due to runoff on the waterside of the levee looking upstream.

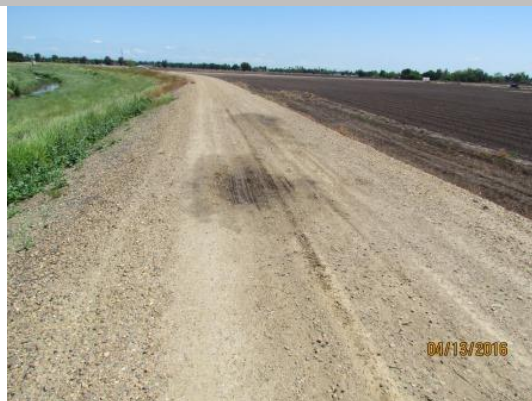
Photo 2 of 2 : FA\_2016\_NA0017\_152\_145\_20160823\_00040.jpg

View of crown depression on the levee.

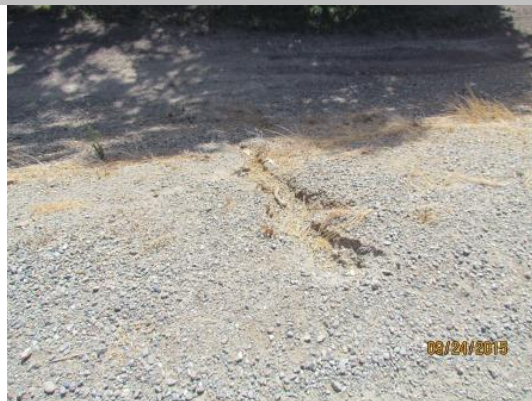
Photo 1 of 1 : FA\_2016\_NA0017\_152\_73\_20160823\_00021.jpg

Erosion due surface runoff was found on the landside of the levee looking downstream.

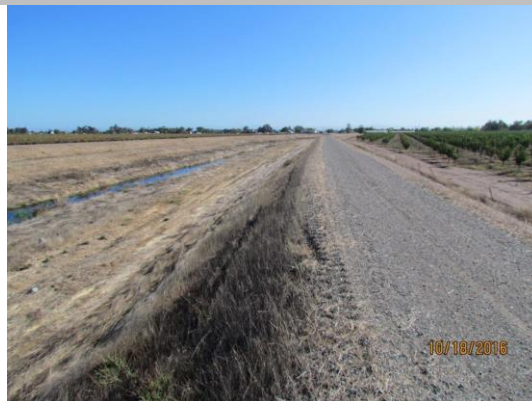
Photo 1 of 1 : FA\_2016\_NA0017\_153\_5\_20161024\_00013.jpg

View of the waterside slope of the levee. Fall 2016.

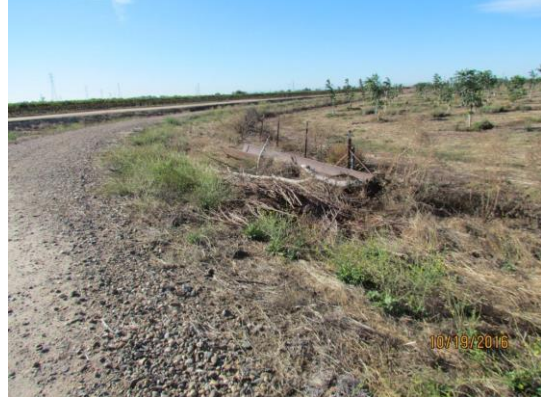
Photo 1 of 1 : FA\_2016\_NA0017\_155\_20\_20161024\_00050.jpg

View of debris on the landside of the levee. Fall 2016

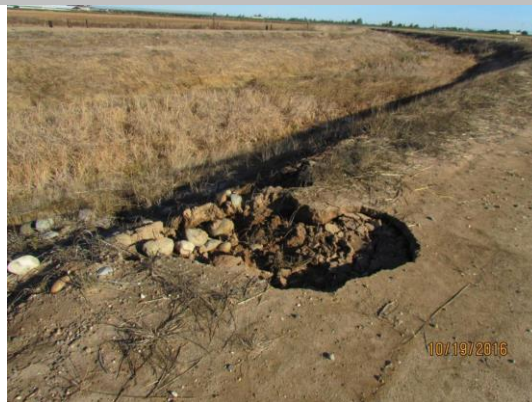
Photo 1 of 1 : FA\_2016\_NA0017\_156\_20\_20161024\_00056.jpg

View of an erosion on the waterside shoulder of the levee. Fall 2016

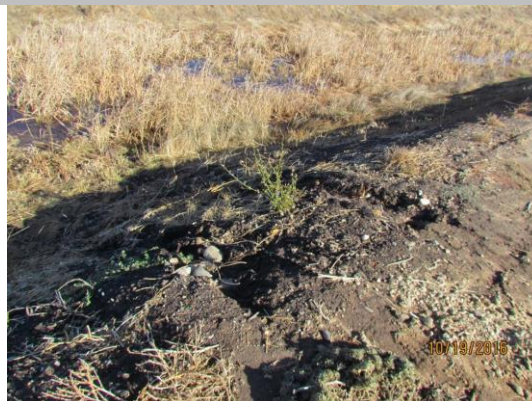
Photo 1 of 2 : FA\_2016\_NA0017\_156\_31\_20161024\_00058.jpg

Updated picture of the erosion on the waterside shoulder of the levee.  
Fall 2016

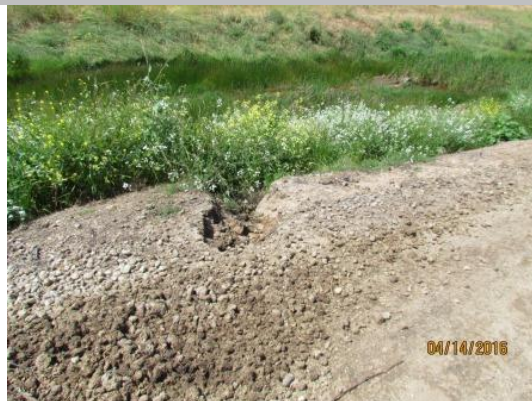
Photo 1 of 2 : FA\_2016\_NA0017\_156\_24\_20160823\_00011.jpg

Updated picture of the erosion on the waterside of the levee during spring 2016 inspection.

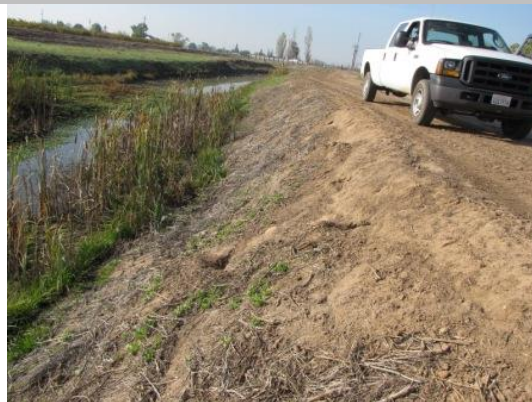
Photo 2 of 2 : FA\_2016\_NA0017\_158\_1\_20160823\_00001.jpg

View of rodent holes in the waterward berm looking downstream.

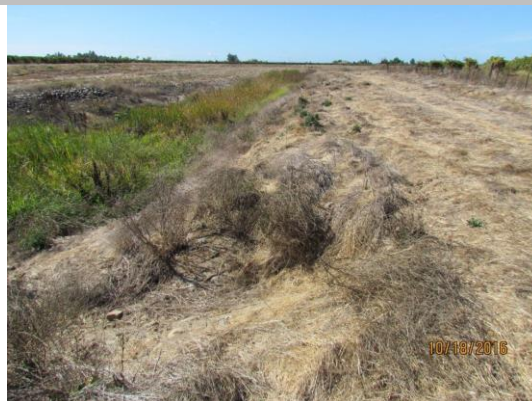
Photo 1 of 1 : FA\_2016\_NA0017\_158\_20\_20161024\_00040.jpg

View of the erosion on the waterside of the levee. Fall 2016.

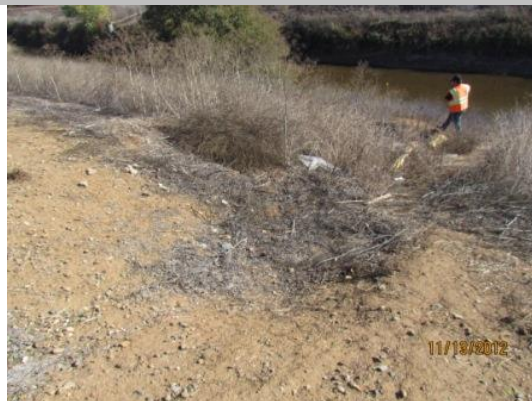
Photo 1 of 2 : FA\_2016\_NA0017\_159\_18\_20160823\_00026.jpg

Updated picture of the slope instability at the waterside slope of the levee looking upstream.

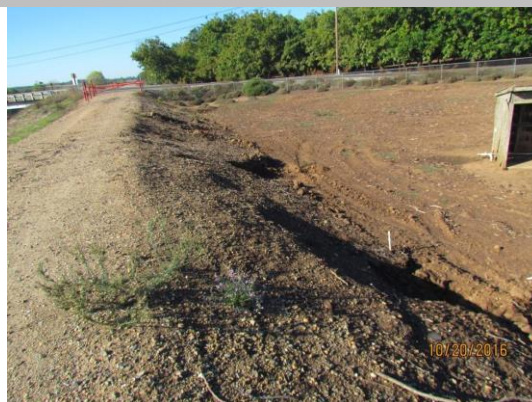
Photo 1 of 1 : FA\_2016\_NA0017\_159\_27\_20161024\_00311.jpg

View of slope instability on the landside toe of the levee looking downstream. Fall 2016

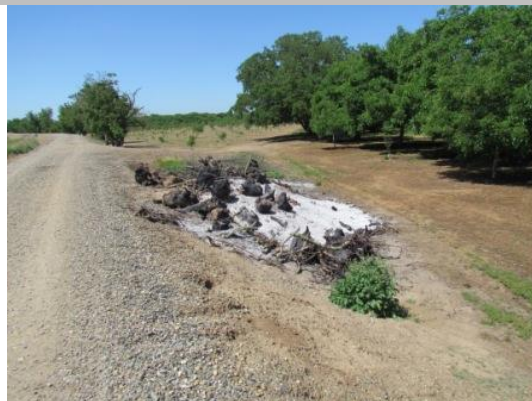
Photo 1 of 1 : FA\_2016\_NA0017\_159\_12\_20160823\_00019.jpg

New material was placed at the toe of the landside of the levee. The picture was taken from the crown looking downstream.

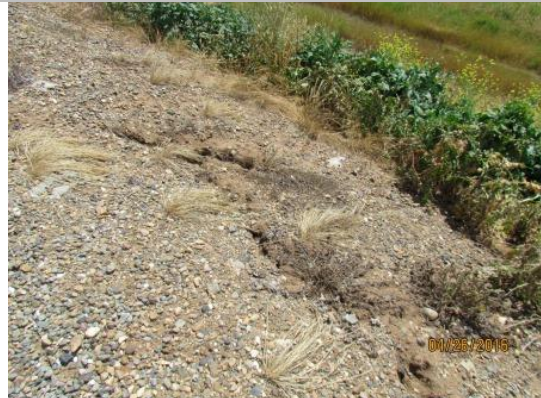
Photo 1 of 1 : FA\_2016\_NA0017\_159\_218\_20160823\_00145.jpg

View of rodent holes on the waterside of the levee looking upstream.

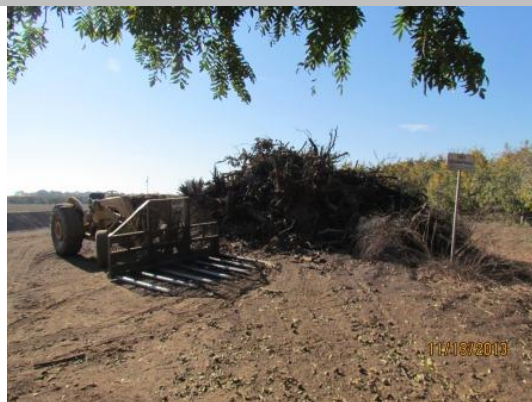
Photo 1 of 2 : FA\_2016\_NA0017\_159\_19\_20160823\_00028.jpg

Updated picture of the prunings pile on the landside of the levee looking downstream during fall 2013 inspection.

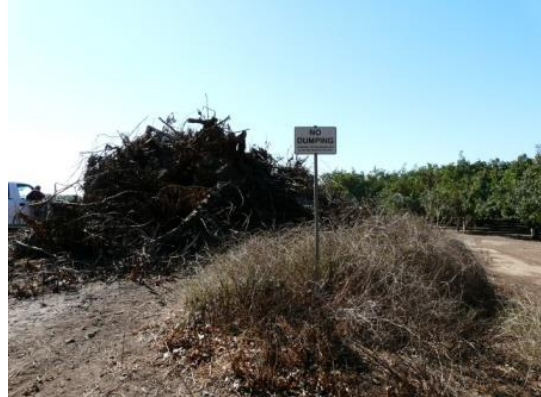
Photo 2 of 2 : FA\_2016\_NA0017\_159\_19\_20160823\_00029.jpg

Example of a prunings pile immediately adjacent to access road.  
Evidence of habitual burnings at this site.

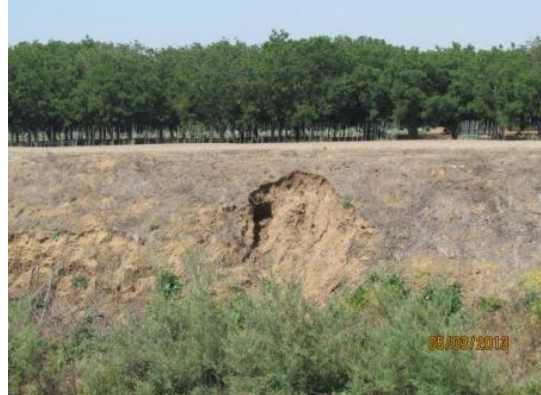
Photo 1 of 1 : FA\_2016\_NA0017\_159\_124\_20160823\_00106.jpg

An animal hole was found on the waterside slope of the levee. The picture was taken from the opposite side of the levee.

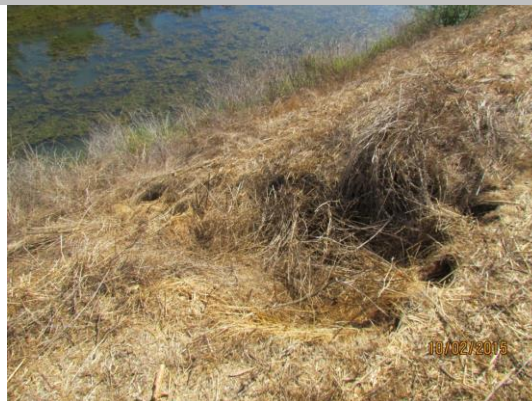
Photo 2 of 2 : FA\_2016\_NA0017\_159\_133\_20160823\_00110.jpg

Erosion was found on the waterside shoulder of the levee looking downstream.

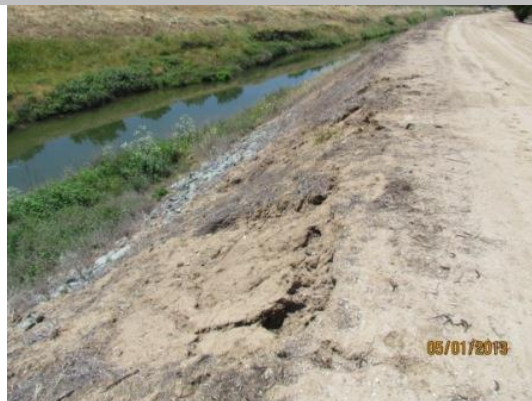
Photo 1 of 1 : FA\_2016\_NA0017\_159\_68\_20160823\_00079.jpg

Slope instability was found on the waterside slope of the levee looking downstream.

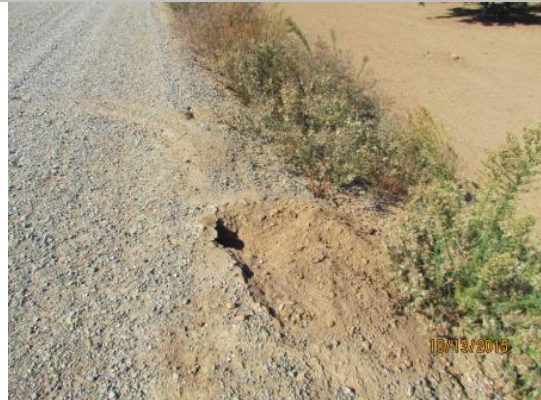
Photo 2 of 2 : FA\_2016\_NA0017\_159\_71\_20160823\_00080.jpg

Updated picture of the rodent holes on the landside of the levee looking downstream during fall 2015 inspection.

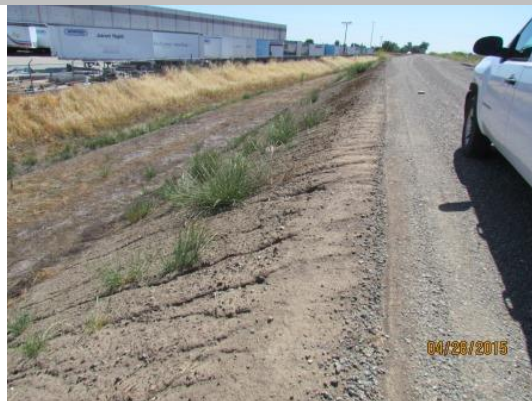
Photo 1 of 1 : FA\_2016\_NA0017\_159\_198\_20160823\_00136.jpg

View of slope instability due to runoff on the landside of the levee looking upstream.

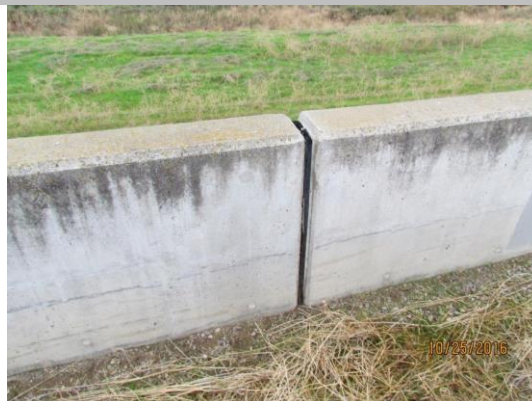
Photo 1 of 1 : FA\_2016\_NA0017\_159\_197\_20161028\_00324.jpg

View of deteriorated monolith joint on the waterside shoulder of the levee. Fall 2016

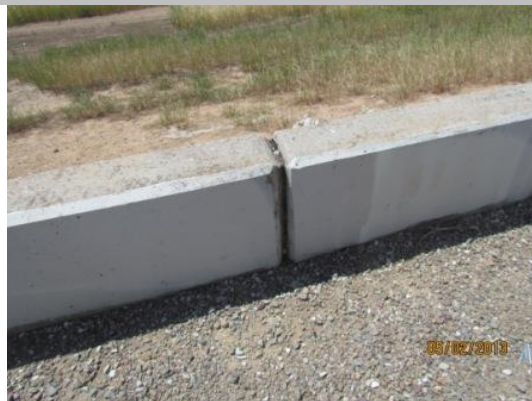
Photo 1 of 1 : FA\_2016\_NA0017\_159\_93\_20160823\_00088.jpg

The monolith joint material is deteriorating at the waterside shoulder of the levee looking downstream.

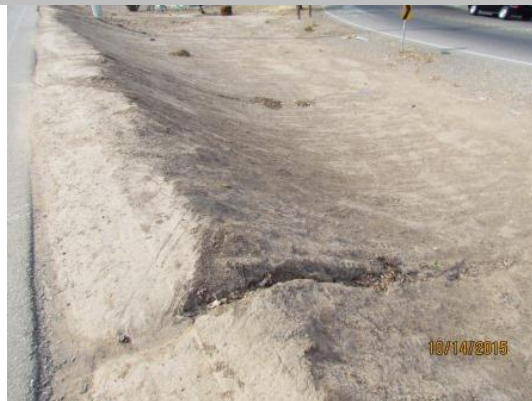
Photo 1 of 1 : FA\_2016\_NA0017\_159\_172\_20160823\_00127.jpg

Erosion was found on the landside of the levee looking downstream.

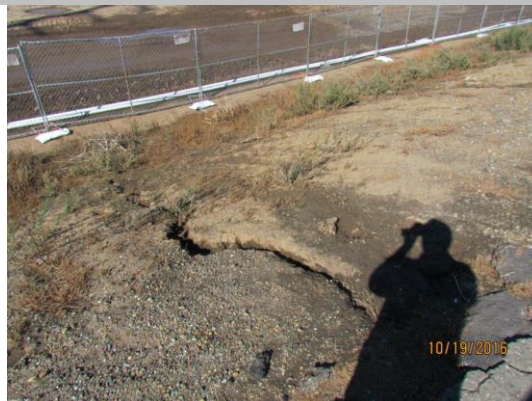
Photo 1 of 2 : FA\_2016\_NA0017\_159\_173\_20161024\_00308.jpg

Updated picture of erosion due to runoff on the landside slope of the levee during fall 2016 inspection.

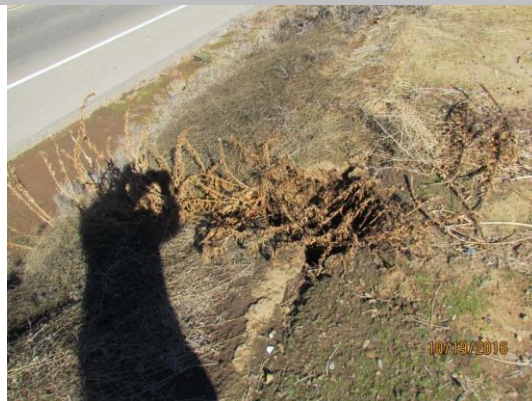
Photo 1 of 1 : FA\_2016\_NA0017\_159\_185\_20161024\_00307.jpg

View of an erosion due to runoff on the landside of the levee. Fall 2016

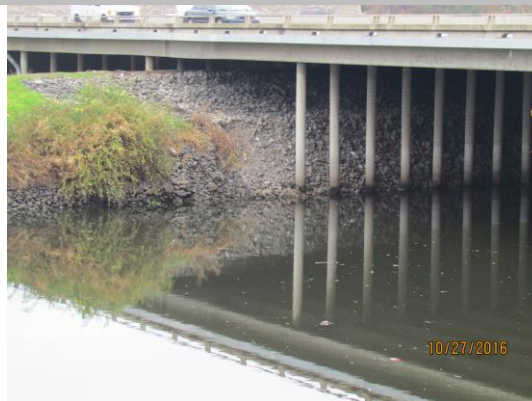
Photo 1 of 1 : FA\_2016\_NA0017\_159\_223\_20161028\_00332.jpg

View of deteriorating revetments on the waterside toe of the levee. The picture was taken from the opposite side of the levee. Fall 2016

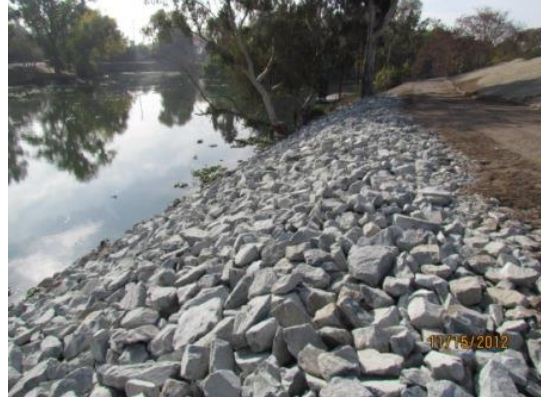
Photo 1 of 1 : FA\_2016\_NA0017\_159\_189\_20160823\_00134.jpg

Revetments were placed by the LMA on the waterside slope of the levee looking downstream.

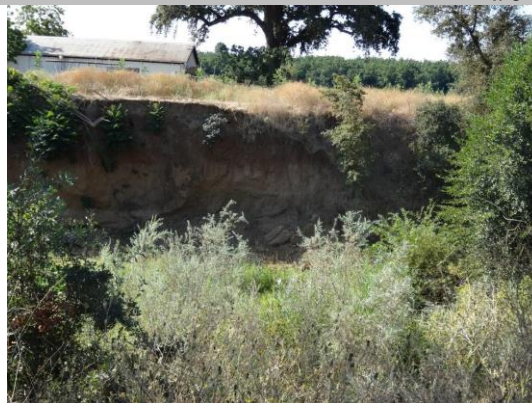
Photo 3 of 3 : SJR2016\_NA0017U16RM23.35\_4.jpg

Close view of the erosion.

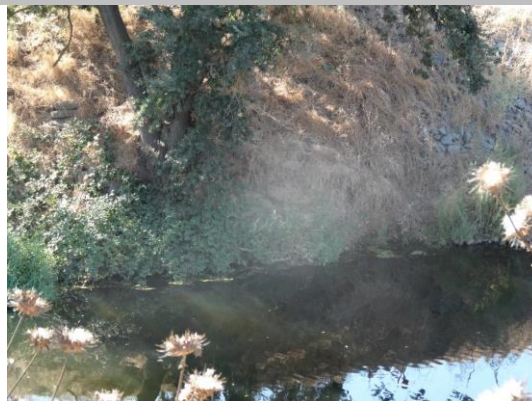
Photo 2 of 2 : SJR2016\_NA0017U16RM22.58\_3.jpg

Front view of the erosion and broken concrete protection on the levee slope.

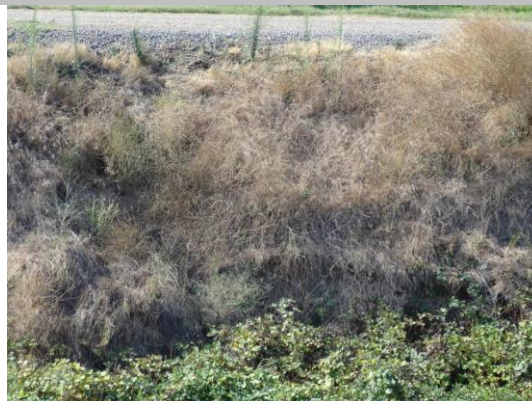
Photo 3 of 3 : SJR2016\_NA0017U16RM22.15\_4.jpg

Close view of the erosion. Note the dense vegetation at the site.

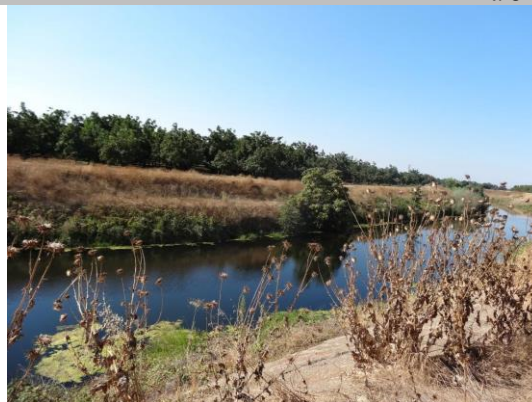
Photo 1 of 3 : SJR2016\_NA0017U16RM21.95\_1.jpg

Front view of the erosion site.

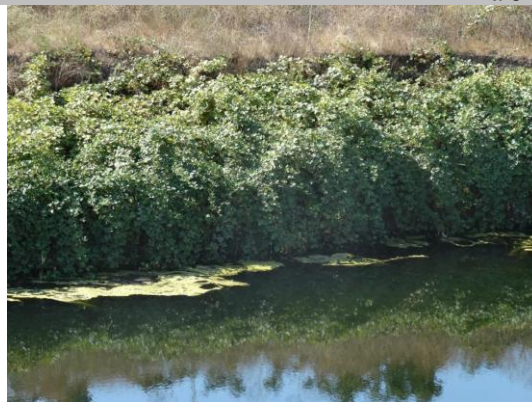
Photo 3 of 3 : SJR2016\_NA0017U16RM21.94\_3.jpg

Close view of the erosion.

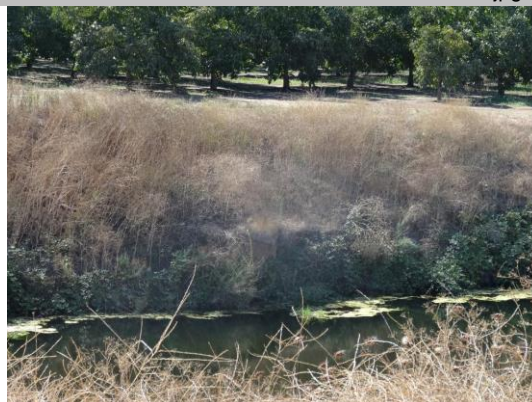
Photo 2 of 3 : SJR2016\_NA0017U16RM21.05\_3.jpg

Front view of the erosion.

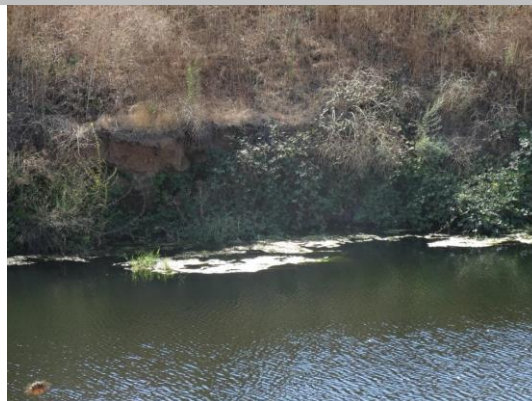
Photo 3 of 3 : SJR2016\_NA0017U16RM21.05\_4.jpg

Close view of the erosion.

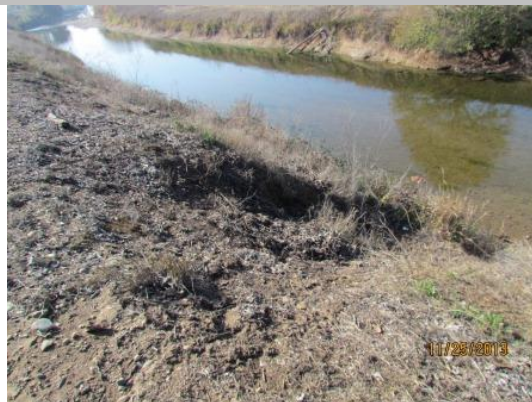
Photo 1 of 1 : FA\_2016\_NA0017\_160\_155\_20160823\_00116.jpg

Erosion was found on the waterside of the levee looking downstream.

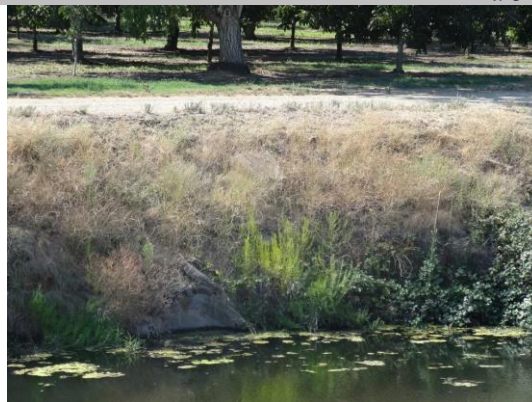
Photo 2 of 2 : SJR2016\_NA0017U16RM20.62\_3.jpg

Close view of the erosion.

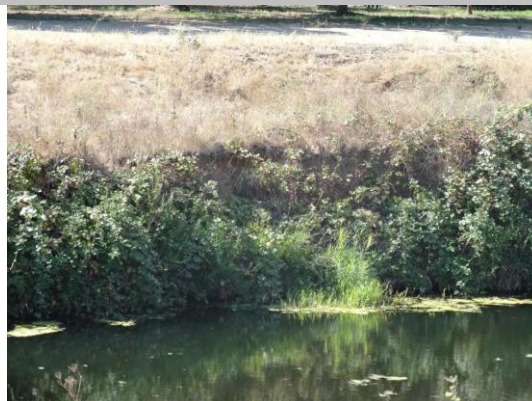
Photo 3 of 3 : SJR2016\_NA0017U16RM20.71\_4.jpg

Close view of the site.

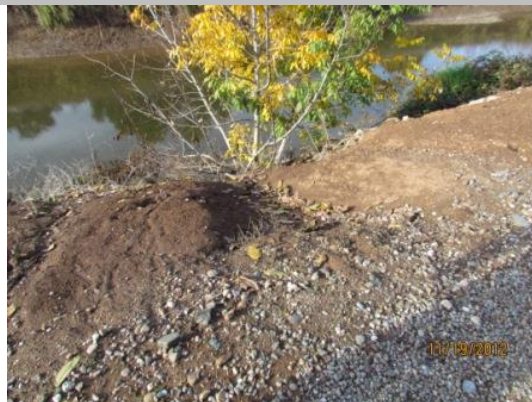
Photo 1 of 2 : FA\_2016\_NA0017\_160\_213\_20160823\_00133.jpg

Updated picture of the slope instability on the waterside shoulder of the levee looking upstream.

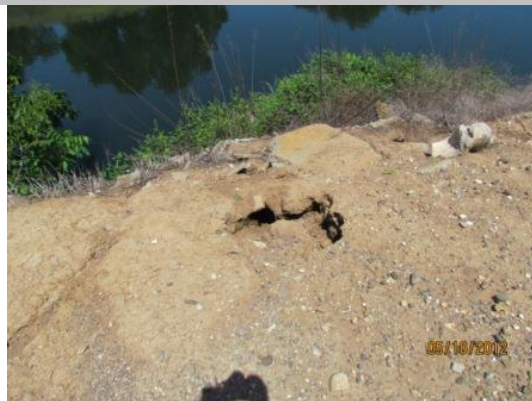
Photo 2 of 2 : FA\_2016\_NA0017\_160\_213\_20160823\_00134.jpg

Slope instability was found on the waterside of the levee looking upstream.

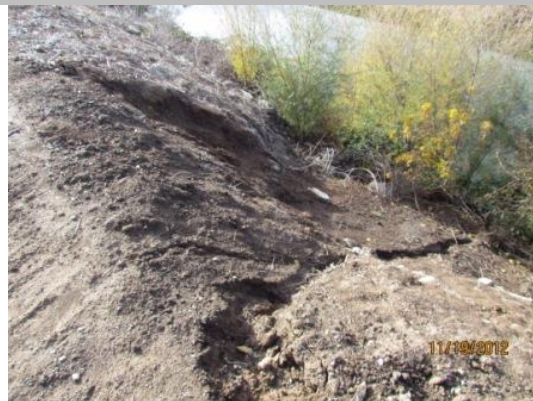
Photo 1 of 2 : FA\_2016\_NA0017\_160\_230\_20160823\_00138.jpg

Slope instability was found on the waterside slope of the levee looking downstream.

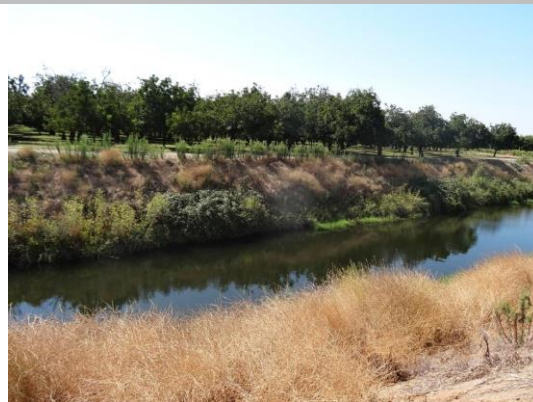
Photo 1 of 3 : SJR2016\_NA0017U16RM19.29\_1.jpg

View of the site from right river bank.

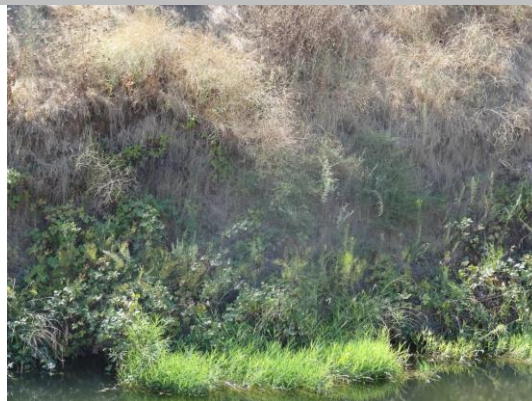
Photo 2 of 3 : SJR2016\_NA0017U16RM19.29\_2.jpg

Close view of the erosion.

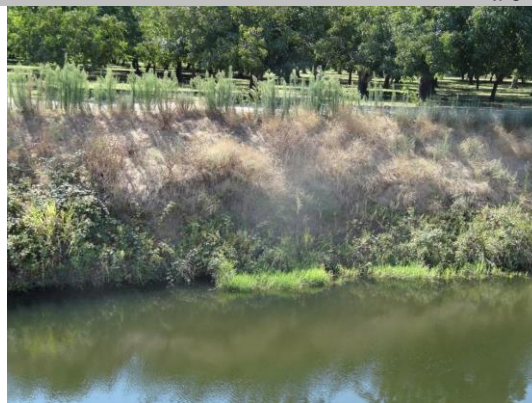
Photo 3 of 3 : SJR2016\_NA0017U16RM19.29\_4.jpg

Front view of the site.

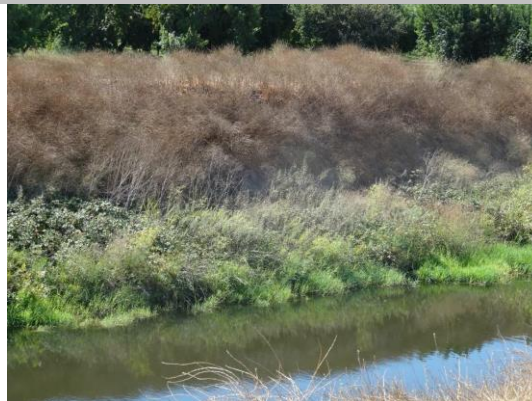
Photo 3 of 3 : SJR2016\_NA0017U16RM19.18\_4.jpg

Close view of the erosion.

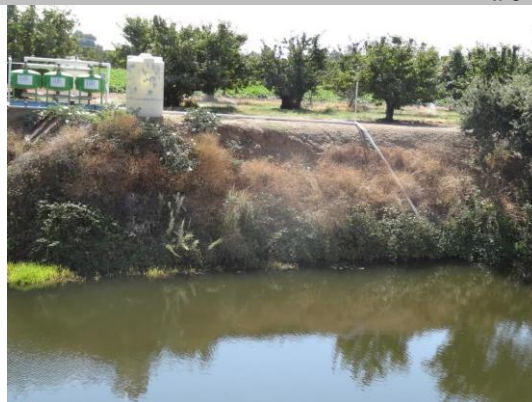
Photo 2 of 3 : SJR2016\_NA0017U16RM18.69\_3.jpg

Close view of the erosion.

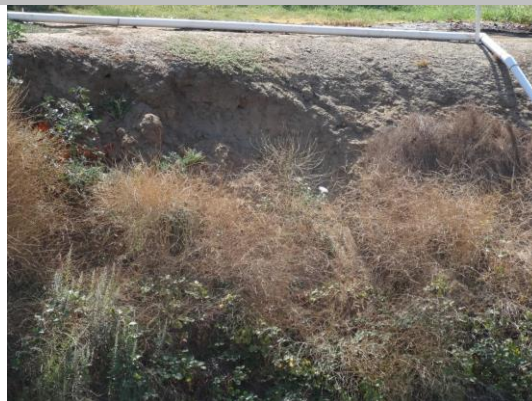
Photo 3 of 3 : SJR2016\_NA0017U16RM18.69\_4.jpg

Close view of the erosion.

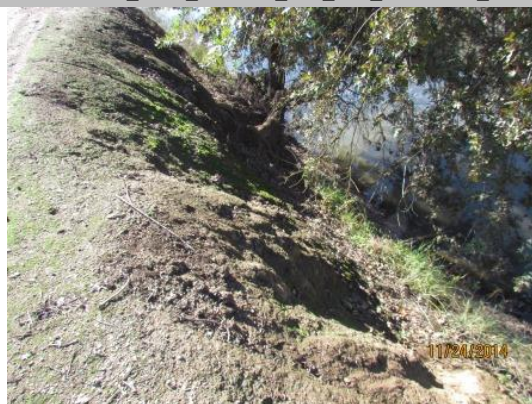
Photo 1 of 2 : FA\_2016\_NA0017\_160\_228\_20160823\_00136.jpg

Updated picture of the slope instability on the waterside of the levee looking downstream.

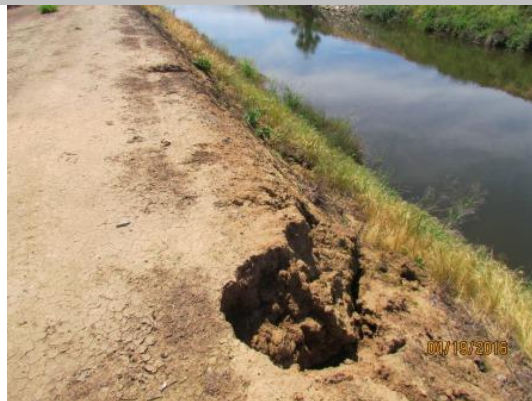
Photo 2 of 3 : FA\_2016\_NA0017\_160\_73\_20160823\_00066.jpg

Updated picture of the erosion on the waterside shoulder of the levee during spring 2016 inspection.

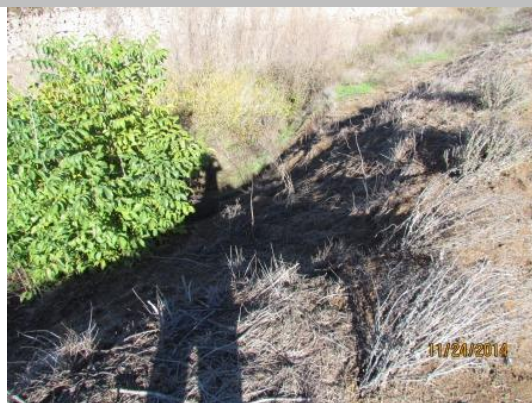
Photo 1 of 1 : FA\_2016\_NA0017\_160\_265\_20160823\_00151.jpg

A slope instability was found on the waterside slope of the levee looking upstream.

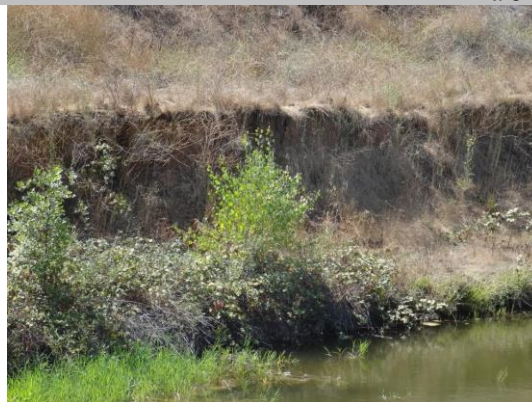
Photo 2 of 2 : SJR2016\_NA0017U16RM17.81\_4.jpg

Close view of the erosion.

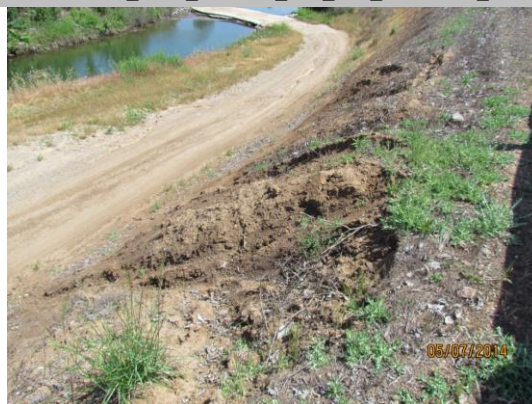
Photo 1 of 2 : FA\_2016\_NA0017\_160\_128\_20160823\_00103.jpg

Updated picture of the slope instability on the waterside of the levee looking upstream during spring 2014 inspection.

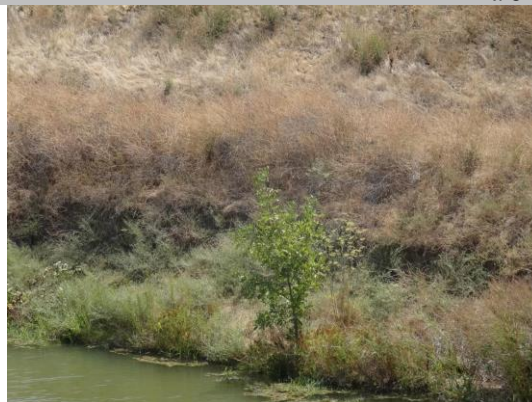
Photo 2 of 3 : SJR2016\_NA0017U16RM13.86\_2.jpg

Close view of the erosion.

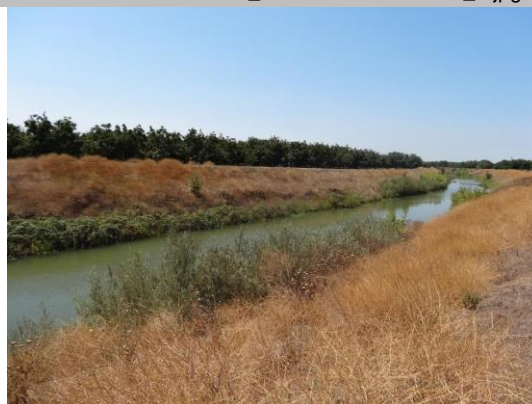
Photo 1 of 3 : SJR2016\_NA0017U16RM13.72\_1.jpg

Upstream view of the erosion.

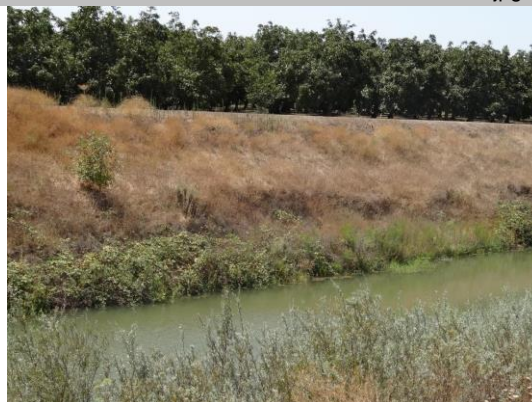
Photo 3 of 3 : SJR2016\_NA0017U16RM13.72\_4.jpg

Front view of the erosion.

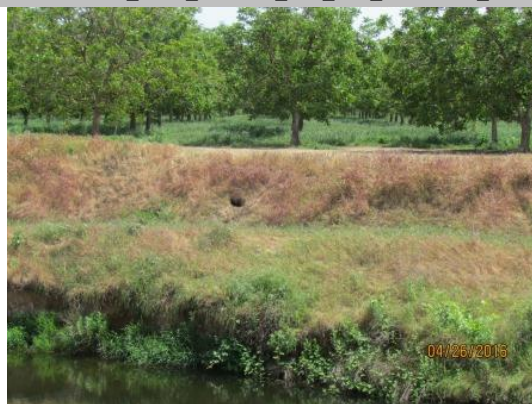
Photo 1 of 1 : FA\_2016\_NA0017\_160\_304\_20160823\_00165.jpg

View of a rodent hole possible made by a coyote on the waterside slope of the levee. The picture was taken from the opposite side of the levee.

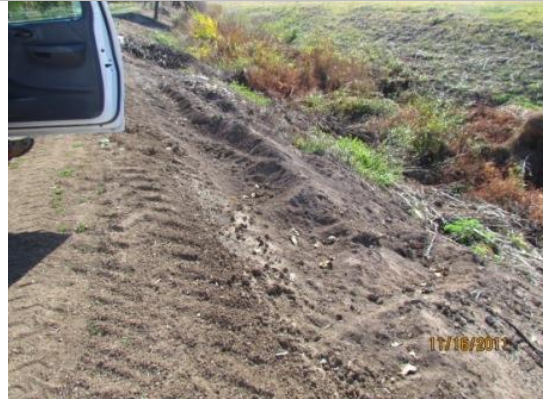
Photo 1 of 1 : FA\_2016\_NA0017\_161\_10\_20160823\_00007.jpg

Slope instability was found on the waterside of the levee looking upstream.
