**Flood Control Project Maintenance
Levee Inspections**

Maintenance Issue Types Only, Levee Inspection Report By Mile - Fall 2017

San Joaquin County Flood Control and Water Conservation District

Waterway	Bank	Unit Miles	Inspection Start/End	Inspector
Unit No. 01 Littlejohn Creek	Left	2.59	10/17/2017 10/17/2017	Pavel Kazi

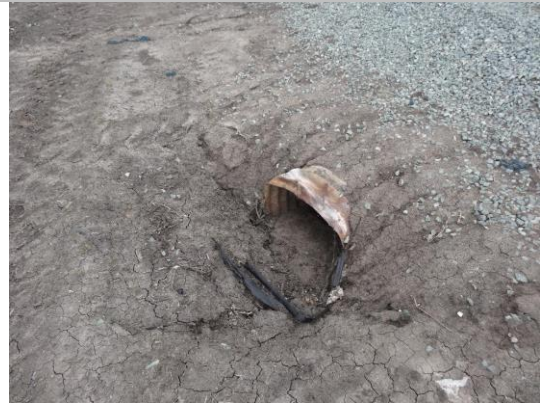
Photo 3 of 3 : UCIP_FA_2017_32747_59252.jpg

LM Start	1.18	Rating **	M	Issue No.	205 (cont)	
LM End	1.18	Issue Type +	Ma	Location *		
Category	Supplemental			GPS Latitude/Longitude		
				Start		End
Item	DWR UCIP LMA Responsibility			37.879076 °	37.879076 °	
				-121.248304 °	-121.248304 °	
DWR ID						
Comment Code						
Inspector Comment						
FS_ID:32747						
DS_ID:17970						
EP_NO: N/A						
Repair Type: Non-Urgent						
Crossing Status: Found						
UCIP Comments: Needs cleaning and clearing the culvert.						
FIELD_STRUCT_DESC: 24-inch corrugated metal drainage pipe						
through the levee, 4.1 feet below the crown. Flap gate on the waterside						
(WS) end. [Additional Reference(s): DWR Levee Log, 1977. USACE						
San Joaquin O&M Manual 613C, Volume 15, May 1963, (Station						
76+60)].						
FS Date: 3/25/2014

LS view: deformed CM inlet pipe on levee slope. Debris and mud on inlet ditch.

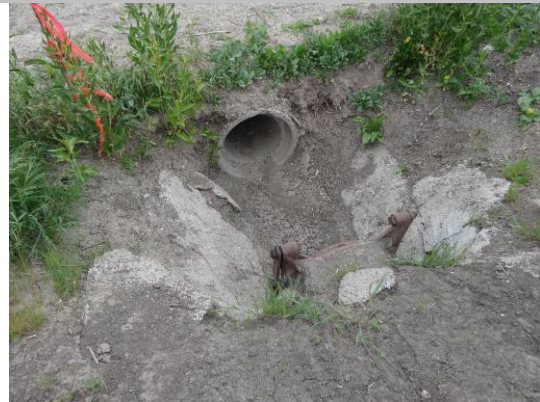
Photo 1 of 3 : UCIP_FA_2017_32652_59121.jpg

LM Start	2.53	Rating **	A/W	Issue No.	207
LM End	2.53	Issue Type +	Ma	Location *	
Category	Supplemental			GPS Latitude/Longitude	
				Start	End
Item	DWR UCIP LMA Responsibility			37.888080 °	37.888080 °
				-121.266631 °	-121.266631 °
DWR ID					
Comment Code					
Inspector Comment					
FS_ID:32652 DS_ID:17966 EP_NO: N/A Repair Type: No Action Needed Crossing Status: Found UCIP Comments: Grouted riprap outlet box and concrete outfall pipe on waterside.Pipe not visible on landside. FIELD_STRUCT_DESC: 24-inch corrugated metal drainage pipe through the levee, 5 feet below the crown. Flap gate on the waterside (WS) end. Grouted riprap outlet box and concrete outfall pipe on the WS. [Additional Reference(s): DWR Levee Log, 1977. USACE San Joaquin O&M Manual 613C, Volume 15, May 1963, (Station 4+00)]. FS Date: 3/25/2014

WS view: outlet box, CMP with flapgate (bottom), and concrete outfall pipe (Top).

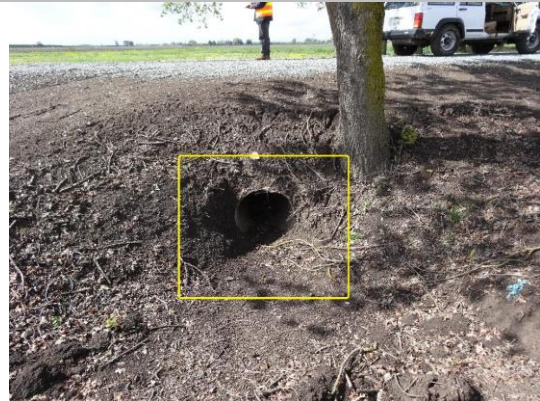
Photo 3 of 3 : UCIP_FA_2017_33125_59938.jpg

LM Start	1.06	Rating **	M	Issue No.	128 (cont)	
LM End	1.06	Issue Type +	Ma	Location *		
Category	Supplemental			GPS Latitude/Longitude		
				Start	End	
Item	DWR UCIP LMA Responsibility			37.877386 °	37.877386 °	
				-121.237044 °	-121.237044 °	
DWR ID						
Comment Code						
Inspector Comment						
FS_ID:33125						
DS_ID:17983						
EP_NO: N/A						
Repair Type: Non-Urgent						
Crossing Status: Found						
UCIP Comments: Needs cleaning and clearing the culvert.						
FIELD_STRUCT_DESC: 24-inch corrugated metal drainage pipe						
through the levee, 6.4 feet below the crown. Flap gate on the waterside						
(WS) end. [Additional Reference(s): DWR Levee Log, 1977. USACE						
San Joaquin O&M Manual 613C, Volume 15, May 1963, (Station						
114+50)].						
FS Date: 4/2/2014

LS view: CM inlet pipe on levee slope.

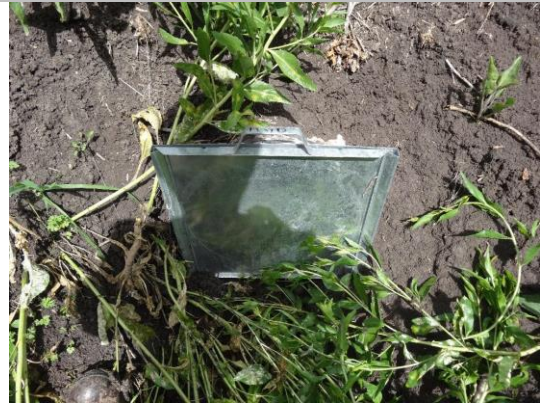
Photo 2 of 2 : UCIP_FA_2017_33163_59951.jpg

WS view: closer view of galvanized iron plate slide gate on HDPE pipe end.

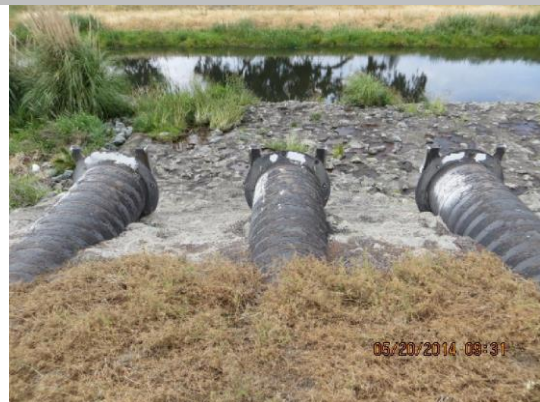
Photo 1 of 2 : UCIP_FA_2017_38088_69295.jpg

LM Start	1.33	Rating **	A/W	Issue No.	1058
LM End	1.33	Issue Type +	Ma	Location *	
Category	Supplemental			GPS Latitude/Longitude	
				Start	End
Item	DWR UCIP LMA Responsibility			38.043293 °	38.043293 °
				-121.349270 °	-121.349270 °
DWR ID					
Comment Code					
Inspector Comment					
FS_ID:38088 DS_ID:23693 EP_NO: N/A Repair Type: No Action Needed Crossing Status: Found UCIP Comments: FIELD_STRUCT_DESC: [Thornton Road Pump Station] 5 of 6: 36-inch wrapped steel storm drainage pipe through the levee, approximately 3 feet below the crown. Pump station on the landside (LS). Flap gate on the waterside (WS) end. [Additional Reference(s): USACE San Joaquin O&M Manual 612 (addendum), February 1999, (HLM 2.16) (Station 114+25)]. FS Date: 5/20/2014

Pipe and flapgate on WS slope.

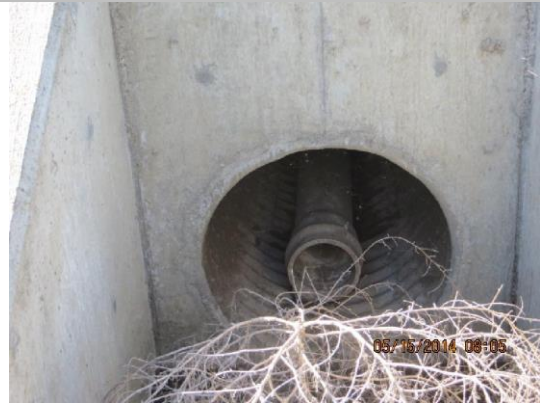
Photo 3 of 3 : UCIP_FA_2017_37838_68826.jpg

Pipe and headwall on LS toe. Irrigation pipe laying inside pipe.

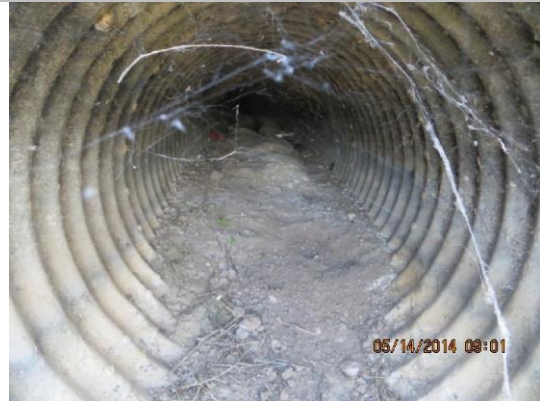
Photo 3 of 3 : UCIP_FA_2017_37745_68565.jpg

Inside of pipe on LS toe. Silt buildup.

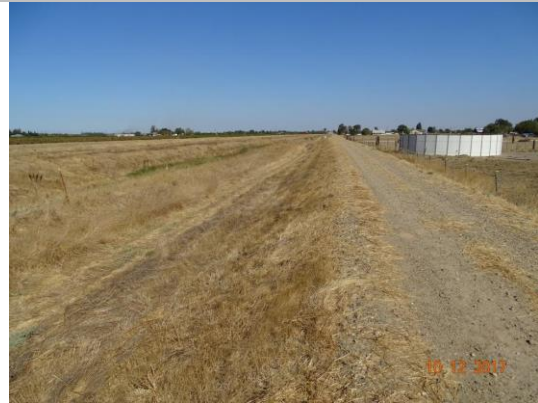
Photo 1 of 1 : FA_2017_NA0017_156_41_20171016_00142.jpg

View of the waterside slope of the levee. Fall 2017

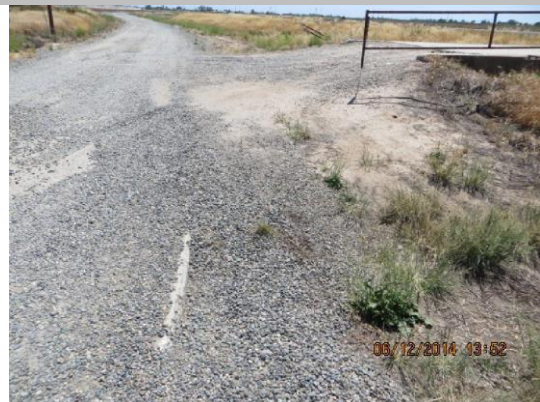
Photo 1 of 2 : UCIP_FA_2017_38627_70797.jpg

Headwall buried on WS shoulder.

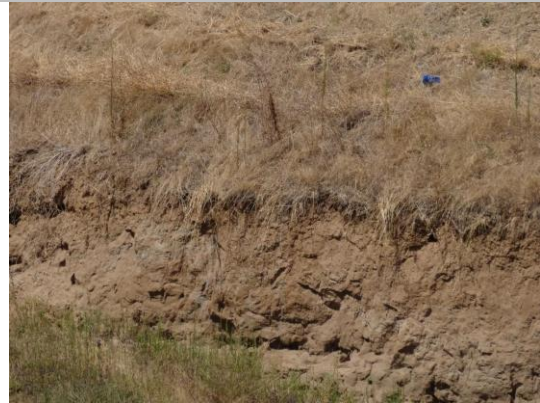
Photo 4 of 4 : SJR2017_NA0017U15RM13.87_4.jpg

Close view of the erosion.

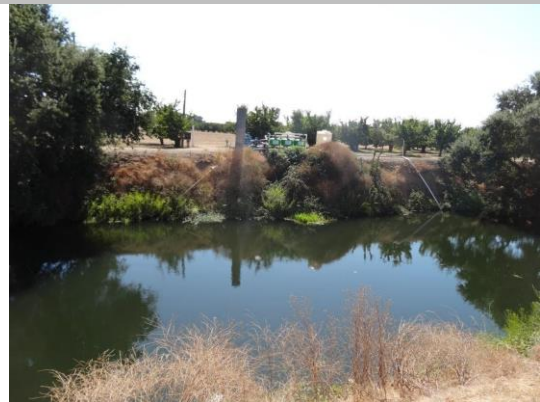
Photo 1 of 4 : SJR2017_NA0017U16RM18.69_1.jpg

View of the erosion site.

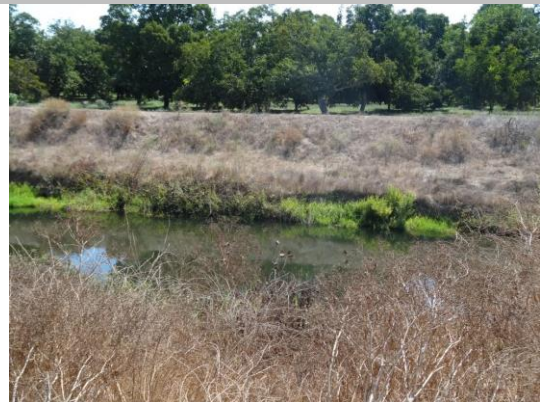
Photo 1 of 4 : SJR2017_NA0017U16RM17.27_1.jpg

View of the erosion from right river bank.

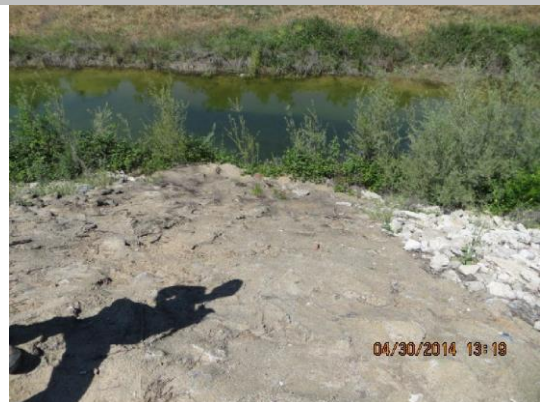
Photo 1 of 3 : UCIP_FA_2017_36145_65409.jpg

Grout over pipe on WS slope.
