**Flood Control Project Maintenance  
Levee Inspections**

**Maintenance Issue Types Only, Levee Inspection Report By Mile - Fall 2018**

**San Joaquin County Flood Control and Water Conservation District**

Waterway	Bank	Unit Miles	Inspection Start/End	Inspector
Unit No. 01 Littlejohn Creek	Left	2.59	10/18/2018 10/18/2018	Wade Wylie

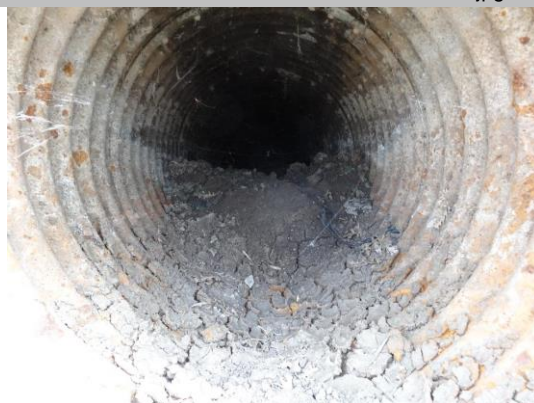
Photo 3 of 3 : UCIP\_FA\_2018\_53494\_59246.jpg

Item	DWR UCIP LMA Responsibility		37.878634 °	37.878634 °								
			-121.241467 °	-121.241467 °								
DWR ID	17973											
Comment Code												
Inspector Comment												
FS_ID:53494 DS_ID:17973 EP_NO: N/A Repair Type: Urgent Crossing Status: Found UCIP Comments: 11/02/2018 Inlet deformed. Outlet missing a slide gate. The LMA states that a new slide gate will be installed in about two weeks. Inlet and outlet have dirt and vegetation issues. Crossing remains "Urgent" until a new slide gate is installed. Contact the LMA to see if they have photographic evidence that a new slide gate was put in. (A. McDonald - DWR UCIP)10/18/2018 Inlet deformed. Outlet missing a slide gate. This means that the pipe cannot be closed during high water. I have escalated this crossing from "No Action Needed" to "Urgent" due to the straight through pipe which could cause flooding during high water. There is a hole in the inlet, due to the deformity. It was most likely ran over by heavy equipment. I do not see enough evidence for an internal pipe inspection. (A. McDonald - DWR UCIP)03/25/2014 May need cleaning of mud in inlet pipe. (W. Wylie - DWR UCIP) FIELD_STRUCT_DESC: 24-inch corrugated metal drainage culvert through the levee, 4.2 feet below the crown. Slide gate on the waterside (WS) end, not found on 10/18/2018. [Additional Reference(s): DWR Levee Log, 1977. USACE San Joaquin O&M Manual 613C, Volume 15, May 1963, (Station 98+65)]. FS Date: 11/2/2018 2:54:00 PM

LS view: inside view of the CMP culvert. May need cleaning and clearing.

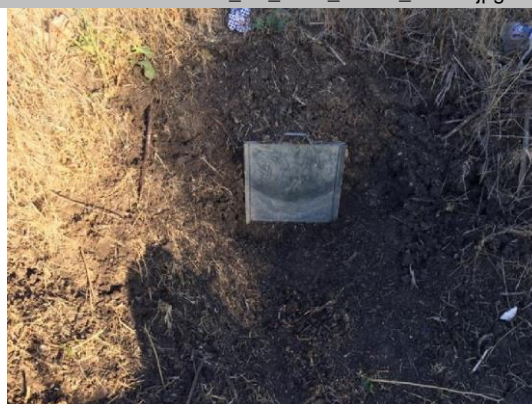
Photo 3 of 3 : UCIP\_FA\_2018\_53452\_78388.jpg

Outlet cleared of dirt and vegetation by the LMA.

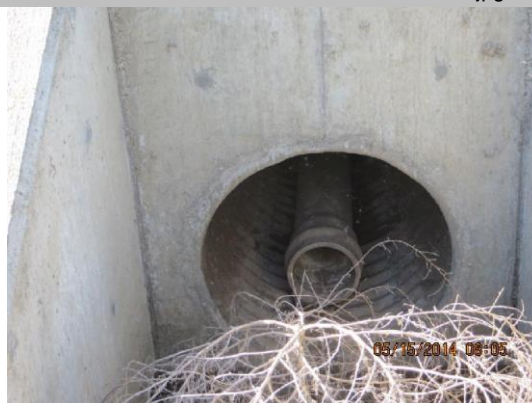
Photo 3 of 3 : UCIP\_FA\_2018\_37838\_68826.jpg

Pipe and headwall on LS toe. Irrigation pipe laying inside pipe.

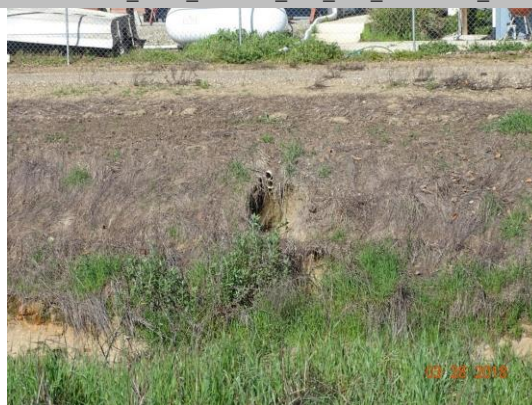
Photo 1 of 1 : FA\_2018\_NA0017\_151\_179\_20180926\_00045.jpg

NA17 SJCFC&amp;WCD Unit 7 Issue 179 LM14.01 erosion waterside photo from opposite side of channel looking west.

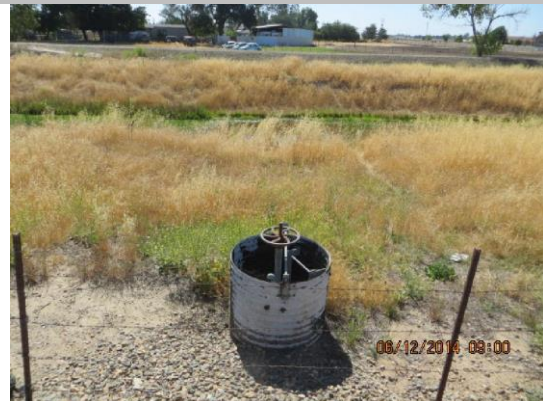
Photo 2 of 3 : UCIP\_FA\_2018\_38564\_70646.jpg

Slide gate in 36-inch CMP riser on WS slope. slide gate does not function as handle is detached from mechanism.

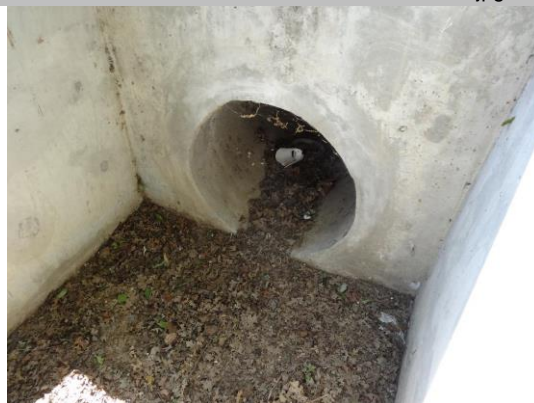
Photo 2 of 2 : UCIP\_FA\_2018\_48304\_63038.jpg

LS view: inlet pipe and headwall on levee toe. May need cleaning of inlet opening.

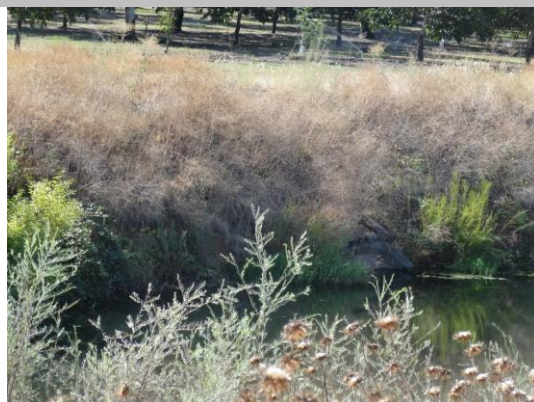
Photo 3 of 4 : FA\_2018\_NA0017\_160\_66\_20181003\_00094.jpg

Close view of the erosion.

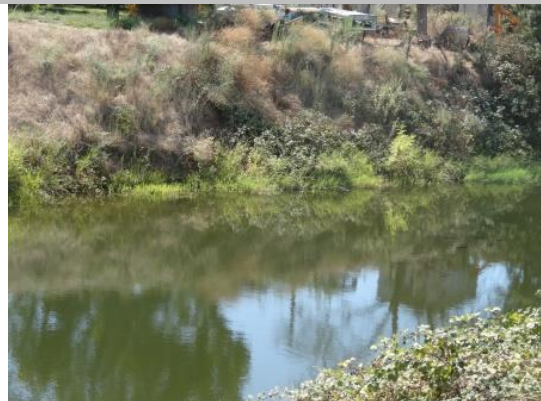
Photo 4 of 4 : FA\_2018\_NA0017\_160\_40\_20181003\_00048.jpg

Close view of the erosion.

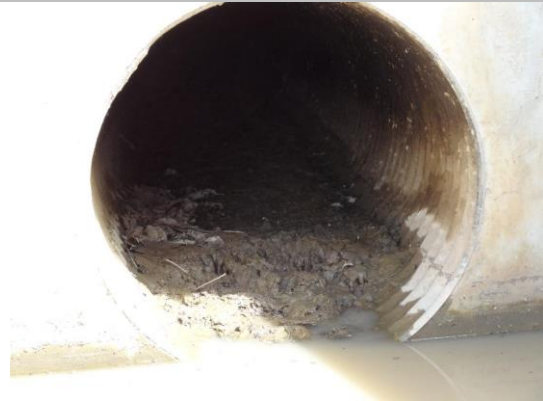
Photo 3 of 3 : UCIP\_FA\_2018\_33114\_59899.jpg

LS view: closer view of CM pipe. May need to clean and clear mud from the pipe.
