**Flood Control Project Maintenance
Levee Inspections**

Maintenance Issue Types Only, Levee Inspection Report By Mile - Fall 2019

San Joaquin County Flood Control and Water Conservation District

Waterway	Bank	Unit Miles	Inspection Start/End	Inspector
Unit No. 01 Littlejohn Creek	Left	2.59	11/14/2019 11/14/2019	Alberto De Leon

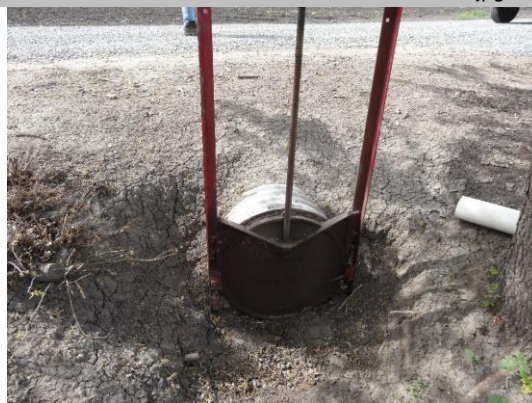
Photo 1 of 3 : UCIP_FA_2019_53494_59248.jpg

Comment Code						
Inspector Comment						
DS_ID:17973 FS_ID:53494 EP_NO: N/A Repair Type: Urgent Crossing Status: Found UCIP Comments: 11/02/2018 Inlet deformed. Outlet missing a slide gate. The LMA states that a new slide gate will be installed in about two weeks. Inlet and outlet have dirt and vegetation issues. Crossing remains "Urgent" until a new slide gate is installed. Contact the LMA to see if they have photographic evidence that a new slide gate was put in. (A. McDonald - DWR UCIP)10/18/2018 Inlet deformed. Outlet missing a slide gate. This means that the pipe cannot be closed during high water. I have escalated this crossing from "No Action Needed" to "Urgent" due to the straight through pipe which could cause flooding during high water. There is a hole in the inlet, due to the deformity. It was most likely ran over by heavy equipment. I do not see enough evidence for an internal pipe inspection. (A. McDonald - DWR UCIP)03/25/2014 May need cleaning of mud in inlet pipe. (W. Wylie - DWR UCIP) FIELD_STRUCT_DESC: 24-inch corrugated metal drainage culvert through the levee, 4.2 feet below the crown. Slide gate on the waterside (WS) end, not found on 10/18/2018. [Additional Reference(s): DWR Levee Log, 1977. USACE San Joaquin O&M Manual 613C, Volume 15, May 1963, (Station 98+65)]. FS Date: 11/2/2018 2:54:00 PM

WS view: CMP outlet with slide gate on the WS slope.

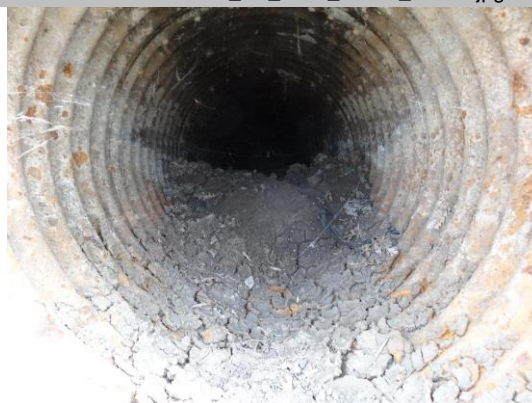
Photo 3 of 3 : UCIP_FA_2019_53494_59246.jpg

Comment Code						
Inspector Comment						
DS_ID:17973 FS_ID:53494 EP_NO: N/A Repair Type: Urgent Crossing Status: Found UCIP Comments: 11/02/2018 Inlet deformed. Outlet missing a slide gate. The LMA states that a new slide gate will be installed in about two weeks. Inlet and outlet have dirt and vegetation issues. Crossing remains "Urgent" until a new slide gate is installed. Contact the LMA to see if they have photographic evidence that a new slide gate was put in. (A. McDonald - DWR UCIP)10/18/2018 Inlet deformed. Outlet missing a slide gate. This means that the pipe cannot be closed during high water. I have escalated this crossing from "No Action Needed" to "Urgent" due to the straight through pipe which could cause flooding during high water. There is a hole in the inlet, due to the deformity. It was most likely ran over by heavy equipment. I do not see enough evidence for an internal pipe inspection. (A. McDonald - DWR UCIP)03/25/2014 May need cleaning of mud in inlet pipe. (W. Wylie - DWR UCIP) FIELD_STRUCT_DESC: 24-inch corrugated metal drainage culvert through the levee, 4.2 feet below the crown. Slide gate on the waterside (WS) end, not found on 10/18/2018. [Additional Reference(s): DWR Levee Log, 1977. USACE San Joaquin O&M Manual 613C, Volume 15, May 1963, (Station 98+65)]. FS Date: 11/2/2018 2:54:00 PM

LS view: inside view of the CMP culvert. May need cleaning and clearing.

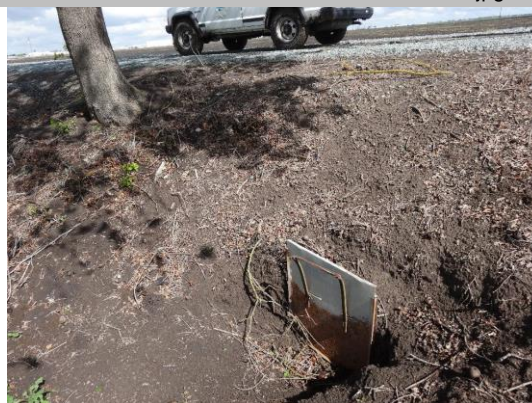
Photo 1 of 3 : UCIP_FA_2019_53453_59937.jpg

Comment Code						
Inspector Comment						
DS_ID:17983 FS_ID:53453 EP_NO: N/A Repair Type: No Action Needed Crossing Status: Found UCIP Comments: 11/02/2018 Inlet and outlet cleared of dirt and vegetation by the LMA. Crossing has been downgraded to "No Action Needed." (A. McDonald - DWR UCIP)04/02/2014 Needs cleaning and clearing the culvert. (P. Amatya - DWR UCIP) FIELD_STRUCT_DESC: 24-inch corrugated metal drainage pipe through the levee, 6.4 feet below the crown. Flap gate on the waterside (WS) end. [Additional Reference(s): DWR Levee Log, 1977. USACE San Joaquin O&M Manual 613C, Volume 15, May 1963, (Station 114+50)]. FS Date: 11/2/2018 11:37:00 AM

WS view: CM drain pipe with plate gate on levee slope.

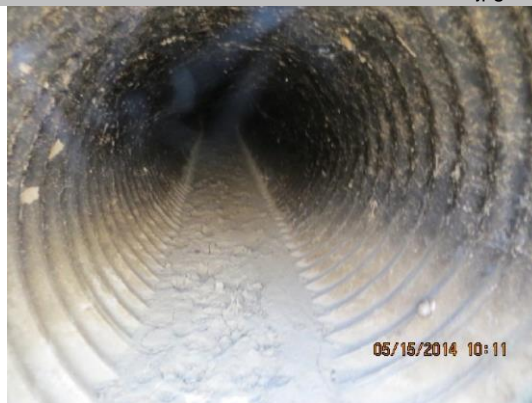
Photo 3 of 3 : UCIP_FA_2019_37874_68897.jpg

Inside pipe at LS toe. Note sediment buildup.

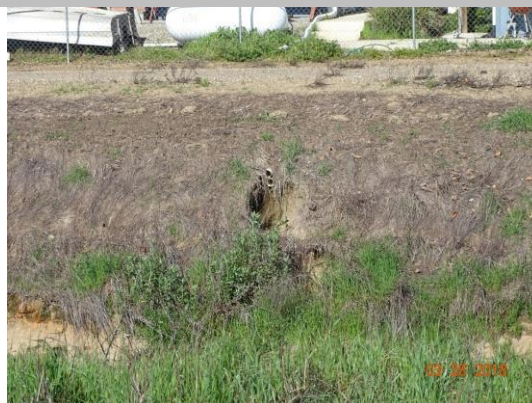
Photo 1 of 1 : FA_2019_NA0017_151_179_20190830_00044.jpg

NA17 SJCF&WCD Unit 7 Issue 179 LM14.01 erosion waterside photo from opposite side of channel looking west.

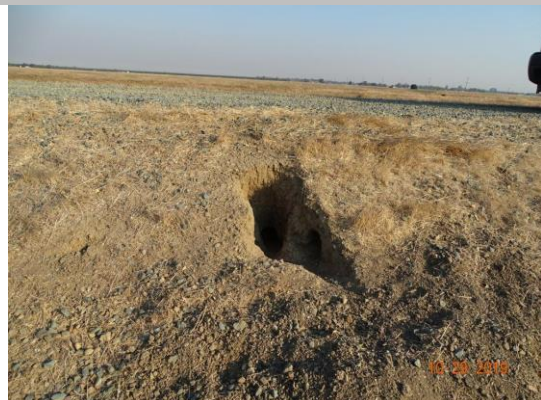
Photo 2 of 2 : FA_2019_NA0017_152_140_20191117_00317.jpg

view of large rodent hole on landside slope. Fall 2019

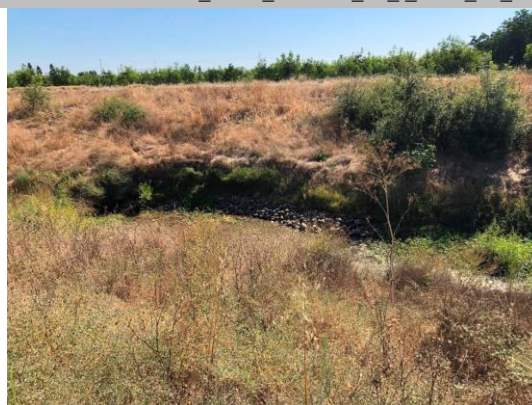
Photo 1 of 3 : SJR2019_DWR_NA0017_08_f_2015_57_1.JPG

Looking at the erosion from the right bank..

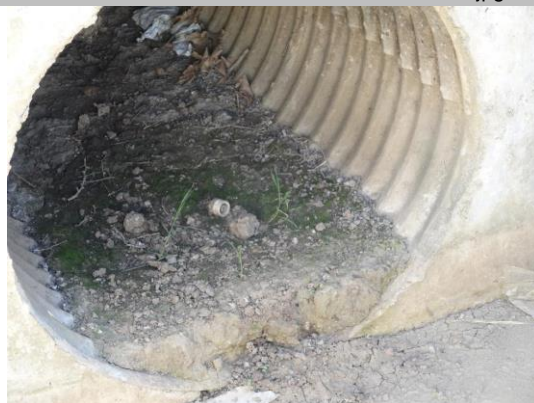
Photo 3 of 3 : UCIP_FA_2019_35047_63101.jpg

LS view: inside view of the CM pipe. Needs cleaning and clearing the pipe.

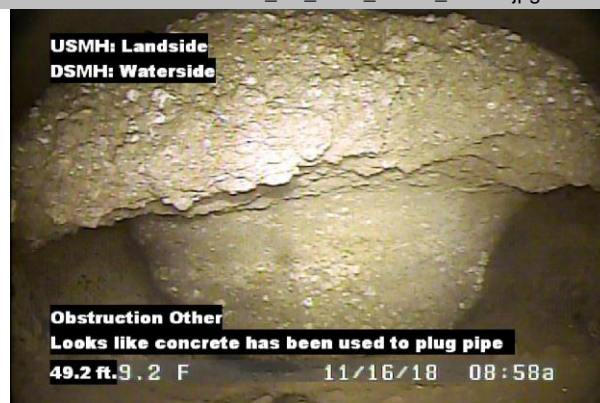
Photo 3 of 3 : UCIP_FA_2019_53535_78645.jpg

Internal inspection reveals a concrete plug on the LS.

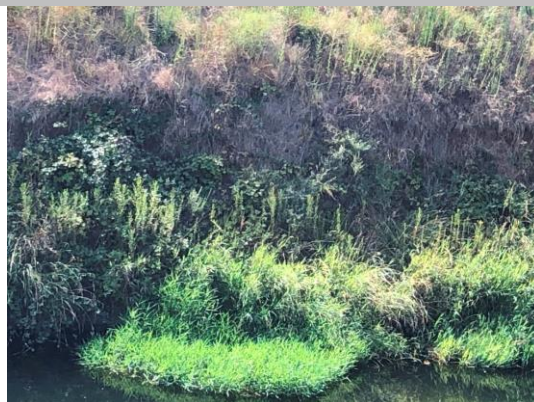
Photo 3 of 3 : SJR2019_NA0017U16RM19.29_5.JPG

Close-up view of the erosion. Note the dense vegetation at the site.

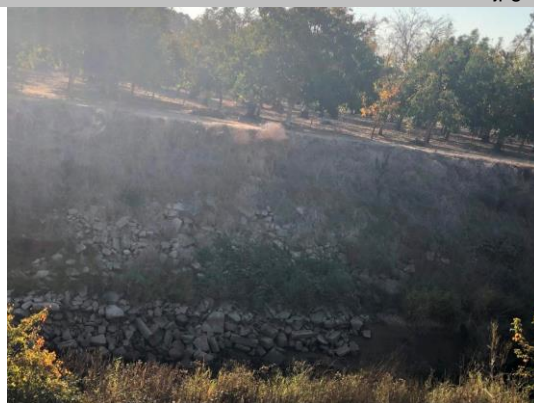
Photo 1 of 3 : SJR2019_NA0017U16RM17.99_2.jpg

View of the repaired site from downstream at the right river bank.

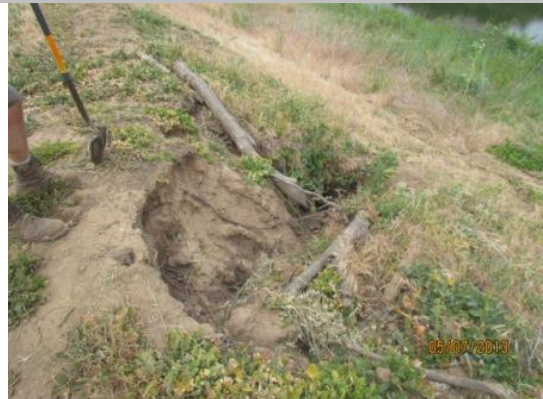
Photo 2 of 2 : FA_2019_NA0017_160_139_20190830_00153.jpg

Erosion was found on the waterside of the levee looking downstream.
