**Flood Control Project Maintenance
Levee Inspections**

Maintenance Issue Types Only, Levee Inspection Report By Mile - Fall 2020

San Joaquin County Flood Control and Water Conservation District

Waterway	Bank	Unit Miles	Inspection Start/End	Inspector
Unit No. 01 Littlejohn Creek	Left	2.59	10/20/2020 10/20/2020	Alberto De Leon

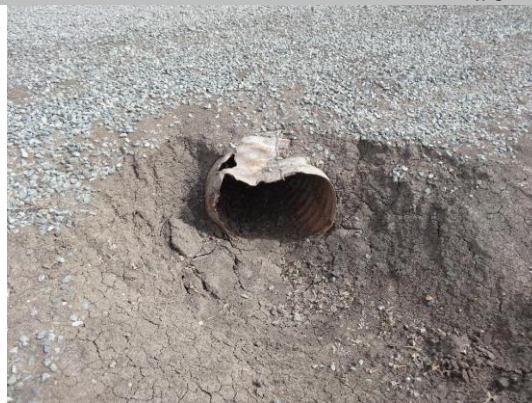
Photo 2 of 3 : UCIP_FA_2020_53494_59247.jpg

Comment Code					
Inspector Comment					
DS_ID:17973 FS_ID:53494 EP_NO: N/A Repair Type: Urgent EVAL Issue: Crossing Status: Found UCIP Comments: 11/02/2018 Inlet deformed. Outlet missing a slide gate. The LMA states that a new slide gate will be installed in about two weeks. Inlet and outlet have dirt and vegetation issues. Crossing remains "Urgent" until a new slide gate is installed. Contact the LMA to see if they have photographic evidence that a new slide gate was put in. (A. McDonald - DWR UCIP)10/18/2018 Inlet deformed. Outlet missing a slide gate. This means that the pipe cannot be closed during high water. I have escalated this crossing from "No Action Needed" to "Urgent" due to the straight through pipe which could cause flooding during high water. There is a hole in the inlet, due to the deformity. It was most likely ran over by heavy equipment. I do not see enough evidence for an internal pipe inspection. (A. McDonald - DWR UCIP)03/25/2014 May need cleaning of mud in inlet pipe. (W. Wylie - DWR UCIP) FIELD_STRUCT_DESC: 24-inch corrugated metal drainage culvert through the levee, 4.2 feet below the crown. Slide gate on the waterside (WS) end, not found on 10/18/2018. [Additional Reference(s): DWR Levee Log, 1977. USACE San Joaquin O&M Manual 613C, Volume 15, May 1963, (Station 98+65)]. FS Date: 11/2/2018 2:54:00 PM

LS view: deformed CMP inlet on a drainage ditch.

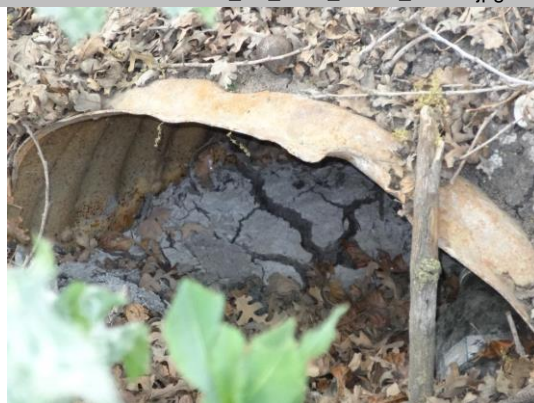
Photo 3 of 3 : UCIP_FA_2020_53459_59249.jpg

LS view: inside view of CM inlet pipe. Needs cleaning and clearing the culvert.

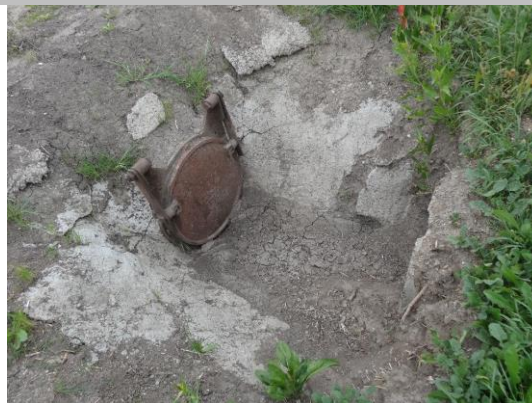
Photo 2 of 3 : UCIP_FA_2020_53462_59120.jpg

Comment Code						
Inspector Comment						
DS_ID:17966 FS_ID:53462 EP_NO: N/A Repair Type: No Action Needed EVAL Issue: Crossing Status: Found UCIP Comments: 11/02/2018 Inlet uncovered from the dirt by the LMA. Some vegetation at the flap gate. Crossing continues to be rated "No Action Needed." (A. McDonald - DWR UCIP)03/25/2014 Grouted riprap outlet box and concrete outfall pipe on waterside. Pipe not visible on landside. (P. Amatya - DWR UCIP) FIELD_STRUCT_DESC: 24-inch corrugated metal drainage pipe through the levee, 5 feet below the crown. Flap gate on the waterside (WS) end. Grouted riprap outlet box and concrete outfall pipe on the WS. [Additional Reference(s): DWR Levee Log, 1977. USACE San Joaquin O&M Manual 613C, Volume 15, May 1963, (Station 4+00)]. FS Date: 11/2/2018 3:43:00 PM

WS view: outlet pipe with flap gate. Grouted riprap on spillway.

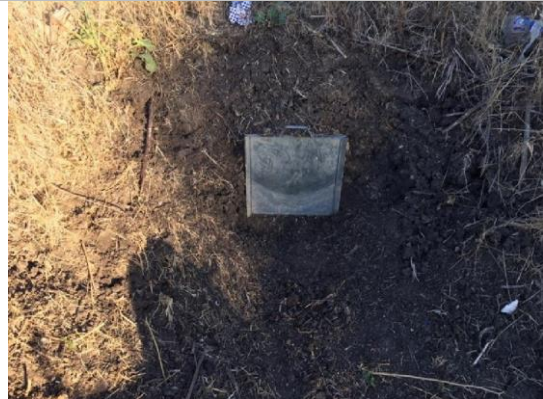
Photo 3 of 3 : UCIP_FA_2020_53452_78388.jpg

Outlet cleared of dirt and vegetation by the LMA.

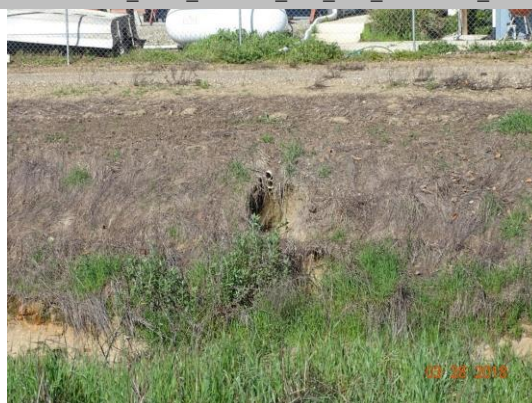
Photo 1 of 1 : FA_2020_NA0017_151_179_20200901_00030.jpg

NA17 SJCF&WCD Unit 7 Issue 179 LM14.01 erosion waterside photo from opposite side of channel looking west.

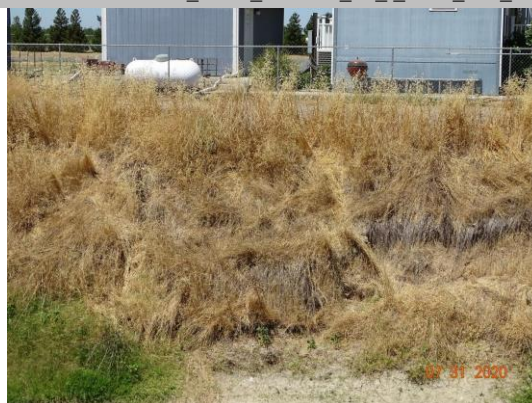
Photo 1 of 2 : SJR2019_DWR_NA0017_07_f_2018_148_04.JPG

7/31/2020: View of the 15-ft long erosion pocket from the opposite bank.

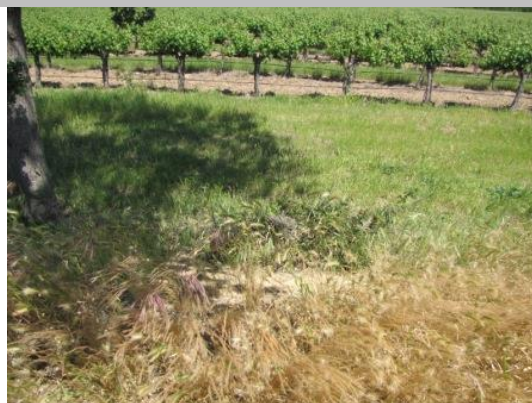
Photo 1 of 1 : FA_2020_NA0017_151_53_20200901_00010.jpg

View of a stump in the landward slope.

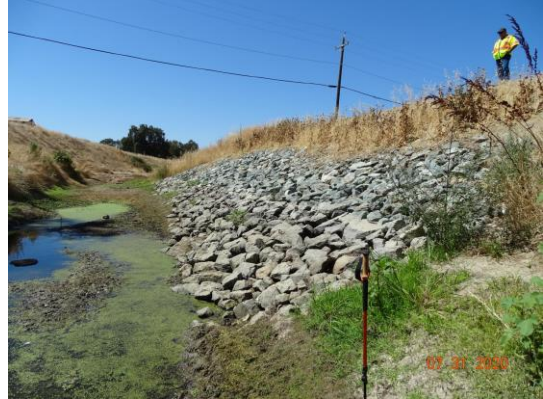
Photo 3 of 3 : SJR2019_NA0017U07RM23.14_03.JPG

7/31/2020: A closer view of the erosion repair looking downstream.

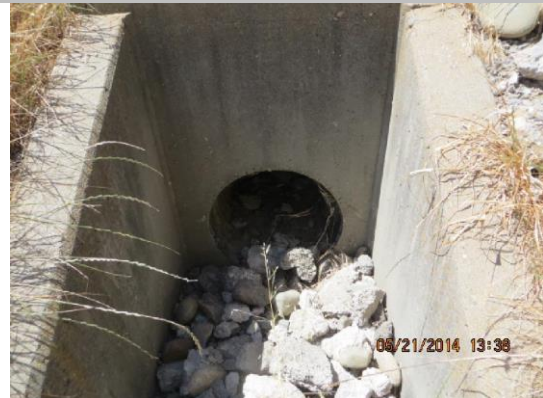
Photo 3 of 3 : UCIP_FA_2020_41809_69978.jpg

Concrete headwall on LS toe. Cobbles distributed at inlet.

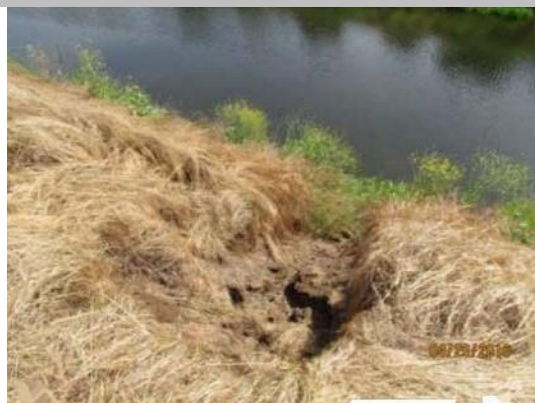
Photo 2 of 2 : SJR2019_SP_2020_NA0017_159_133_20200228_00052.jpg

Spring 2016: View of the erosion on the waterside shoulder.

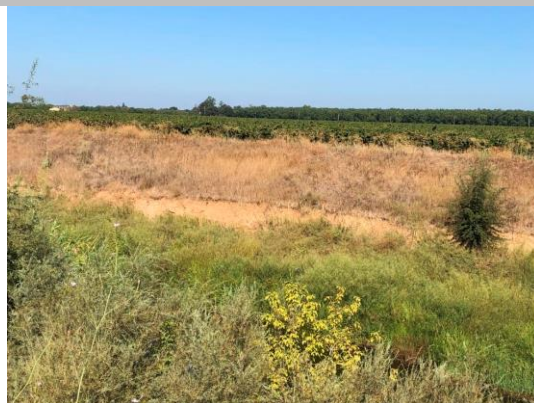
Photo 2 of 2 : SJR2019_NA0017U15RM13.87_3.JPG

8/29/2019: Close-up view of the erosion.

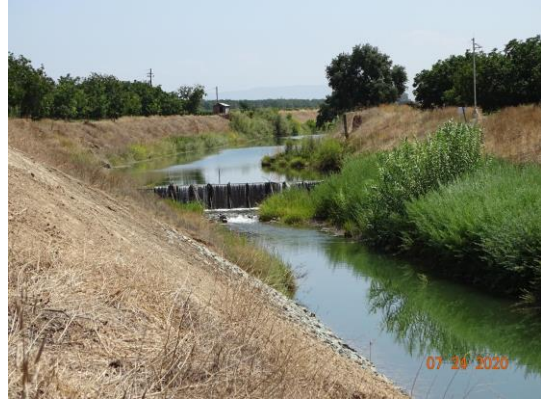
Photo 2 of 3 : SJR2019_NA0017U15RM13.25_07.JPG

7/24/2020: Close-up view of the repaired site.

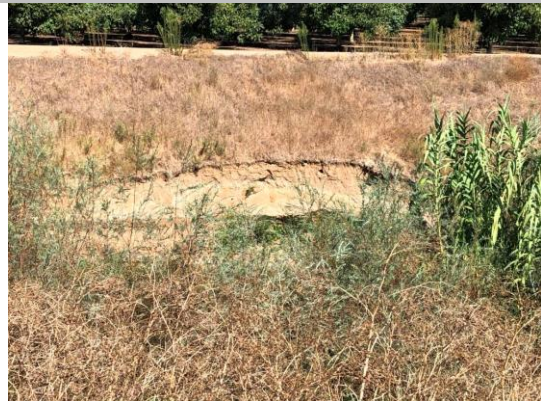
Photo 3 of 3 : SJR2019_DWR_NA0017_15_f_2017_183_2.JPG

8/28/2019: Close-up view of the erosion.

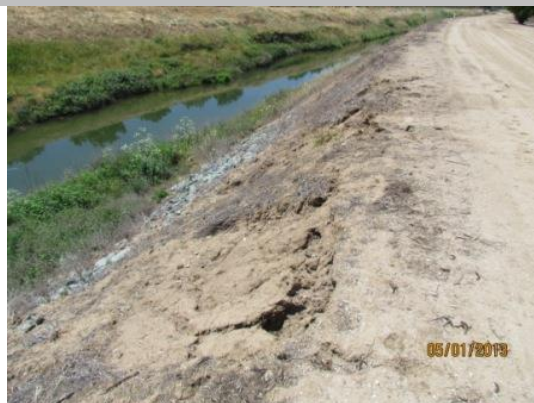
Photo 1 of 1 : FA_2020_NA0017_159_68_20200901_00019.jpg

Slope instability was found on the waterside slope of the levee looking downstream.

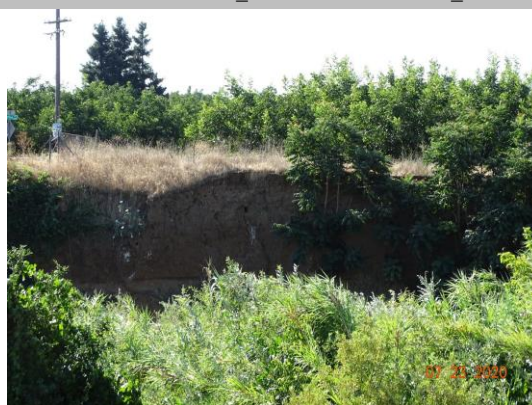
Photo 1 of 3 : SJR2019_NA0017U16RM23.35_01.JPG

7/23/2020: View of the upstream end of the erosion from the opposite bank.

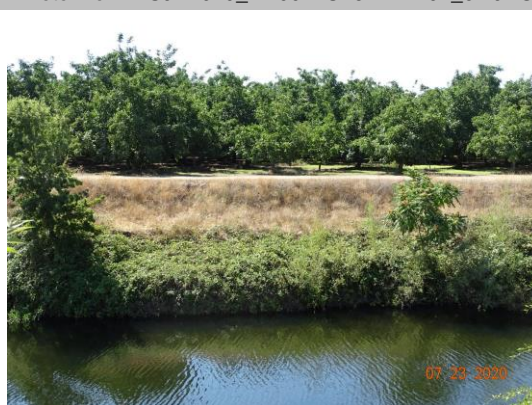
Photo 2 of 2 : SJR2019_NA0017U16RM21.94_02.JPG

7/23/2020: Close-up view of the erosion.

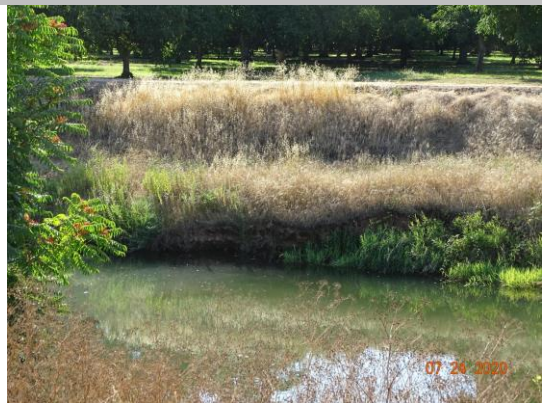
Photo 3 of 3 : SJR2019_NA0017U16RM17.27_04.JPG

7/24:2020: Close-up view of the erosion.

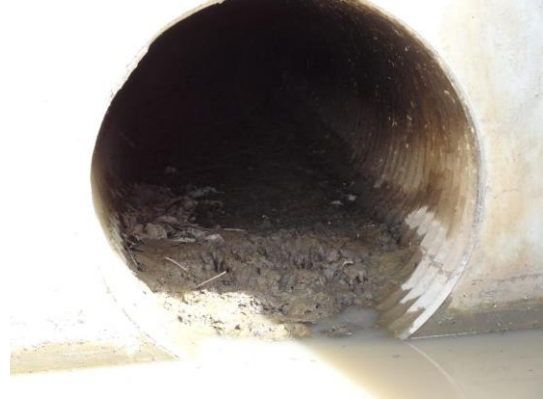
Photo 3 of 3 : UCIP_FA_2020_33114_59899.jpg

LS view: closer view of CM pipe. May need to clean and clear mud from the pipe.
