**Flood Control Project Maintenance
Levee Inspections**

Maintenance Issue Types Only, Levee Inspection Report By Mile - Fall 2021

San Joaquin County Flood Control and Water Conservation District

Waterway	Bank	Unit Miles	Inspection Start/End	Inspector
Unit No. 01 Littlejohn Creek	Left	2.59	10/21/2021 10/21/2021	Alberto De Leon

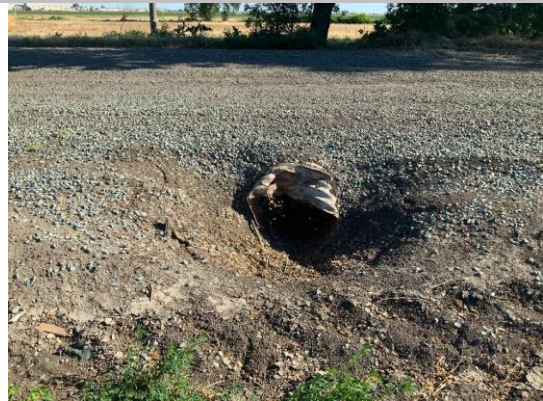
Photo 3 of 3 : UCIP_FA_2021_66998_96793.jpg

DS_ID:17973
FS_ID:66998
EP_NO: N/A
Repair Type: Urgent
EVAL Issue: Flood Risk
Crossing Status: Found
UCIP Comments: 04/27/2021 Pipe status is still Urgent. Slidegate no longer on WS, pipe is open on both ends. LS pipe edges are bent and warped. DWR DMP internal video inspection has found pipe integrity issues. LOF of crossing is between 4.1 and 5. Crossing will be monitored until funding becomes available for rehabilitation. Levee prism in this section appears to be less than 3 feet. No permit was found authorizing this encroachment. CVFPB will need to review crossing to determine owner. The UCIP inspection was completed with LMA representative, J. Nelson. (H. Dunn – GEI) 11/02/2018 Inlet deformed. Outlet missing a slide gate. The LMA states that a new slide gate will be installed in about two weeks. Inlet and outlet have dirt and vegetation issues. Crossing remains "Urgent" until a new slide gate is installed. Contact the LMA to see if they have photographic evidence that a new slide gate was put in. (A. McDonald - DWR UCIP)10/18/2018 Inlet deformed. Outlet missing a slide gate. This means that the pipe cannot be closed during high water. I have escalated this crossing from "No Action Needed" to "Urgent" due to the straight through pipe which could cause flooding during high water. There is a hole in the inlet, due to the deformity. It was most likely ran over by heavy equipment. I do not see enough evidence for an internal pipe inspection. (A. McDonald - DWR UCIP)03/25/2014 May need cleaning of mud in inlet pipe. (W. Wylie - DWR UCIP)

LS view: Inlet at toe, 1 of 2 photos.

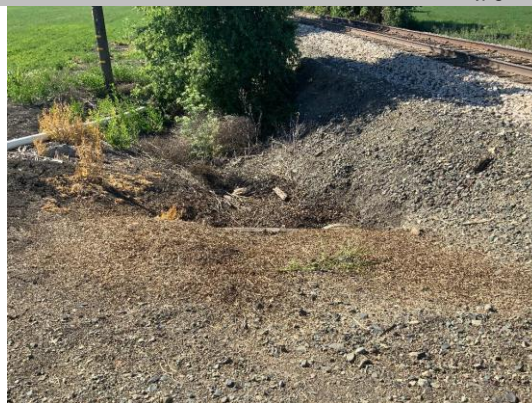
Photo 2 of 3 : UCIP_FA_2021_67003_96808.jpg

Comment Code					
Inspector Comment					
DS_ID:17972 FS_ID:67003 EP_NO: N/A Repair Type: Non-Urgent EVAL Issue: Maintenance Compliance Issue Crossing Status: Found UCIP Comments: 04/27/2021 The record has been upgraded from No Action Needed to Non-Urgent. Some vegetation in front of WS flapgate, recommend removal. DWR DMP internal video inspection has not found pipe integrity issues. LOF of crossing is less or equal to 4.0. Recommend next video inspection in 5 years. Levee prism in this section appears to be less than 3 feet. No permit was found authorizing this encroachment. CVFPB will need to review crossing to determine owner. The UCIP inspection was completed with LMA representative, J. Nelson. (H. Dunn – GEI) 11/02/2018 Inlet and outlet cleared of dirt by the LMA. Crossing has been downgraded to "No Action Needed." (A. McDonald - DWR UCIP)03/25/2014 LS vegetation debris and mud on the inlet ditch and inside the pipe. (P. Amaty - DWR UCIP) FIELD_STRUCT_DESC: 1 of 2: 36-inch corrugated metal drainage pipe through the levee, 6.6 feet below the crown. Flap gate on the waterside (WS) end. [Additional Reference(s): DWR Levee Log, 1977. USACE San Joaquin O&M Manual 613C, Volume 15, May 1963 (Station 94+40)]. FS Date: 4/27/2021

LS view: Headwall visible at toe from crown.

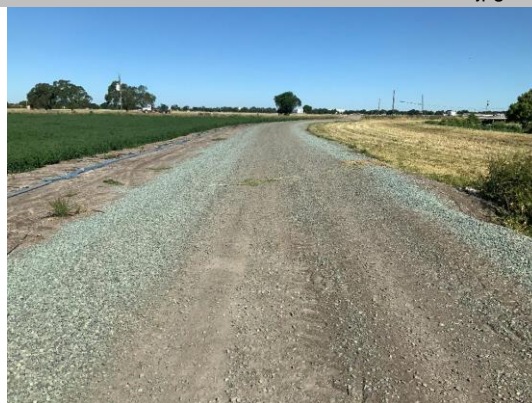
Photo 1 of 3 : UCIP_FA_2021_65263_96829.jpg

DS_ID:17970
 FS_ID:65263
 EP_NO: N/A
 Repair Type: Urgent
 EVAL Issue: Pipe Integrity
 Crossing Status: Found
 UCIP Comments: 04/27/2021 The record has been upgraded from Non-Urgent to Urgent. DWR DMP internal video inspection has found pipe integrity issues. LOF of crossing is between 5 and 6. Crossing will be monitored until funding becomes available to address the issues. The levee prism in this section appears to be less than 3 feet. No permit was found authorizing this encroachment. CVFPB will need to review crossing to determine owner. The UCIP inspection was completed with LMA representative, J. Nelson. (H. Dunn – GEI)11/02/2018 Inlet still deformed. Inlet and outlet cleared of dirt and vegetation by the LMA. Crossing continues to be rated "Non-Urgent." (A. McDonald - DWR UCIP)03/25/2014 Needs cleaning and clearing the culvert. (P. Amaty - DWR UCIP)
 FIELD_STRUCT_DESC: 24-inch corrugated metal drainage pipe through the levee, 4.1 feet below the crown. Flap gate on the waterside (WS) end. [Additional Reference(s): DWR Levee Log, 1977. USACE San Joaquin O&M Manual 613C, Volume 15, May 1963, (Station 76+60)].

Levee crown looking downstream.

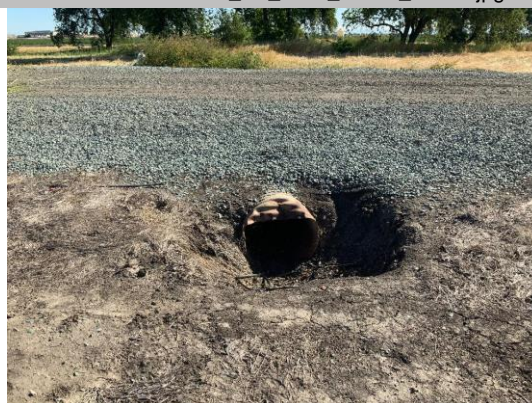
Photo 3 of 3 : UCIP_FA_2021_65263_96831.jpg

LS view: Pipe inlet at toe.

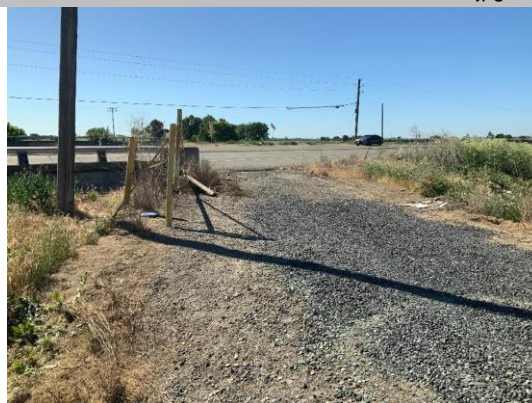
Photo 1 of 3 : UCIP_FA_2021_67070_96838.jpg

Comment Code						
Inspector Comment						
DS_ID:17969 FS_ID:67070 EP_NO: N/A Repair Type: Non-Urgent EVAL Issue: Unauthorized Modification or Non-Compliant Permit Crossing Status: Found UCIP Comments: 04/27/2021 Pipe status is still Non-Urgent. This pipe appears abandoned, no standpipe on WS and no inlet structure on LS. Only pipe with appurtenance left on WS. The levee prism in this section appears to be less than 3 feet. No permit was found authorizing this encroachment. CVFPB will need to review crossing to determine owner. The UCIP inspection was completed with LMA representative, J. Nelson. (H. Dunn – GEI) 03/25/2014 Appears abandoned and should be verified as having been done so properly. (P. Tariq - DWR UCIP)Concrete standpipe on waterside. Abandoned gate valve on waterside. Steel pipe disconnected with the standpipe.Inlet structure with steel gates and 18-inch alfalfa valve on landside. FIELD_STRUCT_DESC: 18-inch reinforced concrete drainage pipe through the levee, 6.2 feet below the crown. [Additional Reference(s): DWR Levee Log, 1977. USACE San Joaquin O&M Manual 613C, Volume 15, May 1963, (Station 68+90) 21-inch pipe listed]. FS Date: 4/27/2021

Levee crown looking upstream.

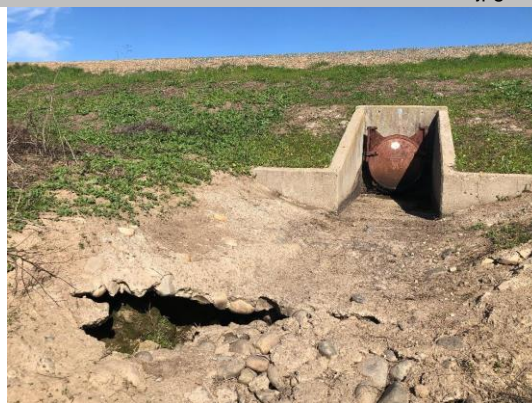
Photo 1 of 3 : UCIP_FA_2021_66347_93666.jpg

WS headwall and flapgate at toe. Minor erosion underneath grouted spillway.

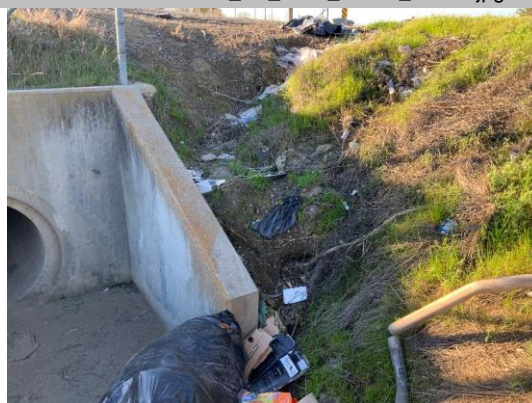
Photo 3 of 3 : UCIP_FA_2021_66542_91862.jpg

LS headwall with minor erosion on slope on side of headwall.

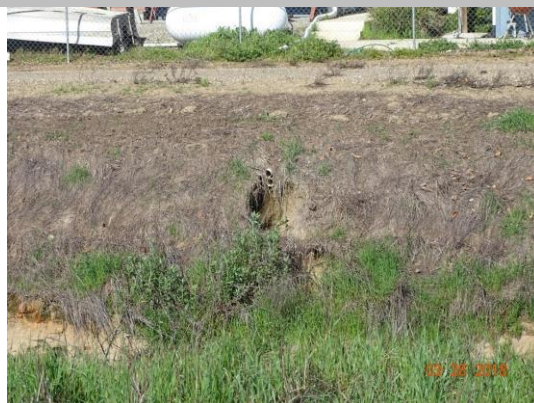
Photo 1 of 1 : FA_2021_NA0017_151_179_20210913_00031.jpg

NA17 SJCFC&WCD Unit 7 Issue 179 LM14.01 erosion waterside photo from opposite side of channel looking west.

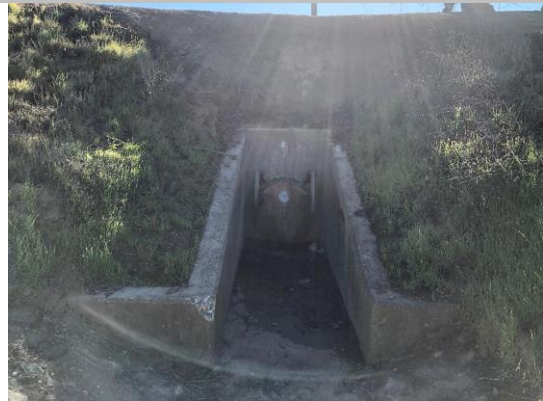
Photo 3 of 3 : UCIP_FA_2021_63793_92890.jpg

WS View: Headwall and flapgate on WS slope. Erosion observed above headwall.

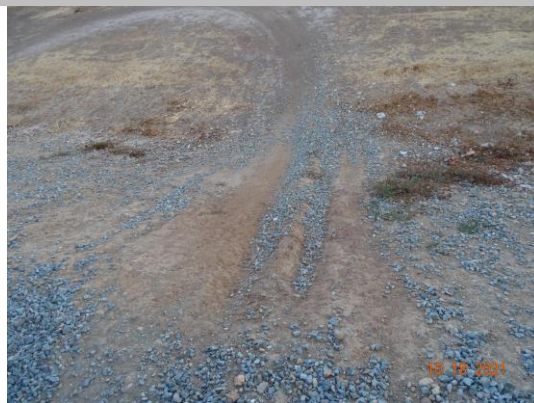
Photo 1 of 1 : FA_2021_NA0017_154_12_20211018_00035.jpg

View of motorcycle ruts on the landside slope. Fall 2021

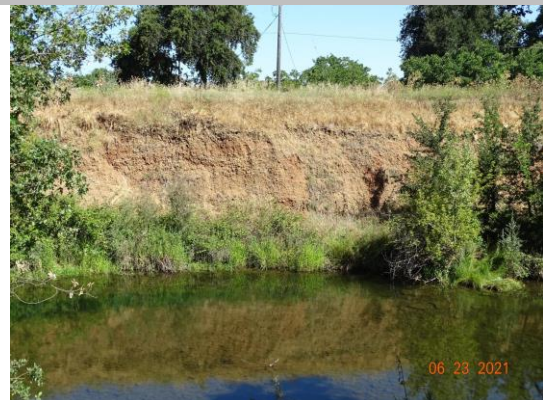
Photo 3 of 3 : SJR2021_NA0017U15RM22.91_3.JPG

6/23/2021: View of the erosion from the opposite bank.

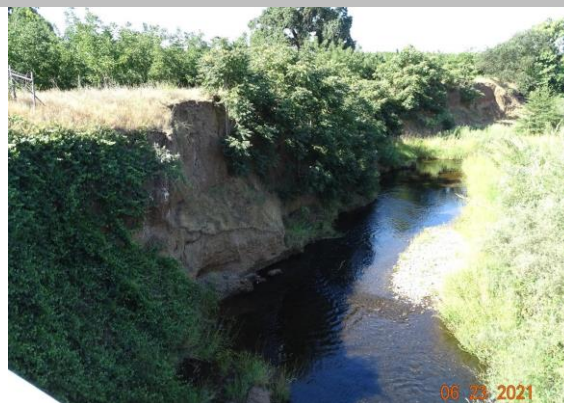
Photo 1 of 3 : SJR2021_NA0017U16RM23.35_1.JPG

6/23/2021: View of the upstream end of the erosion.

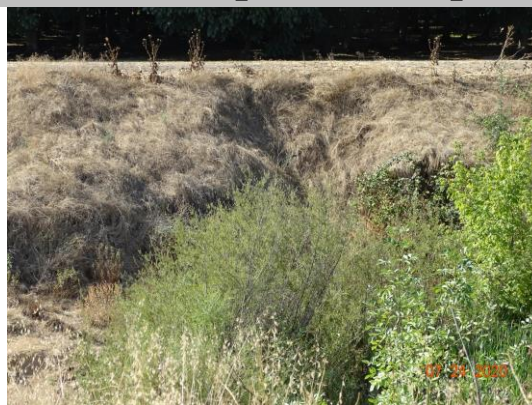
Photo 2 of 2 : SJR2021_NA0017U16RM16.15_04.JPG

7/24/2020: Close-up view of the erosion.

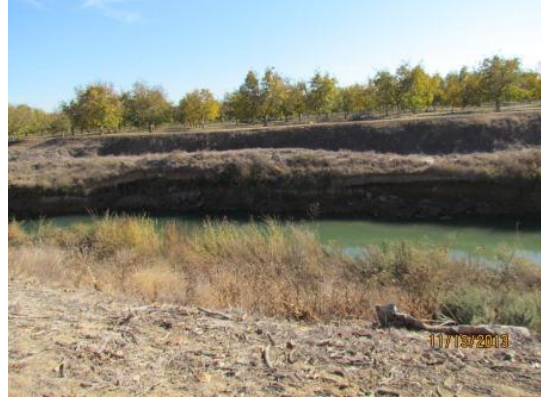
Photo 1 of 1 : FA_2021_NA0017_160_28_20210913_00036.jpg

View of the erosion on the waterside toe of the levee looking from the opposite side of the levee.
