**Flood Control Project Maintenance
Levee Inspections**

Maintenance Issue Types Only, Levee Inspection Report By Mile - Fall 2022

San Joaquin County Flood Control and Water Conservation District

Waterway	Bank	Unit Miles	Inspection Start/End	Inspector
Unit No. 01 Littlejohn Creek	Left	2.59	10/13/2022 10/13/2022	Alberto De Leon

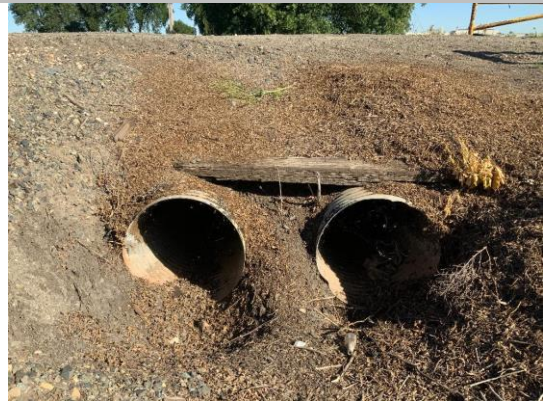
Photo 3 of 3 : UCIP_FA_2022_74233_96816.jpg

Comment Code					
Inspector Comment					
DS_ID:23995 FS_ID:74233 EP_NO: N/A Repair Type: Non-Urgent EVAL Issue: 5, Pipe Damage Crossing Status: Found UCIP Comments: 04/27/2021 The record has been upgraded from No Action Needed to Non-Urgent. DWR DMP internal video inspection has found pipe integrity issues. LOF of crossing is between 4.1 and 5. Crossing will be monitored until funding becomes available for rehabilitation. Vegetation covering WS flapgates, recommend removal. The levee prism in this section appears to be less than 3 feet. No permit was found authorizing this encroachment. CVFPB will need to review crossing to determine owner. The UCIP inspection was completed with LMA representative, J. Nelson. (H. Dunn – GE11/02/2018 Inlet and outlet covered in dirt. Inlet and outlet cleared of dirt by the LMA. (A. McDonald - DWR UCIP)03/25/2014 Needs cleaning and clearing of the culvert. (P. Amatya - DWR UCIP) FIELD_STRUCT_DESC: 2 of 2: 36-inch corrugated metal drainage pipe (CMP) through the levee, 6.6 feet below the crown. Flap gate on the waterside (WS) end. [Additional Reference(s): DWR Levee Log, 1977, (HLM 1.05). USACE San Joaquin O&M Manual, Unit No. 613, Part C, May 1963, Revised 15 April 2010, (Station 94+40). USACE As-Built File No. CA-2-6-147, Sheet No. 147/22, 25 March 1954, (Station 94+40)]. FS Date: 4/27/2021

LS view: Inlets at toe.

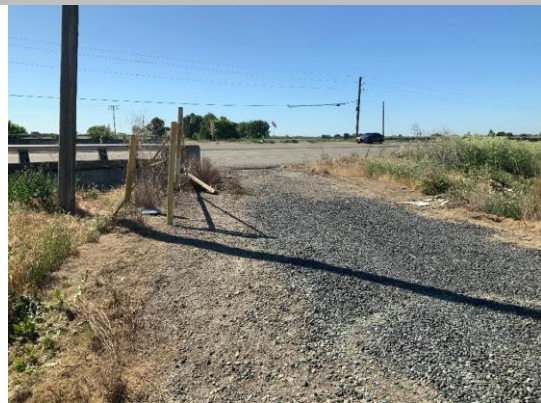
Photo 1 of 3 : UCIP_FA_2022_74238_96838.jpg

DS_ID:17969
FS_ID:74238
EP_NO: N/A
Repair Type: Non-Urgent
EVAL Issue: 10, Unauthorized Modification or Non-Compliant Permit Crossing Status: Found
UCIP Comments: 04/27/2021 Pipe status is still Non-Urgent. This pipe appears abandoned, no standpipe on WS and no inlet structure on LS. Only pipe with appurtenance left on WS. The levee prism in this section appears to be less than 3 feet. No permit was found authorizing this encroachment. CVFPB will need to review crossing to determine owner. The UCIP inspection was completed with LMA representative, J. Nelson. (H. Dunn – GEI) 03/25/2014 Appears abandoned and should be verified as having been done so properly. (P. Tariq - DWR UCIP) Concrete standpipe on waterside. Abandoned gate valve on waterside. Steel pipe disconnected with the standpipe. Inlet structure with steel gates and 18-inch alfalfa valve on landside.
FIELD_STRUCT_DESC: 18-inch reinforced concrete drainage pipe (RCP) through the levee, 6.2 feet below the crown. [Additional Reference(s): DWR Levee Log, 1977, (HLM 1.60). USACE San Joaquin O&M Manual, Unit No. 613, Part C, May 1963, Revised 15 April 2010, (Station 68+90). USACE As-Built File No. CA-2-6-147, Sheet No. 147/1, 25 March 1954, (Station 68+90), 21-inch pipe listed].

Levee crown looking upstream.

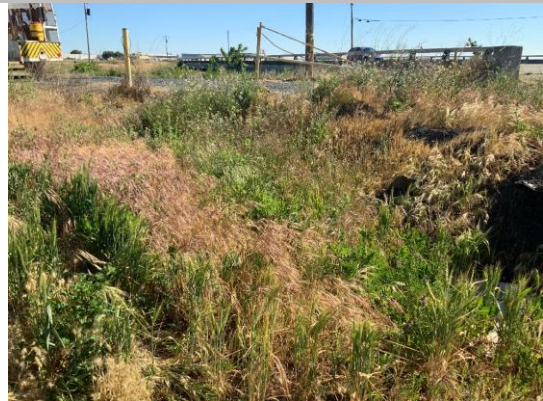
Photo 3 of 3 : UCIP_FA_2022_74238_96843.jpg

LS view: Slope from toe, no inlet structure seen.

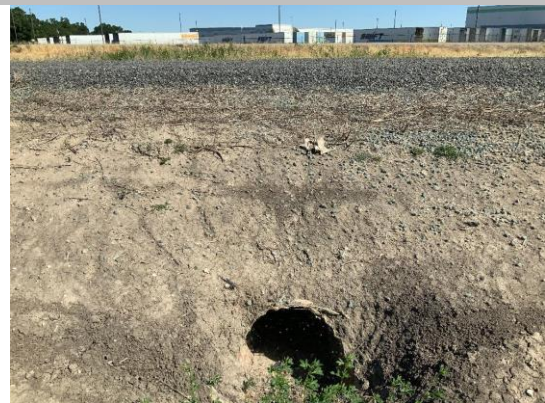
Photo 3 of 3 : UCIP_FA_2022_74325_96873.jpg

Comment Code					
Inspector Comment					
DS_ID:17966 FS_ID:74325 EP_NO: N/A Repair Type: Non-Urgent EVAL Issue: 11, Maintenance Compliance Issue Crossing Status: Found UCIP Comments: 04/27/2021 The record has been upgraded from No Action Needed to Non-Urgent. WS flapgate completely covered in vegetation and LS inlet has some sediment buildup inside, recommend cleaning on both ends. DWR DMP internal video inspection has not found pipe integrity issues. LOF of crossing is less or equal to 4.0. Recommend next video inspection in 5 years No permit was found authorizing this encroachment. CVFPB will need to review crossing to determine owner. The levee prism in this section appears to be less than 3 feet. The UCIP inspection was completed with LMA representative, J. Nelson. (H. Dunn – GEI) 11/02/2018 Inlet uncovered from the dirt by the LMA. Some vegetation at the flap gate. Crossing continues to be rated "No Action Needed." (A. McDonald - DWR UCIP)03/25/2014 Grouted riprap outlet box and concrete outfall pipe on waterside. Pipe not visible on landside. (P. Amatya - DWR UCIP) FIELD_STRUCT_DESC: 24-inch corrugated metal drainage pipe (CMP) through the levee, 5.0 feet below the crown. Flap gate on the waterside (WS) end. Grouted riprap outlet box and concrete outfall pipe on the WS. [Additional Reference(s): DWR Levee Log, 1977, (HLM 2.82). USACE San Joaquin O&M Manual, Unit No. 613, Part C, May 1963, Revised 15 April 2010, (Station 4+00). USACE As-Built File No. CA-2-6-147, Sheet No. 147/1, 25 March 1954, (Station 4+00)]. FS Date: 4/27/2021

LS view: Pipe inlet at toe.

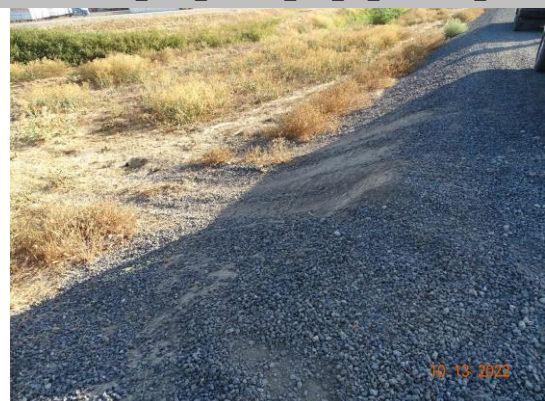
Photo 1 of 1 : FA_2022_NA0017_148_22_20221022_00060.jpg

View of damage on waterside slope caused by motorcycle traffic. Fall 2022

LM Start	2.57	Rating **	M	Issue No.	22
LM End	2.57	Issue Type +	Ma	Location *	WS
Category	Earthen Levee			GPS Latitude/Longitude	
				Start	End
Item	Erosion / Vehicle Traffic			37.888028 °	37.888028 °
				-121.267395 °	-121.267395 °
DWR ID	DWR_NA0017_01_s_2022_22				
Comment Code					
E6 : Repair the levee slope damaged by vehicle traffic and prevent access where possible.					
Inspector Comment					
Repair damage to waterside slope due to motorcycle access.

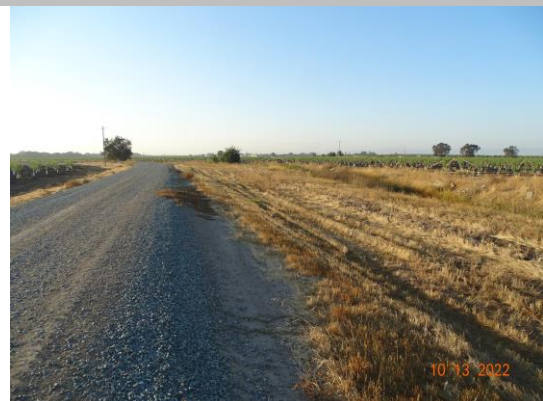
Photo 1 of 1 : FA_2022_NA0017_149_34_20221022_00090.jpg

View of well maintained vegetation on the waterside slope. Fall 2022

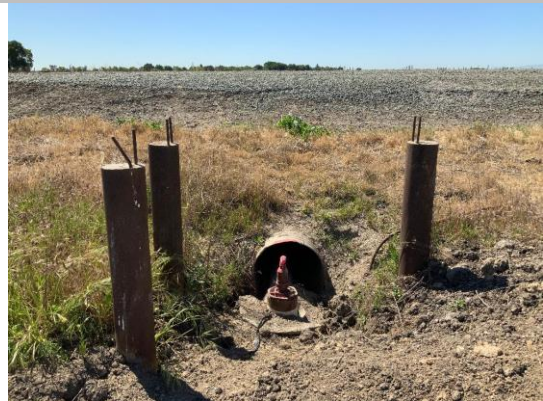
Photo 3 of 3 : UCIP_FA_2022_74365_96995.jpg

Comment Code						
Inspector Comment						
DS_ID:17986 FS_ID:74365 EP_NO: N/A Repair Type: Urgent EVAL Issue: 3a, Flood Risk Crossing Status: Found UCIP Comments: 04/28/2021 The record has been upgraded from No Action Needed to Urgent. No flapgate on the WS, pipe is open on both ends. There is an 8inch plastic pipe now going through this metal pipe that looks to go underground possibly under the channel on WS. Need more information from owner. No permit was found authorizing this encroachment. CVFPB will need to review crossing to determine owner. The UCIP inspection was completed with LMA representative, J. Nelson. (H. Dunn – GEI) 11/02/2018 Inlet cleared of dirt and vegetation by the LMA. Crossing continues to be rated "No Action Needed." (A. McDonald - DWR UCIP)04/02/2014 May need cleaning. (P. Amatya - DWR UCIP) FIELD_STRUCT_DESC: 24-inch corrugated metal gravity drainage pipe (CMP) through the levee, 5.0 feet below the crown. Flap gate on the waterside (WS) end. [Additional Reference(s): DWR Levee Log, 1977, (HLM 0.50). USACE San Joaquin O&M Manual, Unit No. 613, Part C, May 1963, Revised 15 April 2010, (Station 148+18 "N"). USACE As-Built File No. CA-2-6-147, Sheet No. 147/2, 25 March 1954, (Station 148+18 "N")]. FS Date: 4/28/2021

LS view: Pipe inlet at toe.

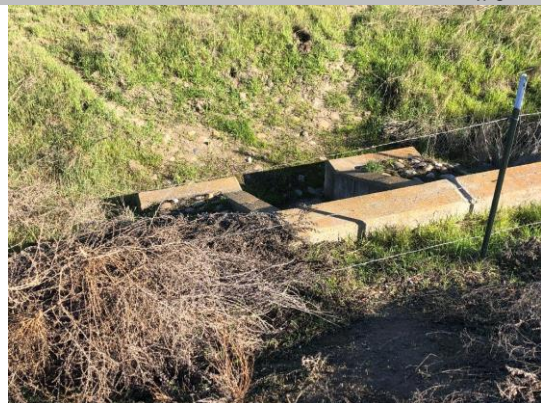
Photo 2 of 3 : UCIP_FA_2022_77213_91086.jpg

LS view: LS headwall from crown. Note barbed wire prevented access to pipe.

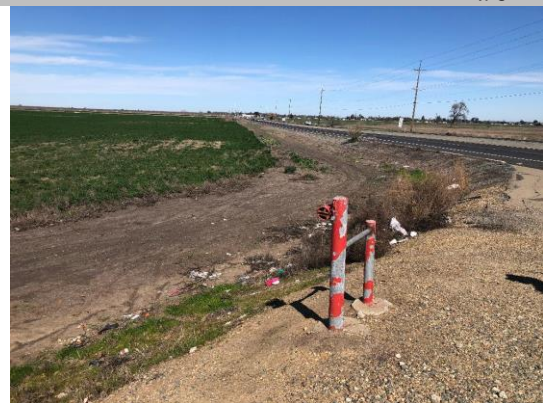
Photo 2 of 3 : UCIP_FA_2022_77235_93743.jpg

LS view: LS toe from crown, metal riser with slidegate.

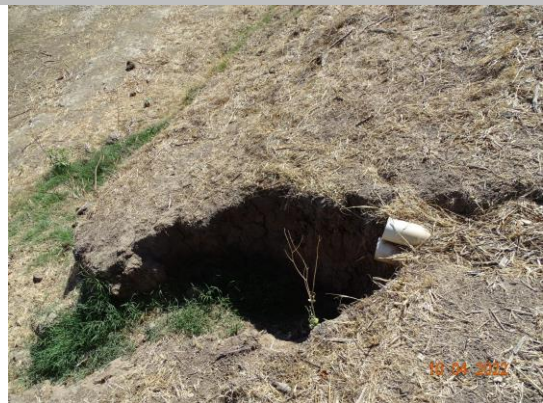
Photo 2 of 2 : FA_2022_NA0017_151_179_20221025_00587.jpg

View of erosion on the waterside slope. Fall 2022

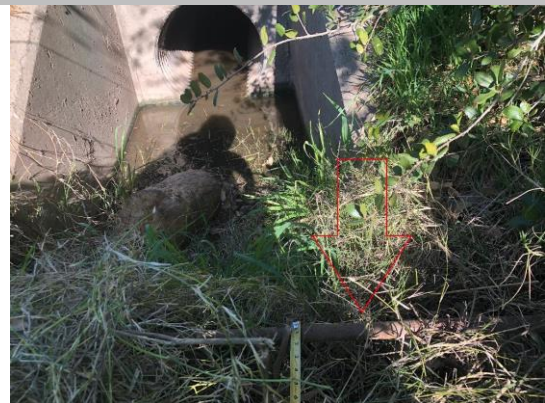
Photo 3 of 3 : UCIP_FA_2022_77569_92173.jpg

1-inch steel pipe observed adjacent to headwall at LS toe.

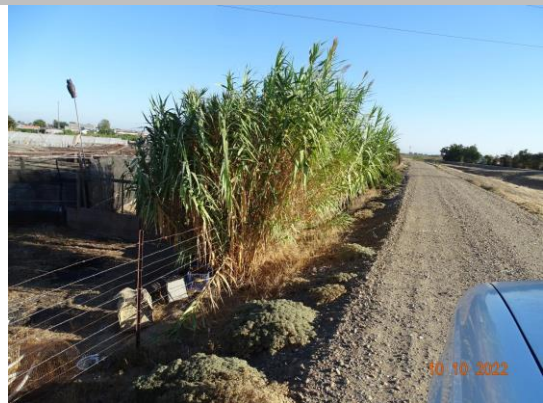
Photo 1 of 1 : FA_2022_NA0017_155_49_20221023_00104.jpg

View of Arundo growing along the landside slope. Fall 2022

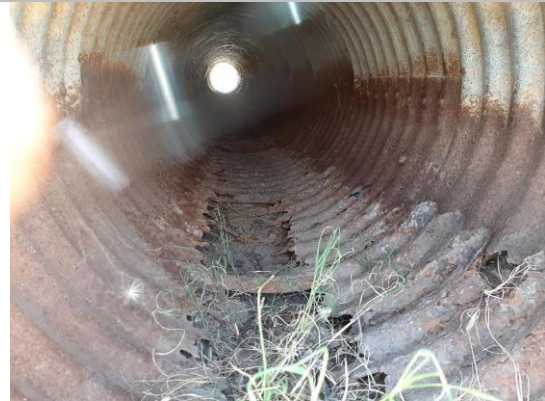
Photo 3 of 3 : UCIP_FA_2022_59675_87240.jpg

View of corrosion inside drainage pipe.

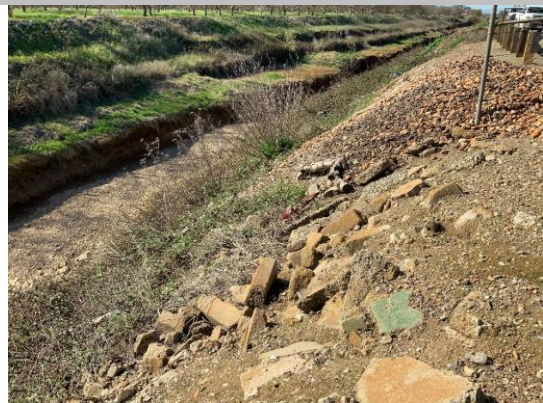
Photo 3 of 3 : UCIP_FA_2022_66920_94211.jpg

WS view: Slope from crown, no pipe visible due to vegetation.

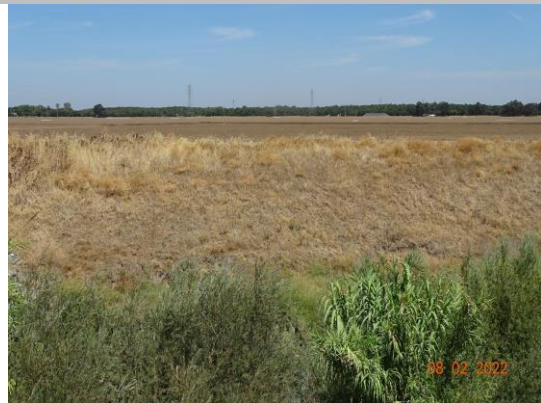
Photo 2 of 2 : SJR2022_NA0017U15RM13.25_4.JPG

8/2/2022: Close-up view of the erosion further upstream.

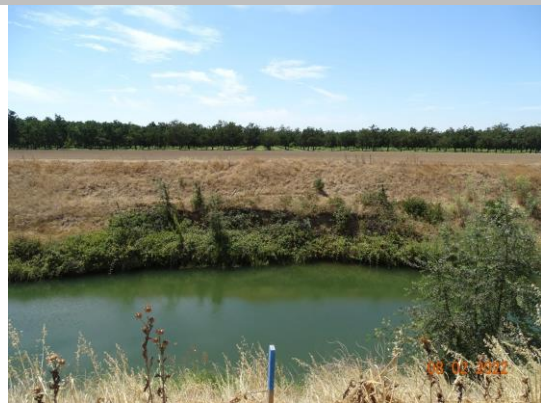
Photo 1 of 2 : SJR2022_NA0017U16RM12.95_2.JPG

8/2/2022: View of the erosion from the opposite bank.
