**Flood Control Project Maintenance
Levee Inspections**

Maintenance Issue Types Only, Levee Inspection Report By Mile - Fall 2023

San Joaquin County Flood Control and Water Conservation District

Waterway	Bank	Unit Miles	Inspection Start/End	Inspector
Unit No. 01 Littlejohn Creek	Left	2.59	10/20/2023 10/20/2023	Alberto De Leon

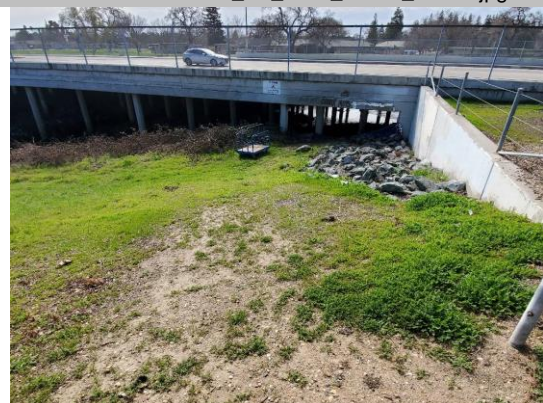
Photo 2 of 2 : UCIP_FA_2023_78865_95779.jpg

WS slope. No indicator found.

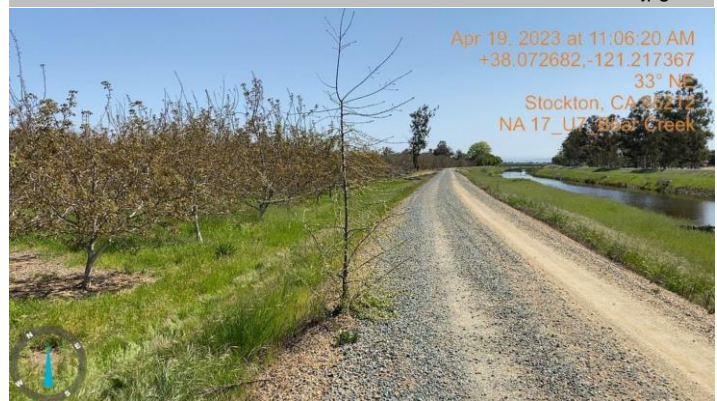
Photo 1 of 1 : FA_2023_NA0017_151_129_20230905_00008.jpg

View of tree saplings on the landside shoulder. Spring 2023

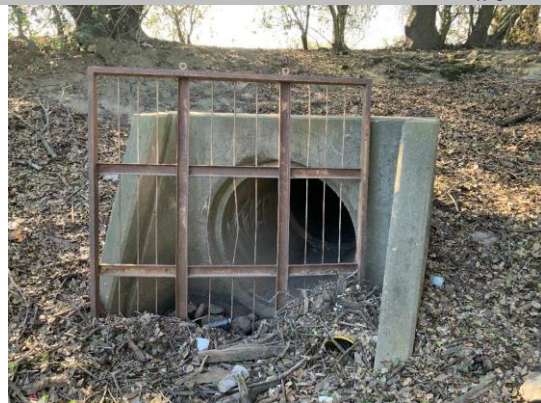
Photo 2 of 3 : UCIP_FA_2023_78928_92791.jpg

LS view: LS headwall, gate adjar, no flapgate.

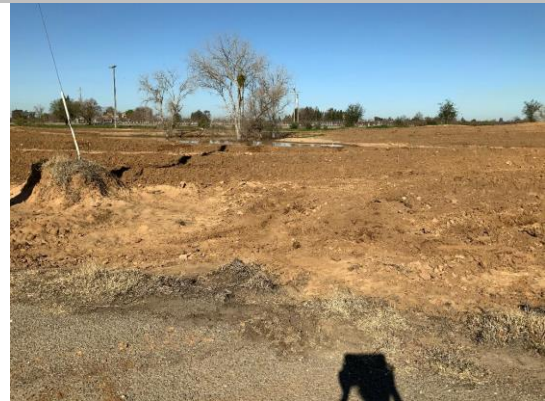
Photo 1 of 3 : UCIP_FA_2023_78976_92809.jpg

LS toe from crown, pipe not visible.

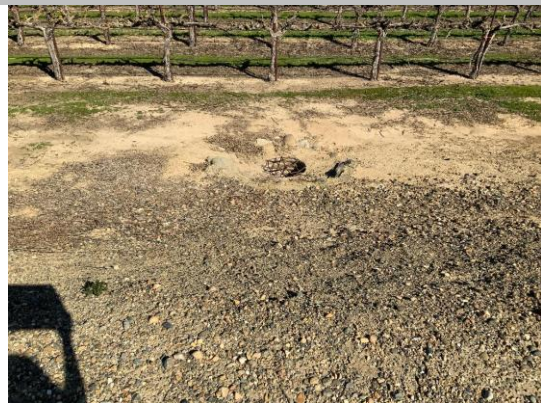
Photo 1 of 3 : UCIP_FA_2023_78389_92905.jpg

LS view: LS toe from crown, pipe inlet with no riser.

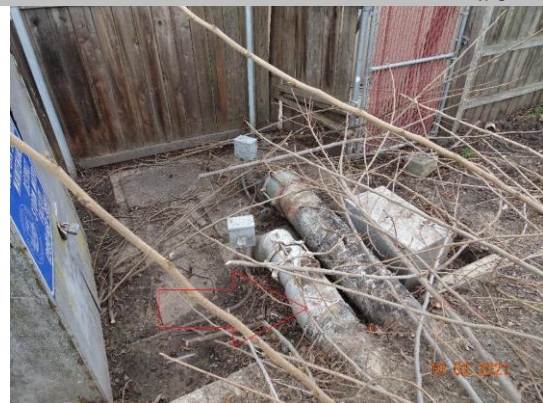
Photo 2 of 3 : UCIP_FA_2023_78439_93415.jpg

LS View: Pipe visible at LS toe. Electrical panel and post adjacent to pipe.

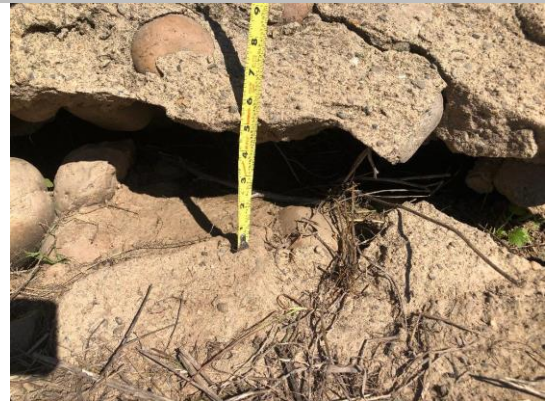
Photo 3 of 3 : UCIP_FA_2023_79017_92659.jpg

WS View: Crack observed in apron at WS toe.

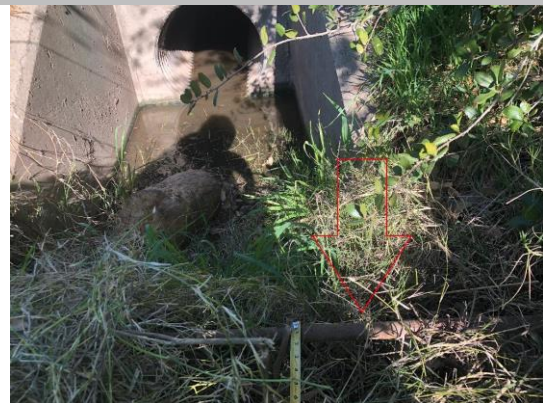
Photo 3 of 3 : UCIP_FA_2023_79417_92173.jpg

1-inch steel pipe observed adjacent to headwall at LS toe.

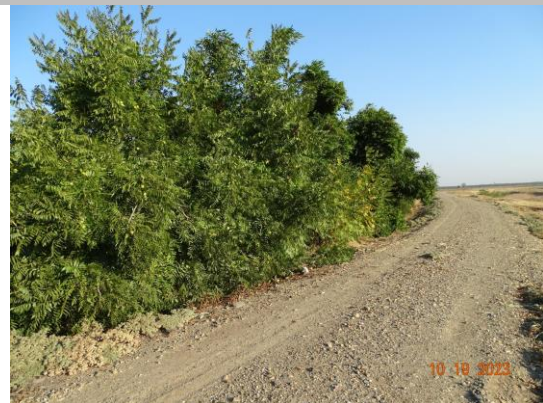
Photo 1 of 1 : FA_2023_NA0017_155_49_20231030_00081.jpg

View of Arundo and wild growth blocking the view of landside slope and easement. Fall 2023

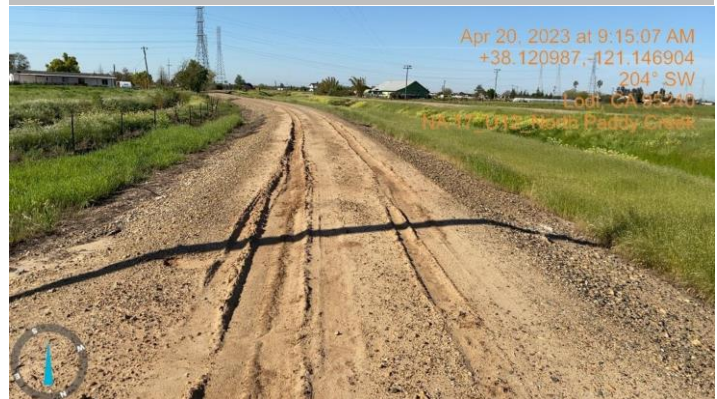
Photo 1 of 1 : FA_2023_NA0017_156_23_20230905_00002.jpg

View of tire ruts on the levee crown. Spring 2023

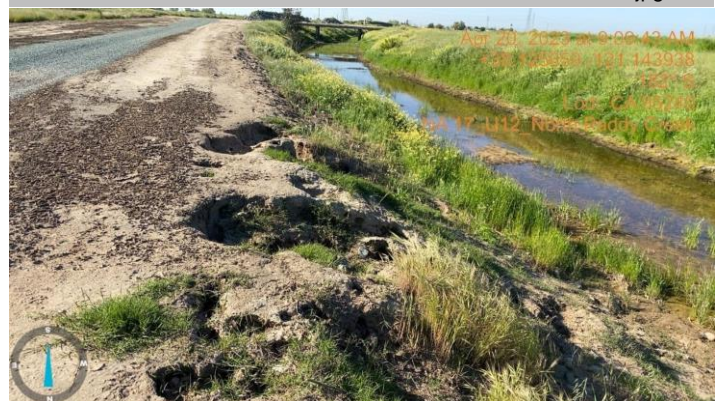
Photo 1 of 1 : FA_2023_NA0017_156_32_20230905_00003.jpg

View of erosion near the waterside hinge point. Spring 2023

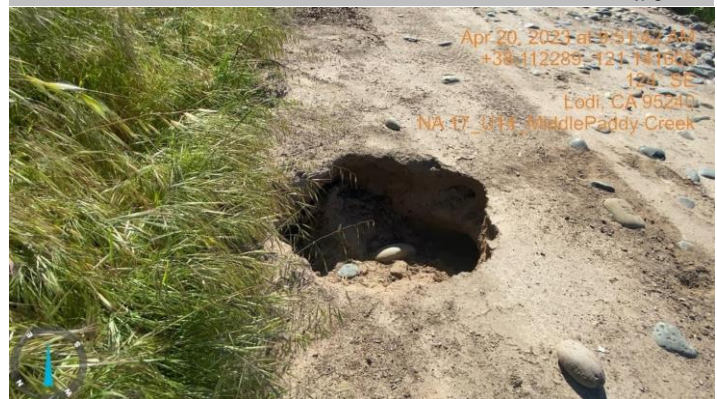
Photo 1 of 1 : FA_2023_NA0017_158_13_20230905_00001.jpg

View of large animal burrow on the crown of levee. Spring 2023

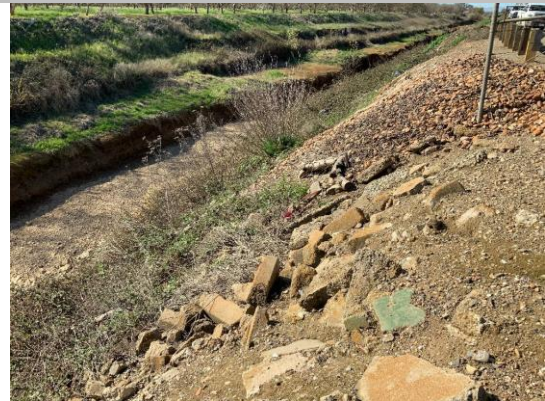
Photo 3 of 3 : UCIP_FA_2023_78687_94211.jpg

WS view: Slope from crown, no pipe visible due to vegetation.

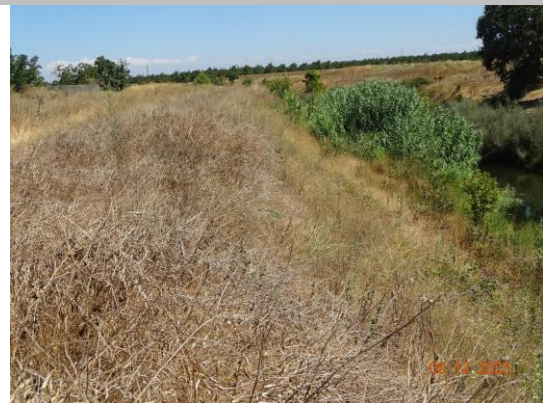
Photo 1 of 1 : FA_2023_NA0017_159_17_20231101_00246.jpg

View channel bank erosion. Summer 2023

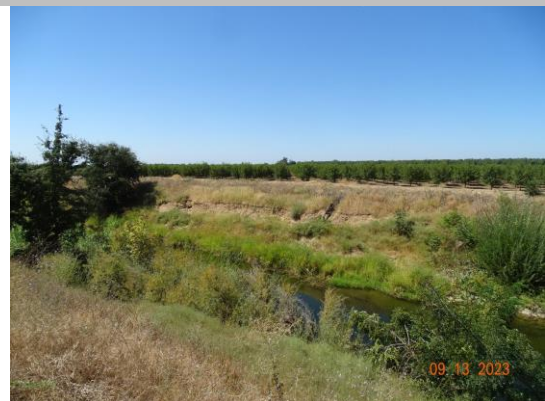
Photo 1 of 1 : FA_2023_NA0017_159_6_20231101_00247.jpg

View of channel bank erosion from opposite bank. Summer 2023

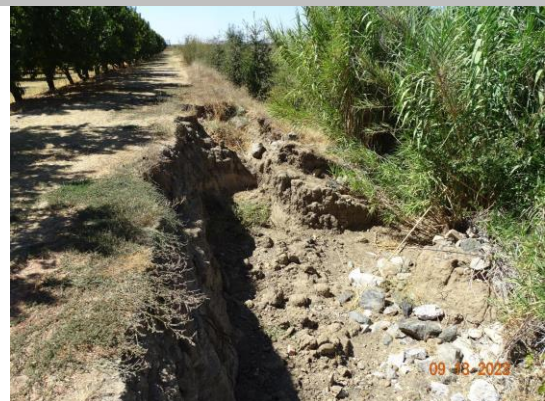
Photo 1 of 2 : SJR2023_NA0017U16RM15.87_3.JPG

9/13/2023: View of erosion looking downstream.

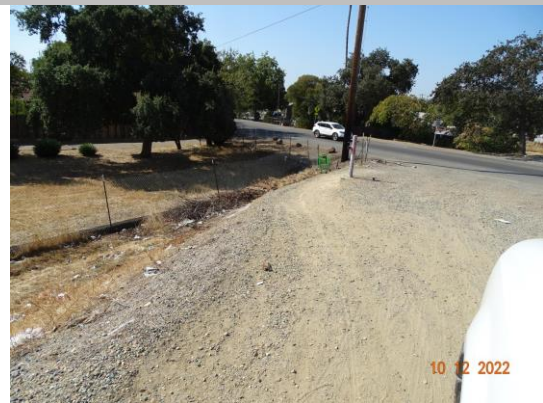
Photo 1 of 1 : FA_2023_NA0017_160_270_20230905_00075.jpg

View of pedestrian pathway along the landside slope. Fall 2022

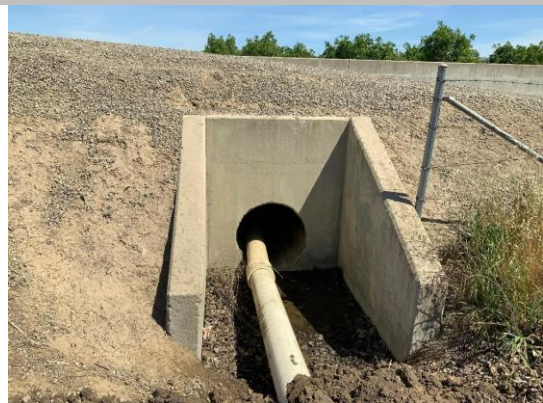
Photo 3 of 3 : UCIP_FA_2023_78219_98751.jpg

LS view: Slope and headwall at toe. Irrigation pipe going through inlet.
