**Flood Control Project Maintenance
Levee Inspections****Maintenance Issue Types Only, Levee Inspection Report By Mile - Fall 2024****San Joaquin County Flood Control and Water Conservation District**

Waterway	Bank	Unit Miles	Inspection Start/End	Inspector
Unit No. 01 Littlejohn Creek	Left	2.59	10/21/2024 10/21/2024	Alberto De Leon

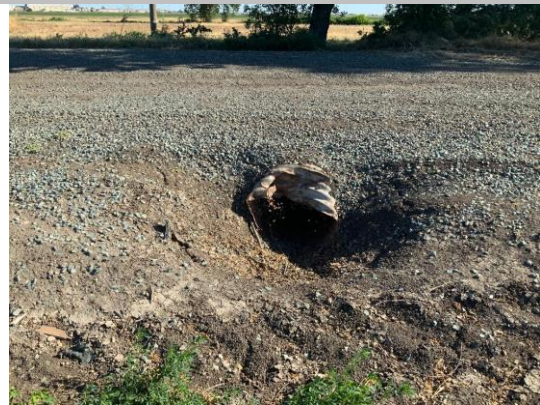
Photo 3 of 3 : UCIP_FA_2024_78235_96793.jpg

DS_ID:17973
FS_ID:78235
EP_NO: N/A
Repair Type: Urgent
EVAL Issue: 3a, Flood Risk
Crossing Status: Found
UCIP Comments: 04/27/2021 Pipe status is still Urgent. Slide gate no longer on WS, pipe is open on both ends. LS pipe edges are bent and warped. DWR DMP internal video inspection has found pipe integrity issues. LOF of crossing is between 4.1 and 5. Crossing will be monitored until funding becomes available for rehabilitation. Levee prism in this section appears to be less than 3 feet. No permit was found authorizing this encroachment. CVFPB will need to review crossing to determine owner. The UCIP inspection was completed with LMA representative, J. Nelson. (H. Dunn ? GEI)11/02/2018 Inlet deformed. Outlet missing a slide gate. The LMA states that a new slide gate will be installed in about two weeks. Inlet and outlet have dirt and vegetation issues. Crossing remains "Urgent" until a new slide gate is installed. Contact the LMA to see if they have photographic evidence that a new slide gate was put in. (A. McDonald - DWR UCIP)10/18/2018 Inlet deformed. Outlet missing a slide gate. This means that the pipe cannot be closed during high water. I have escalated this crossing from "No Action Needed" to "Urgent" due to the straight through pipe which could cause flooding during high water. There is a hole in the inlet, due to the deformity. It was most likely ran over by heavy equipment. I do not see enough evidence for an internal pipe inspection. (A. McDonald - DWR UCIP)3/25/2014 May need cleaning of mud in inlet pipe. (W. Wylie - DWR UCIP)

LS view: Inlet at toe, 1 of 2 photos.

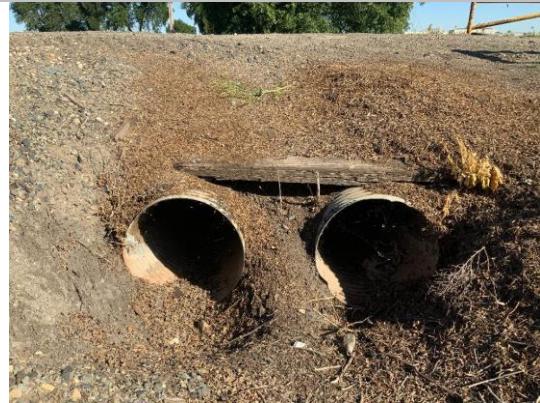
Photo 3 of 3 : UCIP_FA_2024_84806_96809.jpg

Comment Code						
Inspector Comment						
DS_ID:17972 FS_ID:84806 EP_NO: N/A Repair Type: Urgent EVAL Issue: 1, Pipe Integrity Crossing Status: Found UCIP Comments: 09/23/2024 Record updated from Non-Urgent to Urgent. DMP internal video inspection has found severe pipe defects. Crossing will be monitored until funding becomes available to address the issues. (O. Yakimov - DWR UCIP) 04/27/2021 The record has been upgraded from No Action Needed to Non-Urgent. Some vegetation in front of WS flapgate, recommend removal. DWR DMP internal video inspection has not found pipe integrity issues. LOF of crossing is less or equal to 4.0. Recommend next video inspection in 5 years. Levee prism in this section appears to be less than 3 feet. No permit was found authorizing this encroachment. CVFPB will need to review crossing to determine owner. The UCIP inspection was completed with LMA representative, J. Nelson. (H. Dunn ? GEI)11/02/2018 Inlet and outlet cleared of dirt by the LMA. Crossing has been downgraded to "No Action Needed." (A. McDonald - DWR UCIP)03/25/2014 LS vegetation debris and mud on the inlet ditch and inside the pipe. (P. Amatya - DWR UCIP) FIELD_STRUCT_DESC: 1 of 2: 36-inch corrugated metal drainage pipe (CMP) through the levee, 6.6 feet below the crown. Flap gate on the waterside (WS) end. [Additional Reference(s): DWR Levee Log, 1977, (HLM 1.05). USACE San Joaquin O&M Manual, Unit No. 613, Part C, May 1963, Revised 15 April 2010, (Station 94+40), 36-inch pipe listed. USACE As-Built File No. CA-2-6-147, Sheet No. 147/22, 25 March 1954, (Station 94+40)]. FS Date: 4/27/2021

LS view: Headwall and pipe inlets at toe.

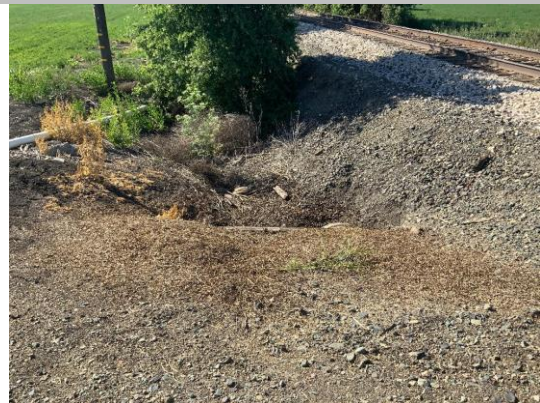
Photo 2 of 3 : UCIP_FA_2024_78237_96815.jpg

Comment Code					
Inspector Comment					
DS_ID:23995 FS_ID:78237 EP_NO: N/A Repair Type: Non-Urgent EVAL Issue: 5, Pipe Damage Crossing Status: Found UCIP Comments: 04/27/2021 The record has been upgraded from No Action Needed to Non-Urgent. DWR DMP internal video inspection has found pipe integrity issues. LOF of crossing is between 4.1 and 5. Crossing will be monitored until funding becomes available for rehabilitation. Vegetation covering WS flapgate, recommend removal. The levee prism in this section appears to be less than 3 feet. No permit was found authorizing this encroachment. CVFPB will need to review crossing to determine owner. The UCIP inspection was completed with LMA representative, J. Nelson. (H. Dunn ? GH/02/2018 Inlet and outlet covered in dirt. Inlet and outlet cleared of dirt by the LMA. (A. McDonald - DWR UCIP) 03/25/2014 Needs cleaning and clearing of the culvert. (P. Amatya - DWR UCIP) FIELD_STRUCT_DESC: 2 of 2: 36-inch corrugated metal drainage pipe (CMP) through the levee, 6.6 feet below the crown. Flap gate on the waterside (WS) end. [Additional Reference(s): DWR Levee Log, 1977, (HLM 1.05). USACE San Joaquin O&M Manual, Unit No. 613, Part C, May 1963, Revised 15 April 2010, (Station 94+40), 36-inch pipe listed. USACE As-Built File No. CA-2-6-147, Sheet No. 147/22, 25 March 1954, (Station 94+40)]. FS Date: 4/27/2021

LS view: Headwall visible at toe from crown.

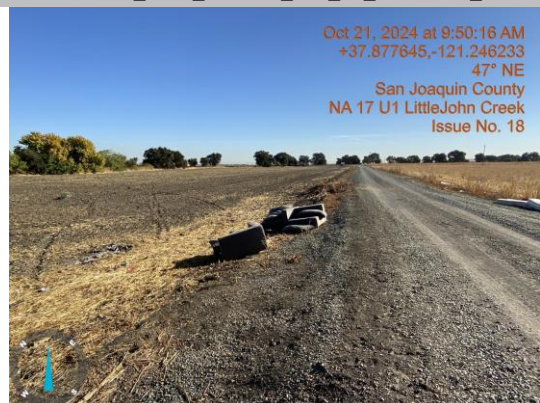
Photo 1 of 1 : FA_2024_NA0017_148_18_20241022_00038.jpg

View of couches along the waterside slope. Fall 2024

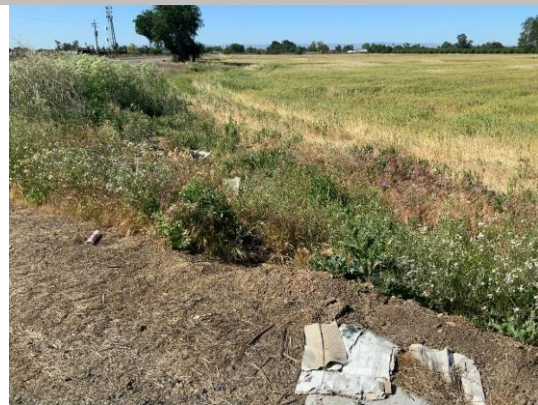
Photo 2 of 3 : UCIP_FA_2024_78240_96842.jpg

DS_ID:17969
FS_ID:78240
EP_NO: N/A
Repair Type: Non-Urgent
EVAL Issue: 10, Unauthorized Modification or Non-Compliant Permit
Crossing Status: Indicator Found
UCIP Comments: 04/27/2021 Pipe status is still Non-Urgent. This pipe appears abandoned, no standpipe on WS and no inlet structure on LS. Only pipe with appertence left on WS. Geophysical results did not confirm presence of pipe through levee. Record will remain in UCIP's inspection records until future Levee Improvement Project can confirm no crossing was found through the levee. The levee prism in this section appears to be less than 3 feet. This crossing was identified as a System Feature. The UCIP inspection was completed with LMA representative, J. Nelson. (H. Dunn ? GEI)03/25/2014 Appears abandoned and should be verified as having been done so properly. (P. Tariq - DWR UCIP) Concrete standpipe on waterside. Abandoned gate valve on waterside. Steel pipe disconnected with the standpipe inlet structure with steel gates and 18-inch alfalfa valve on landside.

LS view: Slope from crown, no inlet structure seen.

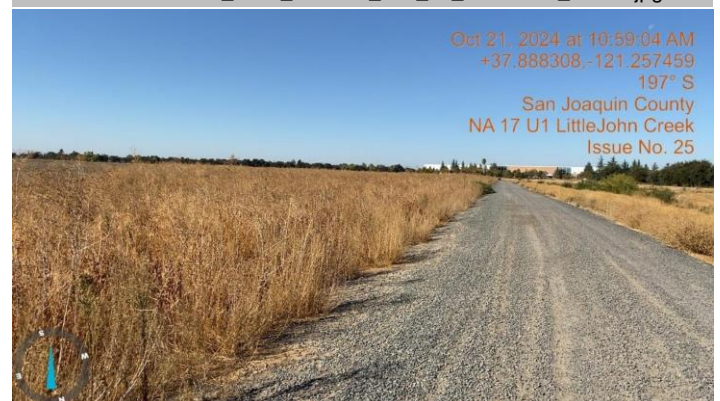
Photo 1 of 1 : FA_2024_NA0017_148_25_20241022_00039.jpg

View of overgrown vegetation along the landside slope and easement.
Fall 2024

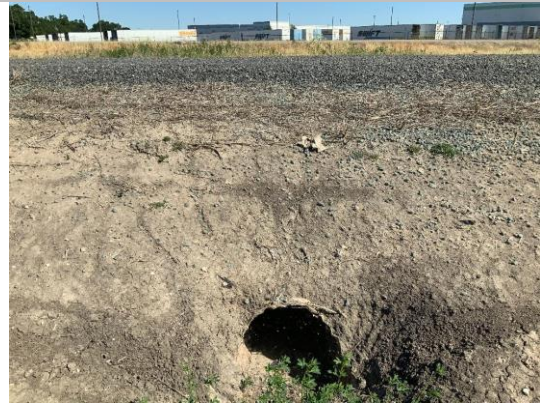
Photo 3 of 3 : UCIP_FA_2024_78852_96873.jpg

Comment Code					
Inspector Comment					
DS_ID:17966 FS_ID:78852 EP_NO: N/A Repair Type: Non-Urgent EVAL Issue: 11, Maintenance Compliance Issue Crossing Status: Found UCIP Comments: 04/27/2021 The record has been upgraded from No Action Needed to Non-Urgent. WS flapgate completely covered in vegetation and LS inlet has some sediment buildup inside, recommend cleaning on both ends. DWR DMP internal video inspection has not found pipe integrity issues. LOF of crossing is less or equal to 4.0. Recommend next video inspection in 5 years No permit was found authorizing this encroachment. CVFPB will need to review crossing to determine owner. The levee prism in this section appears to be less than 3 feet. The UCIP inspection was completed with LMA representative, J. Nelson. (H. Dunn ? GEI)11/02/2018 Inlet uncovered from the dirt by the LMA. Some vegetation at the flap gate. Crossing continues to be rated "No Action Needed." (A. McDonald - DWR UCIP)03/25/2014 Grouted riprap outlet box and concrete outfall pipe on waterside. Pipe not visible on landside. (P. Amatya - DWR UCIP) FIELD_STRUCT_DESC: 24-inch corrugated metal drainage pipe (CMP) through the levee, 5.0 feet below the crown. Flap gate on the waterside (WS) end. Grouted riprap outlet box and concrete outfall pipe on the WS. [Additional Reference(s): DWR Levee Log, 1977, (HLM 2.82). USACE San Joaquin O&M Manual, Unit No. 613, Part C, May 1963, Revised 15 April 2010, (Station 4+00), 24-inch pipe listed. USACE As-Built File No. CA-2-6-147, Sheet No. 147/1, 25 March 1954, (Station 4+00)]. FS Date: 4/27/2021

LS view: Pipe inlet at toe.

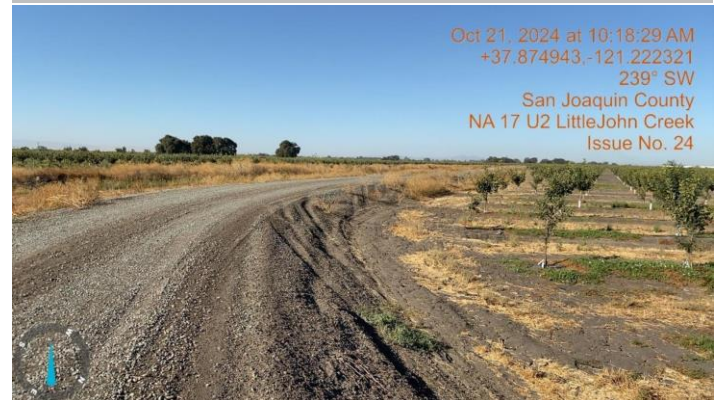
Photo 1 of 1 : FA_2024_NA0017_149_24_20241022_00046.jpg

LM Start	0.03	Rating **	C	Issue No.	21
LM End	0.03	Issue Type +	Ma	Location *	LS
Category	Earthen Levee			GPS Latitude/Longitude	
				Start	End
Item	Erosion / Vehicle Traffic			37.875173°	37.875173°
				-121.220615°	-121.220615°
DWR ID	DWR_NA0017_02_f_2023_21				
Comment Code					
E6 : Repair the levee slope damaged by vehicle traffic and prevent access where possible.					
Inspector Comment

View of vehicle damage on the landside slope. Fall 2024

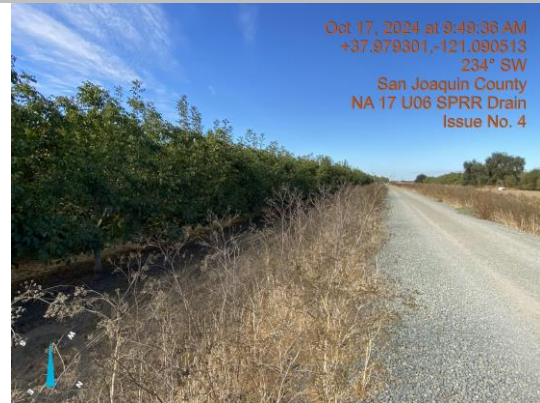
Photo 1 of 1 : FA_2024_NA0017_150_4_20241019_00006.jpg

View of vegetation along the landside slope and easement. Fall 2024

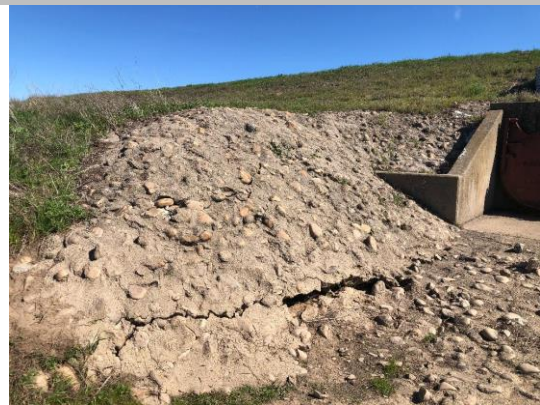
Photo 2 of 3 : UCIP_FA_2024_79017_92658.jpg

WS View: Crack observed in apron at WS toe.

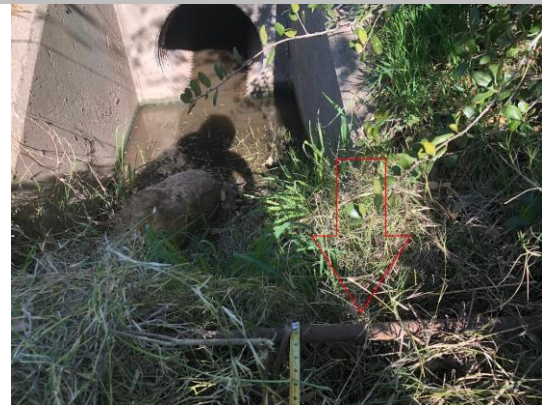
Photo 3 of 3 : UCIP_FA_2024_79417_92173.jpg

1-inch steel pipe observed adjacent to headwall at LS toe.

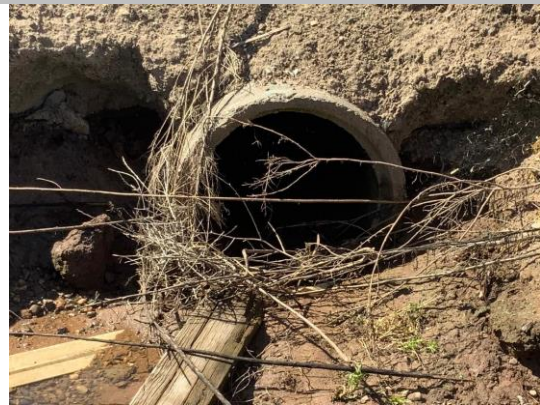
Photo 3 of 3 : UCIP_FA_2024_79142_98420.jpg

LS view: Close up of pipe inlet at toe, some erosion around pipe.

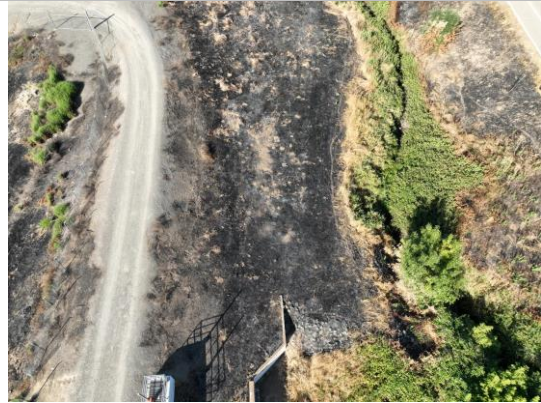
Photo 1 of 2 : SJR2024_NA0017U15RM4.62_7.JPG

8/8/2024: View of the erosion from the opposite bank.

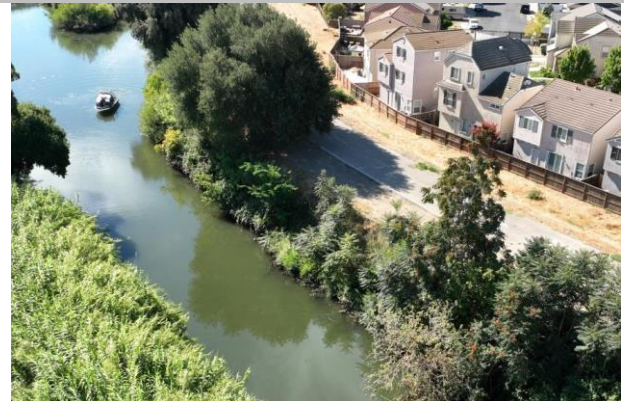
Photo 3 of 3 : SJR2024_NA0017U16RM2.01_8.jpg

8/1/2024: Zoomed in view of erosion.
